Ground Motion Characteristics of the 2015 Gorkha Earthquake, Survey of Damage to Stone Masonry Structures and Structural Field Tests

Rishi Ram Parajuli^{1*} and Junji Kiyono²

¹ Department of Urban Management, Graduate School of Engineering, Kyoto University, Kyoto, Japan, ² Graduate School of Global Environmental Studies, Kyoto University, Kyoto, Japan

Keywords: Gorkha earthquake, ground motion characteristics, damage survey, stone masonry, field test, Schmidt hammer test

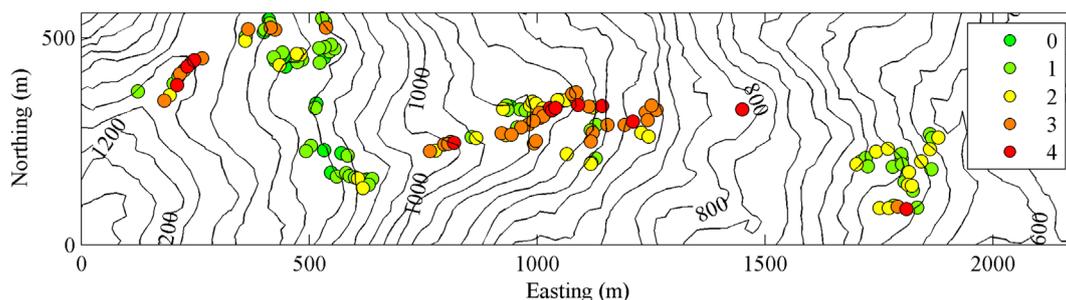
FIGURE 7 | Topographic map of the study area showing structural damage grade.

In the study cluster, there are 149 structures consisting of 58 large, 68 medium, and 23 small-sized buildings with 39, 46, and 15% of weightage, respectively. Damage grade and location were recorded using GPS at the site. **Figure 7** shows the damaged structures on a topographic map. Green colored dots represent grade 0 structures, whereas red dots represent the location of grade 4 structures (as we do not have any grade 5 structures). **Figure 8** shows the damage grade of structures with percentages of structures that include categories of structure sizes. We found that 8% of the structures had a damage grade of 0; 38% were in grade 1; and grade 2 and grade 3 structures were 24% each. The remaining 6% of the structures were damaged severely, at grade 4.

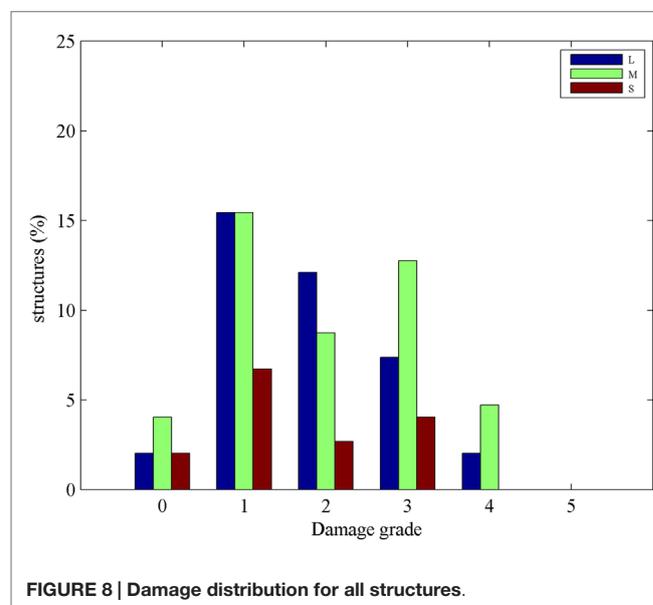
Here, we can see most of the structures fall under damage grades 1, 2, and 3, with less coming from grades 0 and 4. From the survey, we found that most of the buildings on ridge lines suffered heavy damage but those on side-slopes were not damaged as much. The study area comprises an area that includes a mountain ridge along with a local ridge line formed on the middle of the slope. Hence, we categorized the structures as ridge-line structures, those that are located on the ridge line. There are a total of 52 structures located on the ridge line, including the main and local ridge lines. Damage grade details of the structures on the ridge line are shown in **Figure 9**. There are no structures that fall under grade 0; in fact only 15% of the structures graded as 1 with 19% in grade 2. More than half of the structures, i.e., 52%, were grade 3 and the remaining 14% fell under grade 4. A small structure that was graded as 3 on the ridge line is shown in Image S1 in Supplementary Material.

FIGURE 8 | Damage distribution for all structures.

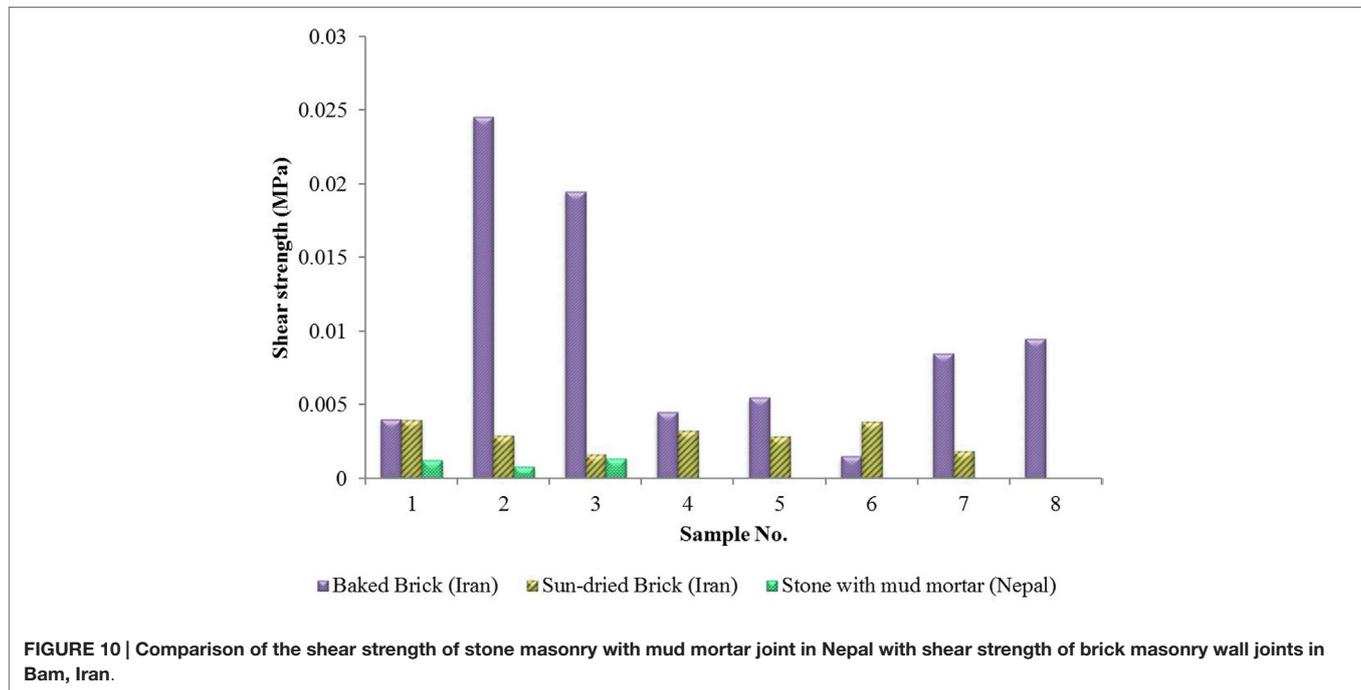
Samples of the test are not enough to conclude the material strength; hence, we compare these values with the test results from the 2003 Iran Bam earthquake damage survey (Kiyono and Kalantari, 2004). Results of the test conducted in Iran and Nepal are shown in **Figure 10**. In Iran, tests were conducted for sun-dried and baked brick masonry structures, where the shear

strengths of mortar bonding were estimated to be 0.0029 and 0.0097 MPa, respectively. The frictional coefficient for the joint was found to be 0.62 and 0.54, respectively, for sun dried and baked brick masonry. Test results from Nepal show that the frictional coefficient lies between the values of sun-dried and baked masonry structures in Iran, but shear bonding strength is much lower than that of both brick masonry structures.

**FIGURE 10 | Comparison of the shear strength of stone masonry with mud mortar joint in Nepal with shear strength of brick masonry wall joints in Bam, Iran.**
