Framing Failures in Wood-Frame Hip Roofs under Extreme Wind Loads

Sarah A. Stevenson¹, Gregory A. Kopp^{1*} and Ayman M. El Ansary²

Stevenson SA, Kopp GA and
El Ansary AM (2018) Framing Failures
in Wood-Frame Hip Roofs under
Extreme Wind Loads.
Front. Built Environ. 4:6.
doi: 10.3389/fbuil.2018.00006

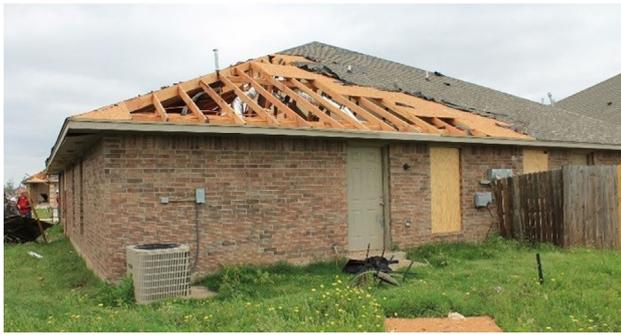
FIGURE 1 | Example of roof sheathing failure, corresponding to DOD-4 (image source: Dr. David Prevatt of University of Florida).

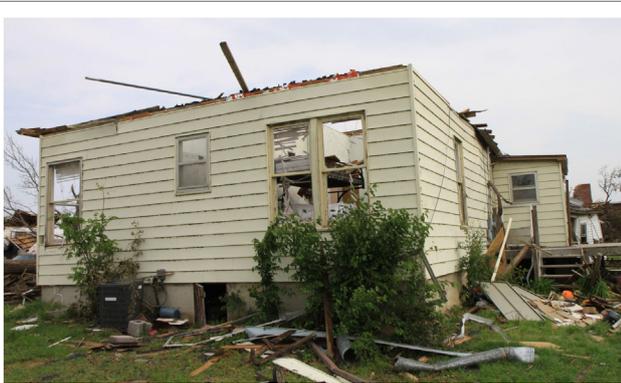
FIGURE 2 | Example of roof-to-wall-connection failure, corresponding to DOD-6 (image source: Dr. David Prevatt).

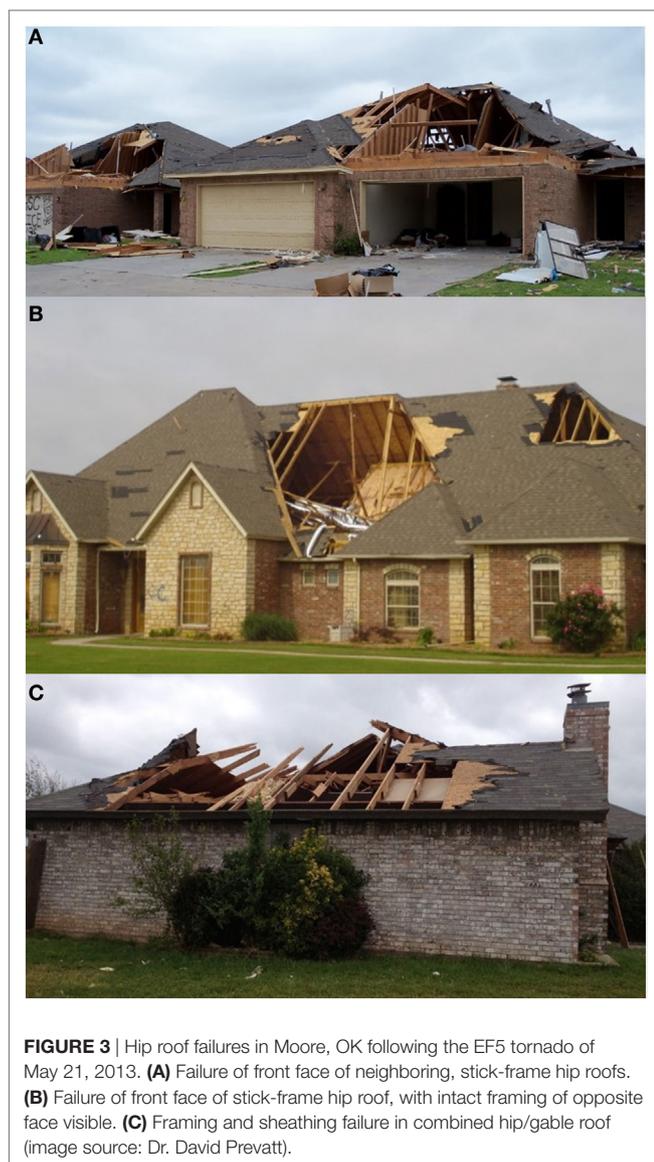
Figure 3A shows neighboring hip-roofed homes that exhibit similar failures of the front face of the roof. The RTWCs appear to be intact around the remaining perimeter of the roof and it is apparent that several members of the roof frame have failed or been removed, in addition to the sheathing covering this portion. At the right side of the photo, the remaining part of the roof is sagging, which further indicates that the underlying frame has failed. The houses shown in **Figure 3A** were located along Kyle Drive at the western edge of Moore, OK. Several houses along this short stretch had similar failures of hip roof framing and were built around 2006 (Graettinger et al., 2014). Inspection of the damage photos from this neighborhood indicate that, of houses experiencing DOD-4 or DOD-6 roof damage, 40% appeared to have failed through similar partial failures. In these cases, it appears that the frame failed at the nailed connections between the members, as no broken lumber is visible. The following section will present additional statistics and observations from two selected neighborhoods following the Joplin, MO tornado.

Figure 3B shows a failure similar to that in **Figure 3A**, but of a much steeper roof. The RTWCs appear to be intact, and a large open cavity is visible where both framing members and sheathing have been removed. Similar to **Figure 3A**, it is apparent that this roof did not exclusively suffer sheathing loss, although the smaller area of sheathing loss at the right side of the photo should be noted. The lack of visible internal members in the cavity, especially those supporting the intact opposite face of the roof, strongly suggest that this roof was built as a stick-frame structure as opposed to the one containing prefabricated trusses. Many of the failed hip roofs in the available data appear to have used stick framing.

Figure 3C shows a partial failure of a combined hip/gable roof. This failure is unique from those shown in **Figures 3A,B** because material failure of the wood members is apparent. The RTWCs appear to be intact, with the lower part of the

roof having lost only sheathing on the right side and framing members, in addition to sheathing, on the left. Near the peak of the roof, the frame has failed on both faces. This structure appears to contain either trusses or stick framing with robust connections. As indicated in the figure just above the RTWC, the members were connected or otherwise reinforced using nailed wooden plates.

Upon inspection of the failures shown in **Figure 3** and similar damage in the available photos, it becomes apparent that partial framing failures are possible, repetitive modes of failure occurring in hip roofs. When comparing these hip roof failures to nearby structures from the data, it was determined that framing failures may govern in some hip roofs at EF2 wind speeds, rather than RTWC failures or sheathing loss. It is also noted that the construction of the roof may be important. The observed stick-frame failures especially suggested that the performance of stick-frame roofs should be distinguished from that of trussed structures in analysis and design, as well as in the present research.

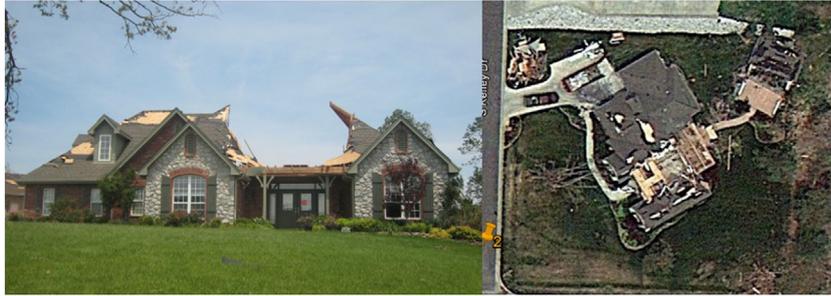
of failure of the RTWC. **Figure 5** shows an example of the steep-sloping hip roofs visible throughout this neighborhood, with an aerial image showing how the surface area of the roof was affected by the failure. In many instances, the largest surfaces of the roof were removed, while parts of the structure enclosing smaller spaces remained in place. Many of these structures also appeared to be of stick-frame construction.

FIGURE 5 | Example of typical hip roof failure in Region 1, including an aerial photo showing the footprint of the partial failure (image source: Dr. David Prevatt, Google Earth).

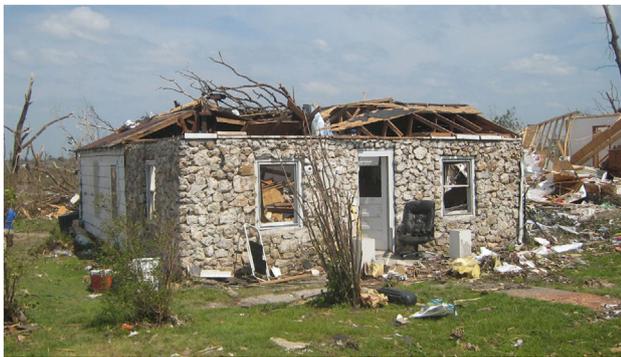
FIGURE 6 | Partial hip roof failure in Region 2 (image source: Dr. David Prevatt).

ambiguous, and because Region 2 was downwind of Region 1, debris likely played a larger role. In any case, in both regions, partial failures are found to occur at least as often as other modes of roof failure. More work is required to obtain a complete set of statistics on these failures and better define the regional conditions that may contribute to their occurrence.

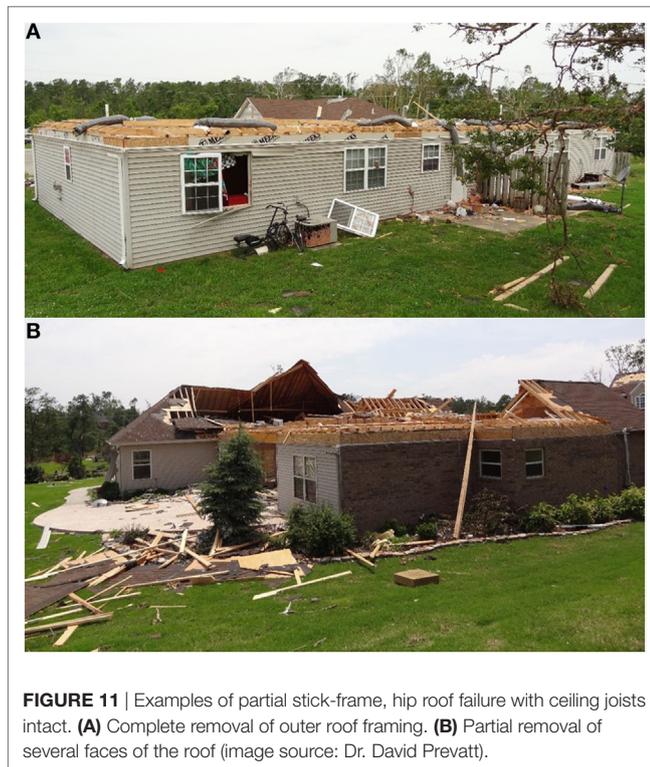
In **Figure 11**, partial framing failure and removal of large sections of the roof appears to have occurred. Upon closer inspection, however, it becomes apparent that the ceiling joists and the ceiling beneath them are intact. Only the external rafters and attached sheathing have been removed or damaged. Based on the results of the D/C analysis for the stick-frame case, this type of failure is unlikely, due to the relatively robust connection between the rafter and the ceiling joist. The RTWC and the connection along the ridge of the roof appear to be much more vulnerable in analysis, in comparison to the seven-nail joint previously mentioned. The pictured failures may have occurred due to improper or missing fasteners between the rafter and the joist at the wall top plate or initiated as failure of the upper rafter joint. Additionally, system effects may have led to progressive, cascading failure of adjacent

joints, resulting in removal of entire faces of the roof following initiation at a single point.

The failures shown in **Figure 11**, and many other similar failures, are interesting because they would be objectively classified within DOD-6 for residential roofs; however, this may be an inaccurate assumption. This is an important point for further exploration because it may influence refinements to the EF-Scale for different residential design methods, or even suggest a new DOD for stick-frame structures.
