Hain A, Zaghi AE, Padgett JE and Tafur A  
(2023), Case studies of multihazard  
damage: Investigation of the interaction of  
Hurricane Maria and the January 2020  
earthquake sequence in Puerto Rico.  
*Front. Built Environ.* 9:1128573.  
doi: 10.3389/fbuil.2023.1128573

# Case studies of multihazard damage: Investigation of the interaction of Hurricane Maria and the January 2020 earthquake sequence in Puerto Rico

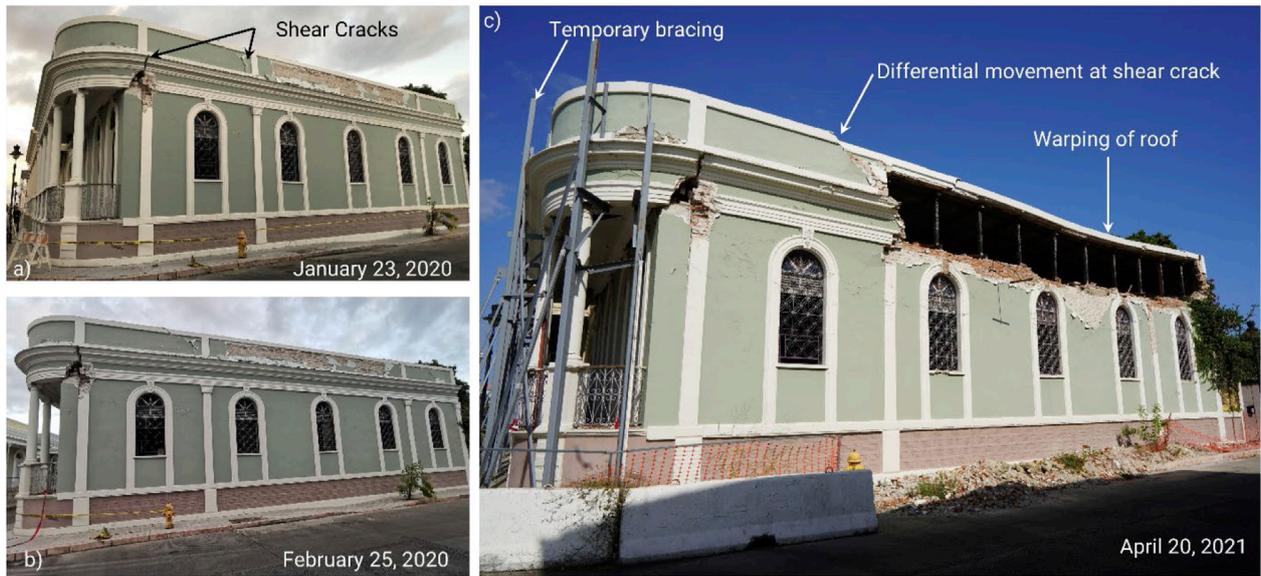
systems. A sample of the damage progression over time is shown in Figure 4. During the initial events, this building sustained severe damage including shear cracking at the awning and at multiple locations along the roof as shown in Figures 4A, B. At this point, the building was roped off and entry was halted for safety concerns. As the aftershocks continued, the damaged worsened, as shown in Figure 4C. One of the shear cracks along the side of the building expanded and the brick wall collapsed which exposed the structural support system of the roof. It is also important to note that the front of the structure was supported by temporary bracing that was installed after the main shock, which prevented the collapse of this portion. This shows that minimal external bracing/shoring or strengthening is an effective strategy in preventing unrecoverable damage or total collapse during aftershocks. This is particularly important for brittle structures

**FIGURE 4**  
 Damage progression of sample historical building in downtown Ponce under aftershock events. Images were taken during consecutive visits on (A) 23 January 2020, (B) 25 February 2020, and (C) 20 April 2021.

that lack an engineered system to provide ductility and energy dissipation, and those with historic significance. To minimize damage in subsequent events it is critical to first identify the repair priorities and then allocate the resources needed to execute the repairs. When identifying repair priorities, safety, economic impact, and historical significance should be considered.

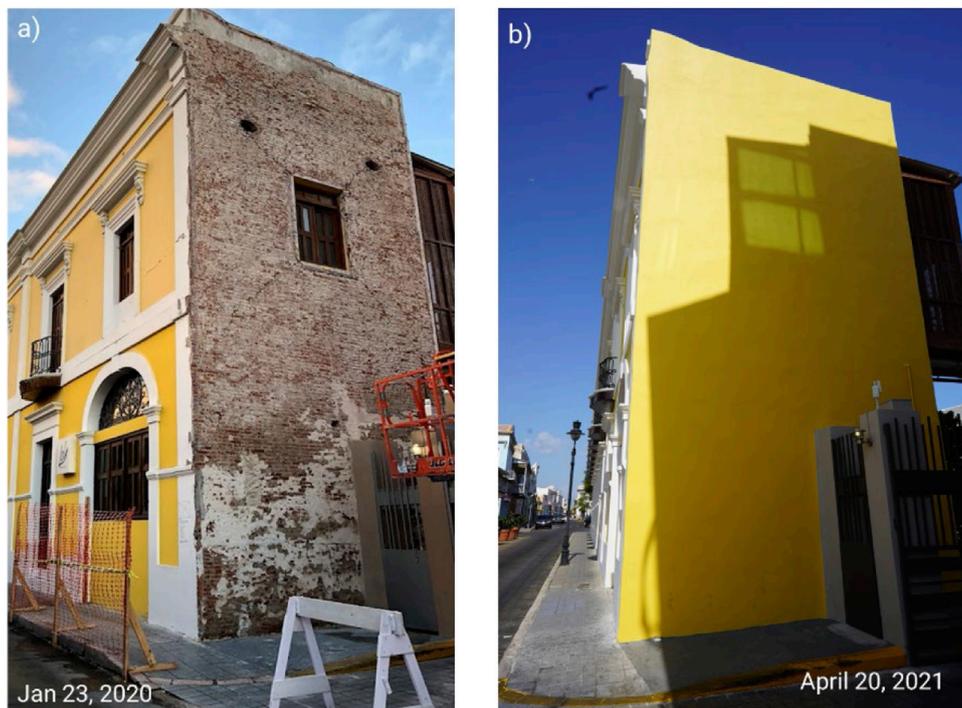
A second example of a historical building that suffered damage during the initial earthquake series is shown below in Figure 5. In Figure 5A, shear cracks on the unreinforced masonry wall around the window opening are visible. This hotel is located in downtown Ponce. It experienced temporary closures after the damage was discovered from the mainshock. The damage was repaired quickly, and the window was removed to form a more robust lateral load resisting system as shown in Figure 5B. This illustrates how the

**FIGURE 5**  
 Historical hotel in Downtown Ponce showing (A) damage after initial earthquake series and (B) view of repaired wall segment.

timely implementation of repairs can protect vulnerable, but significant, structures from increased damage.

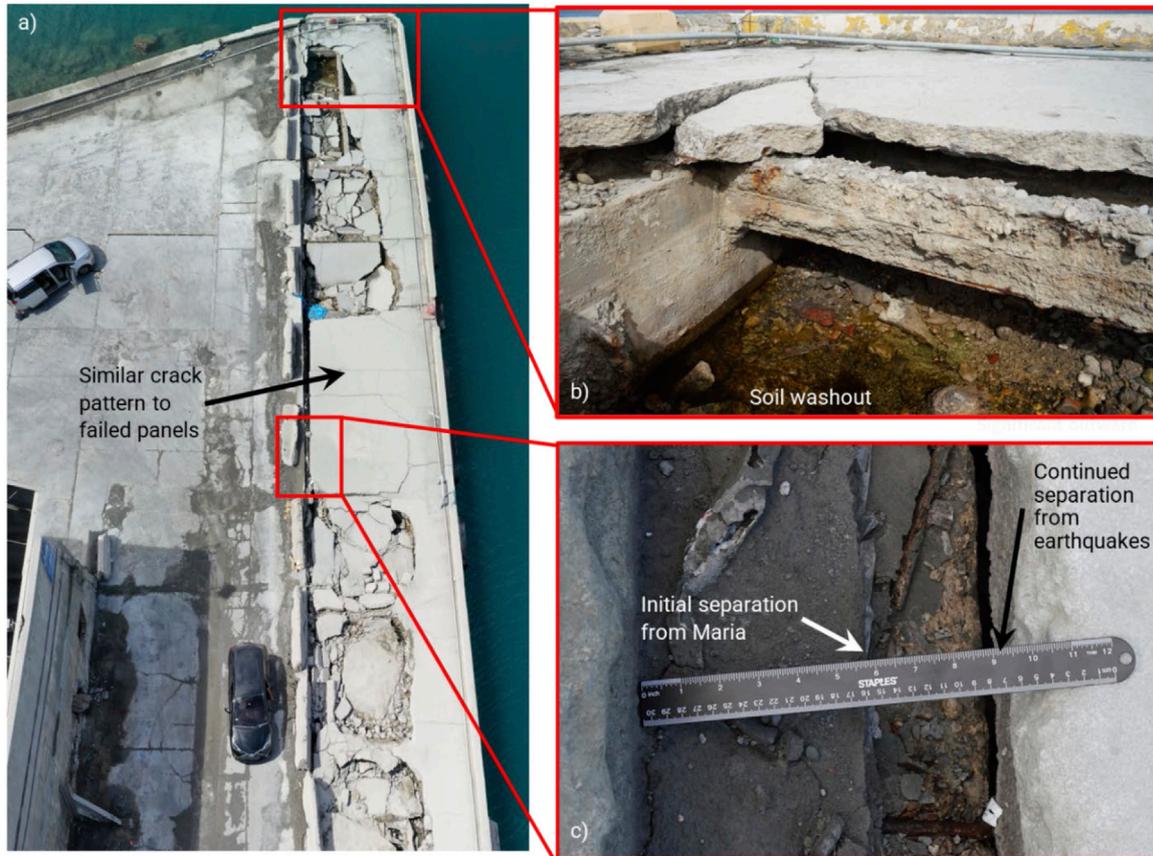
**FIGURE 6**  
 Images of damages to Pier following January 2020 earthquake series including (A) an aerial view of the overall damage, (B) washout of soil underneath collapsed panel, and (C) representative image showing separation of main slab and pier.

This case highlights one pier that sustained severe damage during the earthquakes, shown below in Figure 6. The level of damage sustained was greater than what is expected from earthquakes of this magnitude, suggesting additional factors contributed to the damage. Major damage types included seaward displacement of panels (Figures 6A, C), bowing of the berth (Figure 7), and collapse of panels (Figures 6A, B). Upon inspection, the team determined the slab failure of the pier that occurred during the earthquake series was caused by compromised support conditions. Key personnel from the site noted washout from the pier was evident after Hurricane Maria. In addition, evidence of coastal erosion in the region was noted in Geotechnical Extreme Events Reconnaissance report following the hurricane (Silva-Tulla et al., 2018). The erosion of the supporting soil fill, as shown in Figure 6B, made the unreinforced slab-on-grade vulnerable to the seismic shaking.

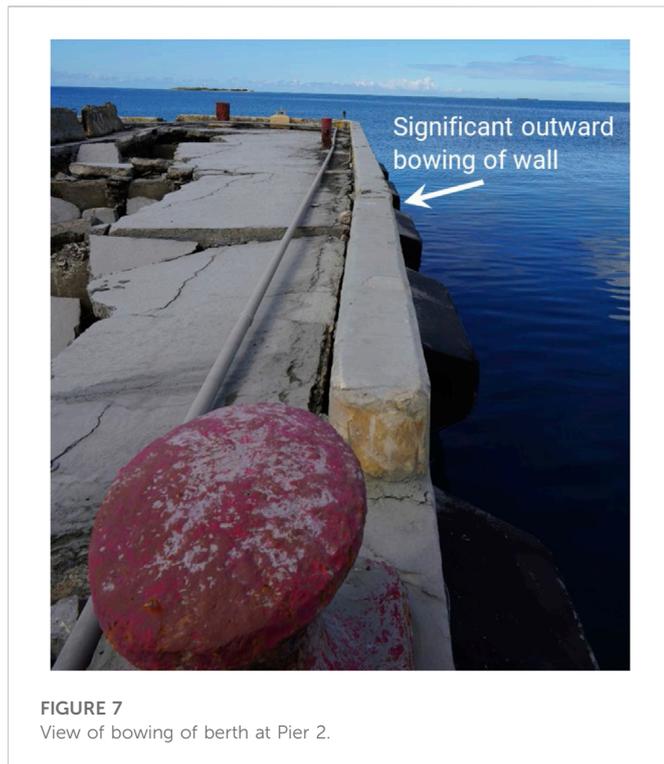
As shown in Figure 7, there was severe bowing of the berth at the upper region of the pier. This bowing shows an area on the edge of the pier that is experiencing larger outward displacements compared to other areas along the length, which suggests more significant pile damage at this location. It is unlikely the bowing is caused by large soil or water pressure at this location, as washout of the soil fill within the damaged regions was observed.

**FIGURE 7**  
View of bowing of berth at Pier 2.

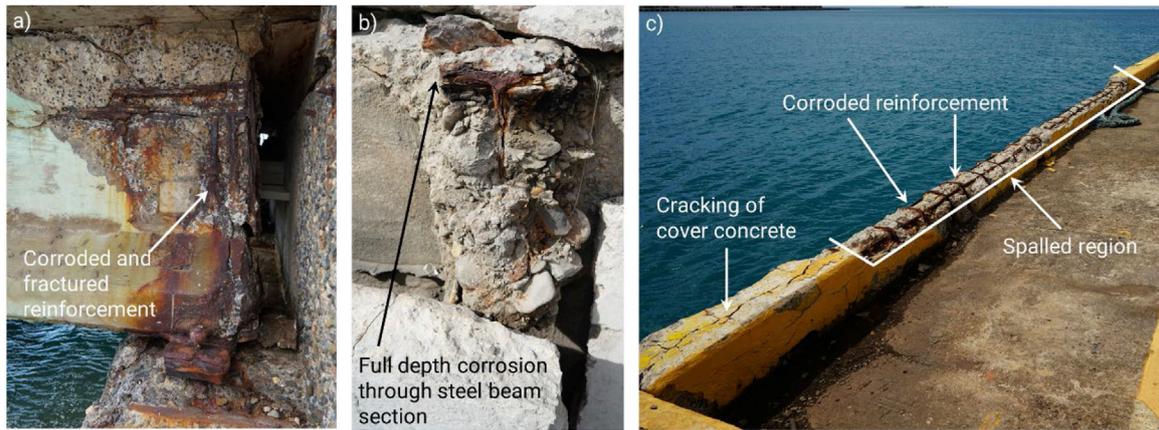
The majority of the earthquake damage at the ports inspected was exacerbated by underlying corrosion of the structure. This was likely worsened or initiated in Hurricane Maria due to acceleration of corrosion damage in structural components due to increased exposure to sea water. The high level of corrosion present contributed to the spalling and failure of elements in the seismic events. Piers had substantial corrosion in the superstructure. This included the beams (Figure 8A), support structures for slabs (Figure 8B) and the concrete barrier surrounding the edge of the piers (Figure 8C). In many cases, the corrosion damage was not observable prior to the earthquakes when the concrete spalled, but the level of corrosion in the exposed elements indicates that corrosion has been occurring for some time. This makes it challenging to identify corrosion in inspections and, therefore, unlikely to be repaired until it reaches a critical level. Understanding the progression of corrosion and how this deterioration impacts structural behavior under extreme events is critical for predicting performance of aging structures and should be considered in design.

Elements at the ports inspected had severe corrosion damage that was observable after the earthquake series. Sample views of different elements with visible deterioration from corrosion include (A) beams, (B) support structures for slabs, and (C) concrete barrier surrounding the edge of the piers.

such as increasing the thickness of the cover concrete, using corrosion resistant reinforcements such as epoxy coated or stainless-steel rebar, or including sacrificial thickness or a concrete coating for steel piles, can mitigate the adverse impacts of corrosion damage. However, implementing such strategies often results in increased costs and not all options were available during the construction of older port structures. For reinforced concrete elements, such as beams, slabs, and piles, corrosion of reinforcement is likely to occur if widespread cracking or insufficient cover is present. Corrosion of the reinforcement leads to the spalling of cover concrete, which then further exposes reinforcement. This corrosion weakens the structural elements and may lead to widespread damage under extreme loadings, such as hurricanes and earthquakes.

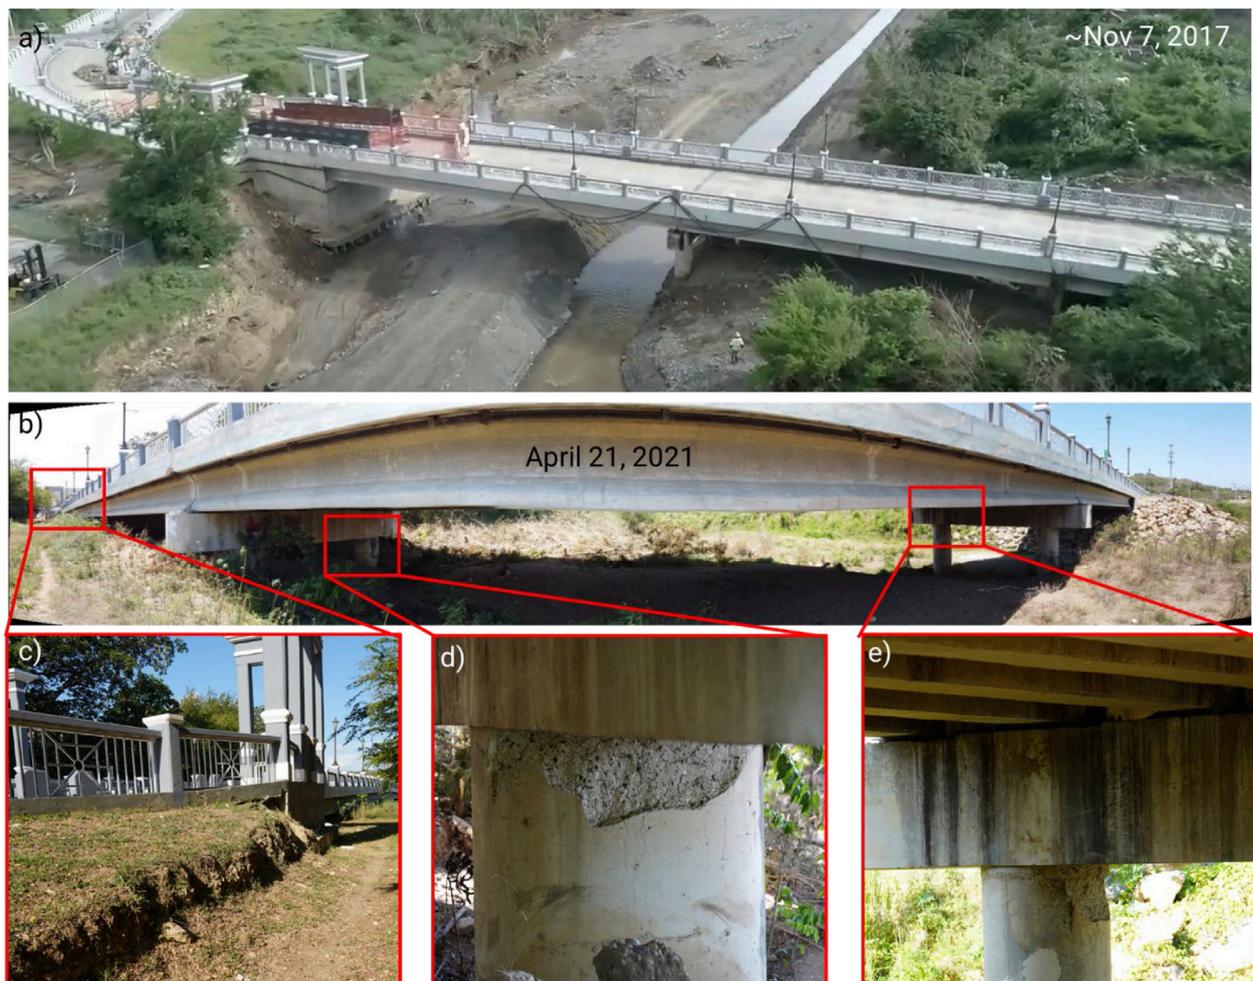
During Hurricane Maria, the Guayanilla River flooded, which resulted in washout and debris impacts. This was observed on the bridge carrying PR-127, which spans the river. The washout was most severe at the abutment, where exposed piles can be seen on the left of Figure 9A. The bridge was closed and required repair, including backfilling behind the abutment and fill work in front of the abutment (Maria, 2017). This bridge was not visited in the missions in 2020, but after seeing the drone footage from after Hurricane Maria, was added to the inspection list for the 2021 mission. Following the earthquake series and as of April 2021, the bridge remained open to traffic. A panoramic view of the bridge taken with a drone is shown in Figure 9B. Upon further inspection, the research team found several examples of seismic damage, including cracking at the abutments from pounding, bent anchor bolts at the bearings, and spalling at the top of the columns, as shown in Figures 9D, E. There was also evidence of geotechnical

Bridge in Guayanilla, PR over the Guayanilla River. These photos include (A) a screenshot from a drone flyover taken 50 days after hurricane Maria (Maria, 2017), (B) an overall view of the bridge taken on the final reconnaissance mission, (C) the geotechnical impacts observed at the abutment, (D) cracking on support column on Pier 1, and (E) cracking of support column on Pier 2.

damage, as shown in Figure 9C, but it was not clear if this was left over from hurricane Maria, or a result of the earthquakes.

This case study was included to show an example of where the multihazard effect was not clear. While there was no direct evidence, the soil washout that occurred at the abutment and piers may have contributed to more extensive damage to the bridge columns than was observed at other bridges in the area. In addition, if this spalling is not repaired in a timely fashion, the column reinforcement at the critical plastic hinge zone will be subjected to premature corrosion damage, which will further weaken the structure.

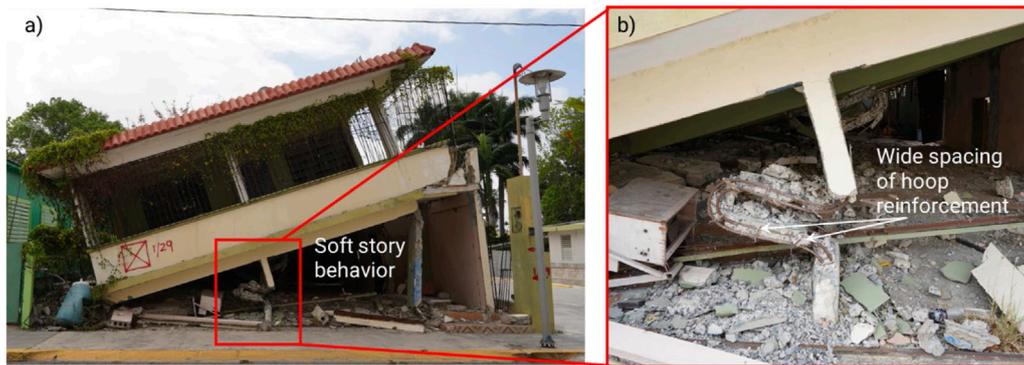
Damage of building in Guánica, PR following earthquake series showing (A) overall damage and soft-story failure mode and (B) close up of support column collapse.
