Aslan H, Kocaman H, Sikar RB and Turan İC (2025) Impact and GNSS-based deformation analysis of the earthquake in Türkiye on 6 February, 2023: a case study of the TAG (Tarsus–Adana–Gaziantep) motorway and Hatay airport.

Impact and GNSS-based deformation analysis of the earthquake in Türkiye on 6 February, 2023: a case study of the TAG (Tarsus–Adana–Gaziantep) motorway and Hatay airport

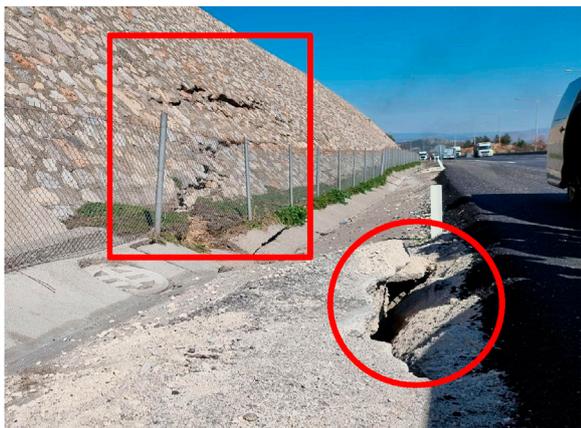
In the main body of the TAG motorway, no serious subsidence problems occurred due to the rigid structure of the viaducts. Although good performance was thus observed, some collapses occurred through some sections of the motorway with the earthquake effect. When viewed from this perspective, it was observed that 50–60 cm collapses occurred at a scale that caused structural problems. These collapses were around the rainwater down-pipe and were effective along approximately 200 m of the road section. In addition, damage occurred in the intercepting ditches, side ditches, and support structures related to subsidence problems. Furthermore, gaps of up to 30 cm were measured between the road pavement and the side ditch (Figure 5). This damage necessitated the closure of the related sections of the motorway to the traffic on the first day of the earthquake, except for emergency vehicles.

FIGURE 5
Collapses and applied emergency repairs on the motorway [Latitude: 37.183063–Longitude: 36.710260].

For the repair of the main road structure, a surface course was laid to re-open the highway and viaduct sections to serve to normal traffic on the second day.

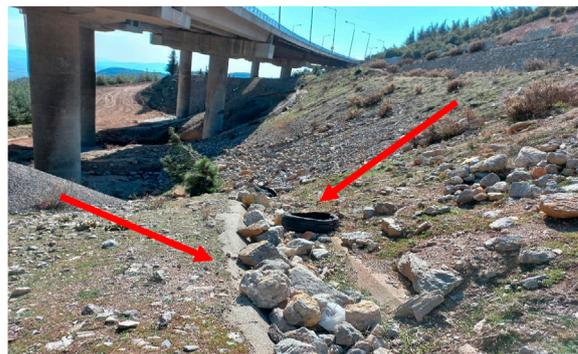
As a result of soil and rock erosion caused by earthquake movements, a blockage occurred in the drainage ditch (Figure 8). The intercepting ditch on the edge of the Nurdagi Viaduct was blocked due to soil movement during the earthquake. A road intercepting ditch is a gutter constructed to drain water coming off the road to protect the cutting slope. As seen in Figure 8, the head ditch was filled with large stones and rock rubble after the earthquake. If this blockage is not removed, it will be difficult to drain the water, and serious problems may arise, including significant negative effects for viaduct footing foundations.

FIGURE 8
Drainage blockage between Nurdagi Viaduct (East) and D.400 Highway [Latitude: 37.171412–Longitude: 36.700336].

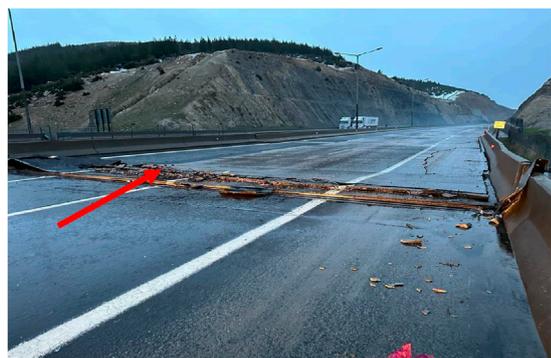
Collapses occurred in the road body as a result of the deterioration of the road infrastructure due to the earthquake

movement and fault effect. Slight collapses such as shown in Figure 6 were repaired, and the roadway was opened to traffic as a result of temporary measures taken by the General Directorate of Highways within the first 24 h after the earthquake.

FIGURE 6
Cracks at Ataturk Viaduct (East) [Latitude: 37.195881–Longitude: 36.722933].

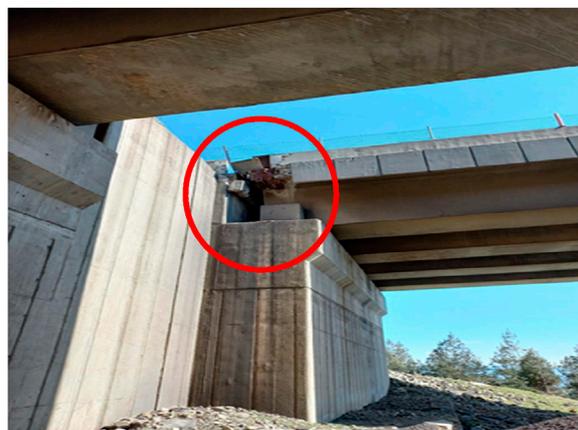
changes and earthquake displacements. As seen in **Figure 9**, the joints available absorbed the damage caused by earthquake shifts and prevented structural damage to the viaduct beams. The main function of the expansion joints is to sacrifice themselves in an earthquake and ensure that the main structure remains standing. When considered from this perspective, the expansion joints did fully accomplished their function. The joint profiles used in the Nurdagi viaduct are of 240 mm cross-sectional profiles; as a result of displacement exceeding this

value, the relevant viaduct joint profiles were seriously damaged. Traffic flow was ensured using steel plates within the scope of temporary repair.

FIGURE 9
Expansion joint damage in reinforced concrete, Nurdagi Viaduct [Latitude: 37.171443–Longitude: 36.700860].

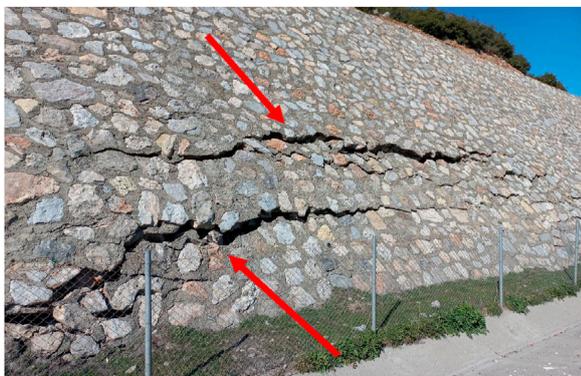
Due to earthquake movements, cracks and displacements occurred in the stone retaining wall on the mixed section of the road consisting of cut and fill (Figure 7). Due to deformation, the stone retaining wall was damaged and lost its functionality. It was observed that no repair work was carried on cracks and deformations as they were not considered within the scope of emergency repair. In order to ensure road safety, it is necessary to repair the stone wall within the scope of permanent repairs after emergency repairs.

FIGURE 7
Deformation on road protective structures (retaining wall) between Ataturk and Turgut Ozal Viaducts [Latitude: 37.183063–Longitude: 36.710260].

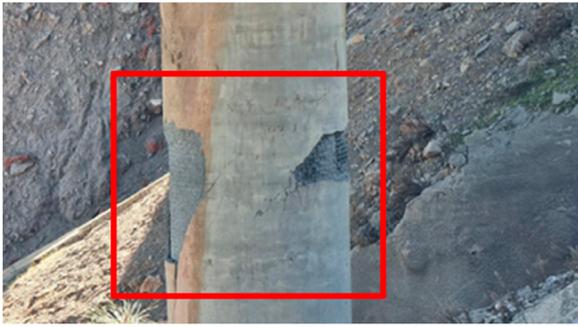
Due to the great earthquake effect, the forces acting in the longitudinal direction of the bridge created deformation in the middle parts of the circular cross-section column. It is

FIGURE 10
Plasticated concrete parts and damaged reinforcement of the abutments at Nurdagi Viaduct [Latitude: 37.170928–Longitude: 36.700281].

Plastication and cracks caused by longitudinal movements were especially observed at the middle points of the mid-high bridge piers. It is important to reinforce these piers where the stated damage occurred on a limited scale.

recommended that this damage be repaired by strengthening the column. **Figure 10** demonstrates the damage that occurred to one of the columns of Nurdagi viaduct.

The use of composite materials such as fiber-reinforced polymer (FRP) is recommended for the strengthening process of the existing concrete viaducts. Additionally, adopting modular steel designs can facilitate both reinforcement and maintenance processes, thereby extending the lifespan of the infrastructure. Base isolation techniques or energy dissipation devices (e.g., dampers) should be employed in both new and existing viaducts to mitigate the effects of seismic forces.

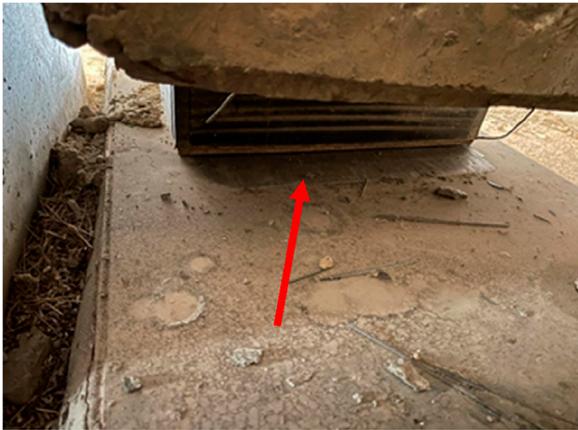
The earthquake caused an average longitudinal displacement of 10 cm in the bearings on which the beams sit (**Figure 11**). It is recommended that all the damaged structural bearings be replaced with the new ones.

FIGURE 11
Damaged structural bearings.

When the reinforced concrete viaducts were examined, it was determined that they were damaged as a result of the longitudinal effect of the earthquake rather than its lateral effect. The elastomeric bearings at the beams fulfilled their duties during the earthquake and had permanent deformation. Accordingly, measurements showed that the viaduct beams shifted longitudinally in the range of 5–10 cm. These elastomer bearings that have completed their duties must be immediately replaced with the new ones.

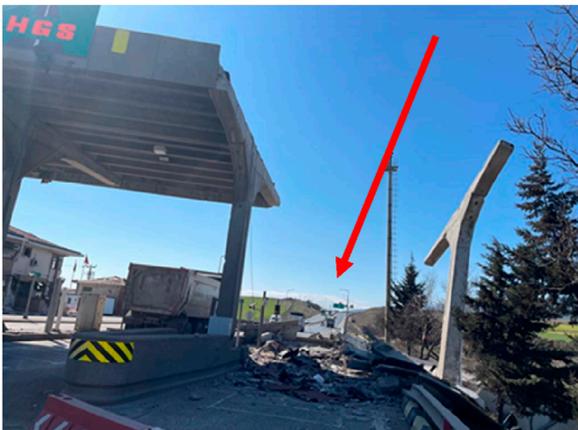
During the earthquake, due to the effect of the fault, the foot on which the toll booth canopy was based moved and the canopy fell to the ground at the Komurler toll booths (**Figure 12**). The collapsed toll booth canopy caused one lane to be closed, resulting in traffic being diverted through other lanes.

FIGURE 12
Damage at Komurler toll booth [Latitude: 37.197524–Longitude: 36.763037].

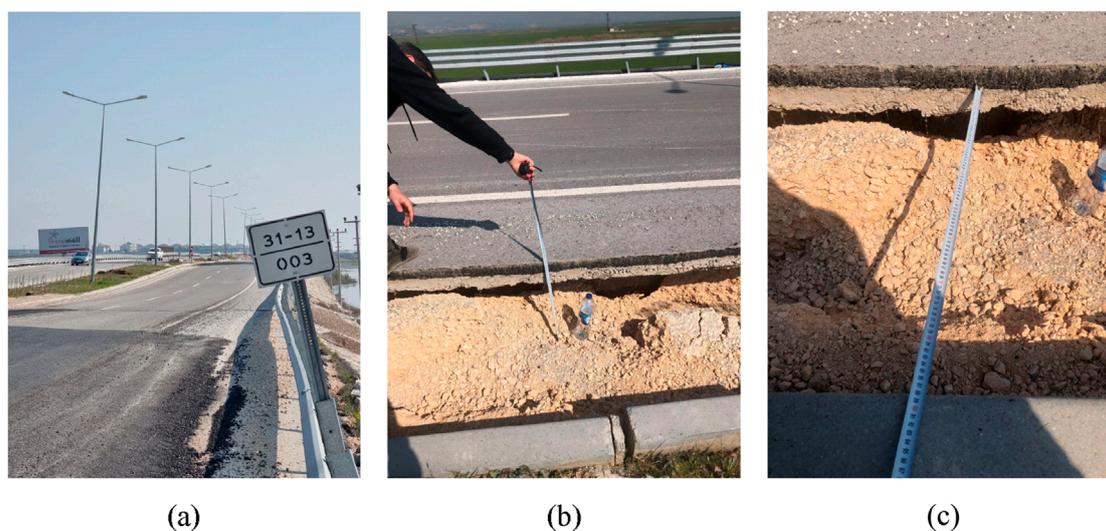
FIGURE 15
(a–c) Field observations and measurements carried out on Hatay airport road on 23.02.2023. (a) General view of the damaged road section; (b) Deformation detail with measurement; (c) Close-up view showing the depth and crack width measurements.

The damaged parts that occurred due to deformation on the airport access road were quickly repaired to ensure that access to the airport after the earthquake was provided. However, as can be seen in Figure 15 obtained from the field observations on 23 February, 2023, 17 days after the earthquakes, there were still visible defects on the road axis.

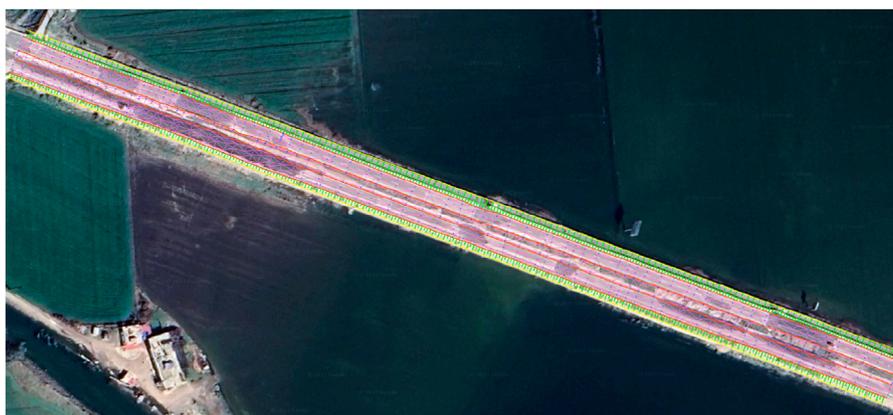
FIGURE 16
General condition of the damaged 600-m section of the airport road with measurements taken.

Following the field observations, the GNSS device was connected to the TUSAGA-AKTİF (CORS-TR) network on the approximately damaged 600 m section of the road, and measurements were made at almost equal intervals (Figure 16). The data obtained from these measurements were evaluated by computer analysis. Subsequently, the cross sections and profile of the current state of the road were obtained to analyze its geometrical characteristics.

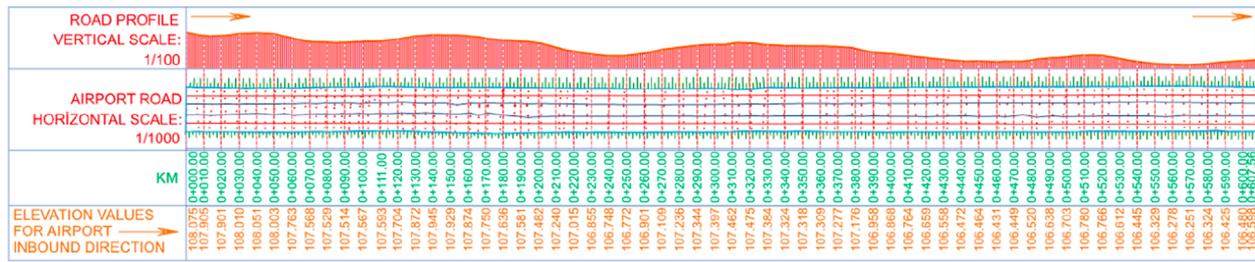
The road geometry was studied and evaluated in two separate ways in the east–west direction as a round trip. Figure 17 illustrates the airport inbound road profile with a 100/1000 (vertical/horizontal) scale created at 1-m intervals in the east–west direction. While the current ground elevation at the starting point of the profile (0 + 000) is 108.075 m, it is 106.598 m at the end point (0 + 607.84).

FIGURE 17 Profile of airport road for east-west direction-inbound traffic to the airport.

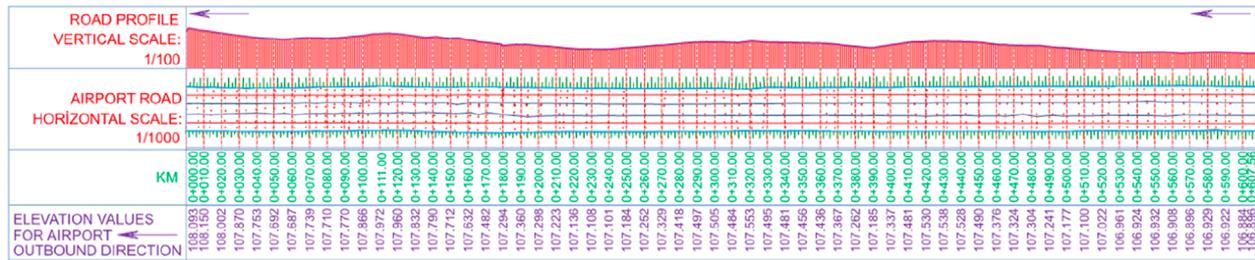
Figure 18 below displays the airport outbound road profile with 100/1000 (vertical/horizontal) scale created at 10-m intervals in the east–west direction. On the surface model developed using the data obtained after the measurements, cross sections were created every 1 m after the starting point, taking the direction of the road as a reference. However, in order to eliminate complexity in the images, these cross-sections are shown only in units of 10 m and its multiples. As can be seen from the figure below, while the current ground elevation at the starting point (0 + 000) of

FIGURE 18 Profile of airport road for east-west direction-outbound traffic from the airport.

the profile is 108.093 m, its value at the end point (0 + 607.56) is 106.896 m.
