Cascading Geological Hazards and Risks of the 2018 Sulawesi Indonesia Earthquake and Sensitivity Analysis of Tsunami Inundation Simulations

Katsuichiro Goda^{1,2*}, Nobuhito Mori³, Tomohiro Yasuda⁴, Adi Prasetyo⁵,
Ario Muhammad⁶ and Daiki Tsujio⁷

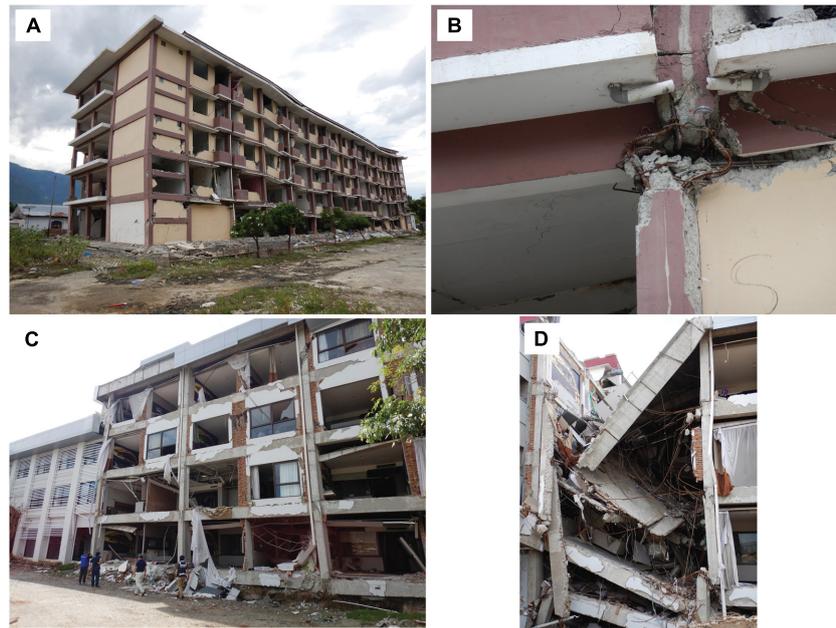
Due to the 2018 Sulawesi earthquake, many buildings were damaged, while several were destroyed. One of the destroyed buildings was a 5-story reinforced concrete apartment which was located 400 m from Palu Bay on the west bank of Palu River (Figure 3A). Some of the columns were fractured (Figure 3B)

FIGURE 3 | Observed earthquake-shaking damage in the Palu bay area (point 4 in **Figure 2**): **(A,B)** damage to a 5-story reinforced concrete apartment and **(C,D)** damage to Mercure Hotel.

and shear cracks were observed on many walls. It appeared that the capacity of the columns was deficient compared with those of the beams/slabs, potentially resulting in a more dramatic failure mode, such as story collapse. At Mercure Hotel, which was along the bay promenade (100 m from Palu Bay), severe damage to columns and infill walls was observed (**Figure 3C**) and a spectacular collapse of one section of the building occurred (**Figure 3D**). It is noted that water marks on some building walls were about 0.5 m above the ground, indicating that the main cause of the building damage was due to shaking. Relatively slender columns appeared to have contributed to the dramatic failures of the structure. The two buildings that are shown in **Figure 3** have a few common characteristics (e.g., mid-rise structures having longer vibration periods than other buildings in the areas and their sites being relatively soft which may amplify ground motions at the sites), enlarging the damage consequences.

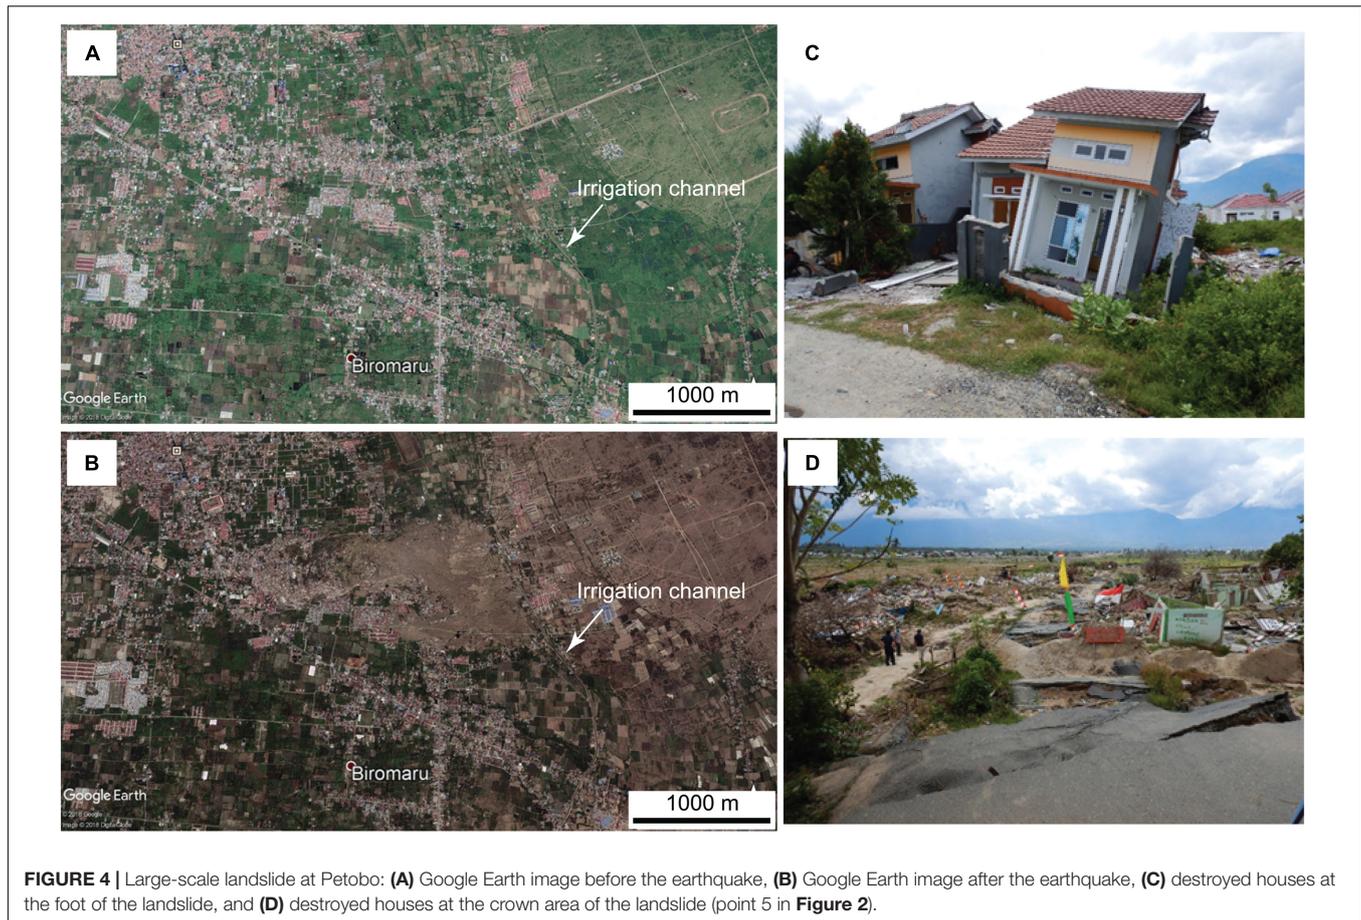
Figures 4A,B show the Google Earth images of Petobo before and after the Sulawesi earthquake. The mudflow swiped approximately a 1.5 km by 1.0 km area (from a satellite imagery). The crown area of the mudflow corresponds to the irrigation channel. Because of the irrigation system, the ground water level was high. At the foot of the mudflow (photo 5 in **Figures 2, 4C**), many houses were destroyed, whereas at the top of the mudflow (**Figure 4D**), many large tensile cracks appeared and roads as well as houses were damaged. Similar damage was also observed at Jono Oge (south of Petobo) having an even larger spatial extent of the damaged area.

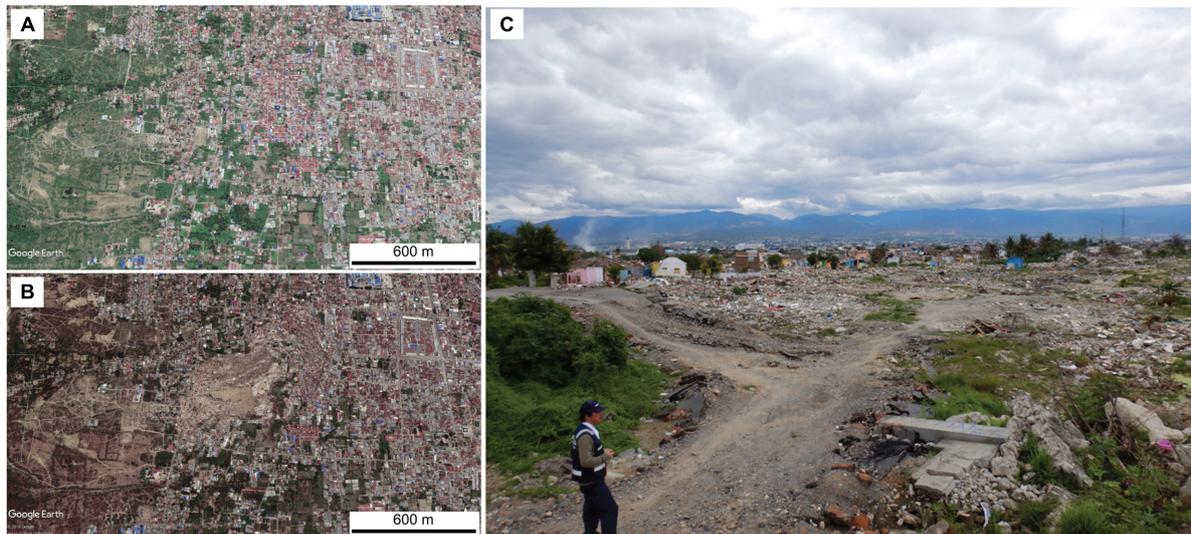
At Balaroa, a mudflow of approximately 0.5 km by 0.5 km (from a satellite imagery) occurred. Although the flow size was smaller than those of Petobo and Jono Oge, this area was more densely populated, being closer to the city center. **Figures 5A,B** show the Google Earth images of Balaroa before and after the

event, whereas **Figure 5C** shows a photo taken at the crown area of the mudflow, where 3–6 m elevation gaps were observed.

FIGURE 5 | Large-scale landslide at Balaroa: **(A)** Google Earth image before the earthquake, **(B)** Google Earth image after the earthquake, and **(C)** view from the crown area of the mudflow.

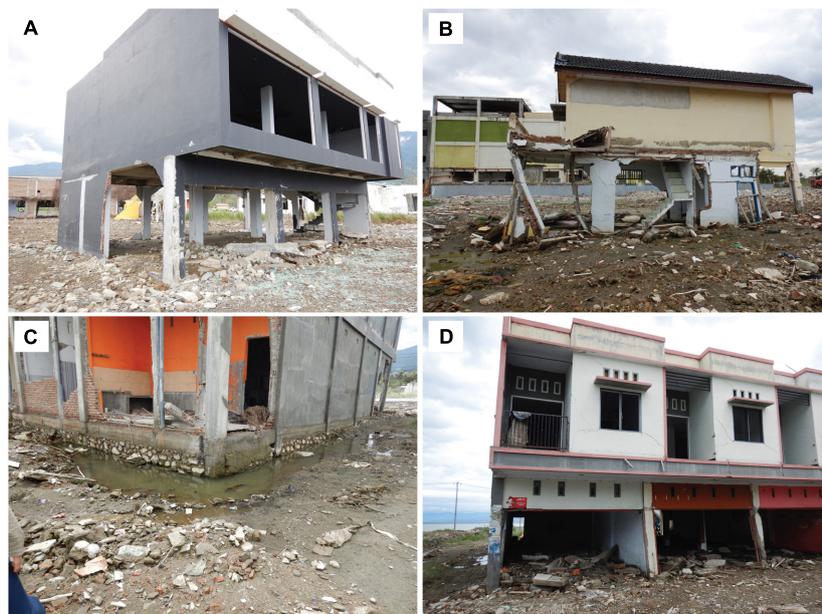
In Palu City, many 1-story and 2-story commercial/business properties (about 100–200 m from Palu Bay, near point 3 in **Figure 2**) were damaged by the tsunami. From the water marks and damage patterns observed at destroyed buildings (**Figures 6A,B**), the maximum tsunami heights were less than a few meters in height from the ground; the upper parts of the buildings were not severely affected. The foundation of some of the buildings was subjected to scouring damage (**Figure 6C**), whereas some notable tilt was caused by the tsunami (**Figure 6D**). Due to the subsidence of the bay area, normal astronomical tidal variations result in inundation of this area (up to about 300 m inland from the shoreline). These kinds of physical conditions make it challenging to carry out the recovery and reconstruction of this important area.

FIGURE 6 | Observed tsunami damage in the Palu Bay area (point 3 in **Figure 2**): **(A,B)** destroyed 2-story buildings, **(C)** sourcing damage, and **(D)** tilted building complex.

of Palu City and are consistent with the photographs shown in **Figure 6**; the maximum inundation depths at locations near the shoreline may reach 3 m to 4 m. The large water depths are caused by the combination of the tsunami waves, ground subsidence, and high tidal level. The simulated inundation areas by Cases 1 and 2 are consistent with the field observations [i.e., inundation depths of about 2 to 4 m; see Figure 14 of Pakoksung et al. (2019)]. Neglecting the tidal level and co-seismic ground deformation effects (Case C) has major influence on the inundated area and leads to an inconsistent appearance of the submerged area (**Figure 13C**). The consideration of the uniform slip distribution (Case 4) leads to notable inundation of the coastal area in Palu City (**Figure 13D**). This is because the elevation along the bay promenade becomes low after the co-seismic subsidence and the high-tide condition with a small tsunami wave is sufficient to flood the low-lying areas. It is noted that our tsunami simulation does not consider any coastal protection measures along the coastal line, while such coastal structures exist. Thus the inundation results for Case 4, shown in **Figure 13D**, may be overestimated. Nevertheless, during our field work, we observed that the low-lying areas along the coastal line were submerged at high tide times, indicating that ground subsidence had real influence in these areas.

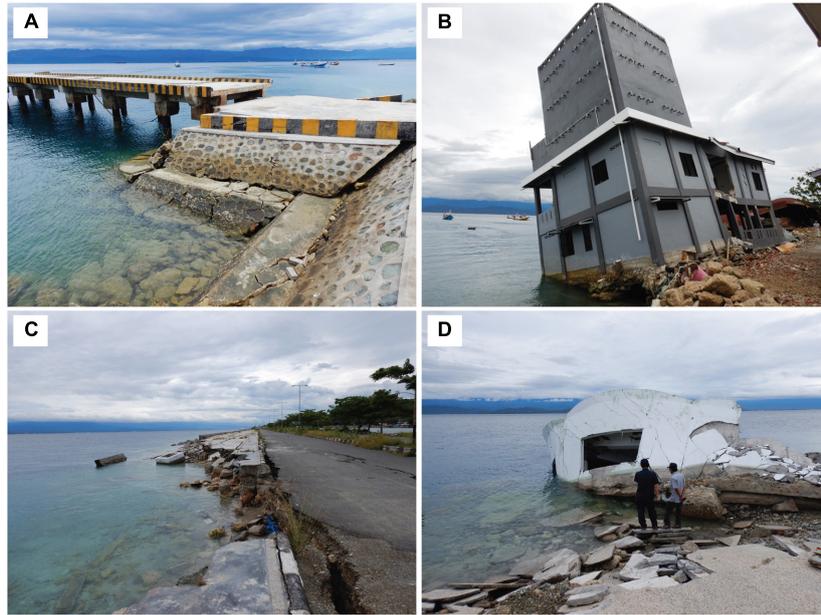
specific buildings occurred mainly due to liquefaction-related ground failures. A section of retaining walls in the port area was damaged due to lateral spreading and moved toward the sea. Consequently, a vertical gap of about 0.6 m was caused at the port (**Figure 7A**). Near the port, a residential house with a facility to keep swallows in the roof part of the building, collapsed due to a liquefaction-related foundation failure (**Figure 7B**). South of Donggala port, the retaining wall of the recreational area, called Pavilion Gonenggati Donggala, collapsed due to lateral spreading of the reclaimed land section (**Figures 7C,D**).

FIGURE 7 | Observed tsunami damage near Donggala port (point 1 in **Figure 2**): **(A)** damage due to lateral spreading, **(B)** liquefaction-related foundation failure, and **(C,D)** damage due to lateral spreading at Pavilion Gonenggati Donggala.

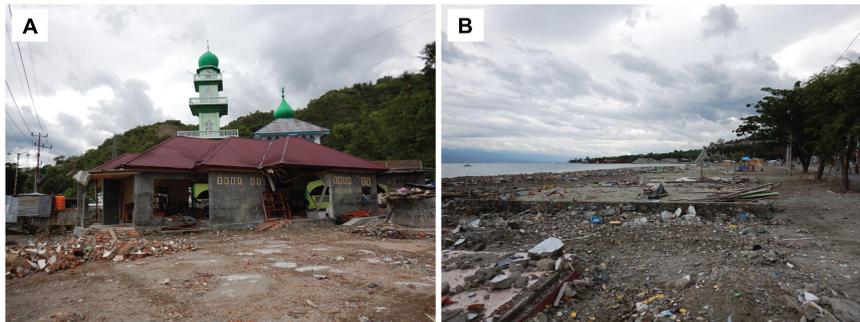
Along the road on the western side of Palu Bay, there were several local areas that were completely devastated by the tsunami (**Figure 8**). These communities appeared to be sparse along the coast and were not affected by the larger-scale tsunami. This indicates that the destructive tsunamis were local and probably caused by underwater landslides (Muhari et al., 2018; Pakoksung et al., 2019; Sasa and Takagawa, 2019). On the other hand, during the field survey, it was observed that several local communities (western side of Palu Bay) that were protected by mangroves were less affected by the tsunami (see a rectangle in **Figure 2**). The PU-03 and PU-04 sites listed in **Table 1** were in these areas and experienced the maximum tsunami height of about 2 m. Houses that faced the open part of mangrove forests were damaged/washed away, whereas those that were built behind the forests were less affected and survived. Such natural barriers can be effective in reducing the impacts of tsunami waves as observed in the 2004 Indian Ocean tsunami (e.g., Danielsen et al., 2005).

FIGURE 8 | (A,B) Tsunami-devastated area on the western coast of Palu Bay (point 2 in **Figure 2**).

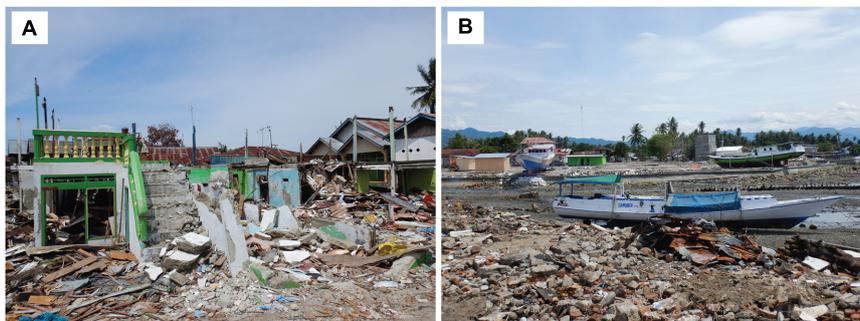
At the Pantoloan port (south of point 7 in **Figure 2**), an *in situ* sea surface elevation measurement was recorded during the tsunami, where the maximum wave height of about 2 m was recorded. North of the Pantoloan port, many vessels, including the large one shown in photo 7 in **Figure 2**, were swept ashore, and local communities were severely damaged by the tsunami (**Figure 9**). At locations further north outside of Palu Bay, destruction of houses was observed sporadically along the road near the epicenter. The maximum tsunami heights at these places (e.g., PU-03 and PU-04 in **Table 1**) were less significant compared with those inside Palu Bay but were sufficient to cause notable damage to buildings that are near the shoreline.

FIGURE 9 | (A,B) Severely-damaged port area on the eastern coast of Palu Bay (point 7 in **Figure 2**).
