Zhang L, Wang Z, Zhang W and Liu S  
(2023), Sandy aquifer collapse  
mechanism and accident treatment of  
the Qingdao metro tunnel.  
*Front. Earth Sci.* 11:1293258.  
doi: 10.3389/feart.2023.1293258

# Sandy aquifer collapse mechanism and accident treatment of the Qingdao metro tunnel

The tunnel collapse occurred during the construction of the Qingdao Metro Line I, resulting in a pit measuring approximately 10 m in diameter and 7 m in depth on the ground surface. The collapse inflicted substantial economic losses, casualties, and subsequent disruptions to ongoing construction activities. To clarify the causes of this collapse and investigate the underlying factors, a comprehensive approach combining field surveys and numerical simulations was undertaken. The results show that the collapse was primarily attributed to inadequate support when facing the challenging geological conditions, poor surrounding rocks (Grade VI) and a high volume of groundwater. The combination of abundant water and sand seeped into the tunnel, culminating in a catastrophic ground collapse. Notably, the arch roof experienced extensive deformation and damage due to the significant seepage pressure, which w

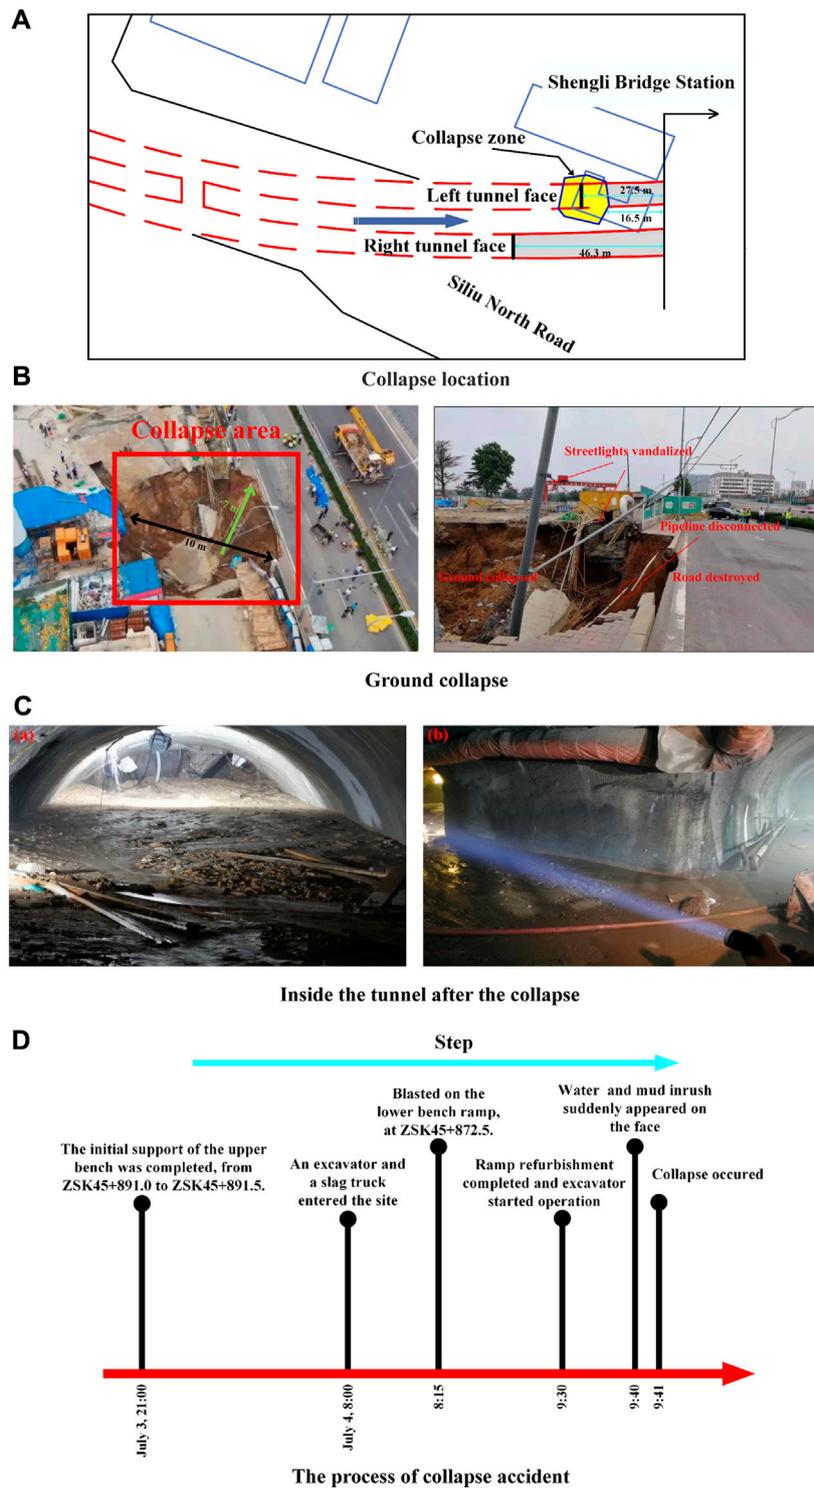
**FIGURE 4**  
The observed collapse accident. (A) Collapse location. (B) Ground collapse. (C) Inside the tunnel after the collapse. (D) The process of collapse accident.

On 4 July 2019, the section with a mileage of ZSK45+891.5 on the left line collapsed at a distance of 16.5 m from the end of the Shengli Bridge Station, as shown in Figure 4A. This disaster evolved from partial water seepage on the tunnel face into water and sand inrush, and eventually formed ground collapse. After the disaster, an obvious pit with the diameter and depth of about 10 m and 7 m was formed on the ground, as shown in Figure 4B. It can be seen from the picture that the underground pipelines and surrounding buildings were destroyed, and the observed cave after the collapse is shown in Figure 4C. Furthermore, after the collapse, a large amount of sediment was accumulated in the tunnel, and it flowed as far as the second transverse channel about 206 m away from the tunnel face, where the sediment accumulation depth was about 1.3 m (Figure 4C). Figure 4C shows that the surrounding rocks of the working face were in good condition, the collapse cavity in the tunnel did not extend to the front of the working face, and the completed grid steel frame of the upper bench of the tunnel only partially sunk, and no grid steel frame collapse occurred. The volume of mud was approximately 1,888.945 m<sup>3</sup> estimated from the sections of secondary lining and primary lining of the tunnel. The evolution of the disaster is shown in Figure 4D, and it takes only 1 minute from the discovery of water and sand inrush on the face to the ground collapse. In addition, in this disaster, one people death and direct economic losses of 2.69 million RMB.

After collapse occurred, a set of remedy measures were conducted. To prevent the expansion of the ground collapse, first the clayey soil and concrete were used to backfill the cave-in. And then the grouting reinforcement was applied to the cave-in. In this section, the grouting reinforcement plan of ground after

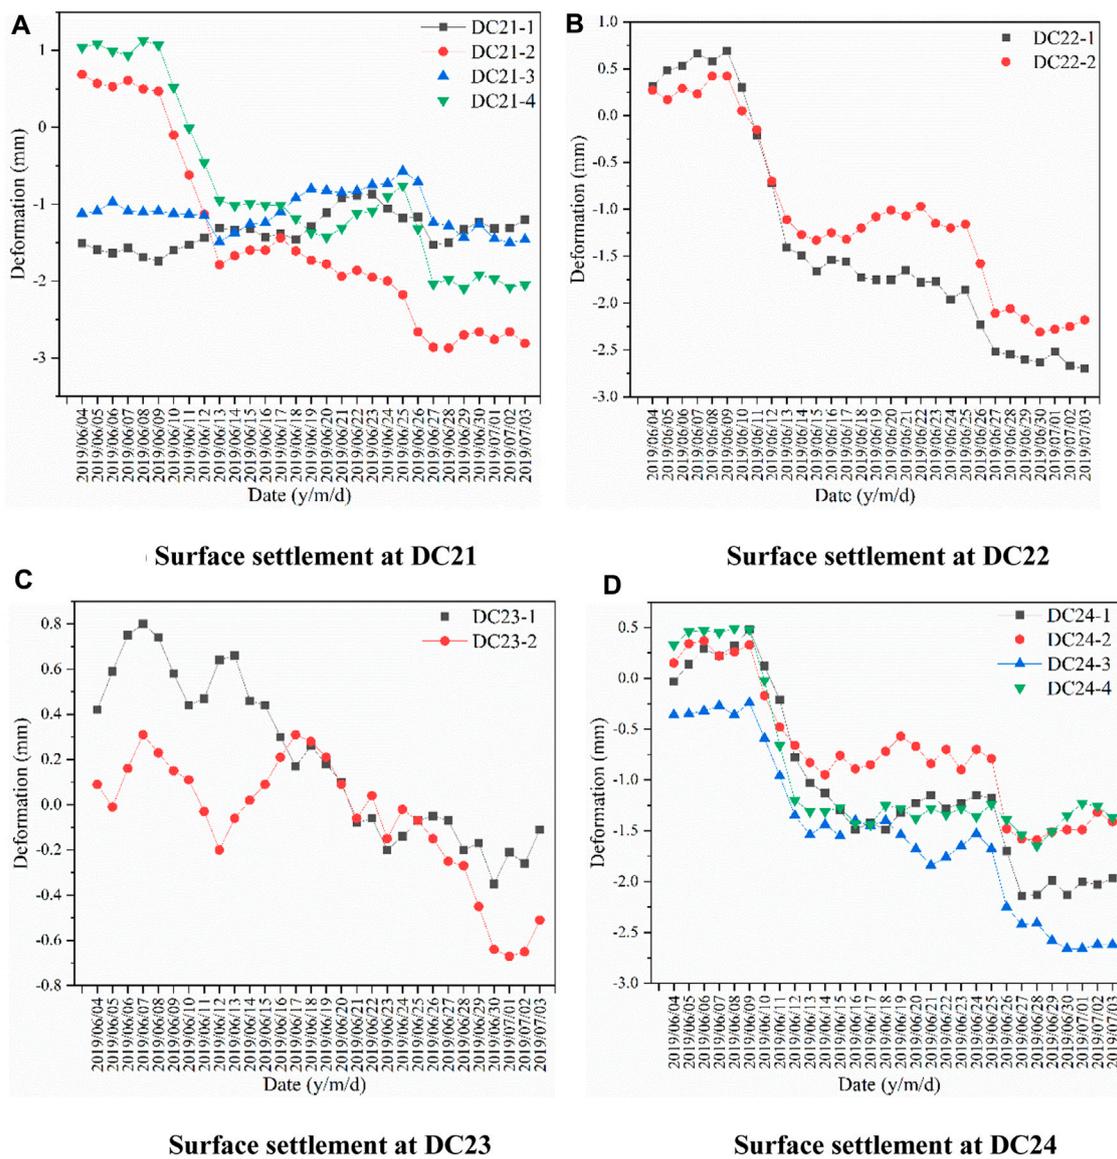
In order to understand the impact of the construction on the surrounding environment and ensure the construction safety, many monitoring points were placed on the surface to record the ground settlement, as shown in Figure 5. The interval between two adjacent monitoring points for ground surface settlement, e.g., DC22 and DC23, is about 20 m. Figure 6 shows the variations of ground settlement from 4 June to 3 July 2019. It can be observed that the settlement increased rapidly at DC21, DC22 and DC24 from 9 June to 13 June. During this

period, the average settlement rate at DC21-2 was the largest, i.e., 0.57 mm/d. After 13 June, the deformation at the three points fluctuated slightly. But on 25 June, the sudden changes of settlement occurred again at DC21, DC22 and DC24. At this time, the settlement rate at DC21-4 was the largest, reaching 0.72 mm/d. After 27 June, the monitor values of three points fluctuated slightly. In particular, the surface deformation fluctuation of DC23 was relatively obvious, changing from heave to subsidence on 7 June, and from subsidence to heave on 12 June. From 17 June to 30 June, the surface deformation at DC23 exhibited continuous subsidence at other times except for slight fluctuation around June 23. Furthermore, from June 28 to 30, the settlement of this point showed a slight acceleration, with an average settlement rate of 0.18 mm/d, which was higher than the previous 5 days of 0.06 mm/d. Besides, the largest monitor value is 2.81 mm at DC21-2.

According to the Code for monitoring measurement of urban rail transit engineering (Ministry of Housing and Urban-Rural Development of the People's Republic of China, 2013), the critical warning value for ground surface settlement of tunnel in this study is 30 mm, and the average deformation rate and maximum deformation rate are 2 and 5 mm/d. Actually, the monitor values of all monitoring points did not reach the critical warning value. The maximum settlement value and settlement rate were 2.81 mm and 0.72 mm/d, respectively, which were much smaller than the settlement warning value. In this respect, this collapse occurred abruptly without obvious portent. But the sudden changes of deformation rates that occurred several times were abnormal. These neglected abnormal phenomena should be paid enough attention, which may avoid the disaster.

**FIGURE 6** Surface settlement before collapse. (A) Surface settlement at DC21 (B) Surface settlement at DC22. (C) Surface settlement at DC23 (D) Surface settlement at DC24.

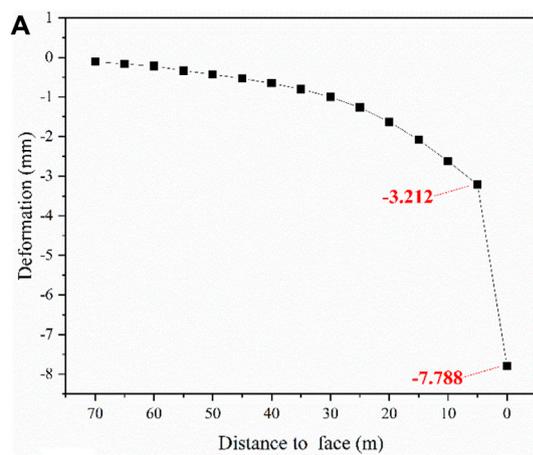
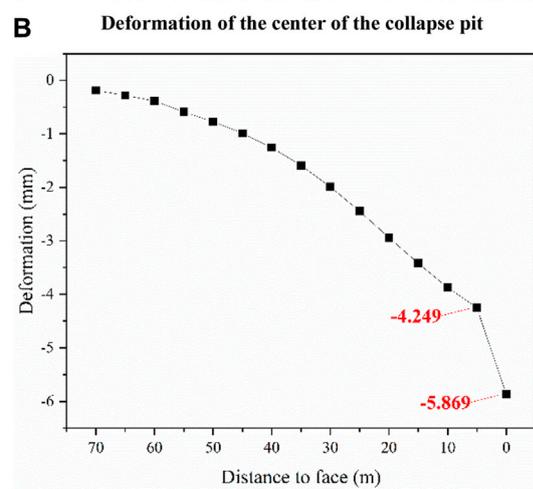
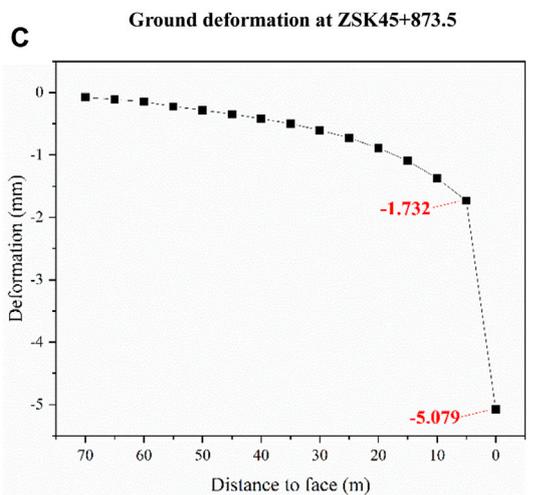
**FIGURE 10**  
Deformation at different locations. (A) Deformation of the center of the collapse pit. (B) Ground deformation at ZSK45+873.5. (C) Ground deformation at ZSK45+913.

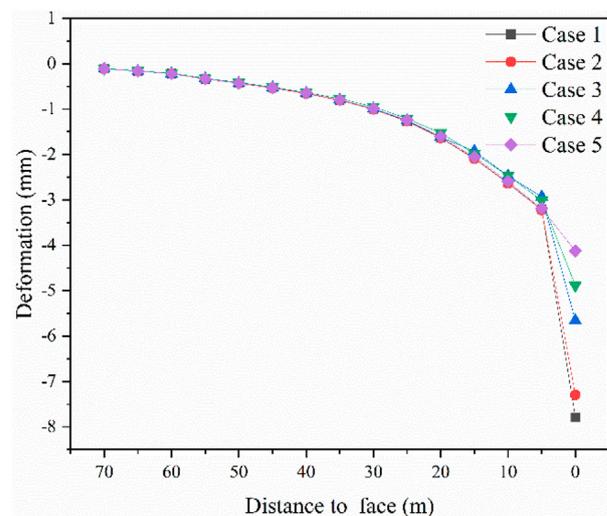
of groundwater at the Kai-sheng section and abundant underground seepage recharge. In Section 3.2.1, the initial water level of the model was set below the plain fill at the interface with the sand layer, which is -2 m. This water level was taken as the case 1, and four control cases of case 2 (-4 m), case 3 (-8 m), case 4 (-12 m), and case 5 (-16 m) were presented under the same construction conditions. The deformation of the center point of the settlement pit after the excavation of different cases were compared, and the results are shown in Figure 11. As the water table decreases, the settlement in case 2, case 3, case 4 and case 5 decreased from -7.788 mm to -7.729, -5.657, -4.885, and -4.127 mm, respectively. In case 2, the settlement at this point caused by last step was 4.517 mm, which was 7.7 times of the previous step. In other cases, the settlement at this point caused by last step were 4.2 times, 2.9 times and 1.6 times of the previous step.

**FIGURE 11**  
Surface settlement at different groundwater levels.

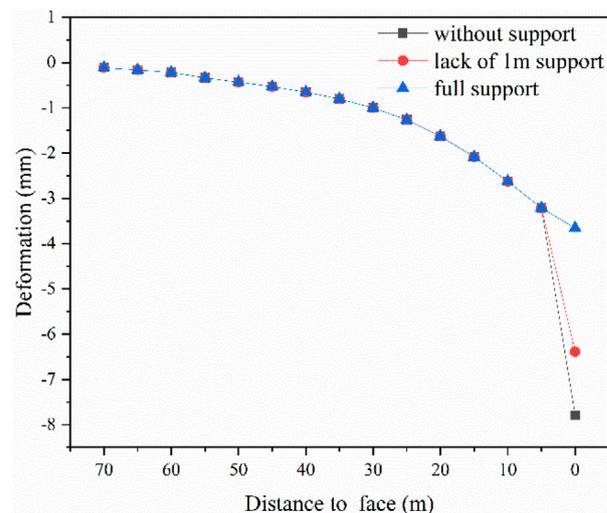
From Figure 12, it can be seen that the deformation curves of the three groups of models basically coincided when the excavation face advance to 5 m away from the accident face. The deformation at this point was -6.387 mm as excavated to the accident zone with a 1 m wide suspension gap, which was 1.401 mm less than that when there was a 2 m wide suspension gap. Under this condition, there was still a sudden change, and the deformation caused by the last excavation step was 3.175 mm and 5.4 times larger than the previous excavation step. However, when fully supported, the deformation at this point was -3.654 mm as excavated to the accident zone, which was 4.134 mm less than that when there was a 2 m wide suspension gap. At this time, the deformation of the last excavation step was 0.442 mm, which was 0.72 times of the previous step. Indicating that the appropriate supporting system can effectively reduce the deformation caused by excavation.

**FIGURE 12**  
Surface settlement under different support conditions.

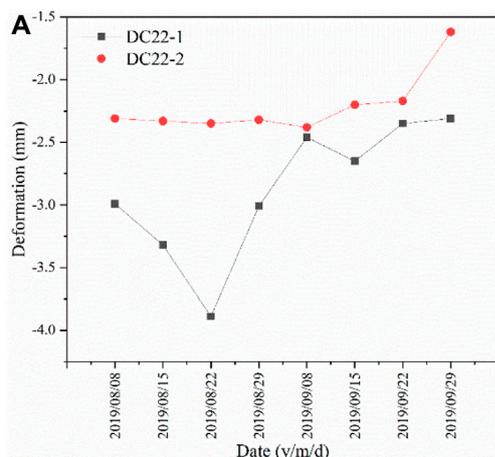
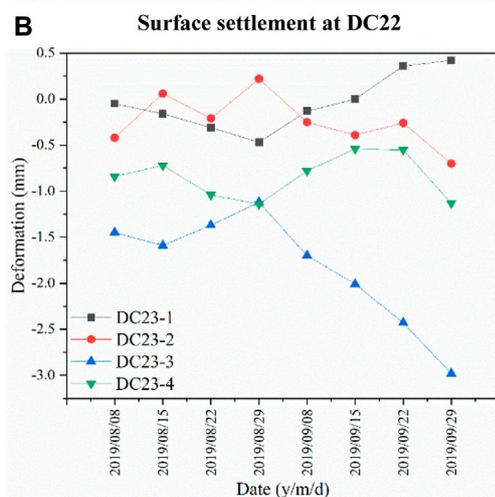
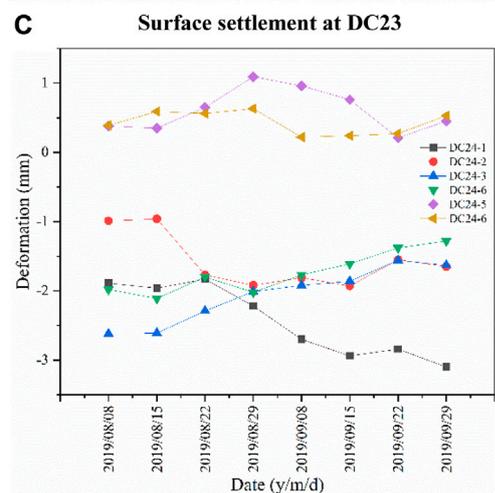
**FIGURE 15** Surface settlement after re-excavation. (A) Surface settlement at DC22. (B) Surface settlement at DC23. (C) Surface settlement at DC24.

Figure 15B shows the variations of ground settlement at DC23 from 8 August to 29 September. The variation at point DC23 can be divided into two stages, *i.e.*, Stage 1 from 8 August to 29 August, and Stage 2 from 29 August to 29 September. In Stage 1, the ground surface at DC23-1 and DC23-4 settled slowly while the ground surface at DC23-2 and DC23-3 heaved. The deformation value at DC23-2 was 0.64mm, which is the largest of these points. The average deformation rates of DC23-1, DC23-2, DC23-3 and DC23-4 were 0.02, 0.03, 0.02 and 0.01 mm/d, respectively. In Stage 2, the ground surface at DC23-1 and DC23-4 heaved while the ground surface at DC23-2 and DC23-3 settled. The deformation value at DC23-3 was 1.86 mm, which is the largest of these points. The average deformation rates of DC23-1, DC23-2 and DC23-3 were 0.03, 0.03, and 0.06 mm/d, respectively. In particular, the ground surface at DC23-4 settled after 22 September, and the settlement value was 0.58 mm.

Figure 15C shows the variations of ground settlement at DC24 from 8 August to 29 September. DC24-5 and DC24-6 were two monitoring points added after the collapse. From this picture, we can see that, the fluctuation of DC24 is slightly. The largest settlement value, approximately –3.10 mm occurred at DC24-1. The average deformation rates of DC24-1, DC24-2, DC24-3, and DC24-4 were 0.02, 0.01, 0.02 and 0.01 mm/d, respectively. The average deformation rate at DC24-5 was 0.03 mm/d, from 8 to 29 August, and was 0.02 mm/d from 29 August to 29 September. The monitor value at DC24-6 was stable. In particular, the largest average deformation rate,

Following the implementation of the support measures, the surface deformation remained well below the critical warning level throughout the re-construction period. Moreover, there were no sudden changes or subsequent collapses observed until the completion of the entire tunnel project. This unequivocally indicates that the grouting scheme employed was highly successful in achieving its intended objectives.

After the accident, the tunnel was filled with concrete, and the area was re-excavated after grouting. Meanwhile, the ground surface deformation after tunnel advance resumed was monitored. Figure 15 shows the monitor values during the subsequent excavation of the tunnel, from 8 August to 29 September 2019. Figure 15A shows the variations of ground settlement at DC22 from 8 August to 29 September. The largest settlement value, approximately –3.89 mm occurred at DC22-1. The variation at point DC22-1 can be divided into three stages, including continuous decrease stage (before 22 August), continuous increase stage (22 August–8 September) and stable stage (after 8 September). From 8 August to 22 August, the settlement value at this point increased from –2.99 mm to –3.89 mm with an average deformation rate of 0.06 mm/d. From 22 August to 8 September, the ground heave value at this point was 1.43 mm with an average deformation rate of 0.08 mm/d. After 8 September, the monitor values at this point were –2.65, –2.35, –2.31 mm, respectively, indicating that the deformation tended to be stable. On the other hand, the deformation at DC22-2 fluctuated slightly. The monitor values at this point were –2.31, –2.33 mm, –2.35 and –2.32 mm, respectively during the period from 8 August to 8 September. After 8 September, the ground surface began to heave. The ground heave value at this point was 0.55 mm with an average deformation rate of 0.03 mm/d, from 8 September to 29 September.
