Yao J, Yang Y, Yang M, Shen Z, He X and
Chen X (2025) Research on the diagnosis of
leakage hazards in a karst reservoir based on
integrated electrical method and geological
method.
Front. Earth Sci. 13:1578017.
doi: 10.3389/feart.2025.1578017

Research on the diagnosis of leakage hazards in a karst reservoir based on integrated electrical method and geological method

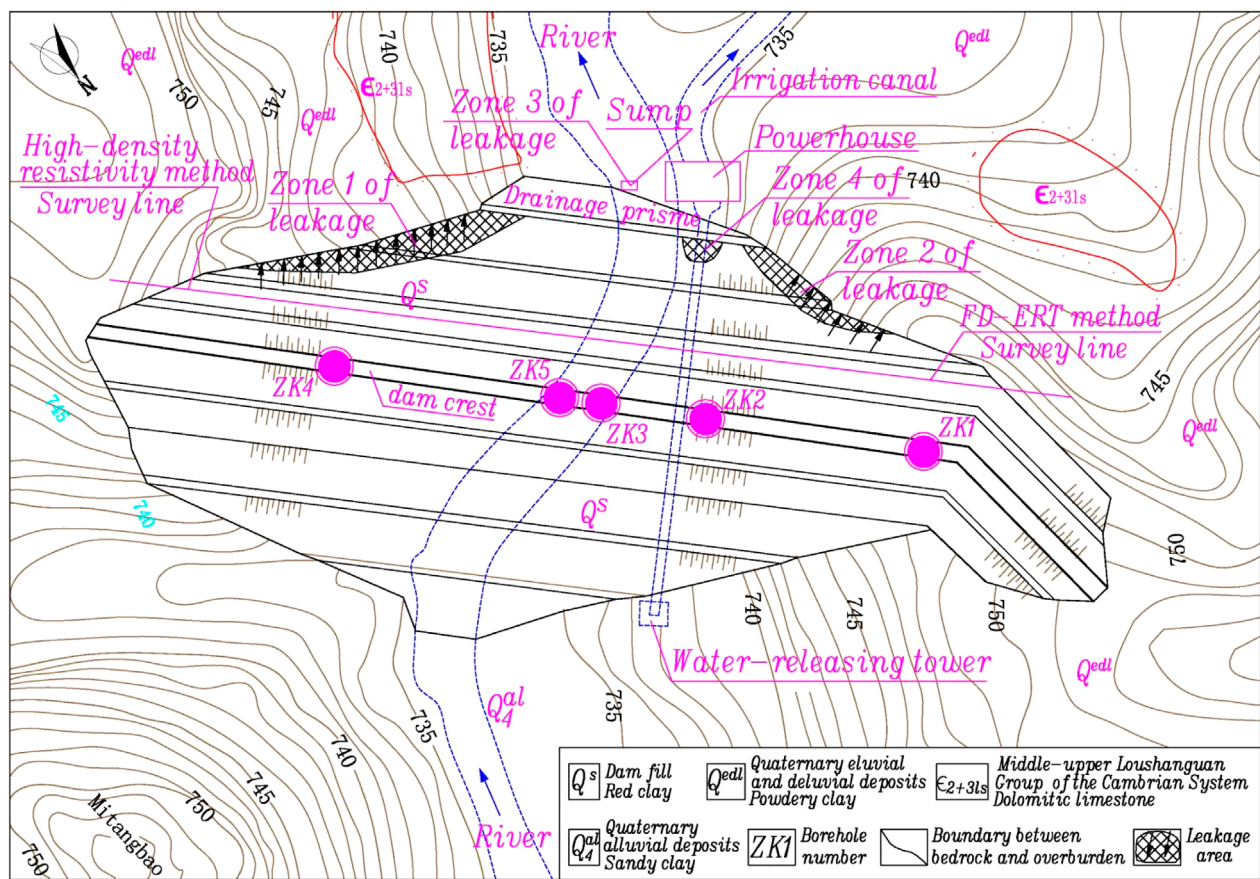
FIGURE 2
Layout diagram of survey lines and location map of leakage risks in the dam.

On 18 August 2023, when the reservoir water level was at 733.32 m, we conducted an exhaustive geological survey and inspection of the leakage risk indications in the dam site area. Field geological investigations revealed that there was abutment seepage around both the left and right dam abutments below elevations of approximately 728.0 m and 724.0 m, respectively. The total seepage volumes amounted to approximately 0.5 L/s and 0.3 L/s, respectively. Additionally, near the areas of concentrated abutment seepage, there were large areas of dispersed seepage with multiple concentrated leakage points on the third and fourth-grade downstream slopes at both ends of the dam body. The dispersed seepage areas measured approximately 30 m² and 18 m², with total seepage volumes of 0.25 L/s and 0.1 L/s, designated as Leakage Area 1 and Leakage Area 2, respectively. Meanwhile, there was a sump well at the middle of the dam toe from which water flowed continuously throughout the year, with a seepage rate of approximately 0.8 L/s, labeled as Leakage Area 3. There was also a dispersed wet area measuring approximately 12 m² on the fourth-grade downstream slope at the top of the power conveyance culvert outlet section, though no concentrated leakage points were observed, designated as Leakage Area 4. Notably, the leakage volumes at these leakage risk points exhibited a high correlation with the reservoir water level, disappearing partially during low water levels but significantly increasing in terms of both dispersed seepage area and concentrated leakage volumes during high water levels, posing a serious threat to dam safety.

Therefore, there are issues such as dam body leakage, dam foundation leakage, and bypass leakage at the dam abutments within the dam site area. Traditional geological methods struggle to interpret information about leakage sources, leakage pathways, and leakage outlets in the dam site area, making it difficult to implement targeted anti-leakage reinforcement measures for the leakage hazards. However, the integrated geophysical exploration method based on High-density resistivity method and frequency-division electrical method can effectively and accurately diagnose the spatial information of potential leakage hazards. Coupled with field geological surveys and geological drilling results for verification, it can ascertain the developmental characteristics and causes of various leakage hazards.

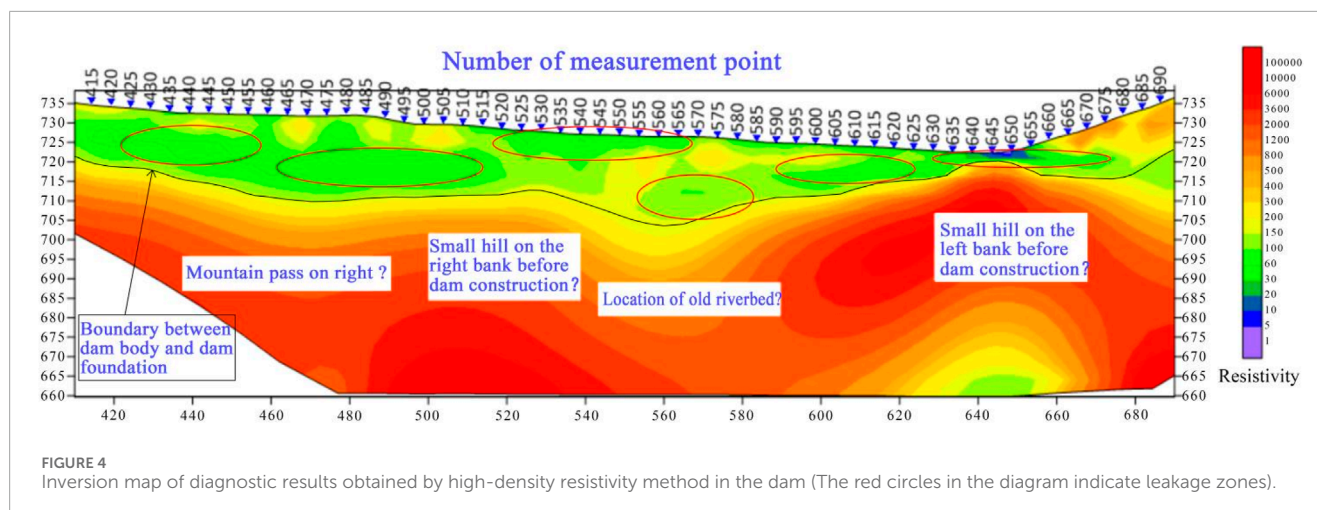
The detection results of the high-density resistivity survey line are shown in [Figure 4](#).

- (1) Low resistivity zones exist at measurement points 415 to 455 with elevations ranging from 730 m to 720 m, and at measurement points 455 to 515 with elevations from 725 m to 715 m. A high resistivity zone that lifts upwards is found

near measurement point 525. Low resistivity zones also exist at measurement points 520 to 570 with elevations ranging from 730 m to 725 m, and at measurement points 555 to 580 with elevations from 715 m to 705 m. A high resistivity zone that lifts upwards is observed near measurement point 645. Low resistivity zones are present at measurement points 590 to 625 with elevations ranging from 720 m to 712 m, and at measurement points 630 to 675 with elevations from 723 m to 718 m. Based on pre-dam construction data, the dam between measurement points 380 and 700 was originally formed by connecting three small hilltops. Specifically, the vicinity of measurement point 470 is a low saddle on the right bank, the area near measurement point 560 is the old riverbed of Songbai River, and the vicinity of measurement point 645 is a small hill on the left side.

- (2) The overall dam body exhibits low resistivity zones dominated by yellow, yellow-green, and green colors, with a resistivity approximately ranging from 30 to 150 Ωm , which is relatively consistent with the resistivity measured in the dam's soil core. However, the resistivity in the low saddle area of the right dam abutment, the old riverbed of Songbai River in the middle, and the small hill area of the left dam abutment is significantly lower. Among these, the resistivity in the small hill area of the left dam abutment is the lowest, with some local areas already appearing as blue zones. This indicates that the water content in the dam fill at these locations is significantly higher, leading to enhanced electrical conductivity. These areas may represent leakage zones within the dam, and their elevations are relatively consistent with the leakage zones at the left and right ends of the dam.

- (3) From the left dam abutment to the right dam abutment, a yellow-orange low-resistivity zone with a resistivity of approximately 200–300 Ωm exists on the surface of the dolomitic limestone at the bottom of the contact surface between the dam and its foundation. This resistivity is significantly lower than the measured resistivity of dolomitic limestone cores obtained from laboratory tests. The thickness of this low-resistivity zone is approximately 3.0 m, within which the water content of the dolomitic limestone and the activity of groundwater are significantly higher than those in the deeper rock mass. Preliminary speculation suggests that karst or joint fissures may have developed within the dolomitic limestone in this area, leading to a higher water content, more active groundwater, enhanced conductivity, and lower rock resistivity at this location. However, based on the exposed rock mass and stone buds in the dam site area, the joint fissures are not well developed, but karst is extremely developed. Therefore, it can be further determined that karst development exists within the rock mass with a thickness of approximately

3.0 m at the shallow surface of the dam foundation, and there are karst leakage pathways.

- (4) The deep rock mass of the dam foundation is mostly composed of high resistivity zones with orange-red and red hues, featuring a resistivity greater than 500 Ωm . This indicates that the deep rock mass of the dam foundation is well-integrated, with low water content in the rock mass. The groundwater is inactive, exhibiting weak conductivity. Karst development is minimal, and the possibility of the development of caves and underground rivers within the rock mass is extremely low.
- (5) A low resistivity zone appears at an elevation of approximately 670 m within the deep part of the small hill on the left dam abutment, indicating that groundwater is relatively active at this location. This suggests the presence of a karst cave or an underground river.

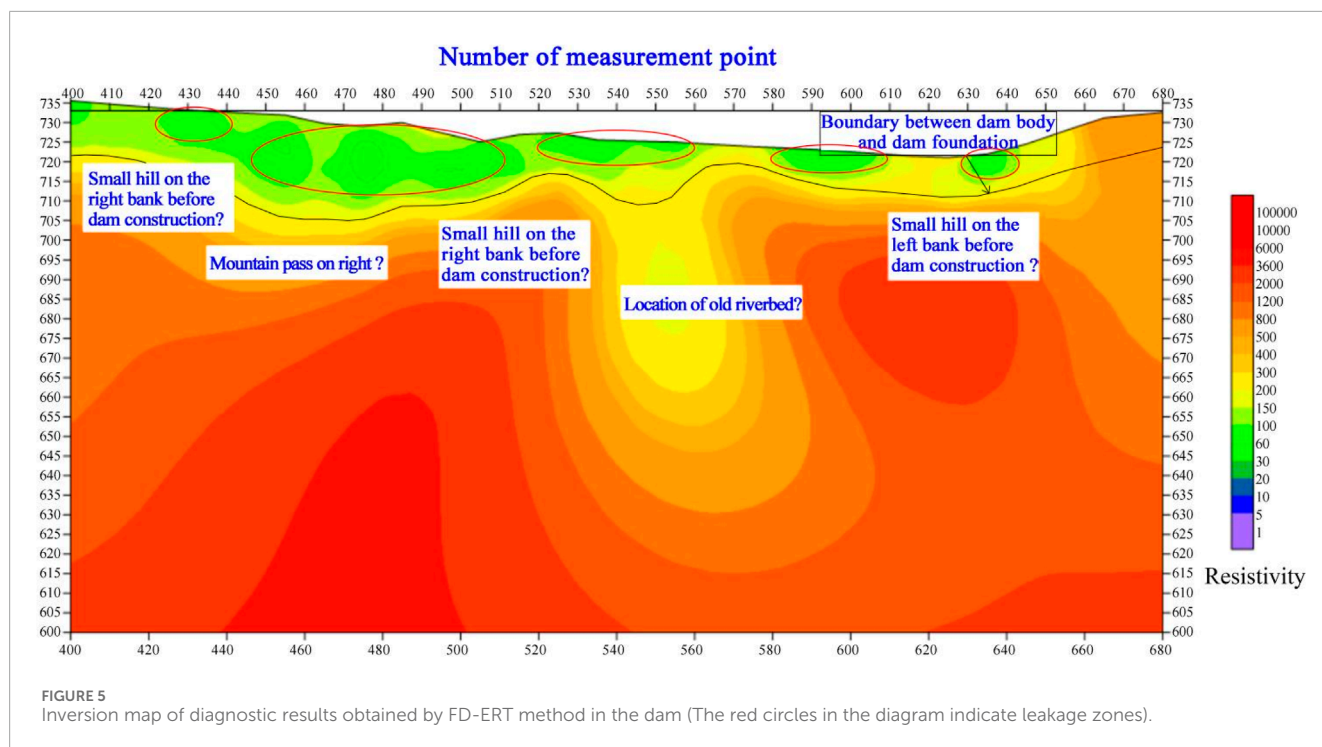
FIGURE 5
Inversion map of diagnostic results obtained by FD-ERT method in the dam (The red circles in the diagram indicate leakage zones).

The detection results of FD-ERT method survey lines are shown in Figure 5.

- (1) The diagnostic results are generally consistent with those obtained by High-density resistivity method, but the frequency-division electrical method demonstrates significantly better detection accuracy for the deep dam body, dam foundation, dam abutment rock and soil mass, and their interfaces, especially in revealing the original topography of the dam foundation. However, High-density resistivity method offers superior detection accuracy for shallow rock and soil masses compared to the frequency-division electrical method. The main reason for this is that the measuring point spacing for High-density resistivity method is 5 m, while it is 20 m for the frequency-division electrical method. Therefore, the latter has lower sensitivity to shallow features compared to the former.

- (2) There is a green low-resistivity zone at measurement points 425 to 460 with an elevation of approximately 730 to 724 m, and at measurement points 445 to 510 with an elevation of approximately 726 to 714 m in the right dam section. Similarly, in the left dam section, there are low-resistivity zones at measurement points 580 to 610 with an elevation of approximately 714–724 m, and at measurement points 630 to 640 with an elevation of approximately 715–721 m. Preliminary speculation suggests that these areas have high water content in the fill soil within the dam body, resulting in strong conductivity, and may represent leakage disease zones within the dam.

- (3) There are noticeable relatively low-resistivity zones in both the dam body and dam foundation at measurement points

535 to 560 in the middle of the dam. At an elevation of approximately 725 to 718 m, there is a leakage disease in the dam body. Within the range of approximately 718 to 660 m in elevation, there exists an ancient low-lying corrosive gully in the dam foundation, which was an old riverbed. Before the dam was constructed, it was filled with Quaternary overburden, leaving behind permeable weak zones or pathways. These are located roughly in the same longitudinal position as the water collection well behind the dam. Preliminary speculation suggests that the continuous water inflow in the water collection well behind the dam may originate from the leakage in the dam foundation and dam body at the location of this old riverbed.

- (4) Beneath the contact surface between the dam body and the dam foundation, there exists a continuous layer of yellow to orange-yellow low-resistivity zone with a thickness of approximately 3.0 m on the surface of the dam foundation rock and soil. This may be due to the development of karst features such as solution pores, caves, solution holes, or sinkholes in the dolomitic limestone at the surface of the dam foundation. The presence of karst leakage pathways results in high water content in the surface rock mass of the dam foundation, active groundwater, and enhanced conductivity.
