# Characterization of ply bulge failures in truck bus radial tyres

Ply bulge failure in Truck and Bus Radial (TBR) tyres, predominantly observed in the shoulder region, is a critical issue impacting tyre performance and safety. This study investigates the root cause of such failures through a comprehensive analysis of 13 field-return tyres of varying patterns and sizes. A multi-step methodology, including visual inspection, X-ray analysis, shearography, microscopy, FTIR, and adhesion testing, was employed to characterize the failure mechanism. Visual inspection was used to identify external factors such as punctures, overloading, or bead damage, while X-ray analysis confirmed the absence of structural defects, such as cord spacing irregularities or belt offset, indicating that intrinsic material interactions were the primary drivers of failure. Shearography pinpointed incipient separation areas, which were further examined microscopically. Microscopic analysis revealed debonding failure mode at the carcass ply-rubber interface as the primary crack initiation mode, followed by propagation along cord surfaces and then transferring to adjacent cords. To distinguish between rubber deg

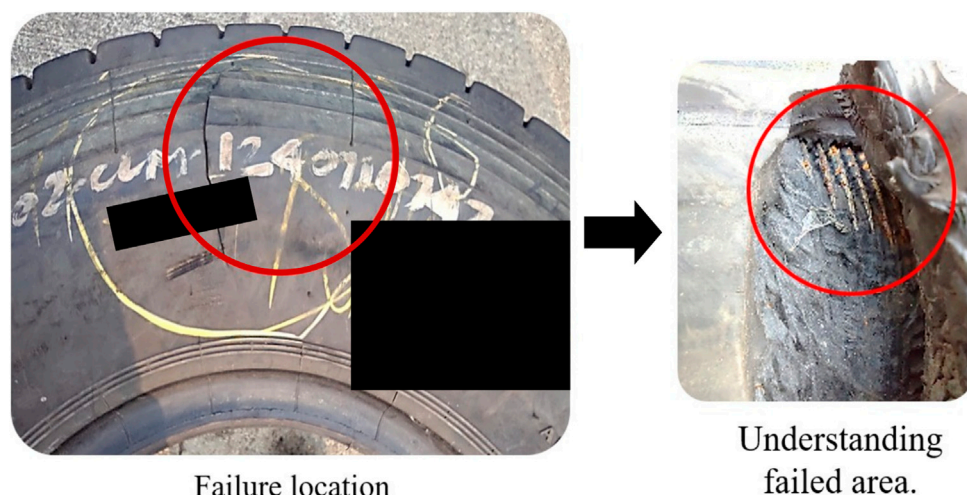
FIGURE 1  
Ply bulge failure in TBR tyre.

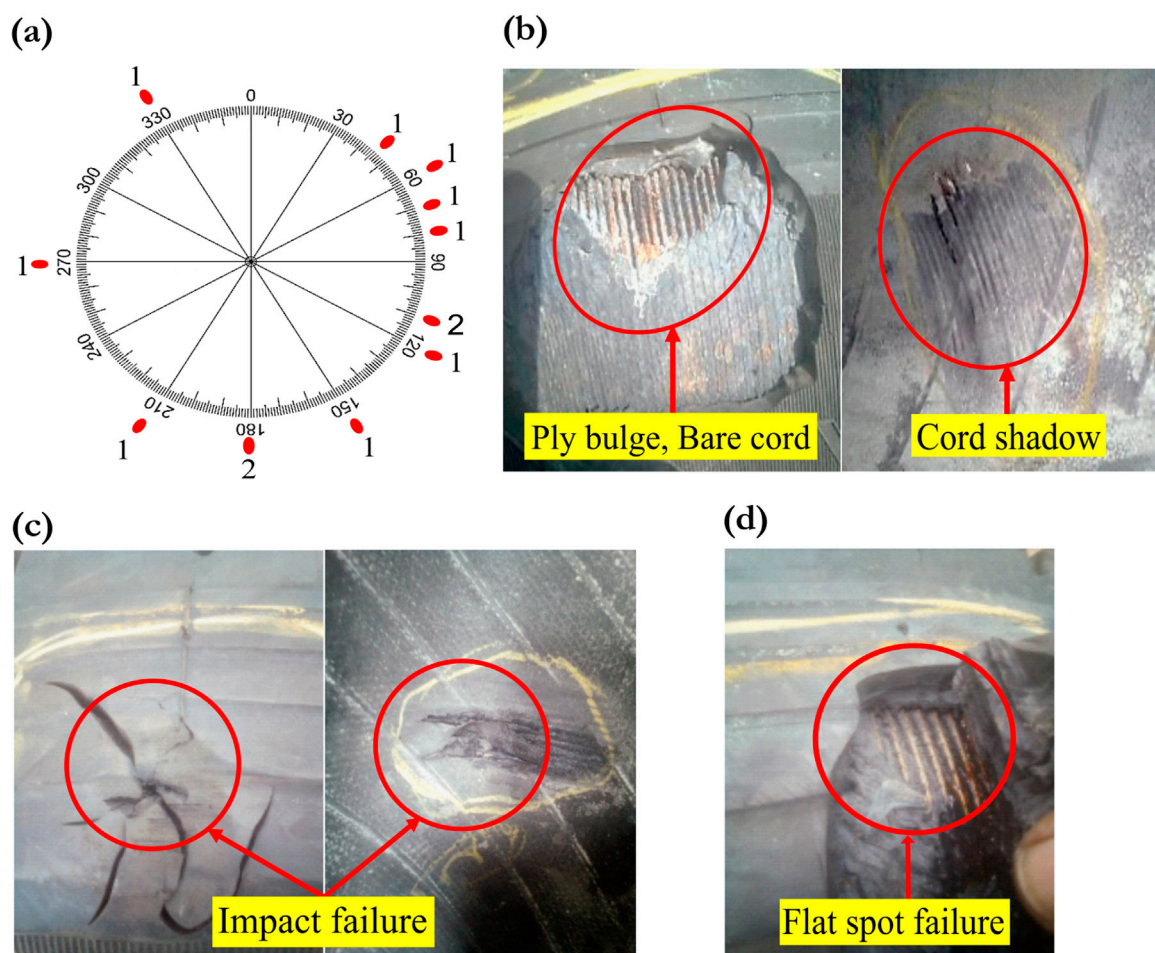
FIGURE 4  
Visual analysis: (a) Failure location at different circumferential positions of the tyre, (b) Bare cord and cord shadow at the failure location, (c) Failure due to impact, (d) Failure due to flat spot.

These failures were not restricted to any specific side, whether NSS or SS, and could occur at any circumferential location around the tyre, as shown in Figure 4a. In all tyres, cord shadows were visible from the inside, and bare cords were observed from the outside, as

illustrated in Figure 4B. Three tyres had punctures, but only two of these punctures were near the failure locations. Additionally, flat spots were observed near the failure regions in several tyres, which were attributed to harsh braking. One tyre showed evidence of

impact damage, where the failure occurred at the point of impact due to a clear loss of casing integrity. The wear percentage was measured for each tyre. Excluding tyre number 3 (X1613648xxx), the average wear was found to be 48.53%. Market analysis showed that the average tyre wear in Salem was 56.97%, while in Bikaner it was 36.73%. The lower wear percentage observed in the Bikaner region was attributed to overloading conditions, which are commonly practiced by truck drivers in that region. This resulted in earlier failures and lower wear percentages at the time of ply bulge failure. Overall, the visual inspection suggests that external factors such as impact, punctures, flat spots, and overloading significantly contribute to ply bulge failures. Punctures and impacts create entry points for air seepage and moisture infiltration, accelerating rubber aging and reducing its mechanical properties. On the other hand, flat spots and overloading increase stress on the carcass ply, leading to premature failure.

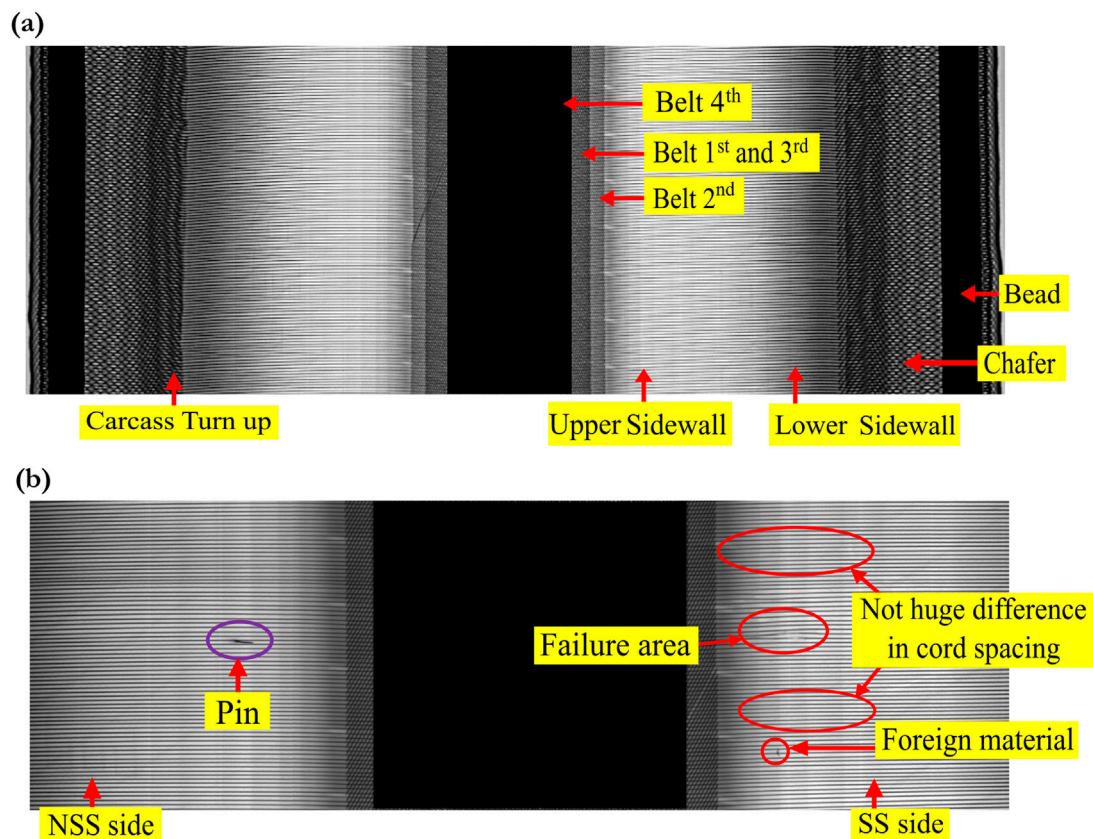
FIGURE 5  
(a) Identifying different components from the X-ray image, (b) X-ray image of failed tyre.

X-ray analysis of the tyres revealed no significant manufacturing defects. The identification of different components in the X-ray images and analysis of the regions near the failure were conducted as shown in Figure 5. The cord spacing near the failure regions was within acceptable limits in all tyres, indicating that no manufacturing issues contributed to the ply bulge failure.

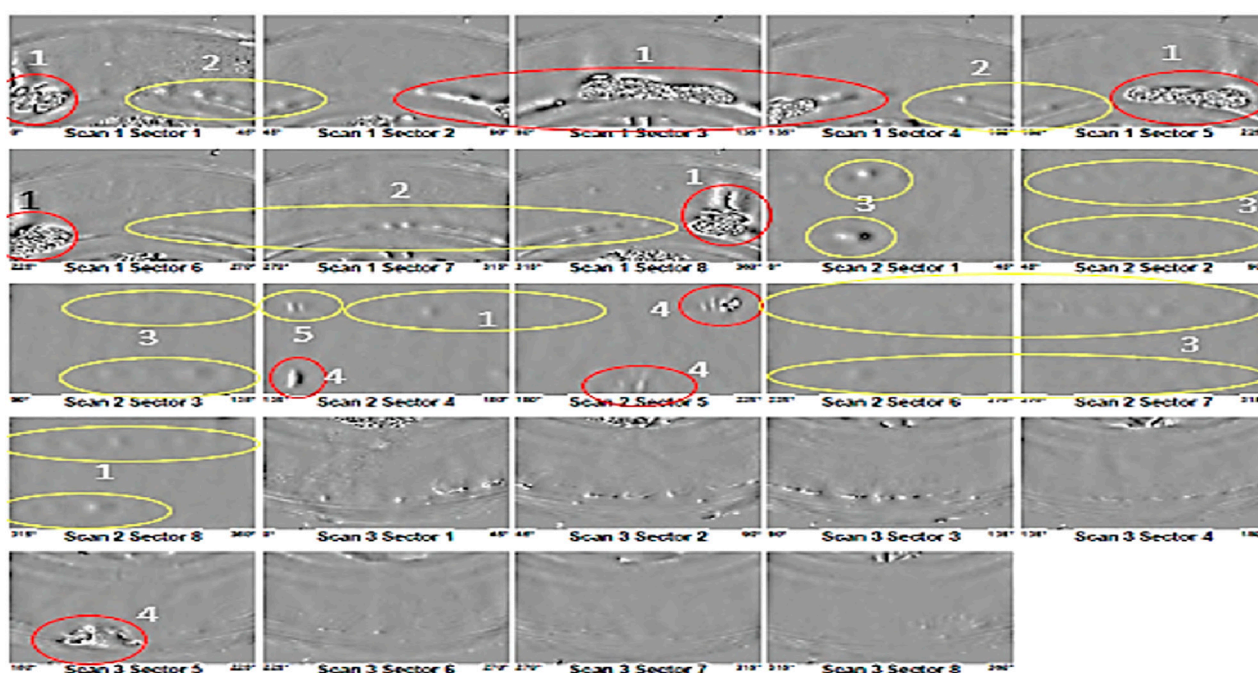
In the shearography images, various fringes were observed, indicating different levels of separation. As shown in Figure 6, areas encircled in red represent major separations, while those encircled in yellow indicate minor separations. The shearography

FIGURE 6  
Shearography image of Tyre 1.

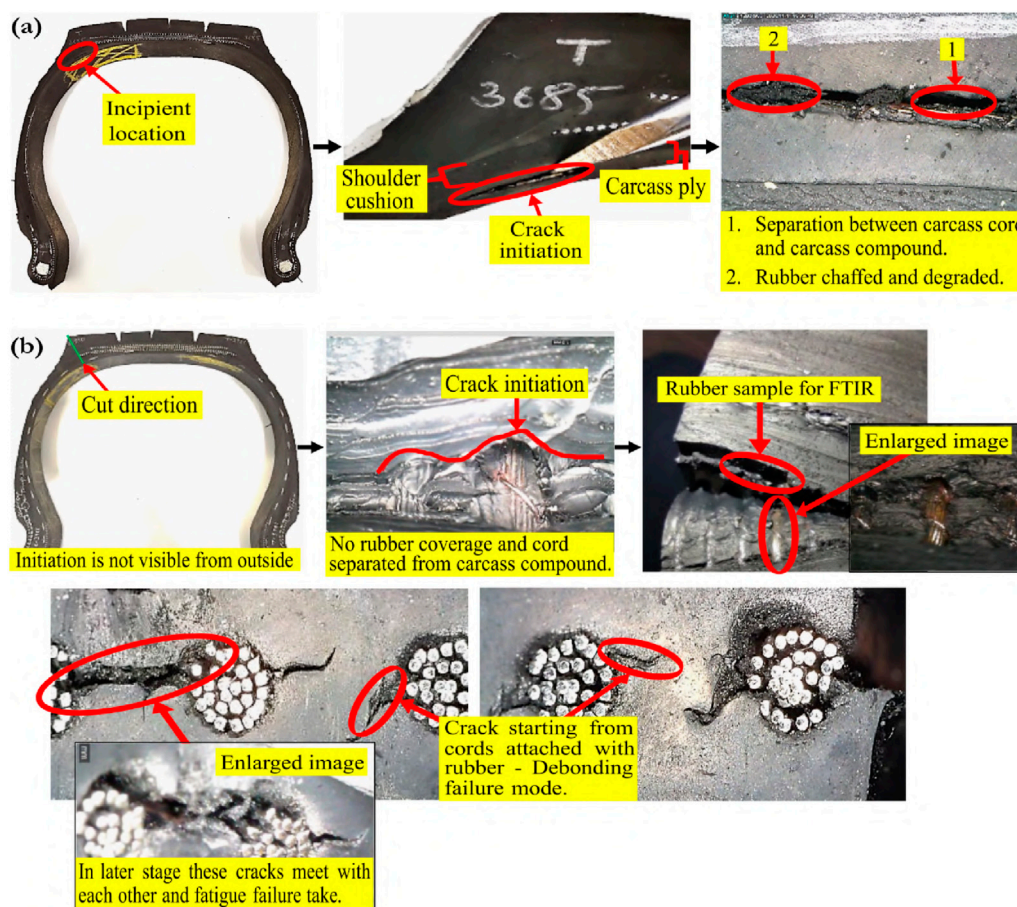
Subsequently, microscopic image analysis was performed on six incipient cut sections. Initially, the cut sections were examined to identify the initiation areas, as shown in Figure 7A. From Figure 7A, it is evident that crack initiation occurs directly below the mid-region of the shoulder cushion within the carcass ply.

A separation between the cord and skim compound is clearly visible, with the cords exhibiting a lack of rubber coverage due to chafing and degradation under rolling conditions at the time of crack initiation. Additionally, the presence of brass coating on the carcass cord was observed.

In the second stage of analysis, a perpendicular cut was made at the shoulder section of the tyre cut section using a cutting tool, focusing on the carcass ply region, as illustrated in Figure 7B. The resulting images revealed that crack initiation occurs at the interface where the cords are bonded to the rubber, indicating that the initiation does not occur in the rubber matrix phase. Instead, the initiation is observed as a de-bonding failure mode at the cord-rubber interface along one of the cords, which subsequently propagates to nearby adjacent cords.

FIGURE 7  
Microscopic analysis of tyre: (A) On the cut section, (B) Within the cut section.

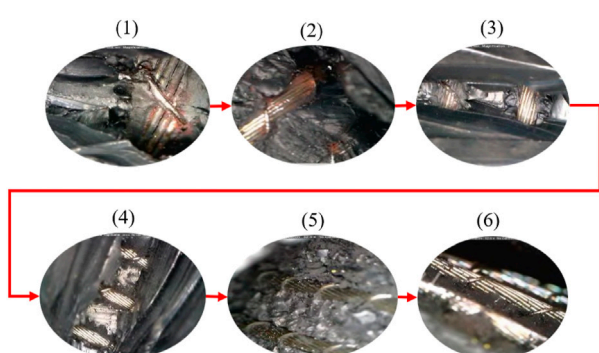
As the crack grows to a sufficient length along the cord, it transfers into the rubber matrix, leading to localized crack propagation towards adjacent cords, as depicted in images 3 and 4 of Figure 8. This progression highlights a coupled damage mechanism where the micro-level debonding failure transitions into macro-level delamination.

When the crack becomes sufficiently large, spanning multiple cords (typically 2–4 cords), a macro-level delamination occurs. This delamination causes the separation of the carcass ply from the surrounding structure, as illustrated in images 5 and 6 of Figure 8. The delamination leads to tearing and squeezing of the ply layers, compromising the integrity of the inner liner. This results in air leakage, bulging of the upper sidewall region, and, ultimately, catastrophic failure through bursting.

FIGURE 8  
Crack nucleation and propagation.

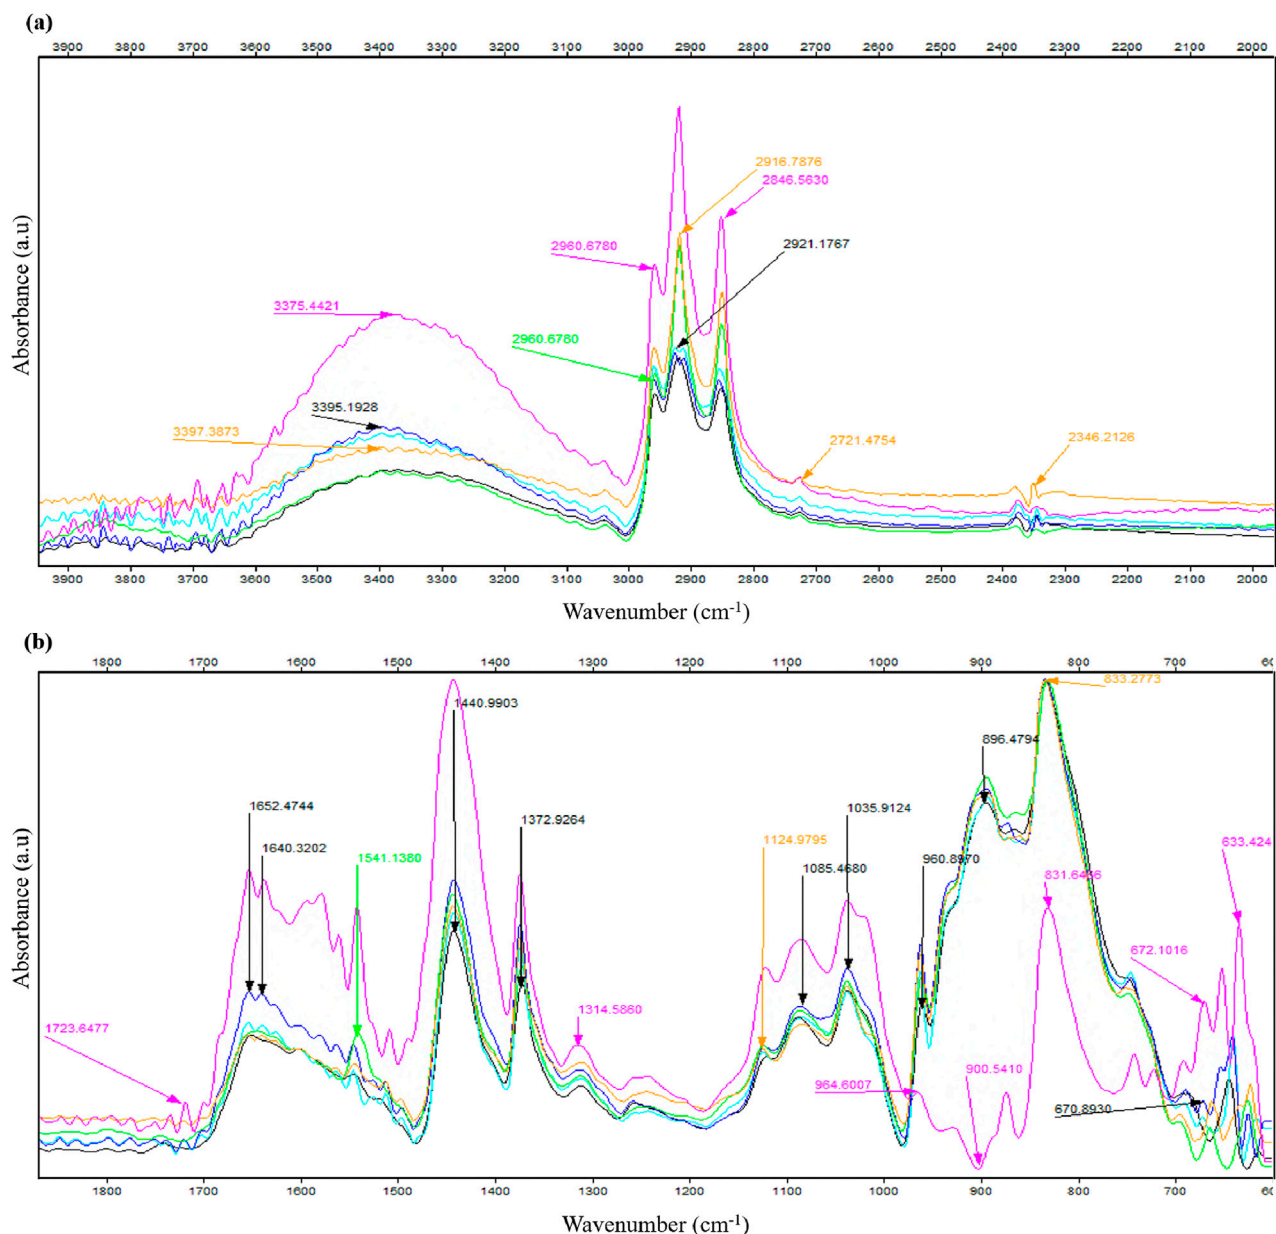
FIGURE 9  
FTIR spectra of tyre cut sections: (A) from 4,000  $\text{cm}^{-1}$ –1,900  $\text{cm}^{-1}$  and (B) from 1,900  $\text{cm}^{-1}$ –600  $\text{cm}^{-1}$ .

The wear rate cannot be directly correlated with oxidation, as the FTIR analysis reveals varying chemical changes that are not uniformly dependent on wear levels. For tyres with less wear, a significant increase in OH groups is observed, whereas tyres with higher wear show a notable increase in  $\text{CH}_2$  groups. The increase in  $\text{CH}_2$  and  $\text{CH}_3$  groups in field-return tyres suggests the occurrence of saturation, driven by mechanical strain and thermal aging, particularly in the shoulder region. These processes cause the breaking of C-C and C-S bonds, leading to the formation of alkane groups.

such as secondary amides, imines, and nitrous compounds. Furthermore, no significant decrease in vinyl and alkene groups is observed in the field-return tyres when compared to fresh tyres. In contrast, the climatic chamber tyre exhibits distinct chemical changes. The vinyl group is nearly absent, and a decrease in alkene groups is observed. This behavior confirms that degradation is more pronounced in tyres subjected to accelerated aging conditions in the climatic chamber.

Overall, the findings suggest minimal rubber degradation in the tyre carcass ply compound of field-return tyres. The compound remains structurally sound, with limited degradation that does not significantly affect its physical properties. Therefore, failure is unlikely to result from compound property degradation.
