# Seismic Vulnerability of Buildings in Historic Centers: From the “Urban” to the “Aggregate” Scale

Giulia Cocco, Andrea D’Aloisio, Enrico Spacone and Giuseppe Brando\*

Department of Engineering and Geology (INGEO), University “G. D’Annunzio” of Chieti-Pescara, Pescara, Italy

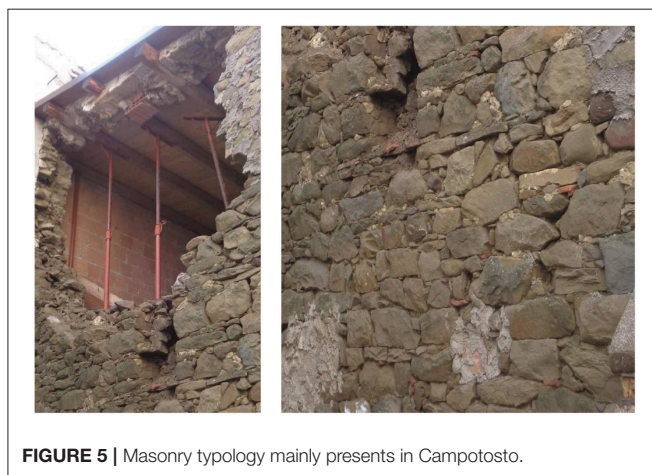
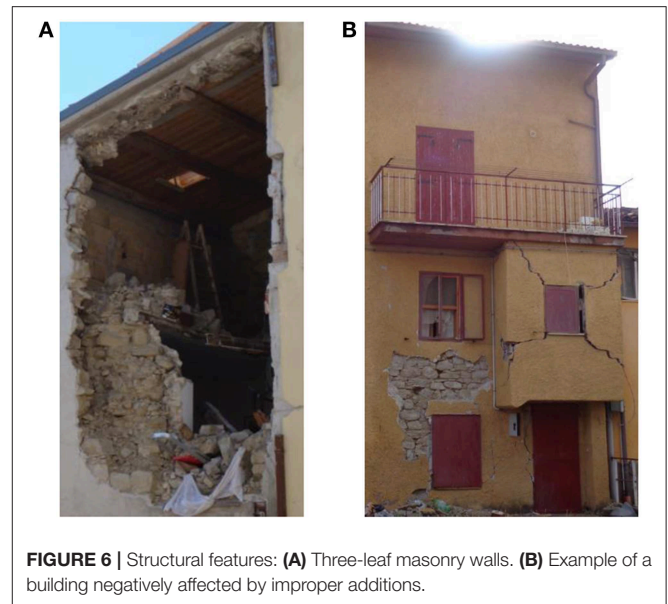
Moreover, several buildings and aggregates show signs of transformation over time that worsened their original structural behavior, such as additions in plan (**Figure 6B**) and elevation, new or enlarged openings and use of materials that are not homogeneous with respect to the original ones, such as reinforced concrete used for horizontal slabs, ring beam, lintels and roofs.

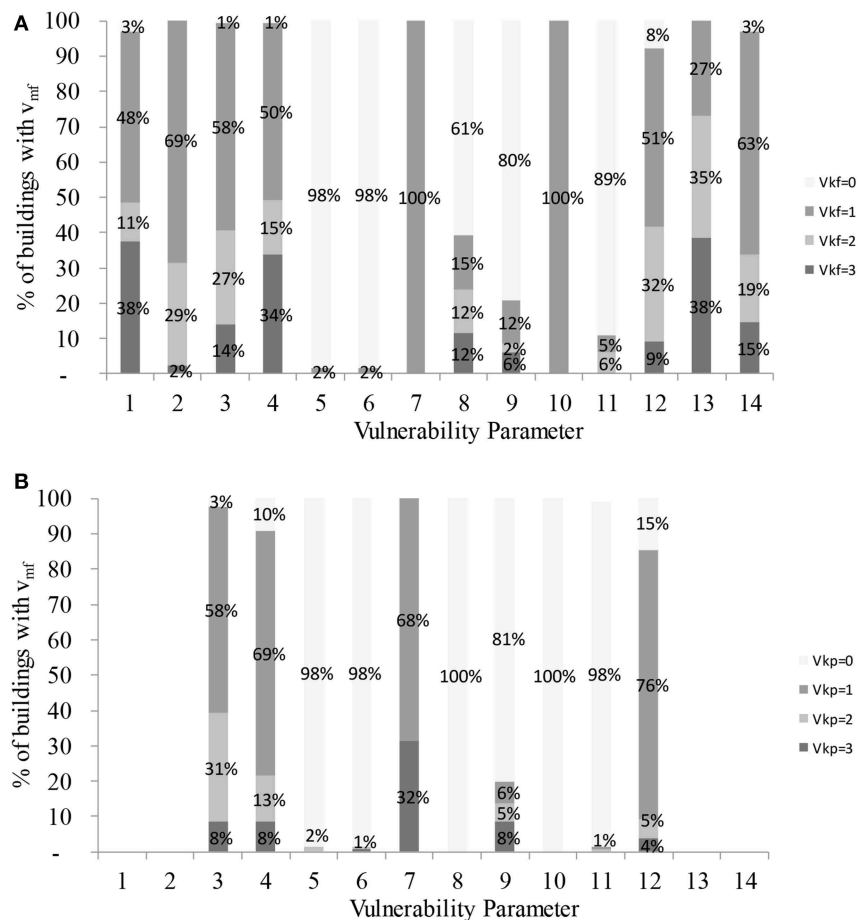
**FIGURE 9** | Distribution of the (A) fragility and (B) protection scores for the buildings of Campotosto.

In this way, it has been possible to identify and to classify the most influential fragilities (**Figure 9A**) and mitigation measures (**Figure 9B**) that characterize the analyzed buildings.

Also, possible interventions to be implemented for pursuing a risk mitigation have been preliminarily determined. As it can be observed in **Figure 9A**, the fragilities related to the potential trigger of the out-of-plane (Vulnerability source n° 3) and in-plane mechanisms (Vulnerability source n° 4) are particularly relevant. Moreover, a low percentage of buildings with effective anti-seismic preventive measures have been observed, as it is shown in **Figure 9B**.

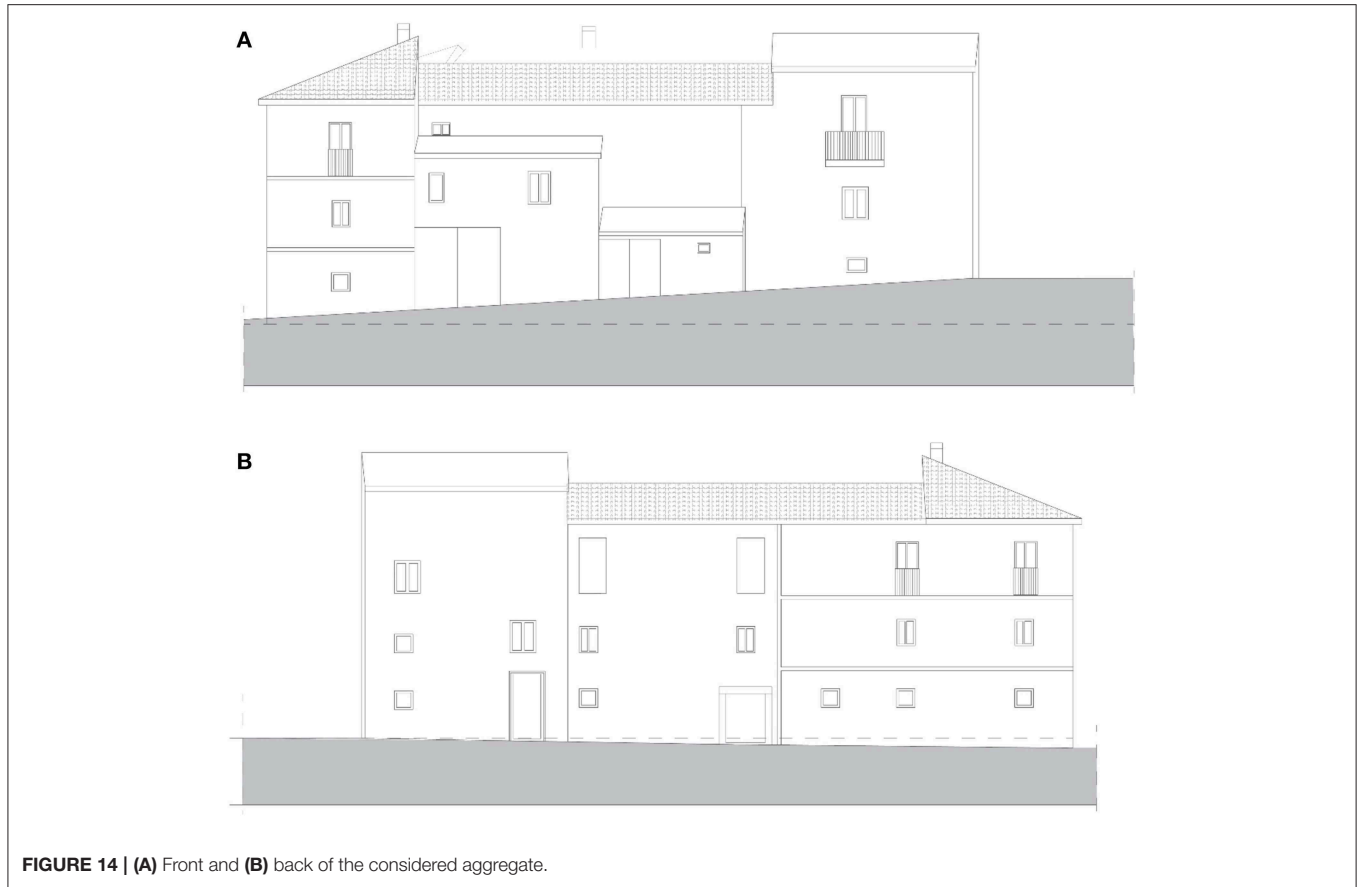
FIGURE 14 | (A) Front and (B) back of the considered aggregate.

in Figure 1B. The plan of the building and its cadastral identification are depicted in Figure 13, whereas in Figure 14 the front and the back are shown. The aggregate develops mainly along one longitudinal axis with a length of about 24 meters and a width of about 6 meters. It consists of 3-stories buildings with an average height of 7.4 meters.

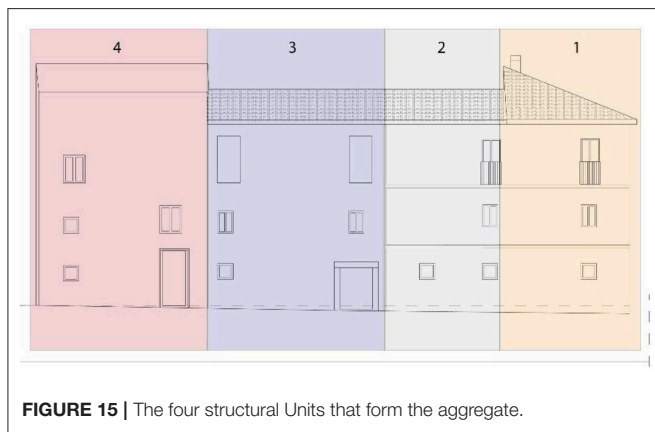
FIGURE 15 | The four structural Units that form the aggregate.

Given the impossibility of obtaining detailed historical documents, hypotheses concerning the development of the aggregate during the centuries have been done, mainly based on the analysis of the opening misalignments in the façade. Four structural units have been therefore detected (Figure 15).

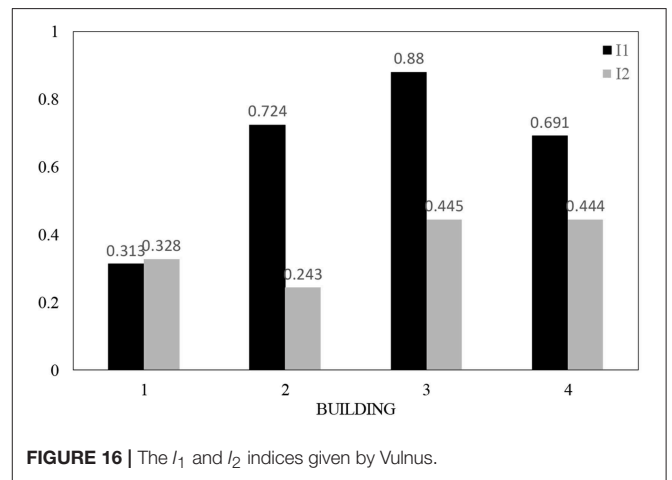
FIGURE 16 | The  $I_1$  and  $I_2$  indices given by Vulnus.

lower than 1, with a minimum of 0.243 for the out of plane mechanism of the Building 2. This result was actually confirmed by analyzing the damage provoked by the earthquake occurred in January 2017. In fact, several cracks and some triggered out-of-plane mechanisms were observed, with a general state of damage that in the EMS-98 scale can be classified with a grade  $D_3$ .

It is interesting to note that the  $I_2$  indices are lower than  $I_1$ , this stressing the higher sensitivity of the aggregate to experience out-of-plane mechanisms.

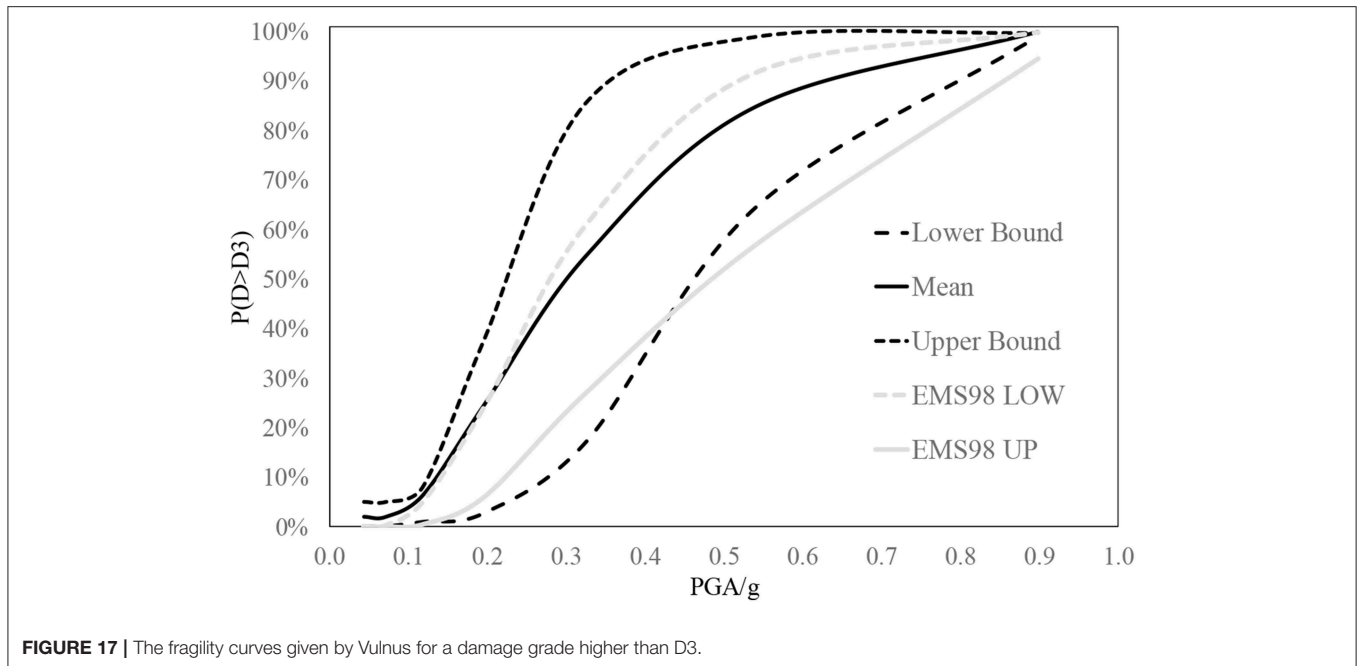
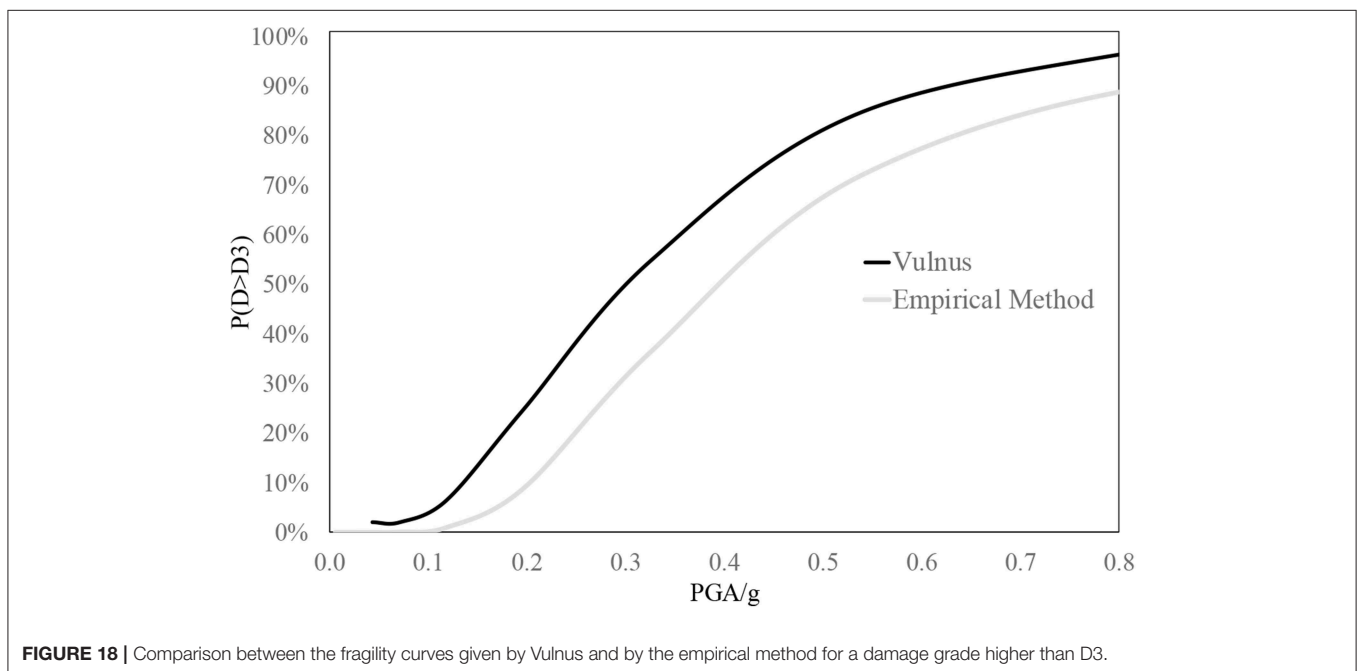
In **Figure 17**, the obtained fragility curves are shown. In the same figure, two other fragility curves, named “Lower Bound” and “Upper Bound,” are represented. They can be considered as a lower and an upper bound of the fragility and are obtained by Vulnus through a proper modification of the curve “Mean,” once that uncertainties, related to those parameters that cannot be determined accurately, on the indices  $I_1$ ,  $I_2$ , and  $I_3$  are properly accounted for. Also, the curves corresponding to the vulnerability classes “A” (curve “EMS98 LOW”) and “B” (curve “EMS98 UP”), according to the macroseismic scale EMS-98 are reported. It is possible to observe that, considering the mean curve, the buildings of the aggregate have to be assimilated to a vulnerability class “A.”

- The considered clustered building is characterized by a fragility curve for severe damage (damage grade higher than  $D_3$ ) that well fit the fragility curve given by the EMS-98 macroseismic scale for a Vulnerability Class A.
- The fragility curve given by the analytical method based on the Vulnus evaluation is higher than the one provided by the
