In-situ Corrosion Measurements of WWII Shipwrecks in Chuuk Lagoon, Quantification of Decay Mechanisms and Rates of Deterioration

Ian D. MacLeod*

Western Australian Museum, Fremantle Museums and Collections, Western Australian Maritime Museum, Fremantle, WA, Australia

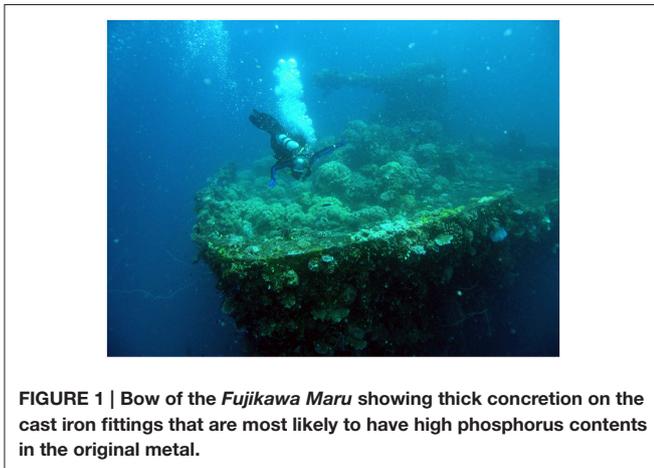
FIGURE 1 | Bow of the *Fujikawa Maru* showing thick concretion on the cast iron fittings that are most likely to have high phosphorus contents in the original metal.

It has been found that the thickness of the marine concretion is directly related to the availability of iron itself and also to the amount of phosphorus that is present in the iron alloy. Marine organisms suffer from the fact that iron, which is needed for the mitochondria in their cells, is a limiting resource in the marine environment. Since the pH of the surrounding sea water is quite alkaline the availability of the essential nutrient of iron is limited because of the insolubility of both iron (II) and iron (III) oxy-hydroxide species. The presence of high concentrations of these important reagents, under the protective envelope of the concretion, and other nutrients promotes the amount of marine growth on the submerged shipwreck. Additionally it has been found that anaerobic bacteria are capable of converting iron phosphide into a volatile form of a phosphine that is a stimulant to marine growth (Iverson and Olson, 1983; MacLeod, 1988). All the concretion data came from wrought and cast iron objects which had all corroded in shallow temperate coastal waters and that had not been subjected to diving tourism or events such as dynamite fishing. It was found that when the total thickness of the marine concretion is divided by the number of years of immersion then there is a linear relationship between the average rate of marine growth and the weight percent of phosphorus in the iron alloy. Because the composition of the steel used in the construction of the ships will naturally vary, the amount of marine growth will change in accordance with the amount of phosphorus in the iron alloys. This is specially noted in the nineteenth century wrought iron anchors which had cast iron balls on the extremities of the wrought iron stocks and the concretion is invariably much

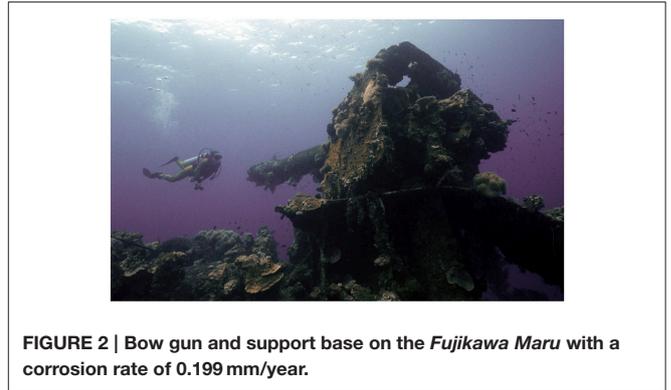
FIGURE 2 | Bow gun and support base on the *Fujikawa Maru* with a corrosion rate of 0.199 mm/year.

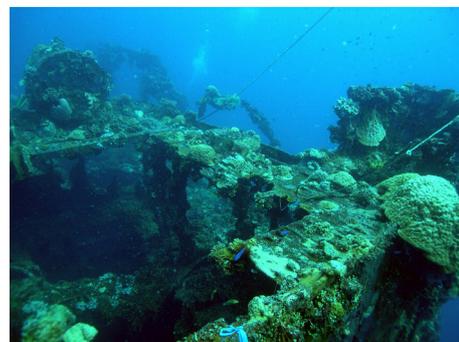
FIGURE 3 | View of the bridge of the *Fujikawa Maru* showing extensive corrosion loss due to accumulated effects of years of dynamite fishing.

to be set up between the hydrolysis of the metal ions and the reactions between the acid and the concretion. The Chuuk lagoon data for the *Fujikawa Maru* shows that a certain minimum concretion thickness is needed before the pH values are truly indicative of the underlying corrosion rate (MacLeod et al., 2007). The impact of the dynamite fishing has resulted in the most popular wrecks, such as the *Fujikawa Maru*, having a corrosion rate which is approximately 46% higher than similar vessels at the same depth that have not been subjected to such human intervention (MacLeod and Richards, 2009). The effect on the wreck is high and can be dramatically seen in images of the upper works of the bridge, which now have many holes in it, where at a combination of corrosion and damage from mooring of a dive vessels has resulted in periodic shedding of the concretion and its protective coating from the iron metal, as seen in Figure 3.

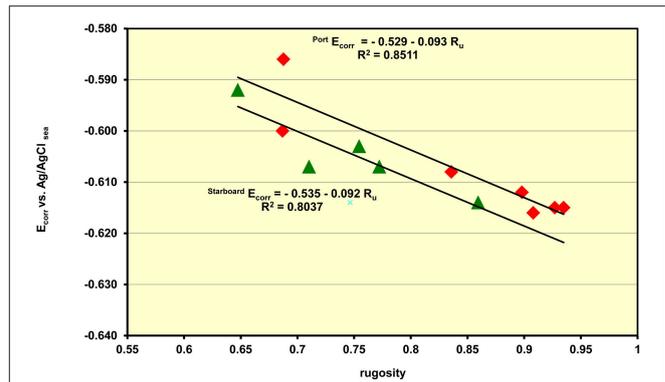
FIGURE 4 | Plot of the rate at which the E_{CORR} values move to more protective values as the roughness of the marine growth decreases with increasing depth.

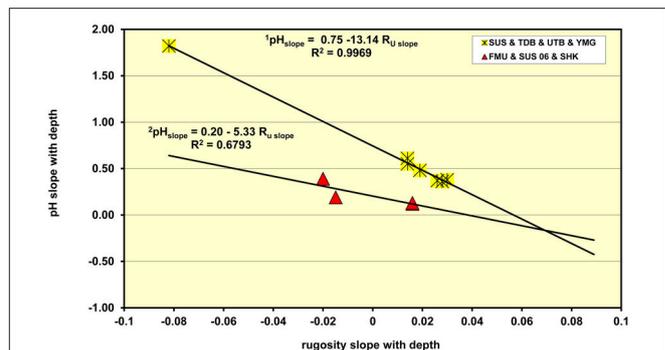
FIGURE 5 | Plot of the slope of the pH dependence on water depth and the dependence of rugosity on water depth which shows up the differences between sites that are undisturbed and those that have been subjected to “dynamite fishing.”

group (the *Fujikawa Maru*, *Susuki*, and *Shinkoku Maru*) where the equation describing the response of the damage wrecks is given by,

$${}^2\text{pH}_{\text{slope}} = 0.20 - 5.33 R_{u\text{slope}}$$

For the dynamite damaged wrecks there is a lower square of the correlation coefficient, $R^2 = 0.6793$, owing to the limited number of readings and wrecks that could be readily accessed. The second group covers those undamaged parts of the *Susuki* patrol boat, the *Tonoas Dock Boat*, the *Unidentified Tonoas Boat* and the so called *Yamamoto* gun boat. For these wrecks the relationship between the sensitivity of the plot of pH as a function of rugosity is given by,

$${}^1\text{pH}_{\text{slope}} = 0.75 - 13.14 R_{u\text{slope}}$$

In this equation the slope of the pH plot against rugosity is 2½ times that on the disturbed wrecks. The R^2 for the undisturbed parts of the wrecks was 0.9969 which is an extraordinarily high correlation, particularly considering that the data is collected from the natural shipwreck environment. Since the slope of

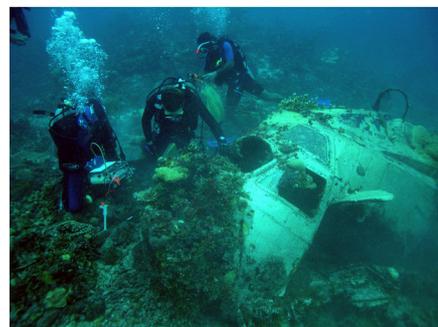
FIGURE 6 | Colonization on the *Emily* flying bomber with areas of no growth of marine organisms contrasting with other areas of significant growth after 62 years of immersion in seawater.

The colonization of substrates by marine organisms is dependent upon a balance between opportunity and toxicity of the substrate that presents itself to the floating larvae. If the surface is very smooth there is little chance of coral polyps to colonize the object. This is very readily seen in the wrecked aeroplanes of the lagoon when a combination of rivets and metal sheeting is of identical composition and there is minimal stress difference that could initiate localized pitting reactions. The corrosion mounds associated with pitting reactions dramatically increases the micro-roughness of the surface and thereby enhances colonization by marine organisms. There is little chance for a foothold for marine larvae on smooth aluminum alloys which is why there are sections of the nose cone and cockpit of the *Emily* flying bomber (a four engine armed marine reconnaissance aircraft of the Imperial Japanese Navy) is essentially devoid of colonization. However when there is a difference in composition of rivets and the alloys of the metal sheet subtle changes in corrosion can create precipitates around the surface of the riveted zones that enable a roughened substrate to form which is why

some areas of the were colonized and others appear to be quite bare even after 60 years of immersion in warm tropical sea water (see **Figure 6**). When a series of data sets are being examined some systematic trends and responses become apparent, which would appear to be otherwise “invisible” on the basis of a few measurements of a random site visit.

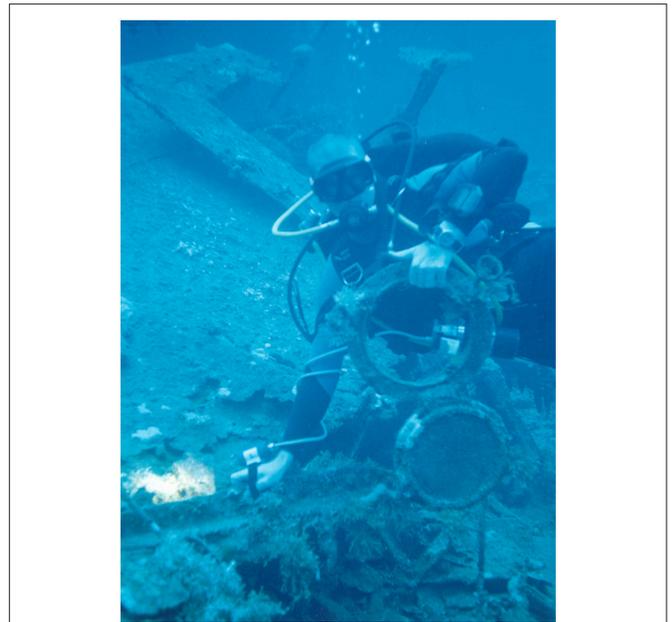
FIGURE 7 | The upside down *Yubae Maru* wreck undergoing accelerated corrosion due to unrelieved stress in the structure.

During the studies on the wreck of the *Yubae Maru* it was noted that this vessel has a greater corrosion rate than would be expected on the basis of the depth alone. The average depth of the site is 28 m and the corrosion rate was 0.095 mm/year which is relatively high for a wreck at that depth since it is very close to the long term marine corrosion rate for iron of 0.1 mm/year, which is generally found for wrecks at relatively shallow depths. One of the underlying reasons for the accelerated rate of decay is because the ship is lying upside down. Thus, there are many stresses in the vessel which are not those for which the Naval architects designed the ship. The bottom of the wreck site is littered with large plates of structural steel that had become detached from the frames that form the basis of the ship's structure (Figure 7). The calculations of the present corrosion rate indicate that the vessel is likely to undergo significant collapse in the next 5 years. This information is vitally important when one is considering the risk of oil escaping from within the wreck.
