Possible Failure Mechanism of Buildings Overturned during the 2011 Great East Japan Tsunami in the Town of Onagawa

Six buildings were overturned in the town of Onagawa during the 2011 Great East Japan tsunami. This study investigates the possible failure mechanisms of building overturning during tsunami flow. The tsunami inundation depth and flow velocity at each overturned building were recalculated by using a tsunami numerical simulation and verified using a recorded video. The overturning moment is a result of hydrodynamic and buoyancy forces, whereas the resisting moment is a result of building self-weight and pile resistance force. This study aimed to demonstrate that the building foundation design is critical for preventing buildings from overturning. The analysis results suggest that buoyancy force can generate a larger overturning moment than hydrodynamic force, and the failure of a pile foundation could occur during both ground shaking and tsunami flow. For the pile foundation, pile resistance force plays a significant role due to both tension and shear capacities at the pile head and skin friction capacity between the pile and soil, which can be calculated from 18 soil b

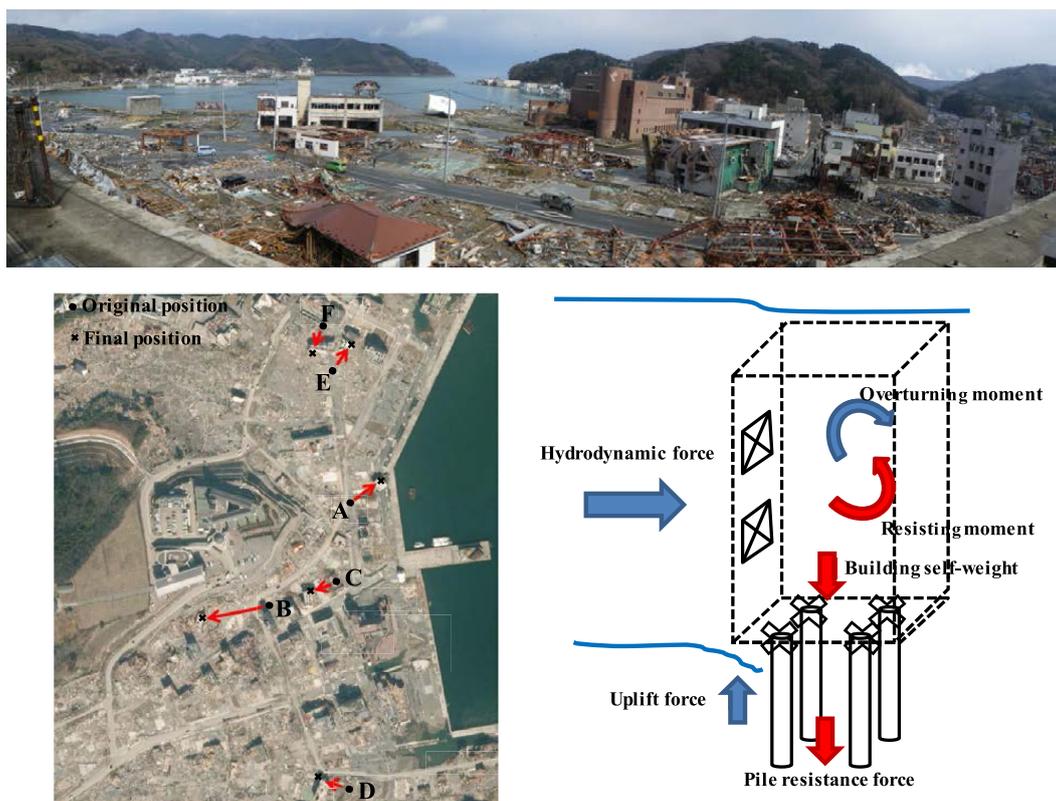
FIGURE 1 | Six overturned buildings in the town of Onagawa and free-body-diagram of building overturning. Note: taken by our survey team in March 29, 2011 at the town of Onagawa and Google Earth.

Our survey team observed that most of six overturned buildings in Onagawa had shifted away from sea and thus appeared to be overturned by striking wave. The tsunami force is estimated to be many tons per square meter with a long-period wave (e.g., 30 min), which led to a prolonged interaction of tsunami flow acting on these overturned buildings. The water released from the uppermost floors of the buildings generated uplift force, which caused a large overturning moment with hydrodynamic force. Small openings were observed in these overturned buildings, which could also generate large uplift force. However, there was sufficient time for water to flow inside the buildings because of the long-period wave. Thus, only the accumulated air between the top of the windows and the ceiling generated buoyancy force (Suppasri et al., 2013). The survey team also stated that most of the piles were probably pulled out and broken at the pile head as a result of ground shaking, hydrodynamic force, buoyancy force, and soil liquefaction. Five overturned buildings (i.e., Buildings A, B, C, D, and E) in **Figure 1** were analyzed in this study, and the characteristics of each overturned building are provided below.

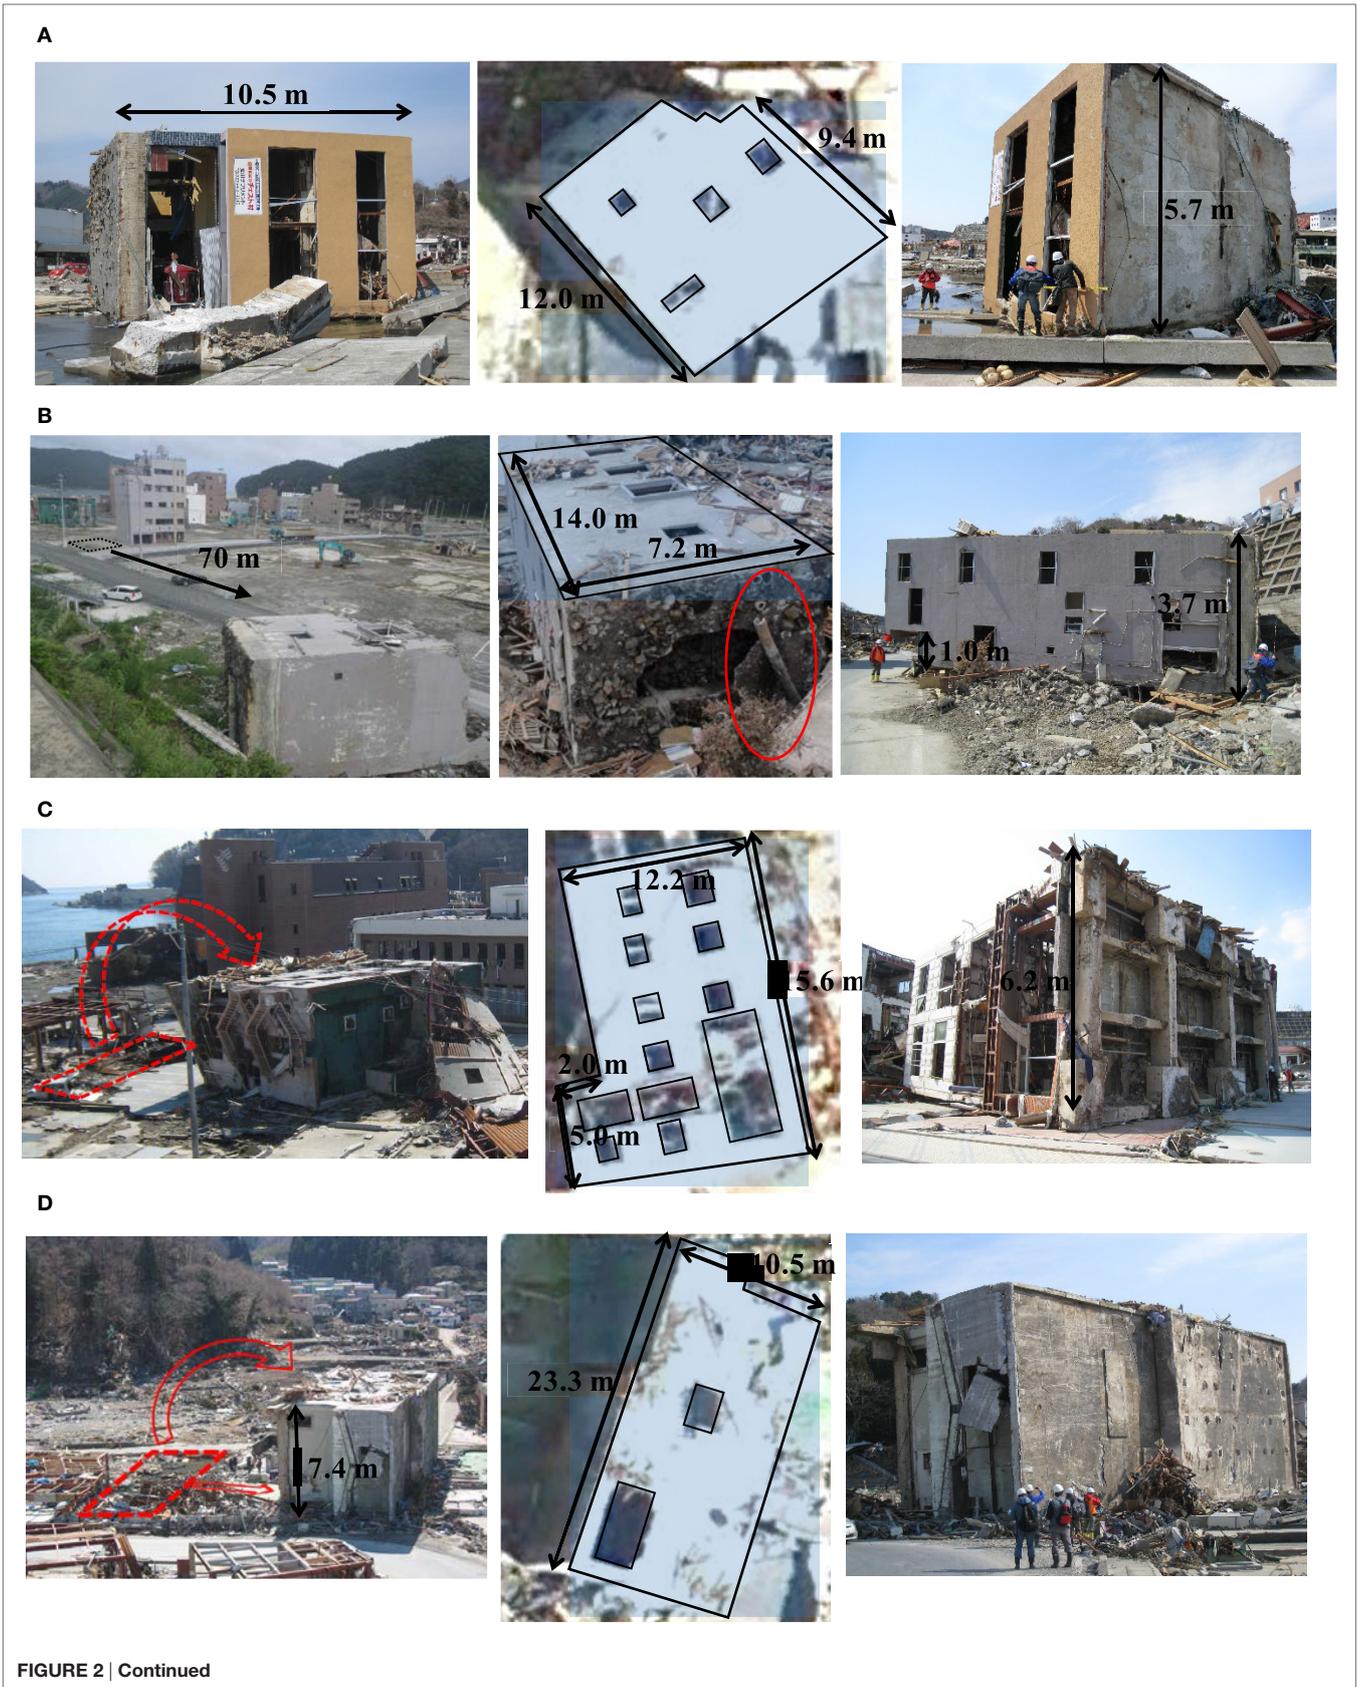
FIGURE 2 | The characteristics of five overturned buildings in the town of Onagawa. (A) Building A, (B) Building B, (C) Building C, (D) Building D, and (E) Building E. Note: taken by our survey team in March 29, 2011 and July 9, 2011 at the town of Onagawa.

Building D is believed to have been built between 1965 and 1975 (Nikkei BP Company, 2011). It was used as a refrigerated warehouse with a two-story RC structure and a pile foundation, as shown in **Figure 2D**. The pile foundation had six pile caps with four piles with a diameter of 20 cm in each pile cap. All piles were broken at the pile caps. No spiral reinforcing bar was observed inside the piles, but six longitudinal reinforcing bars were observed inside each pile. This building was floated more than 1 m and moved approximately 7 m, and all piles were ruptured at or near the joints (Tokimatsu et al., 2012). No pile remained connected to the pile caps, suggesting a higher level of shear in the overturning motion than was experienced in the other overturned building with a pile foundation (Fraser et al., 2013). This building was lifted by the hydrostatic buoyancy off of its pile foundation, which did not have tension capacity due to the minimal reinforcing steel (Chock et al., 2013). In addition, it was lifted off its original site and carried over a low wall before being deposited approximately 15 m inland from its original location (Chock et al., 2013).

Building A is believed to have been built between 1965 and 1970 adjacent to the shoreline (Onagawa, 2013). It was used as a repair shop of fishing boats in the past but was being used as a commercial store before the tsunami (Onagawa, 2013). The building was submerged by 0.4 m of seawater at high tide for many months after the tsunami due to the residual subsidence from the earthquake. The building was a three-story RC structure with a mat foundation on hard ground, as shown in **Figure 2A**. Small openings were observed on the face of this building subject to tsunami flow. As shown in **Figure 1**, this building overturned seaward, but it is expected that the initial failure was landward (consistent with the other buildings) and this building was then moved during tsunami return flow to its final position (Fraser et al., 2013). On the other hand, the building may have been overturned seaward by the receding wave (Onagawa, 2013). Due to the mat foundation, only building self-weight could provide a resisting moment against the overturning moment from hydrodynamic and buoyancy forces.

Building B is believed to have been built between 1955 and 1975 based on its type of foundation (Nikkei BP Company, 2011). It was an accommodation building with a four-story RC structure and a pile foundation, as shown in **Figure 2B**. The pile foundation had 32 hollow concrete pipe piles with a pile diameter of 20 cm. This building was moved 70 m from its original position. As shown in **Figure 2B**, some piles were pulled from the ground, and some were broken under the foundation. Twelve of the 32 piles under the foundation appear to have been effective in resisting the overturning moment (Kabeyasawa et al., 2012). No spiral reinforcing bar was observed inside the piles, but six longitudinal reinforcing bars

were observed inside each pile. The settled ground around a neighboring building indicated the occurrence of soil liquefaction (Tokimatsu et al., 2012).

Building C is believed to have been built between 1980 and 1985 (Onagawa, 2013). The building was used as an accommodation facility in the past but was being used as offices for private business and accommodations for sailors before the tsunami (Onagawa, 2013). The building was moved approximately 10–16 m from its original location by the tsunami (Onagawa, 2013). The building was submerged by 0.2 m of seawater at high tide for a short period after the tsunami. It was a four-story steel-frame building with a pile foundation, as shown in **Figure 2C**. The pile foundation had 8 pile caps with 20 piles having a diameter of 25 cm. Most hollow concrete pipe piles failed at the connection to the pile cap under the foundation unless one pile on the upper right was pulled out. A spiral reinforcing bar and six longitudinal reinforcing bars were observed inside each pile, and the six reinforcing bars had ruptured. This building was constructed from steel frames and ALC walls; thus, building self-weight was less than that of RC buildings. This building was floated, carried away and then overturned by tsunami flow, and most of the piles were broken at their joints with the pile caps (Tokimatsu et al., 2012).

Building E is believed to have been built in 1980 (Onagawa, 2013). It was a police box on the first floor and a rest area on the second floor (Onagawa, 2013). The building was overturned

near its present location and then moved to its present location by the receding wave (Onagawa, 2013). Some damage from floating debris can be observed on the upper part of the building. The building was submerged by 0.3 m of seawater at high tide for a short period after the tsunami. The building was a two-story RC building with a pile foundation, as shown in **Figure 2E**. The pile foundation had 6 pile caps with 14 piles having a diameter of 25 cm, and most of the piles were pulled out of the ground. No spiral reinforcing bar was observed inside the piles, but six longitudinal reinforcing bars were observed inside each pile. The settled ground near a neighboring building indicates that liquefaction occurred (Tokimatsu et al., 2012).

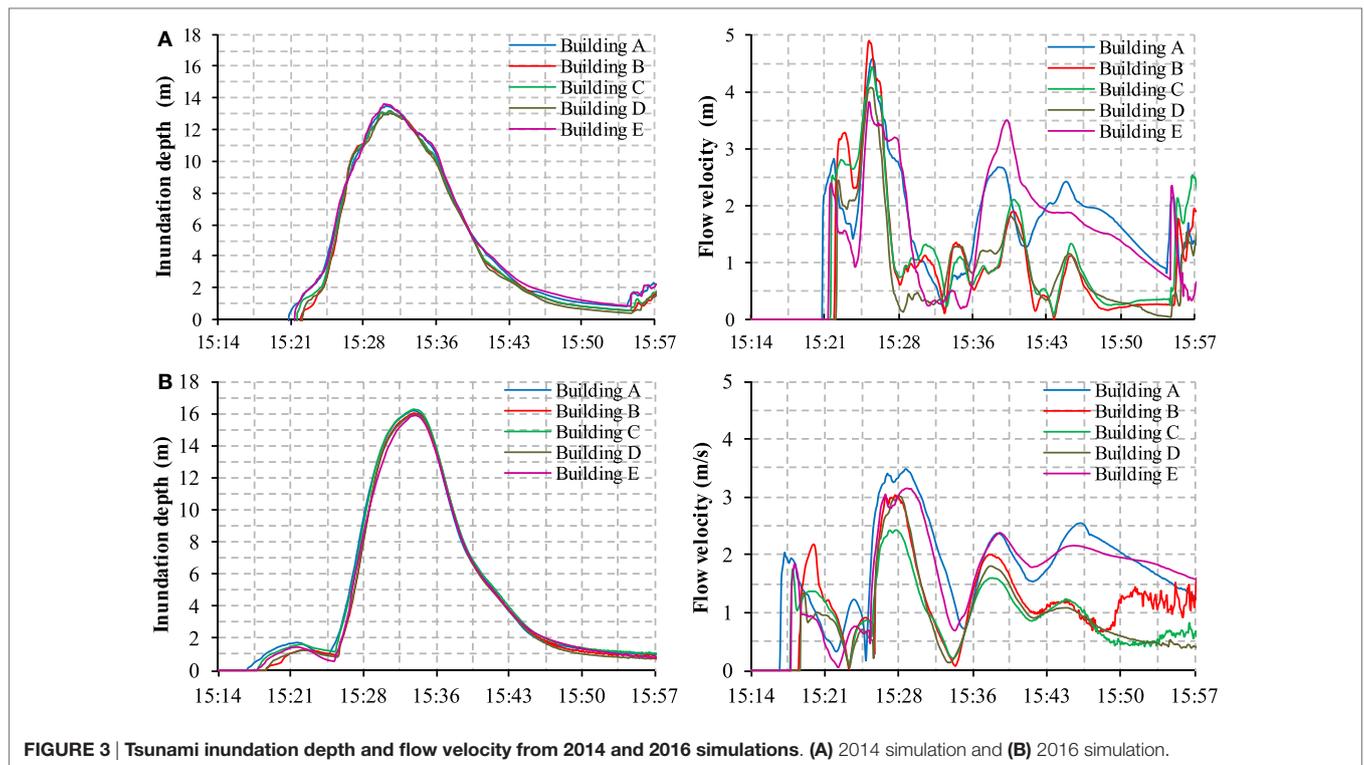
The tsunami inundation depth and flow velocity in the time series at each overturned building validated by the interpretation of the video data are shown in **Figure 3**. The peak inundation depth and peak flow velocity occurred at different times, which could result in the induction of large hydrodynamic force at any time during the striking or receding wave. **Figure 3A** shows the calculated time series of the tsunami inundation depth and flow velocity in 2014 (Adriano et al., 2014). In this 2014 simulation, the maximum inundation depth was not consistent with the video analysis, although the maximum flow velocity was somewhat consistent. **Figure 3B** shows the calculated time series of the tsunami inundation depth and flow velocity in 2016, including the crustal deformation (Adriano et al., 2016). In this 2016 simulation, the maximum inundation depth was consistent with the video analysis, whereas the maximum flow velocity was lower than that of the video analysis. However, these numerical tsunami simulations were generated by the tsunami source model, which is typically used to reproduce tsunami propagation for all affected areas in Japan after the 2011 Great East Japan tsunami. This source model is not specific to only the studied area in Onagawa, which makes it different from other reverse models that attempt to be consistent with the video evidence. In this study, sets of inundation depth and flow velocity from both 2014 and 2016 simulations were used to estimate hydrodynamic and buoyancy forces.

The overturning moment is partially the result of hydrodynamic force, which can be calculated from the inundation depth and flow velocity, as shown in **Figure 3**. This study assumed that these overturned buildings were surrounded by water and had a minimum unbalanced hydrostatic force, i.e., a minimum tsunami load. For each overturned building, hydrodynamic force (F_d) was applied as a uniform load over the depth of tsunami flow (Federal Emergency Management Agency, 2011) as

The overturning moment is also partially the result of buoyancy force, which can be calculated from the inundation depth shown in **Figure 3**. For each overturned building, buoyancy force (F_b) was set equal to the water weight of the residual air space inside it, which also depends on the opening ratio. A residual air space ratio (C_b) of 0 indicates that the entire building was filled with water, whereas a residual air space ratio of 1.0 indicates that no water entered the building, expressed as

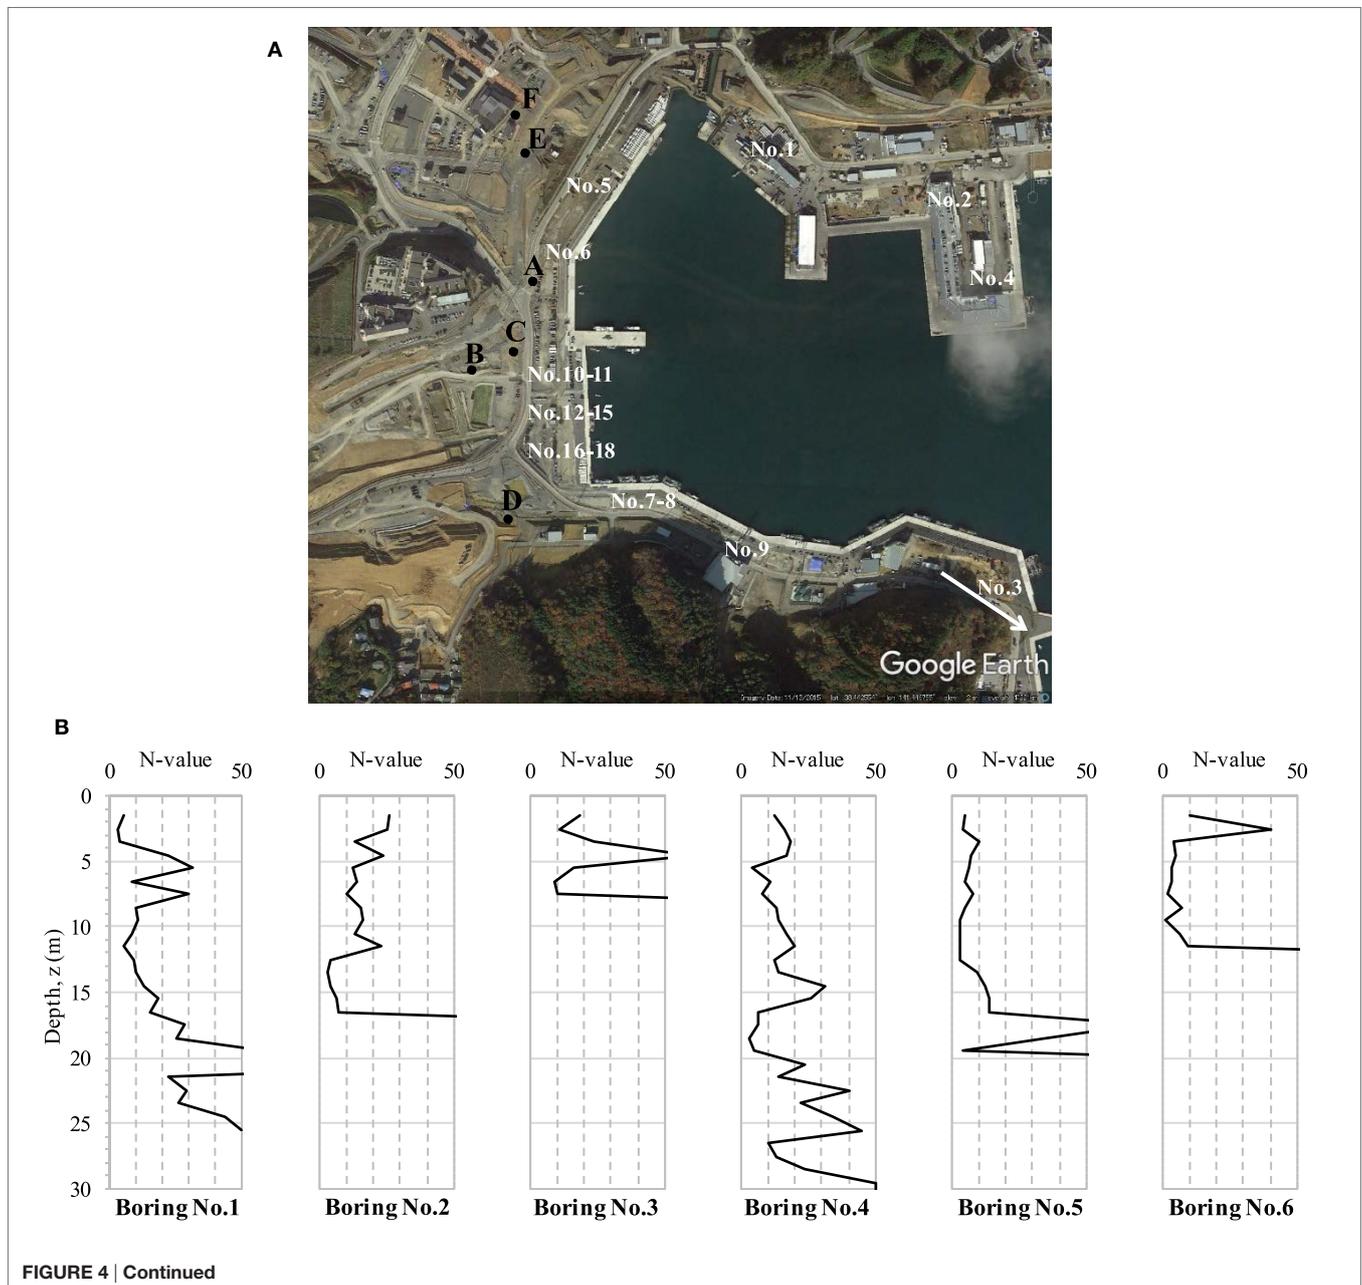
Eighteen soil boring data were obtained from the Onagawa office to represent the soil profiles of overturned buildings with pile foundations, as shown in **Figure 4**. The coastal area in **Figure 4A** (covered by the red-dashed line) was largely filled by soil (Onagawa, 1960). A soil boring data contains soil layers, such sand, gravel, silt, and clay, and N value, as shown in **Figure 4B**. In the case of pulling a pile out of the ground, pile resistance force (R_{TC}) is calculated from skin friction capacity (Q_s) between the pile and soil based on the recommendations for the design of building foundations (Architectural Institute of Japan, 2001) as

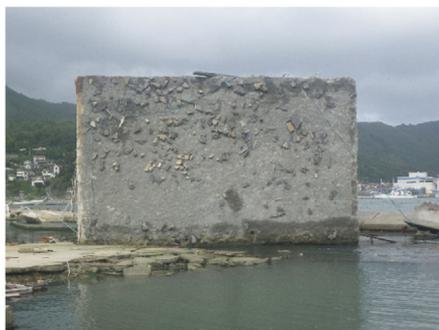
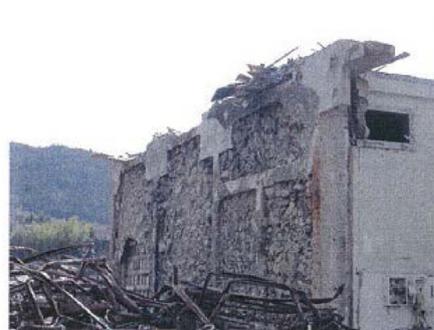
FIGURE 5 | Mat foundation of Building A and pile foundation of Building D. Note: taken by our survey team in March 29, 2011 at the town of Onagawa.

from hydrodynamic force (F_d) and buoyancy force (F_b) to the resisting moment calculated from building self-weight (W). Building A had a mat foundation, and all piles of Building D failed during the ground shaking, as shown in **Figure 5**. **Figure 6A** shows the tsunami inundation depths and flow velocities at Buildings A and D in the 2014 and 2016 simulations. The residual air space ratio (C_b) was estimated based on the condition of larger buoyancy force than building self-weight, as shown in **Figure 6B**. The residual air space ratios for Buildings A and D were approximately 0.6 and 0.4, respectively. **Figure 6C** shows the time series of the overturning moment (M_d and M_b) and the resisting moment (M_w).

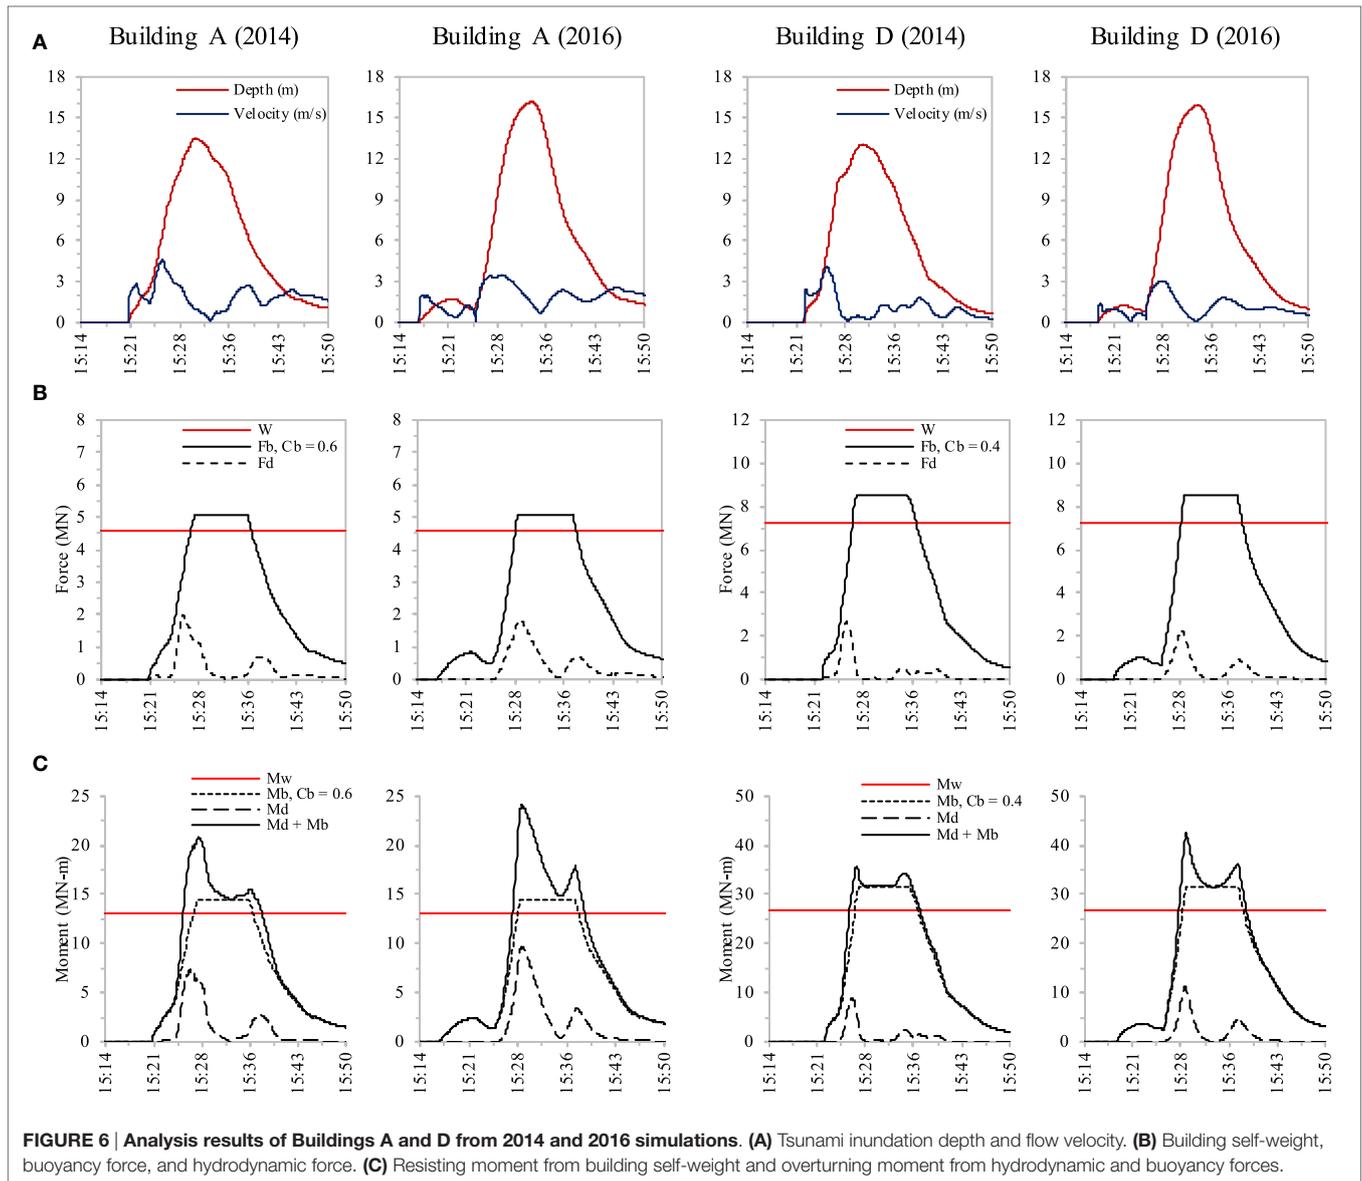
FIGURE 6 | Analysis results of Buildings A and D from 2014 and 2016 simulations. (A) Tsunami inundation depth and flow velocity. **(B)** Building self-weight, buoyancy force, and hydrodynamic force. **(C)** Resisting moment from building self-weight and overturning moment from hydrodynamic and buoyancy forces.

based on the 2014 simulation reveals that the peak overturning moment ($M_d + M_b$) that occurred at 15:27 was 1.33 times higher than the resisting moment (M_w), whereas a comparison based

on the 2016 simulation suggests that the peak overturning moment that occurred at 15:29 was 1.59 times higher than the resisting moment. The peak overturning moment in the 2014

simulation occurred when the inundation depth was 9.98 m and the flow velocity was 2.02 m/s², whereas the maximum depth and velocity of 13.05 m and 4.07 m/s², respectively, occurred at different times, as shown in **Figure 6A**. The peak overturning moment in the 2016 simulation occurred when the inundation depth was 10.43 m and the flow velocity was 2.71 m/s², whereas the maximum depth and velocity of 15.93 m and 3.02 m/s², respectively, occurred at different times, as shown in **Figure 6A**. Building D was 10.5 m tall; thus, it was overturned when the tsunami flow was lower than the top of the building.

Another observation is that buoyancy force could generate an overturning moment larger than hydrodynamic force, particularly for Building D, as shown in **Figure 6C**. After building overturning occurred at 15:28, these buildings floated and then moved from their original positions such that buoyancy force was immediately greater than building self-weight, as shown in **Figure 6B**.

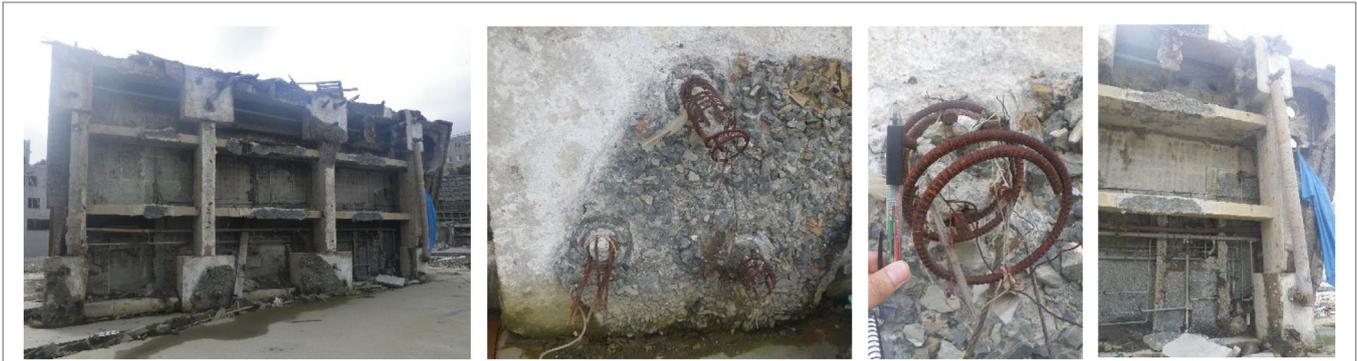
FIGURE 7 | Pile foundation of Building C (one pile pulled out of ground). Note: taken by our survey team in March 29, 2011 at the town of Onagawa.

For Building C, the pile foundation failed during tsunami flow through the observed tension failure between the pile heads and pile caps in which the tensile strength of a pile (F_t) was 307 kN, as shown in **Table 4**. The effective piles out of the 20 piles were used

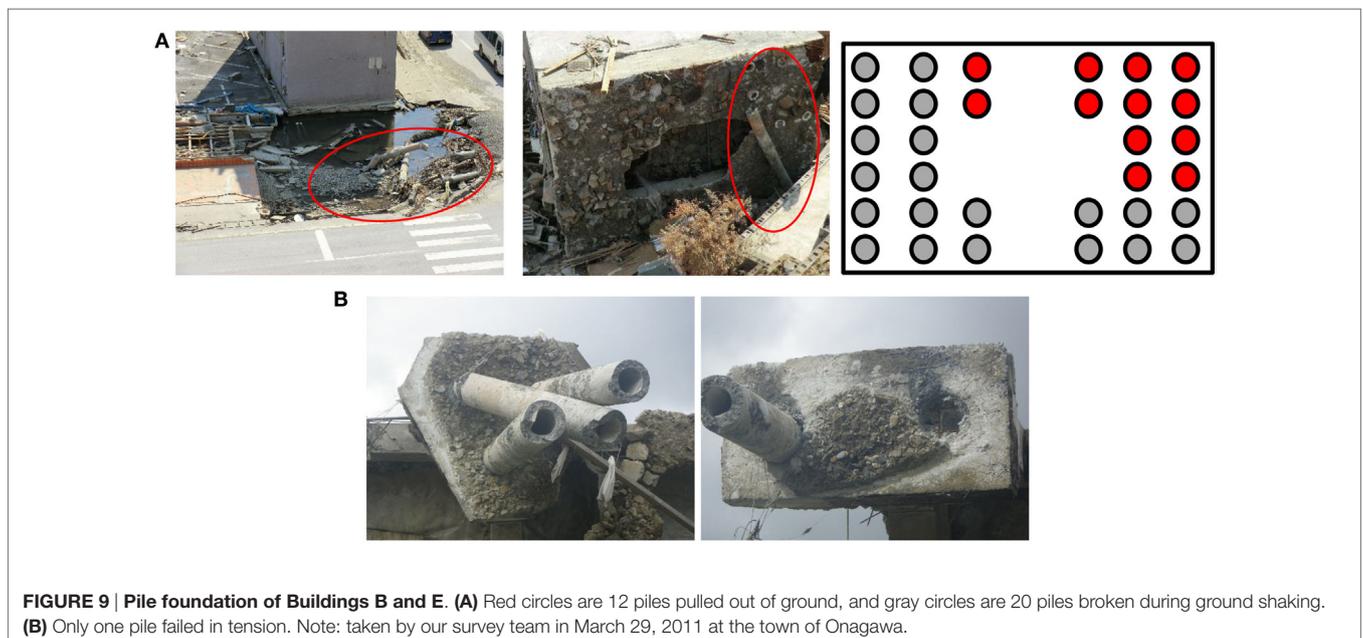
The overturning mechanisms of Buildings B and E were investigated by comparing the overturning moment calculated from hydrodynamic force (F_d) and buoyancy force (F_b) to the resisting moment calculated from building self-weight (W) and pile resistance force (R_{TC}). Building B had a pile foundation, and 12 piles were pulled out of the ground, as shown in **Figure 9**, whereas

20 piles might have failed as a result of base shear force during the ground shaking because the safety factor was close to 1.00, as shown in **Table 4**. Building E had a pile foundation, and all piles were pulled out of the ground except for one pile that failed in tension, as shown in **Figure 9**. **Figure 10A** shows the tsunami inundation depths and flow velocities at Buildings B and E in the 2014 and 2016 simulations. The residual air space ratio (C_b) was estimated based on the condition of larger buoyancy force than building self-weight, as shown in **Figure 10B**. The residual air space ratios for Buildings B and E were approximately 0.7 and 0.6, respectively. **Figure 10C** shows the time series of the overturning moment (M_d and M_b) and the resisting moment (M_w and M_r).

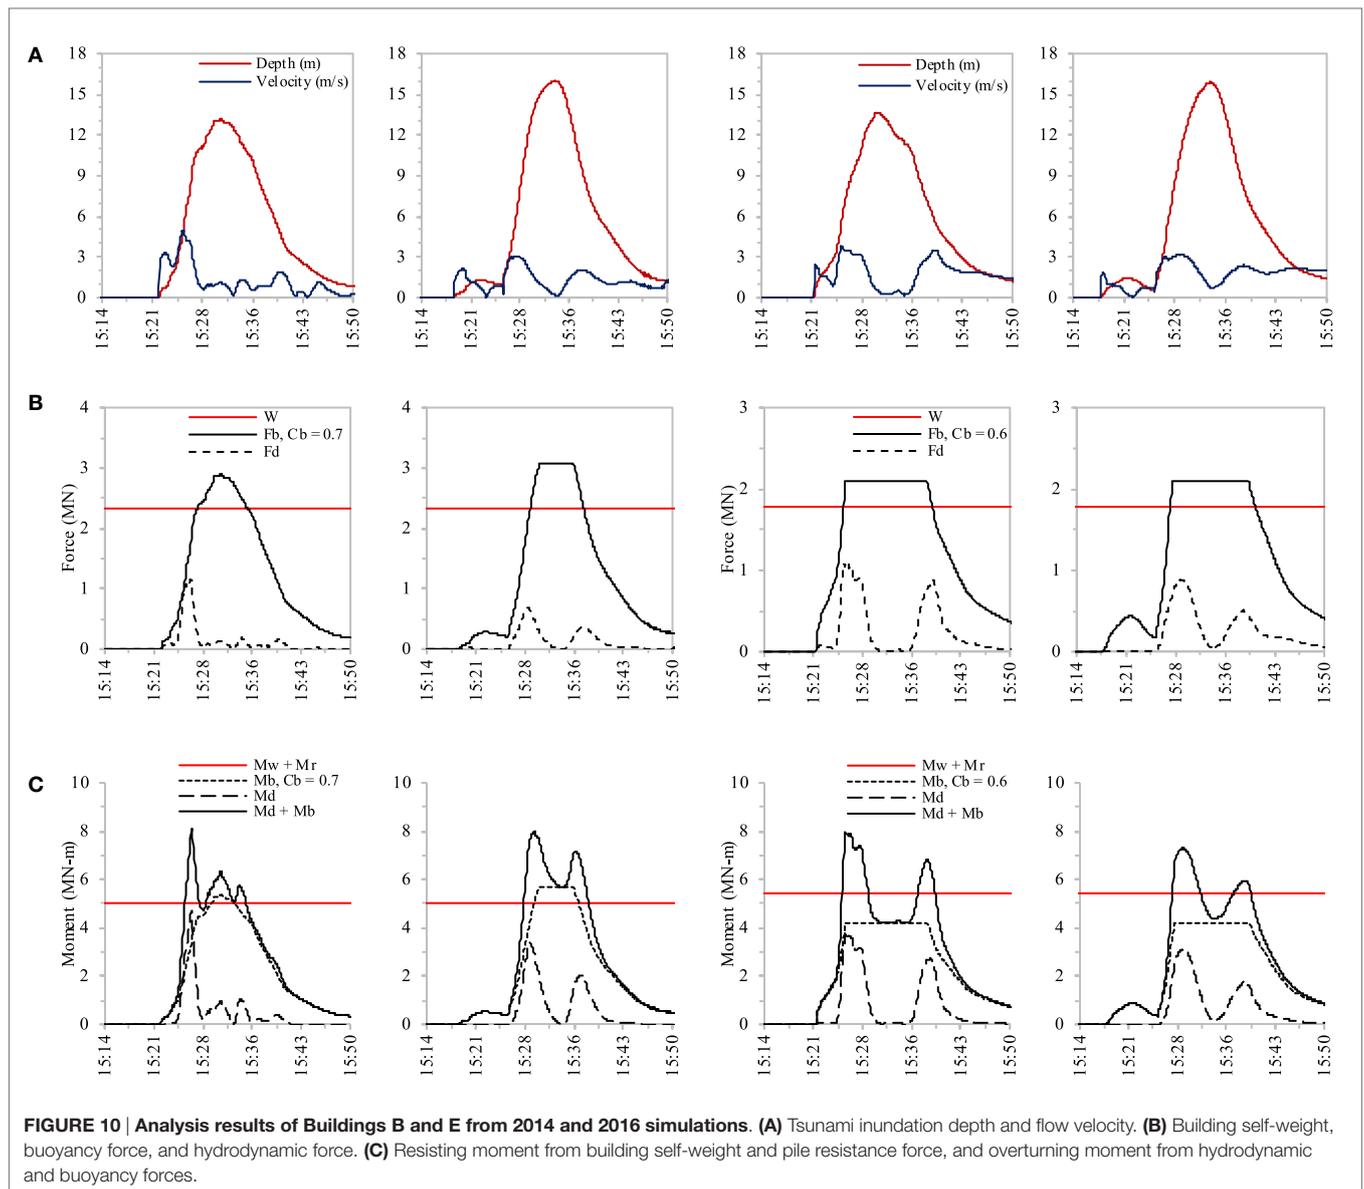
For Building B, boring No. 11 at the nearest location and the assumed pile length of 6 m were used to calculate skin friction capacity (Q_s) of a pile, which was 38 kN/m, for a pile diameter of 20 cm, as shown in **Table 3**. As shown in **Table 5**, the comparison of Building B based on the 2014 simulation reveals that the peak overturning moment ($M_d + M_b$) that occurred at 15:27 was 1.61 times higher than the resisting moment ($M_w + M_r$), whereas the comparison based on the 2016 simulation suggests that the peak overturning moment that occurred at 15:30 was 1.59 times higher than the resisting moment. The peak overturning moment in the 2014 simulation occurred when the inundation depth was 8.71 m and the flow velocity was 3.73 m/s², whereas the maximum depth and velocity of 13.19 m and 4.90 m/s², respectively, occurred at different times, as shown in **Figure 10A**. The peak overturning moment in the 2016 simulation occurred when the inundation depth was 12.45 m and the flow velocity was 2.10 m/s², as the maximum depth and velocity of 16.02 m and 3.03 m/s², respectively, occurred at different times, as shown in **Figure 10A**. Building B was 14.0 m tall; thus, it was overturned when tsunami flow was lower than the top of the building.

capacity (Q_s) of a pile, which was 64 kN/m, for a pile diameter of 25 cm, as shown in **Table 3**. As shown in **Table 5**, the comparison of Building B based on the 2014 simulation in reveals that the peak overturning moment ($M_d + M_b$) that occurred at 15:26 was 1.47 times higher than the resisting moment ($M_w + M_r$), whereas the comparison based on the 2016 simulation suggests that the peak overturning moment that occurred at 15:29 was 1.34 times higher than resisting moment. The peak overturning moment in the 2014 simulation occurred when the inundation depth was 7.06 m and the flow velocity was 3.48 m/s², whereas the maximum depth and velocity of 13.63 m and 3.82 m/s², respectively, occurred at different times, as shown in **Figure 10A**. The peak overturning moment in 2016 occurred when the inundation depth was 10.57 m and the flow velocity was 3.15 m/s², whereas the maximum depth and velocity were 15.88 m and 3.15 m/s², respectively, occurred at different times,

as shown in **Figure 10A**. Building E was 7.0 m tall; thus, it was overturned when tsunami flow exceeded the top of the building.
