How Can Vernacular Construction Techniques Sustain Earthquakes: The Case of the Bhatar Buildings

Carabbio R, Pieraccini L, Silvestri S
and Schildkamp M (2018)
How Can Vernacular Construction
Techniques Sustain Earthquakes:
The Case of the Bhatar Buildings.
Front. Built Environ. 4:18.
doi: 10.3389/fbuil.2018.00018

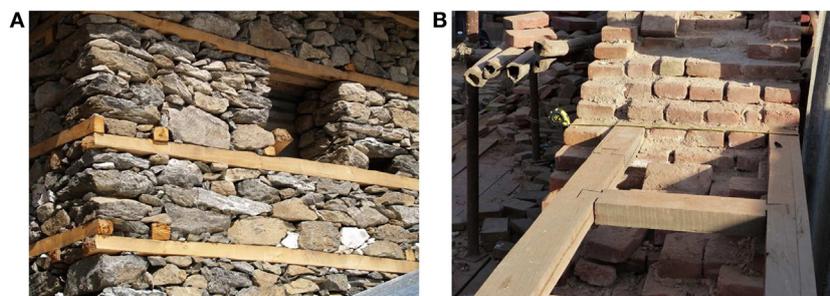
FIGURE 1 | (A) Wooden bands and dry-stacked rubble stone masonry (photo credit: Tom Schacher). (B) Wooden bands and brick masonry with lime mortar in Bhaktapur, Nepal (photo credit: Martijn Schildkamp).

In countries worldwide, including many Himalayan regions, examples can be found of load-bearing masonry with horizontal wood lacing, but without vertical reinforcement (Langenbach, 2009). For the wall material, generally bricks or stones are used, and the masonry is either constructed with mortar or dry-stacked, depending on local availability and preference

(**Figure 1**). In the north of India the technique is called “Taq,” usually built with bricks and mud mortar. Nepal does not have local names for the techniques, whereas in Pakistan the technique is known as “Bhatar,” and the buildings predominantly consist of dry-stacked stone walls. According to Schacher (2007), the Pashto word “Bhatar” specifically indicates beams with a cross section of 3”–4”, which are then combined into continuous wooden ladders with cross pieces, used to reinforce the walls. In some cases, a weak mud or lime mortar is used, which may result in lower quality of masonry, as the masons take less care in proper placement of the stones (Dowling et al., 2007).

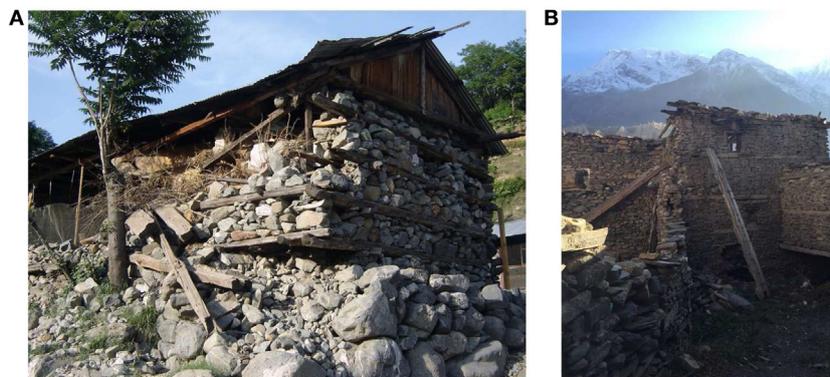
FIGURE 2 | (A) Partially collapsed Bhatar house near Battagram in Pakistan (photo credit: Jitendra Bothera). (B) Out-of plane collapse mechanism of a wall and intervention with wooden posts in Nepal (photo credit: Tom Whity).

On the other hand, Himalayan regions present a significant seismic activity (Chaulagain et al., 2015) and the “weight issues” concerning Bhatar are not negligible due to the significant mass of walls and roof. Nonetheless, Bhatar buildings are known to have a strong resistance to seismic forces (Langenbach, 2015). This is provided by the combination of dry-stacked stone masonry, which has a high capacity for energy dissipation, and the timber bands with their excellent tensile and elastic properties (Dowling et al., 2007). As a matter of fact, seismic damage figures of Bhatar or Taq buildings are hard to find and damage reports are possibly non-existent. When asked for such data during a reconnaissance mission after the 2005 Kashmir earthquake, officials stated that they were “*unaware of any, but in years past, there may have been*” (Langenbach, 2009). Only few pictures have been found. **Figure 2A** shows the partial collapse of a house near Battagram that may be caused by improper

bonding due to the large size and irregular shape of the stones. The wood lacing that became visible after the 2015 earthquake in Nepal is incorporated in a brick wall with mud mortar. It is currently being restored and the wood is replaced. A possible explanation for the failure of many timber-laced brick buildings in Nepal is the bad state of the wood due to neglect of maintenance. **Figure 2B** testifies the occurrence of an out-of-plane collapse mechanism in a Bhatar building in Nepal and the raw reinforcement intervention with wooden posts.

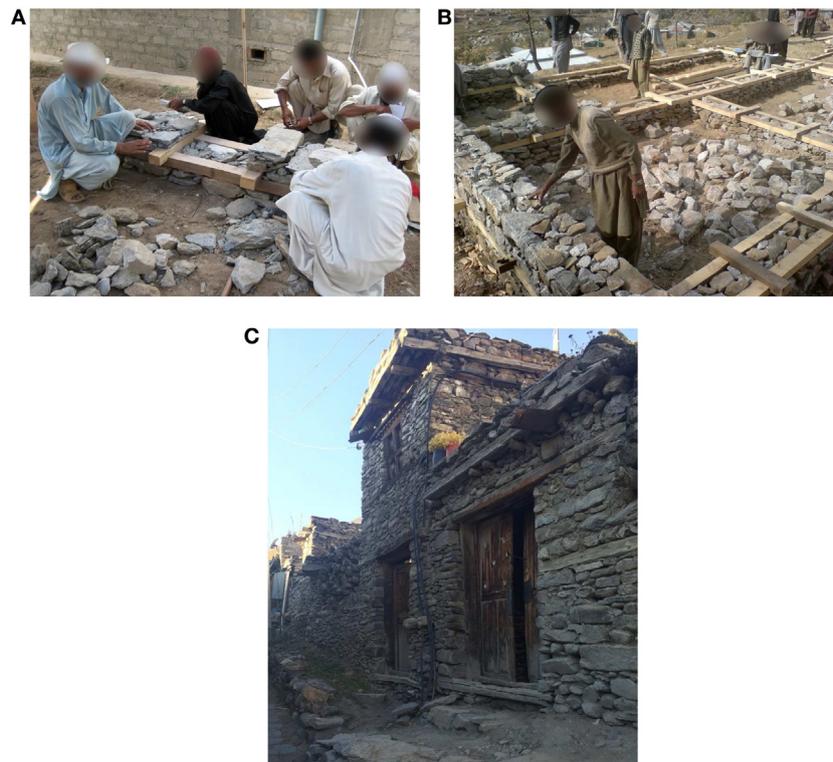
FIGURE 3 | (A) Construction process of a single Bhatar wall (by courtesy of the French Red Cross). **(B)** Construction of a Bhatar building (by courtesy of the Swiss Agency for Development and Cooperation). **(C)** A typical Bhatar building (photo credit: Tom Whity).

For the wooden reinforcements, it describes mainly two kinds of timber elements. First, “*long members*” parallel to the wall should be placed every 60 cm along the wall height. Second, transversal “*short cross braces*” with a maximum spacing of around 90 cm hold together the longitudinal long members, in order to compose the “*horizontal wooden beam*” or “*horizontal band*” (Figures 3A,B). Complex structures may be composed by coupling together simple units (Figure 3C).

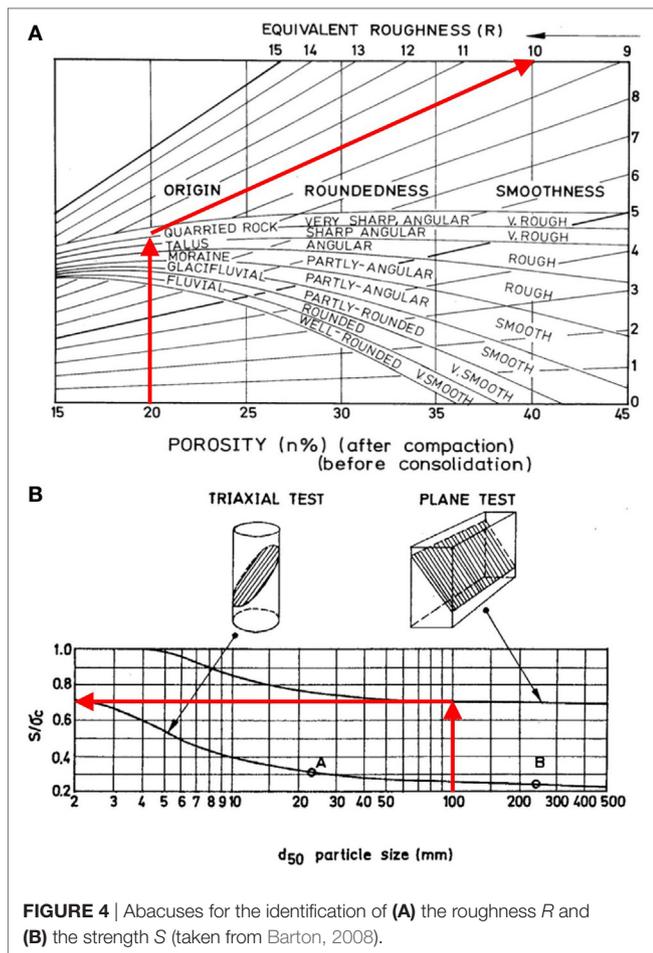
On the one hand, Barton suggests that roughness *R* is estimated as a function of porosity (*n*%) and the origin of the rock-fill. In this study, considering the peculiarities of the Bhatar construction process, *n* = 20 and quarried rock origin have been assumed, thus leading to *R* ≈ 10 (**Figure 4A**).

On the other hand, Barton suggests that strength *S* is estimated as a function of the *d*₅₀ particle size parameter and the kind of test conducted to measure the UCS of the rock sample tests (plane or triaxial testing). In this study, considering the peculiarities of the Bhatar construction process, *d*₅₀ = 100 mm and “plane testing” have been assumed, thus leading to *S* = 0.7 σ_c (**Figure 4B**), where σ_c is the UCS.

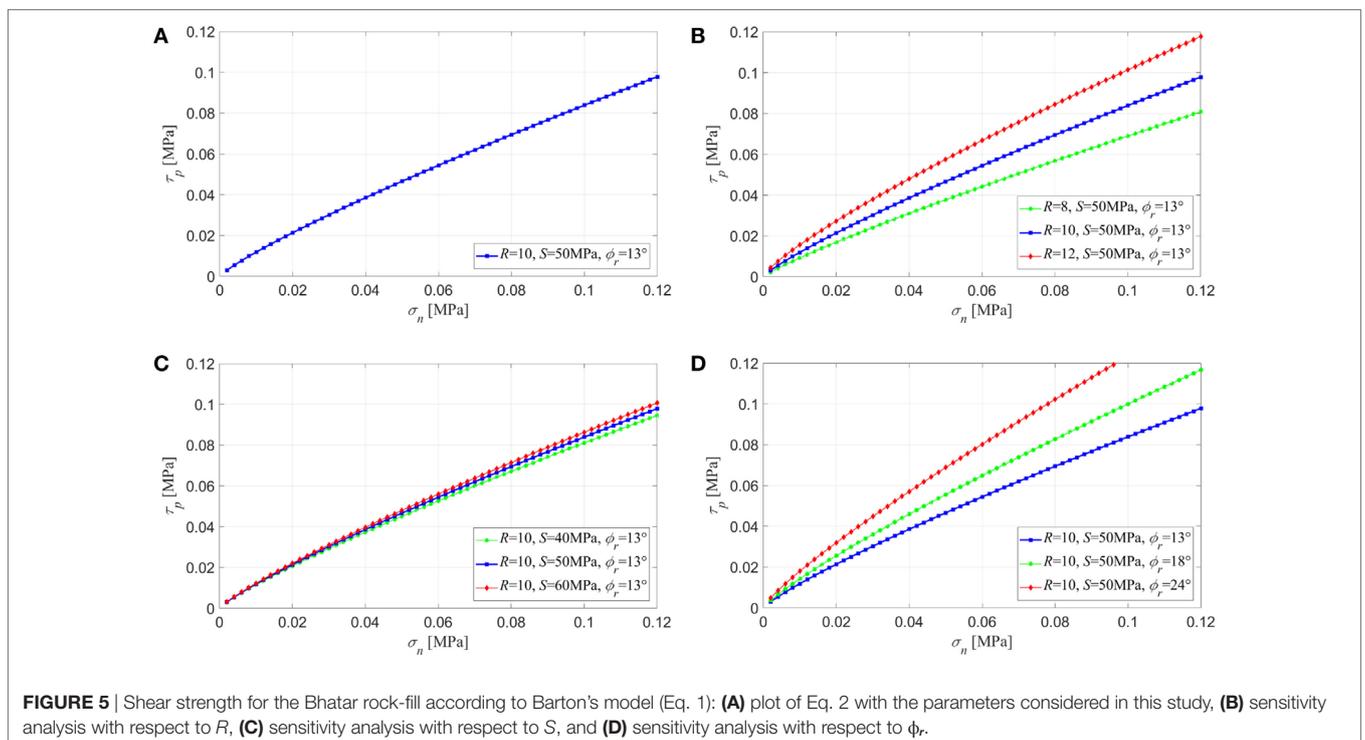
Figure 5A represents the shear strength $\tau_p(\sigma_n)$ for the case under exam, according to Eq. 2. It can be observed that, for the limited stress range concerned, a simply linear relationship could be considered as first approximation (such as the Mohr-Coulomb's friction law, where the term within the square brackets represents the friction angle ϕ , where cohesion is neglected). The results of a quick sensitivity analysis with respect to the three parameters of the Barton's model are presented in **Figures 5B,C,D**. A variation of about $\pm 20\%$ has been taken for R and S (even if for S it could be lower, provided

that the coefficient of variation for the UCS values of **Table 2** is around 14% and the ratio S/σ_c is almost constant, equal to 0.7 for large particle size). Making reference to the range of the ϕ_r values suggested by Krsmanovic and Popovic (1966), the values 13°, 18°, and 24° have been assumed. The model is basically not affected by the strength S of the stones, while, on average (over the common range of σ_n values), the variation in the shear strength due to a variation of +20% in the roughness R becomes equal to +25%. The choice of the residual friction angle ϕ_r plays an important role, since using 24° instead of 13° leads to an increase of about +50% in the shear strength. As later developed in Section “In-Plane Seismic Analysis of a Bhatar Wall,” the shear strength of the material directly affects the shear strength of the wall against sliding failure.

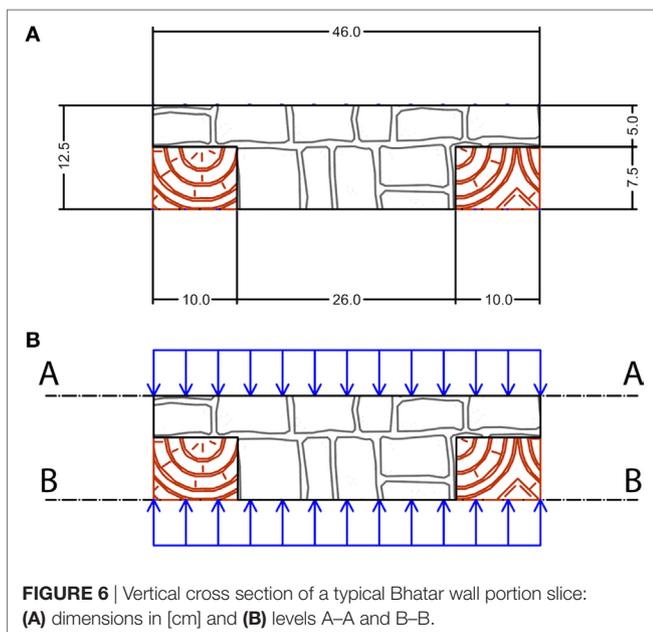
FIGURE 6 | Vertical cross section of a typical Bhatar wall portion slice: (A) dimensions in [cm] and (B) levels A–A and B–B.

Figure 6 shows the typical cross section of a Bhatar wall portion, including the horizontal band (long members). At level A–A, the blue arrows represent the normal stresses $\sigma_v^{(A-A)}$ acting on a layer composed only by rubble stones. At level B–B, the blue arrows represent the normal stresses $\sigma_v^{(B-B)}$ acting on the layer

Assuming that $\mu_{t-s} < \mu_{s-s}$, the timber–stone contact area A_{t-s} can be neglected in the estimation of the shear strength at level B–B. Thus, the shear strength of level B–B is smaller than the shear strength of level A–A. An area reduction factor ξ may be introduced equal to the ratio of the stone–stone contact area A_{s-s} at level B–B to the total area A of the horizontal surface at level B–B. In this study, considering a wall thickness equal to 46 cm and a width of 10 cm for each one of the two timber long beams, the ratio (A_{s-s}/A) results equal to 0.57.

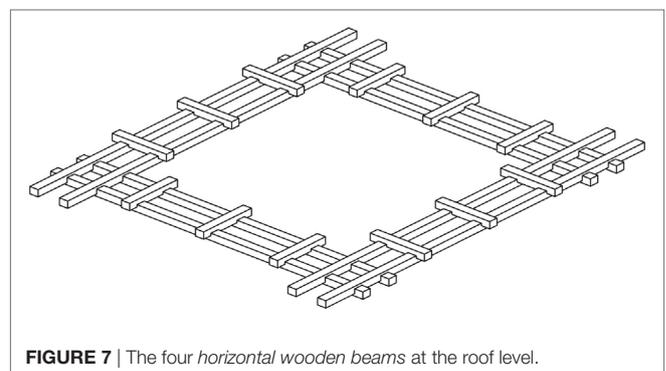
FIGURE 7 | The four horizontal wooden beams at the roof level.

- *foundation beams*, continuous;
- *wall beams*, semi-continuous due to disruption of door openings;
- *lintel beams*, which continuously cross over the level of doors and windows;
- *top beams*, continuous, also called *roof beams* as they are used to connect the roof to the wall (**Figure 7**).

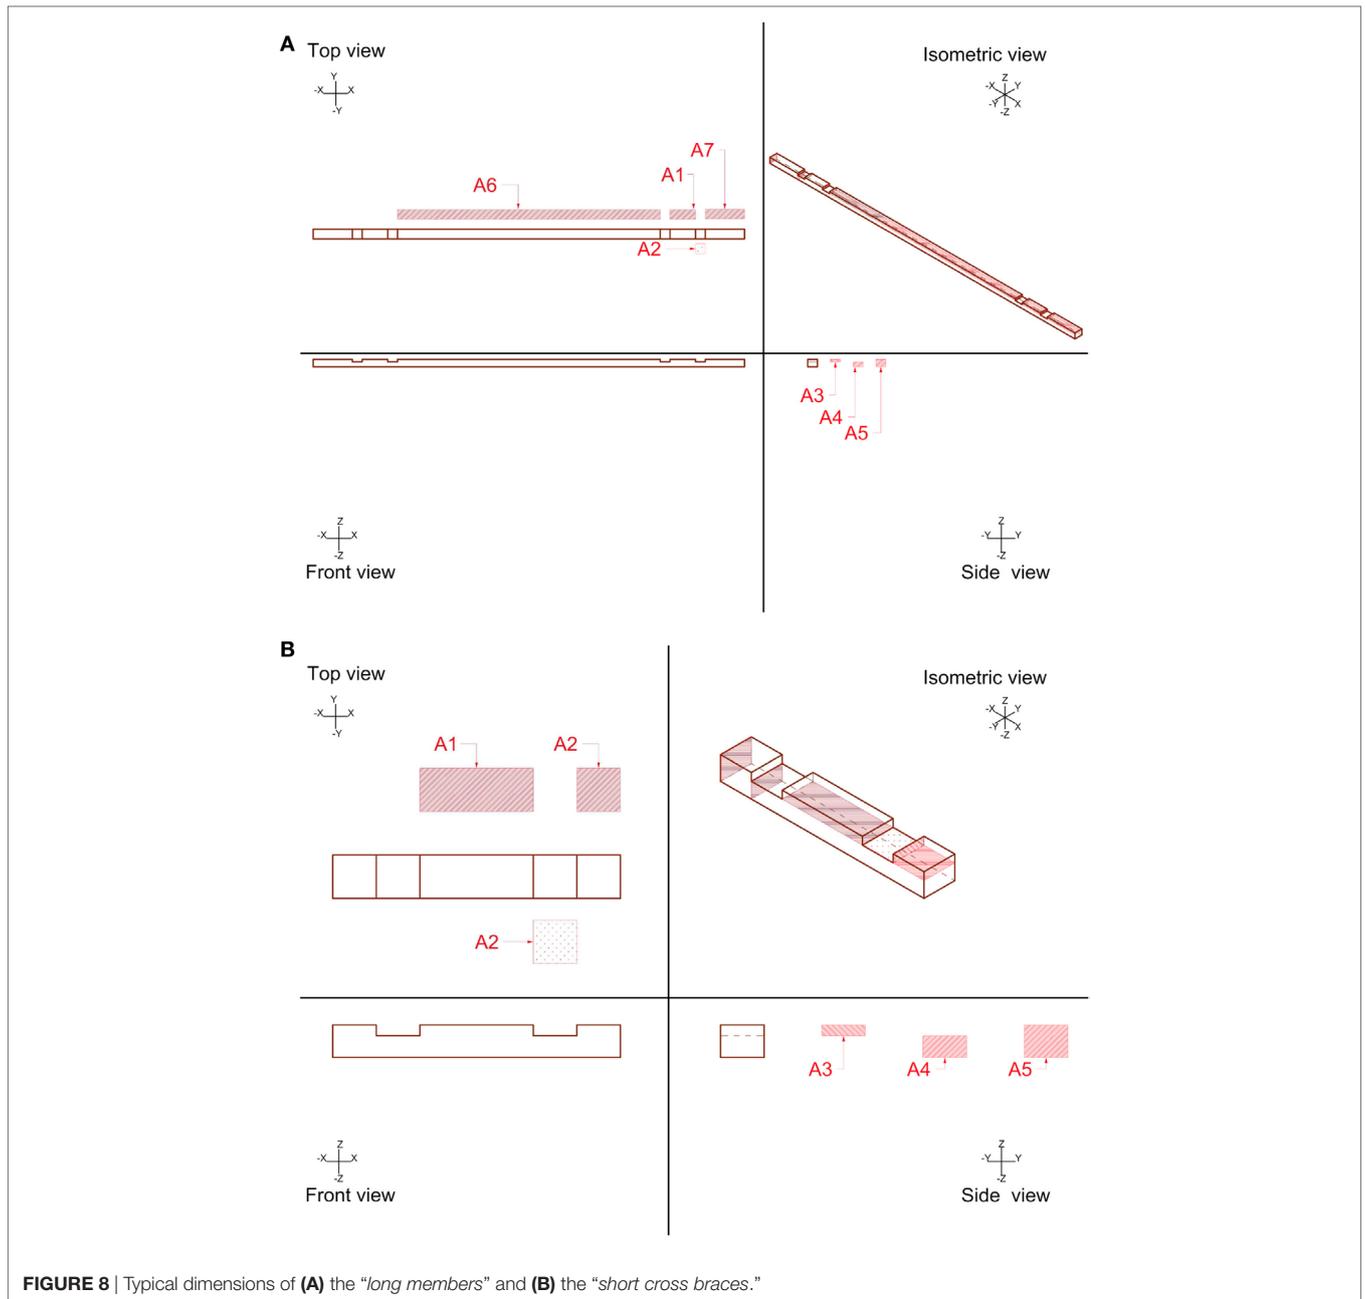
FIGURE 8 | Typical dimensions of (A) the “long members” and (B) the “short cross braces.”

To analyze the stresses on the timber elements, the areas of the significant cross sections of both the long members and the short cross braces have been first identified in **Figures 8A,B**, then computed and reported in **Table 3**.

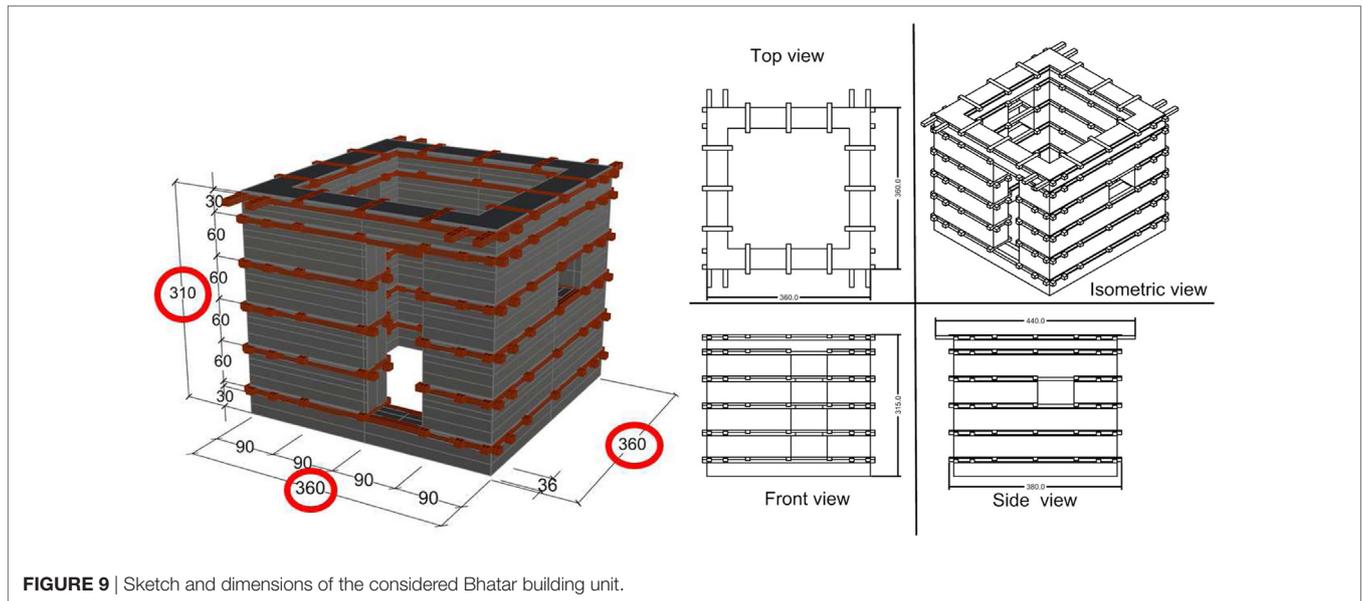
According to the guidelines given by Schacher (2007), a basic one-room building unit has been defined, which is characterized by the following details (Figure 9):

- foundation made of stones,
- seismic horizontal bands made of wood,
- square plan dimensions $L = 3.6$ m and $W = 3.6$ m,
- height $H = 3.1$ m,
- 1 door characterized by width = 0.9 m and height = 2.4 m,
- 2 windows characterized by width = 0.9 m and height = 0.6 m.

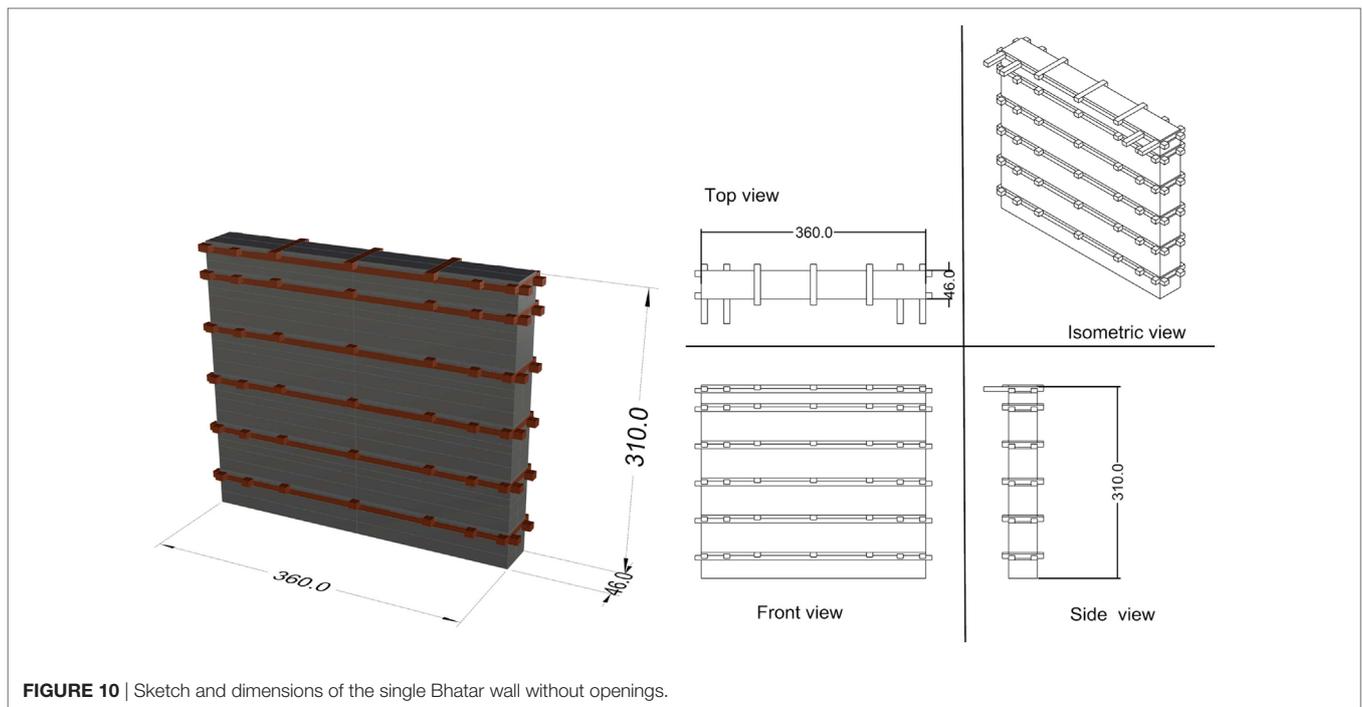
The Bhatar building is studied making reference to four single walls (the only one without openings is detailed in **Figure 10**).

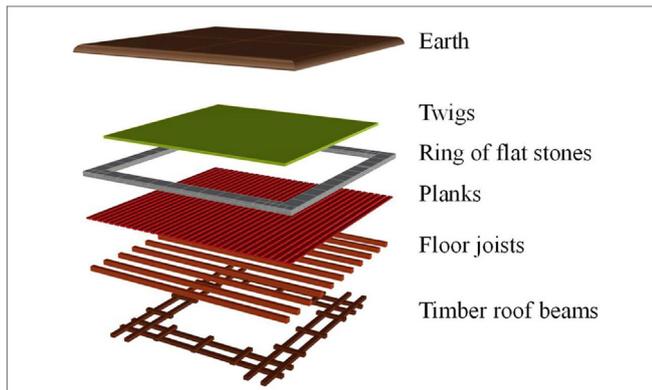
FIGURE 11 | Flat heavy earthen roof.

The roof has been considered as flat heavy roof with earth cover, which is composed as follows from the bottom up (**Figure 11**):

- Timber roof beams,
- Roof joists 10 cm height,
- Planks 3 cm thick,
- Ring of flat stones 10-cm thick,
- Layer of twigs 5-cm thick,
- Layer of earth 20-cm thick.

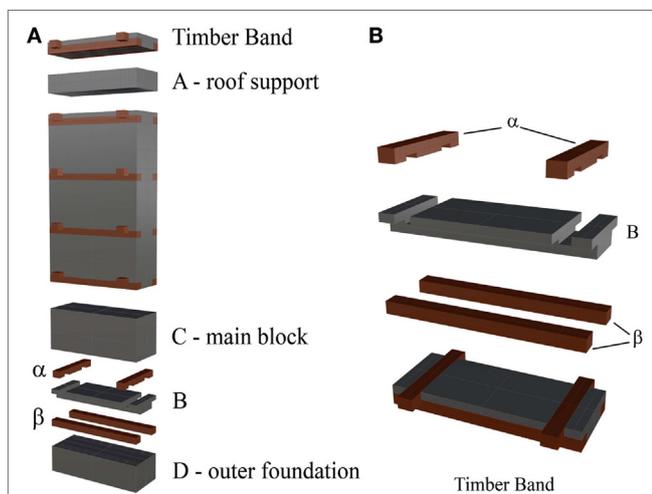
FIGURE 12 | (A) The 1.2 m wide vertical strip portion of the Bhatar wall. (B) Details of the wall around the horizontal wooden band.

The static analysis has been conducted with reference to a 1.20-m-wide vertical strip portion of the Bhatar wall (characterized by dimensions: 1.20 m × 0.46 m × 3.00 m), as represented in **Figure 12**.

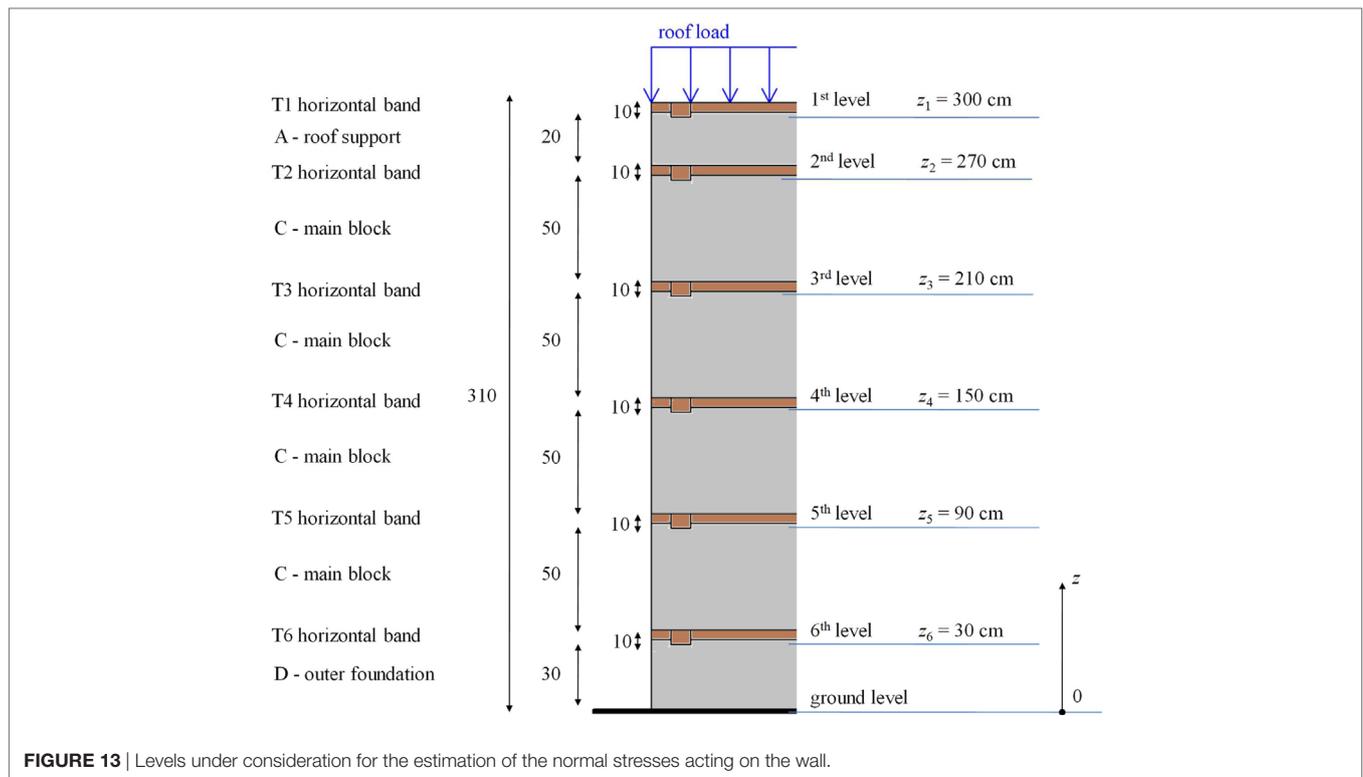
FIGURE 13 | Levels under consideration for the estimation of the normal stresses acting on the wall.

Figure 13 identifies the levels at which the stresses have been computed. They correspond to the critical stone–timber contact

interfaces immediately below each horizontal wooden band, and to the ground level.

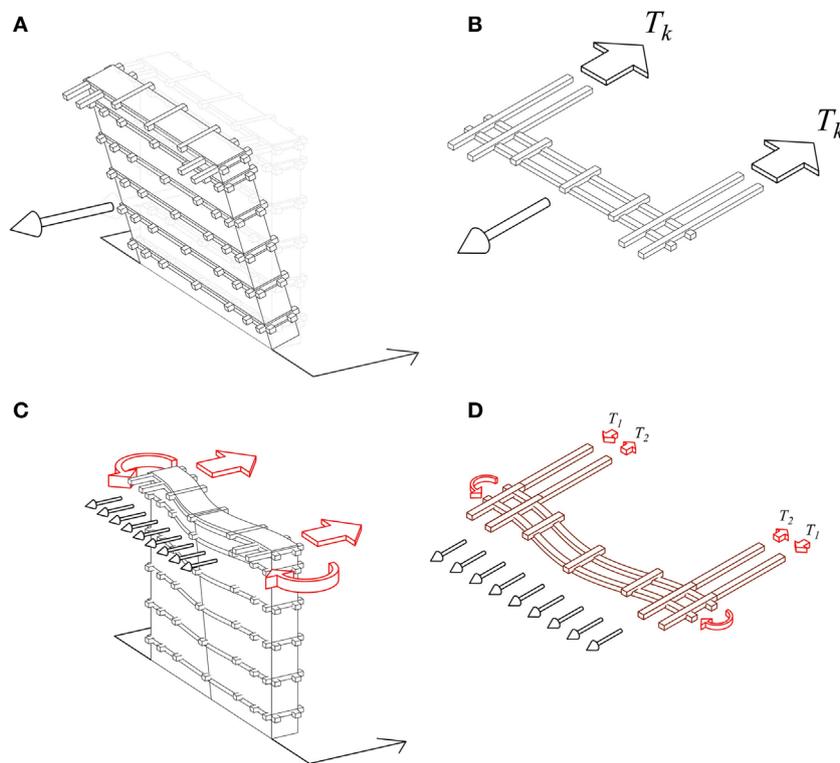
FIGURE 15 | **(A)** Overturning behavior with a rigid response of the wall. **(B)** Tie action provided by the two horizontal bands at the k -th level. **(C)** Bending behavior with a flexible response of the wall. **(D)** Horizontal wooden beams acting as bond beams at each level.

Out-of-plane failure mechanisms may occur due to overturning behavior with a rigid response of the wall (**Figure 15A**) or due to a bending behavior with a flexible response of the wall (**Figure 15C**).

Both mechanisms are still under investigation. On the one hand, the overturning with a rigid response of the wall (**Figure 15A**) is counteracted by the tie actions provided by the horizontal bands

(Figure 15B), with the flat heavy earth roof acting as a deformable slab. On the other hand, the bending behavior with flexible response of the wall (Figure 15C) is investigated with the heavy roof being a deformable slab, and with the embedded timber elements considered as bond beams providing flexural stiffness and strength to the wall (Figure 15D).

where $W_{rot,j}$ is the weight of the wall portion rotating above the j -th horizontal band, z_j represents the height of the j -th horizontal band level, and t_{wall} is the thickness of the wall (0.46 m). $2T_k$ represents the total tie action provided by the two horizontal bands at the k -th level at both sides, counteracting the detachment mechanism of the considered wall portion from the two orthogonal walls which work as lateral-resisting elements with in-plane actions (**Figure 15B**).
