Knowledge-Based Approach for the Structural Assessment of Monumental Buildings: Application to Case Studies

Silvia Caprili^{1*} and Irene Puncello^{2*}

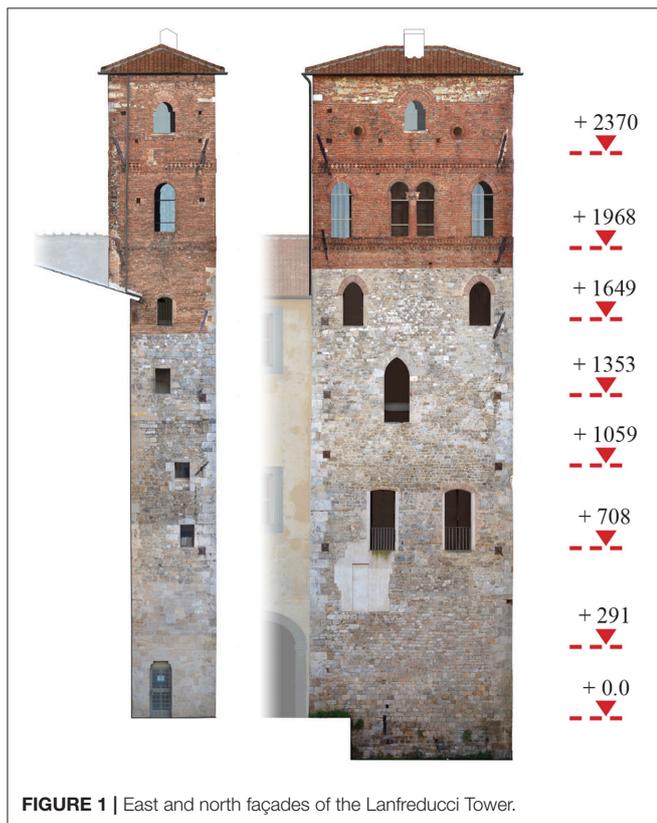
FIGURE 1 | East and north façades of the Lanfreducci Tower.

The drawings, the structural sections, and the plans of the different levels of the Lanfreducci Tower are presented in **Figures 1–4**. The architectural/geometrical survey was

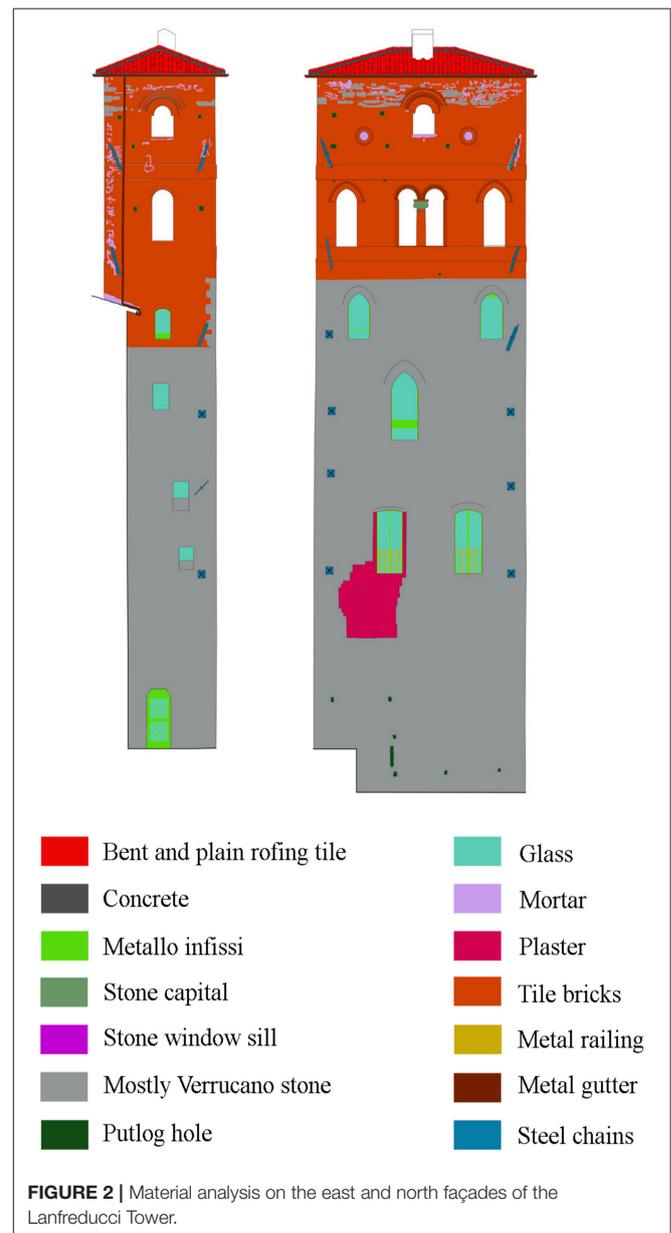
FIGURE 2 | Material analysis on the east and north façades of the Lanfreducci Tower.

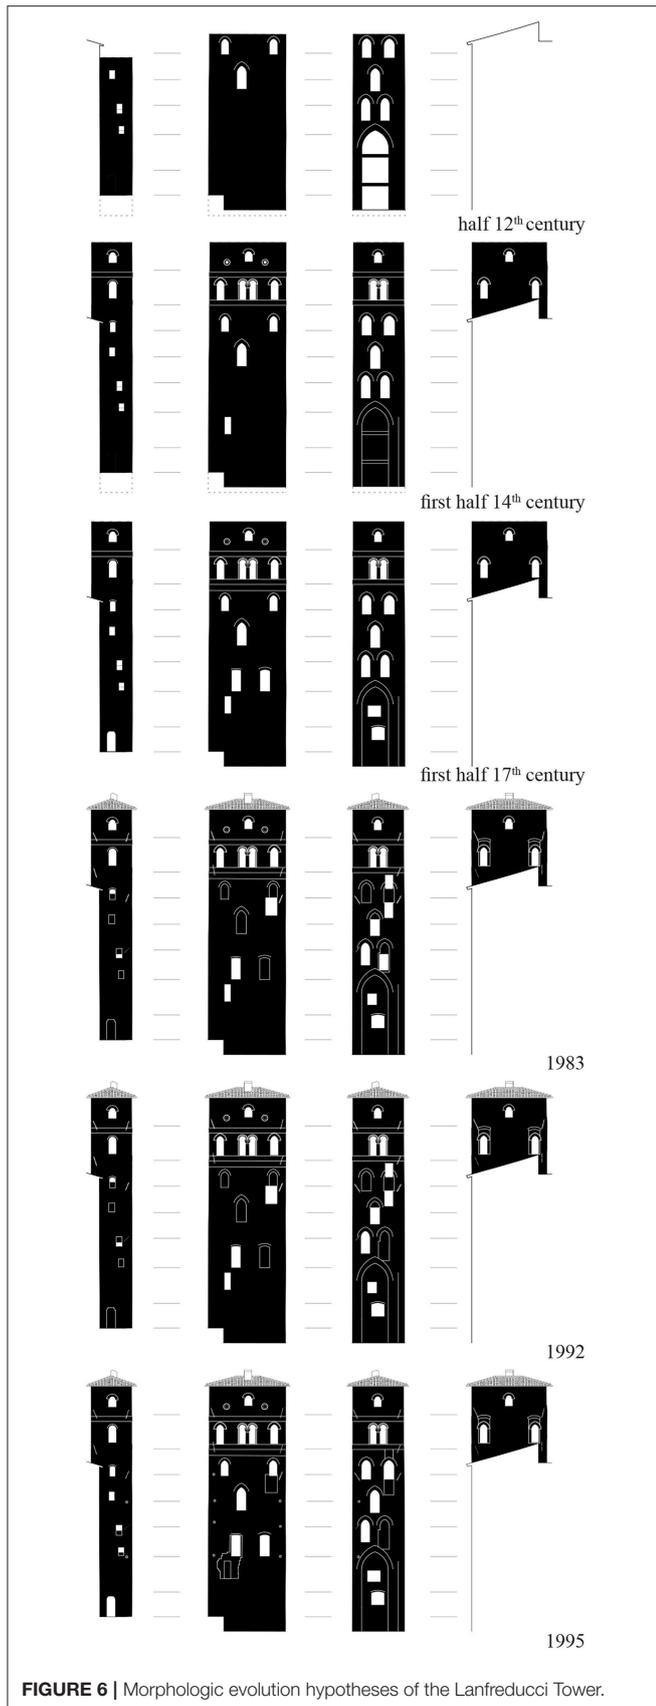
FIGURE 6 | Morphologic evolution hypotheses of the Lanfreducci Tower.

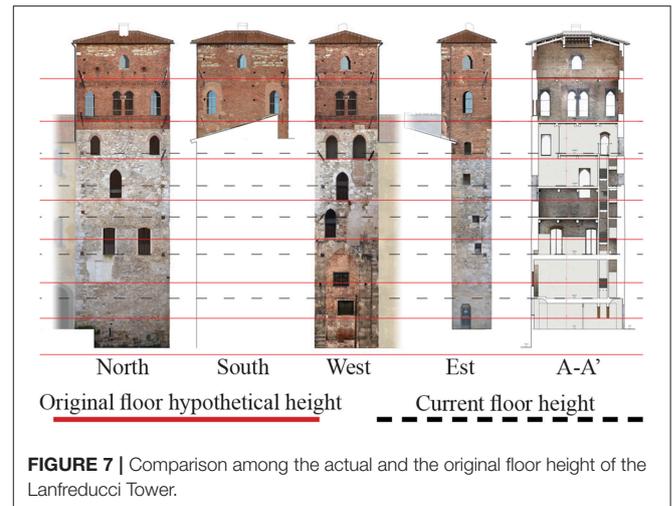
FIGURE 7 | Comparison among the actual and the original floor height of the Lanfreducci Tower.

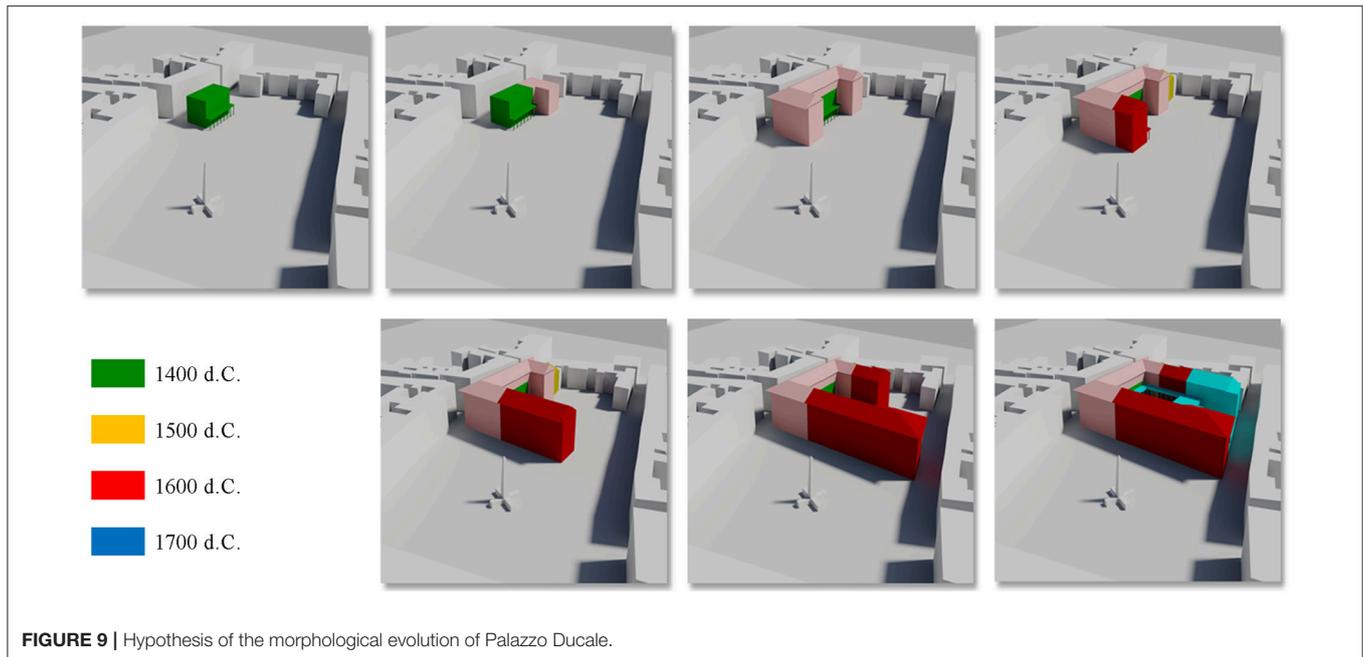
FIGURE 9 | Hypothesis of the morphological evolution of Palazzo Ducale.

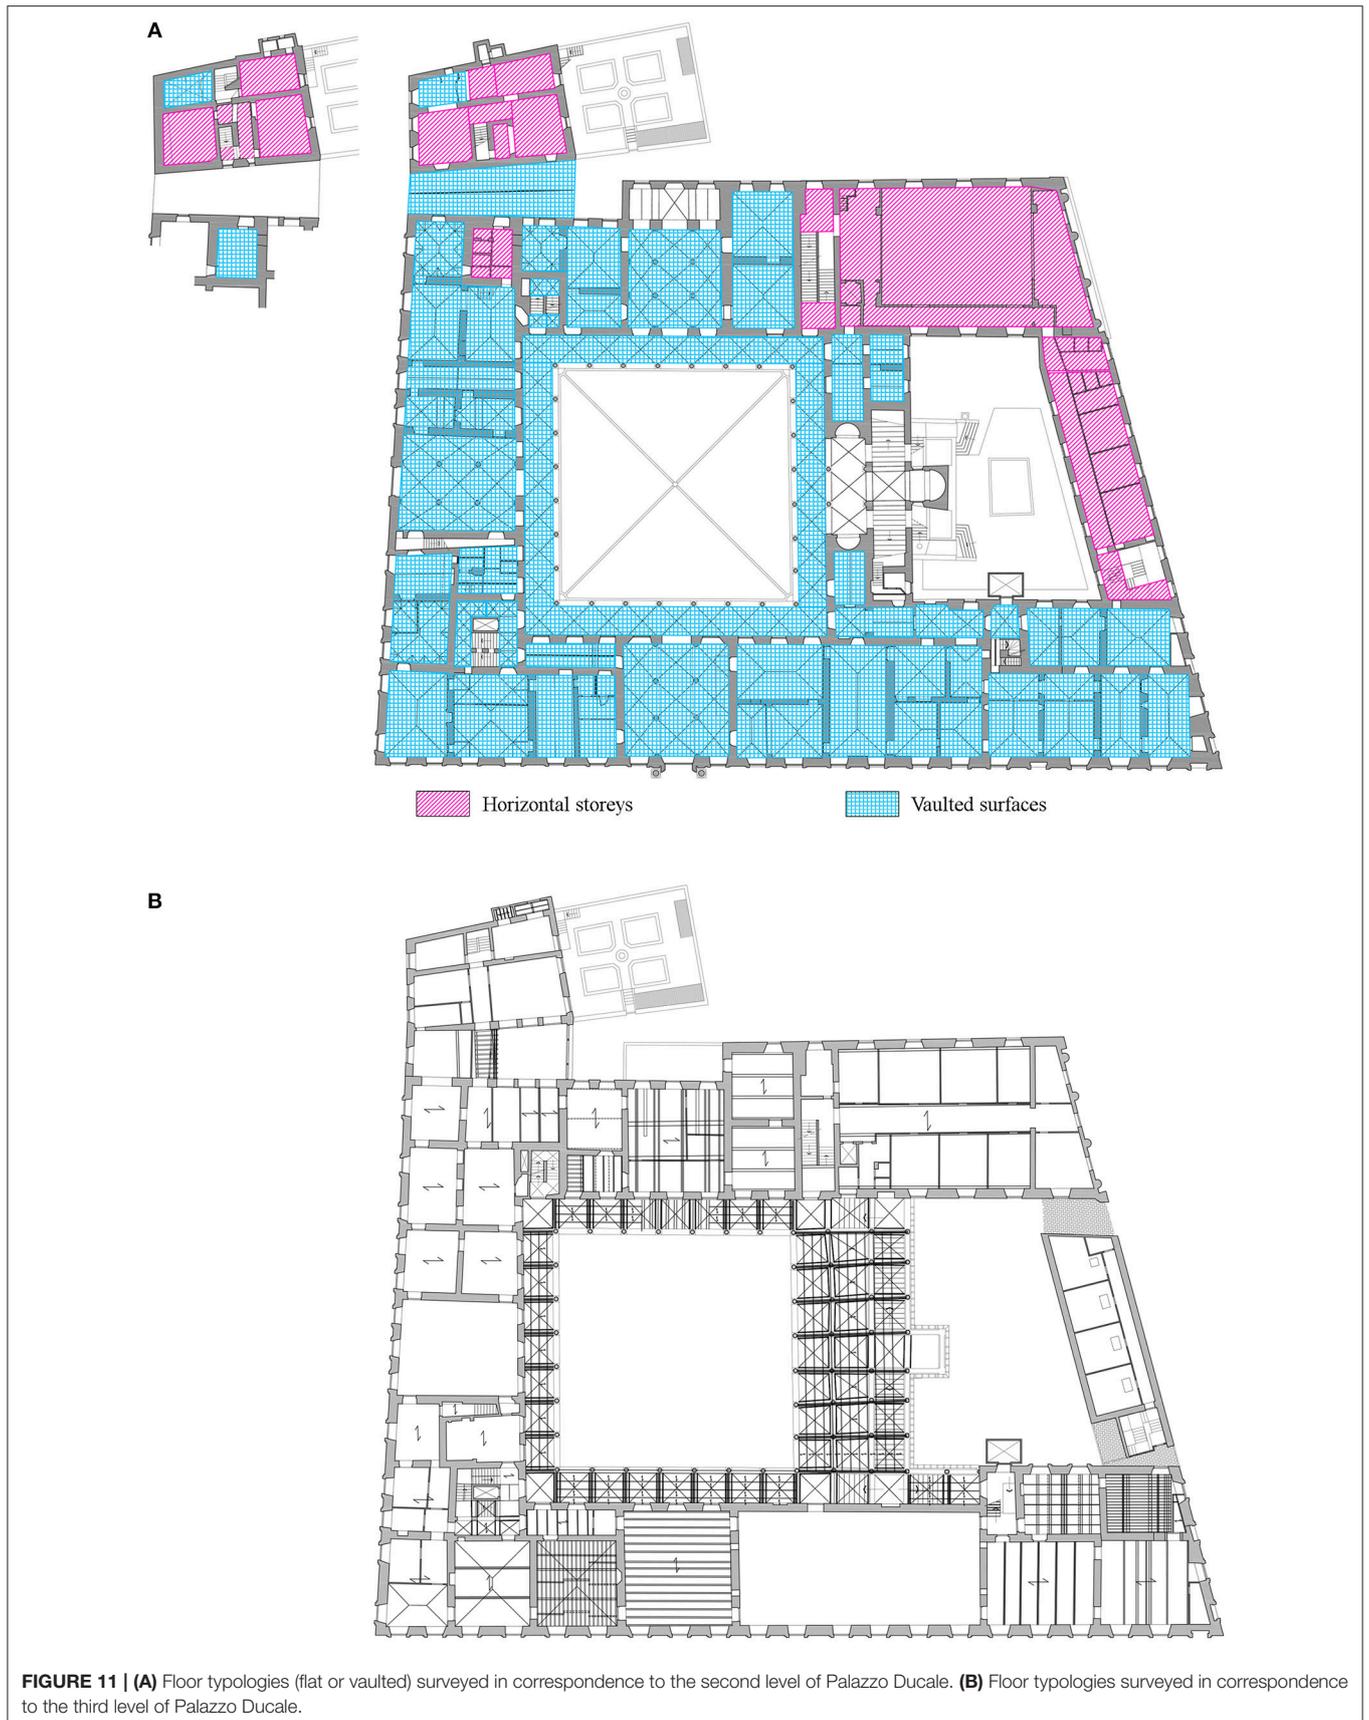
Floor at the third level of Palazzo Ducale, partially composed by timber- frame structures and partially composed by steel-frame structure.

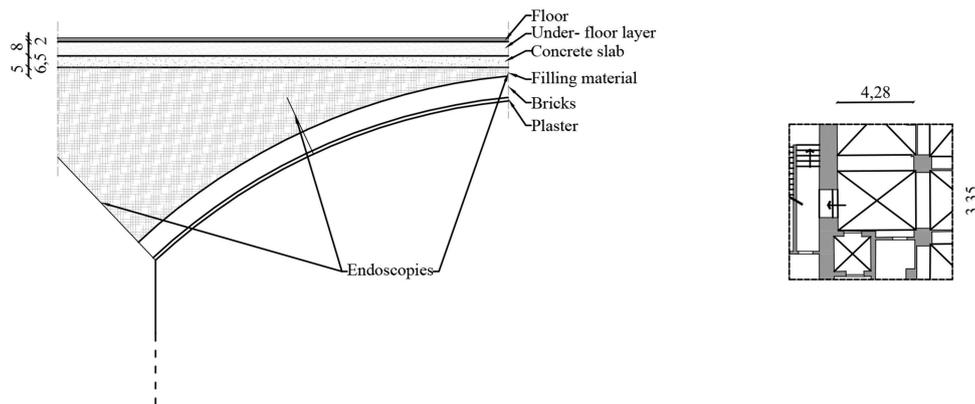
FIGURE 12 | Examples of structural details surveyed in Palazzo Ducale.

joists with or without reinforcement, as well to identify frames with insufficient support length in the wall. An extended *in situ* survey campaign was planned to investigate all the typologies of horizontal structures by defining the floor stratigraphy, the geometrical size, and the structural characteristics of elements. For each investigation, structural sections (Figure 12), useful for the modeling, were provided.

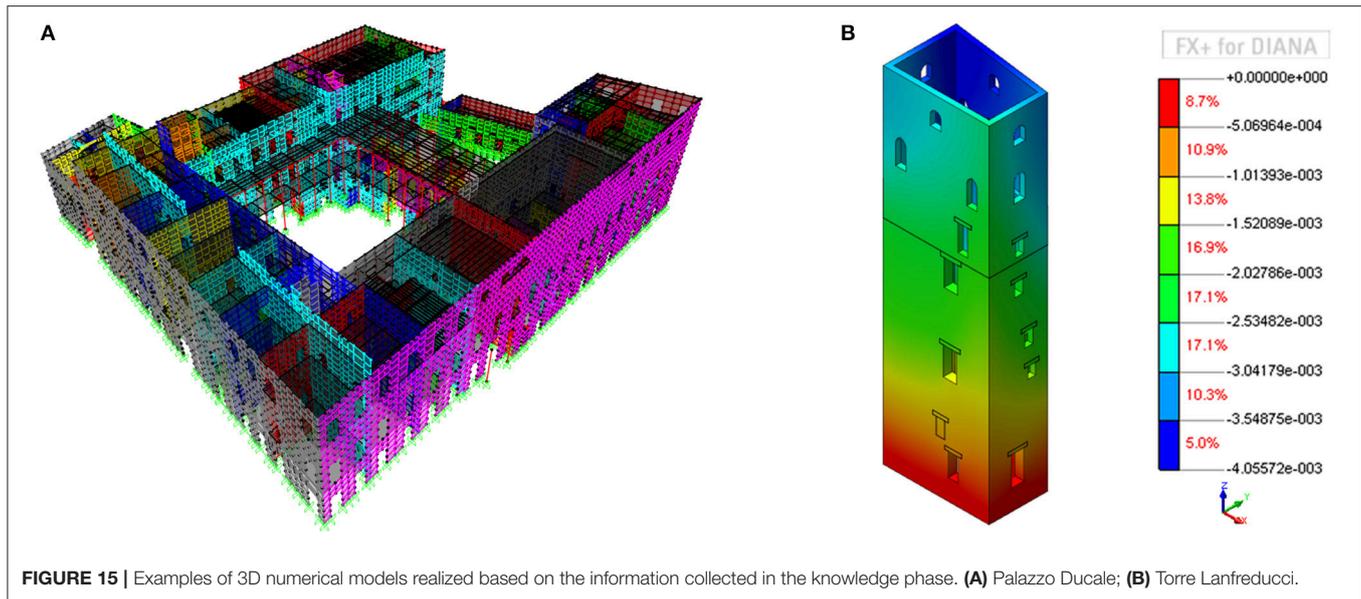
FIGURE 15 | Examples of 3D numerical models realized based on the information collected in the knowledge phase. **(A)** Palazzo Ducale; **(B)** Torre Lanfreducci.

The application of the proposed multistep procedure granted reliability to the 3D numerical finite element models, realized for the execution of the analyses, adopting, for example, the models represented in Figure 15 based on a deep and *in situ* knowledge of the construction analyzed.
