# Large-Scale Seismic Vulnerability and Risk of Masonry Churches in Seismic-Prone Areas: Two Territorial Case Studies

In this paper, seismic vulnerability and risk assessment of two samples of churches, located in Teramo and Ischia island (Naples gulf), both affected by the most recent earthquakes that occurred in Italy, are presented. To this aim, we applied a simplified method particularly suitable for seismic evaluations at a territorial scale, providing a global resulting score to be compared among the cases analyzed. The data obtained allowed us to provide vulnerability maps and a seismic risk index for all the considered churches. In addition, the calculated indexes permit a preliminary health state evaluation of the inspected churches, for ranking the priorities and planning additional in-depth evaluations.

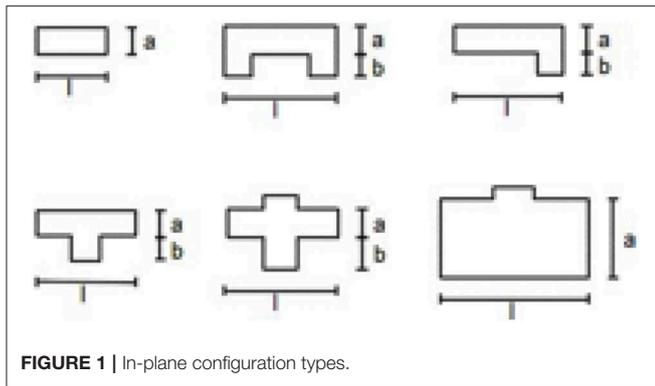
FIGURE 1 | In-plane configuration types.

In the case of a rectangular building, a significant parameter is the ratio between the dimensions of minor and major sides  $\beta_1 = a/l \times 100$  (Figure 1). In case of plan layouts with different shapes, in addition to the  $\beta_1$  parameter, it is necessary to take into account another parameter  $\beta_2 = b/l \times 100$ , which is the ratio between the deviation size and the larger dimension (Figure 1).

The assignment to a given class is made on the basis of the most unfavorable conditions set by the  $\beta_1$  and  $\beta_2$  parameters as follows:

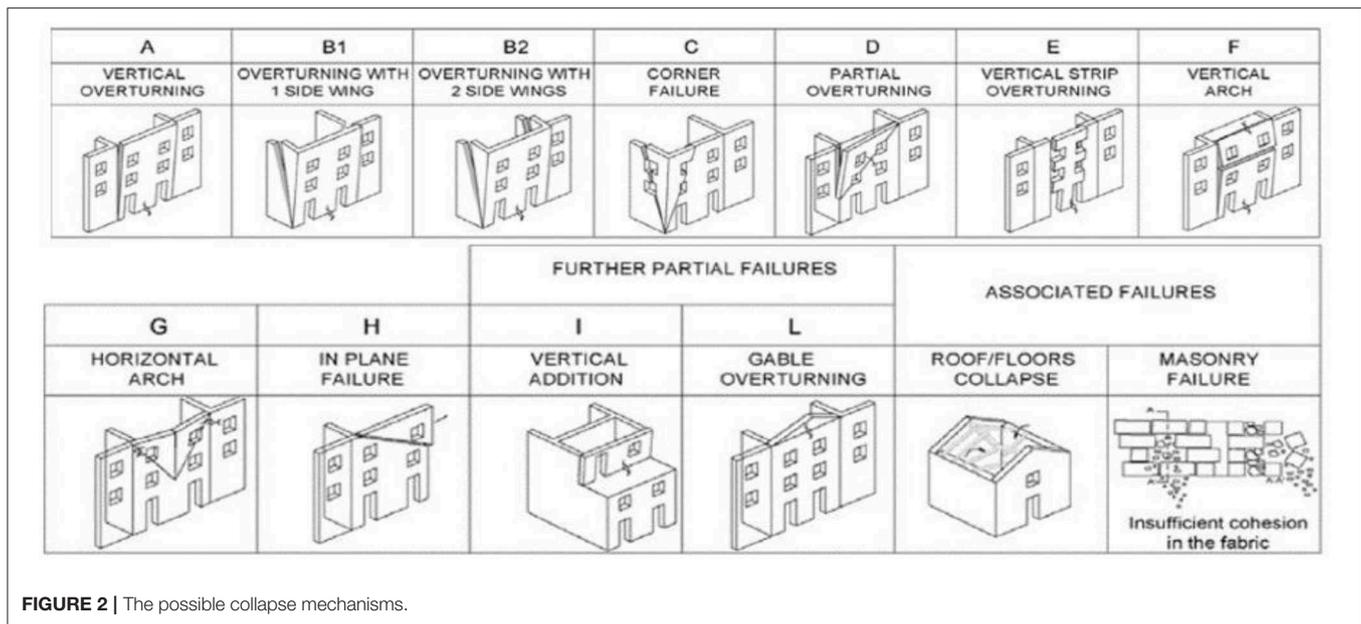
Cracks and deformations can derive from different causes, such as construction defects, humidity presence, earthquakes, etc. The analyzed damage allows the interpretation of possible collapse mechanisms. In the vulnerability general form, it is necessary to identify in the appropriate section the type of existing damage (structural, non-structural, or humidity) and to express the percentage extension on the structural elements. The possible collapse mechanisms are illustrated in **Figure 2**.
