A review of local construction practices applied on unreinforced adobe buildings in South America

Giulia Cocco*, Giuseppe Brando and Enrico Spacone

Department of Engineering and Geology, University "Gabriele d'Annunzio" of Chieti-Pescara, Pescara, Italy

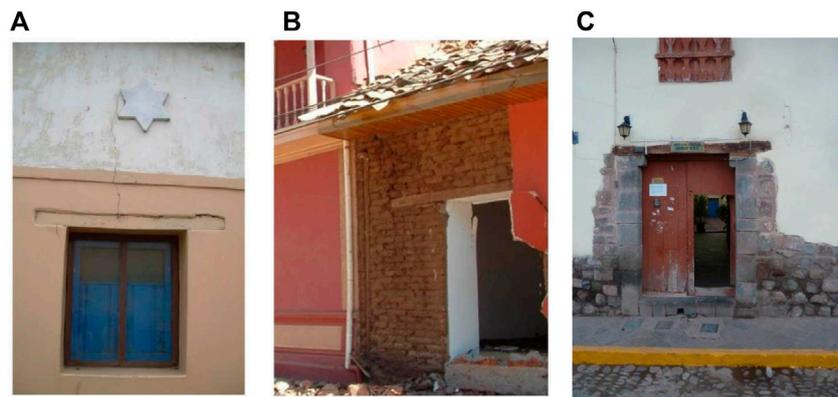
FIGURE 3

Typical wooden lintels in (A) Guatemala (Source: [Dominik et al., 2004](#)), (B) Chile (Source: [Velasquez, 2004](#)), and (C) Peru.

Adobe structures usually present no more than two stories, with horizontal wooden slabs and openings (at least one door and two windows) occupying approximately 30–40% of the wall length, as shown in Table 1. To ensure a proper bending strength of the spandrels upon the openings, the use of wooden lintels is a frequent practice, as shown in Figure 3.

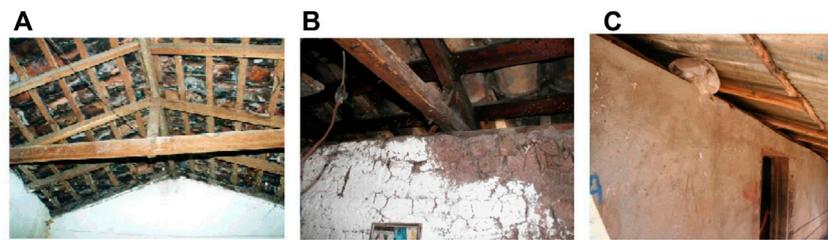
FIGURE 4

Traditional wooden roofs in (A) El Salvador (Source: Lopez et al., 2004), (B) Honduras (Source: French, 2004a), and (C) Nicaragua (Source: French, 2004b).

Roof systems can be double-pitched or flat, although a slight slope for moving away the rainwater is always present. These roofs generally have a load-bearing structure with wooden or bamboo trussed beams that rest directly on the underlying adobe walls, without the presence of ring beams or other element of support Figures 4A,B. Above them, a wooden plank floor, surmounted by a layer of canes, is always present, with juxtaposed earth and clay tiles or metal sheeting (Figure 4C), as reported in Table 1.

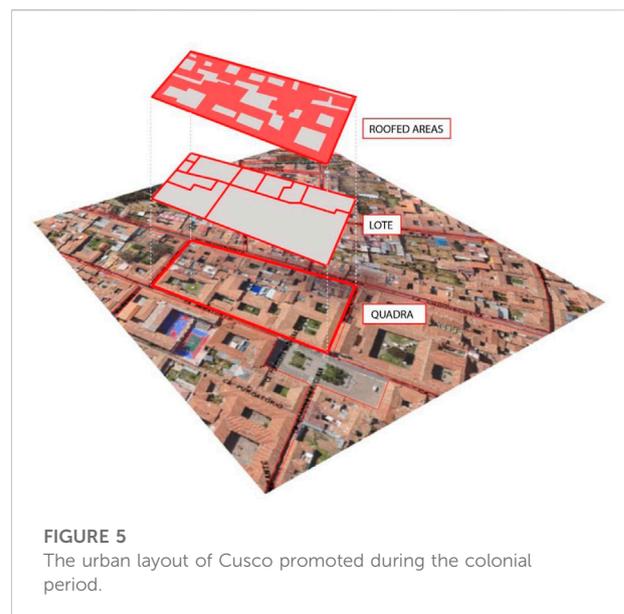
FIGURE 5

The urban layout of Cusco promoted during the colonial period.

The authors' urban survey focusing on adobe dwellings showed that these buildings present similar structural configurations. Indeed, the urban plan of Cusco is characterized by several groups of clustered structures forming isolated blocks of buildings surrounded by roads, called "quadra." The elementary unit of the "quadra" is called "lote," and it is generally composed of various structural units placed side by side to create an internal courtyards (Figure 5).

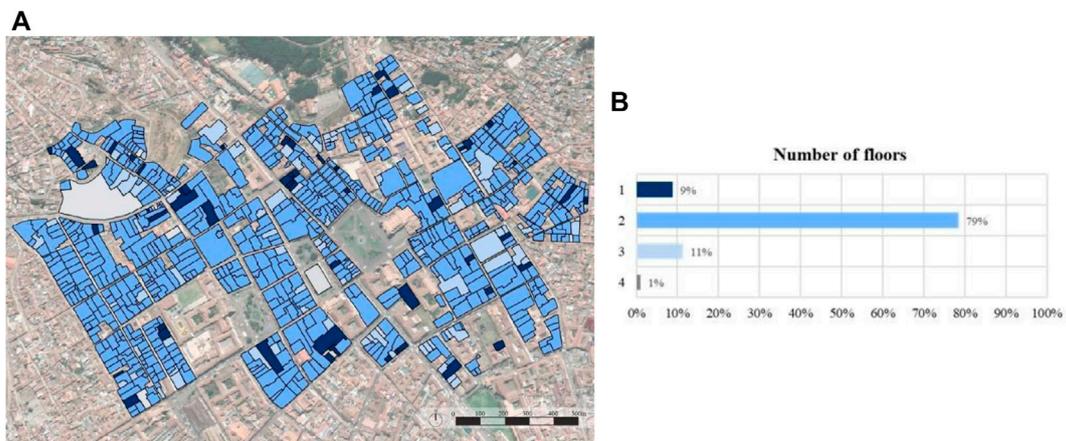
FIGURE 8 (A) Territorial distribution of the number of stories and (B) relative frequencies in the historical center of Cusco.

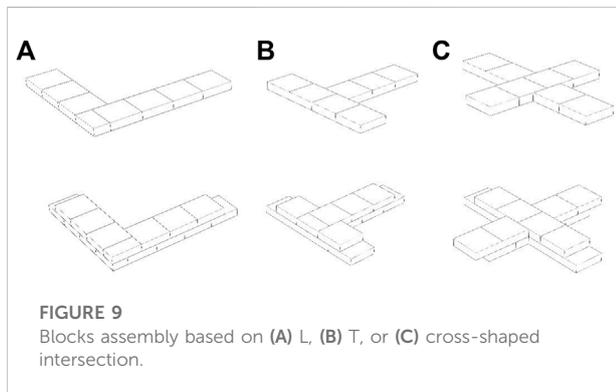
FIGURE 9 Blocks assembly based on (A) L, (B) T, or (C) cross-shaped intersection.

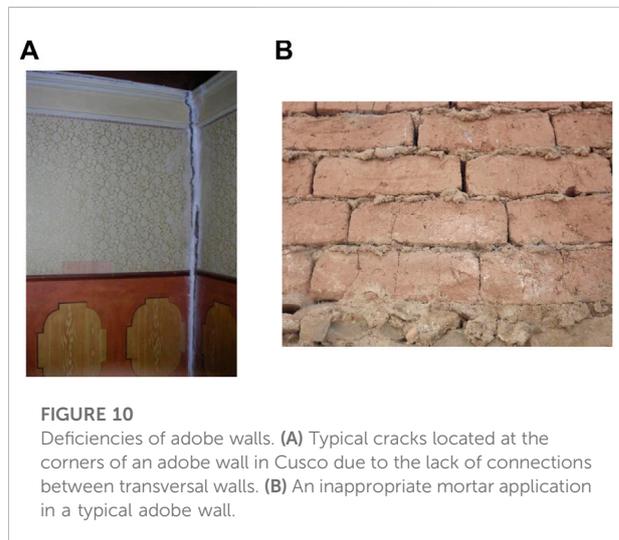
FIGURE 10 Deficiencies of adobe walls. (A) Typical cracks located at the corners of an adobe wall in Cusco due to the lack of connections between transversal walls. (B) An inappropriate mortar application in a typical adobe wall.

rarely applied in Cusco, as shown in Figure 10B, where a recurring situation for a typical adobe wall, made of blocks assembled with very thin layers of mortar, moreover only in the horizontal direction, is depicted. The insufficient quantity of mortar led to the formation of voids with consequent blocks cracking.

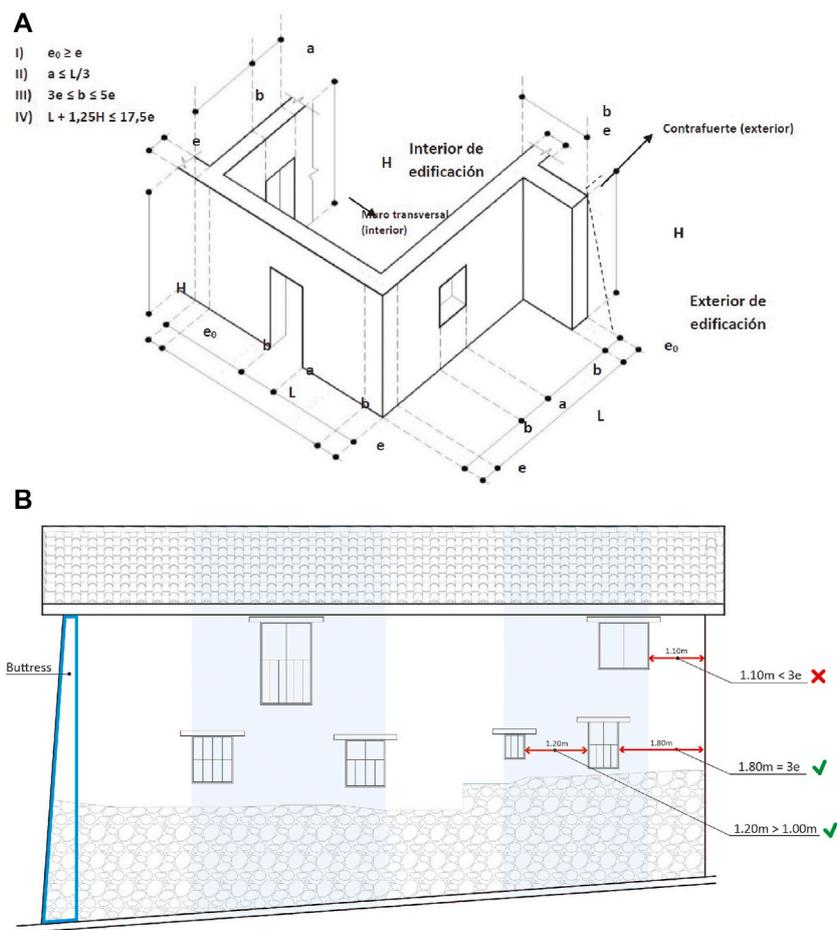
FIGURE 11

(A) Recommendations of the Peruvian Code (Ministerio de Vivienda, Construcción y Saneamiento, 2017) for the correct position of openings, in comparison with (B) the distribution of the openings on the façade of a typical adobe dwelling in Cusco.

To avoid the wall overturning under the action of external forces, the Peruvian Code recalls the importance of buttresses that act as vertical reinforcement elements. They must have a thickness (e_0) bigger than that of the wall (e) (**Figure 11A**). In

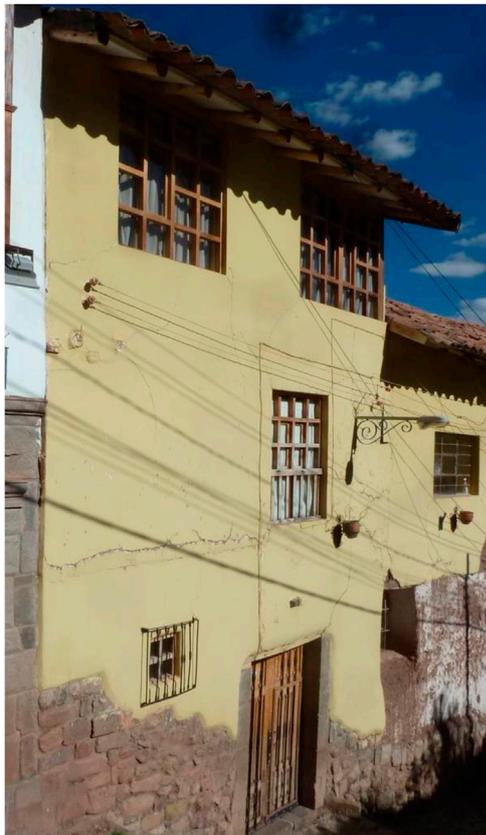
FIGURE 12
Typical cracks due to the uncorrect distribution of openings on an adobe façade.

In Cusco, façades with not centered openings are recurrent. Moreover, the distances between the openings and the piers of the building are often not sufficient and not proportional to the wall thickness. **Figure 11B**, showing a building in the historic center of Cusco, highlights how the openings are all concentrated on two areas of the façade, and they are scattered along with the building height. Furthermore, considering that the wall thickness (e) is about 0.60 m, the opening in the upper right should be placed at least 1.80 m ($3e$) away from the pier, but it is clear that this limit is not complied with. On the contrary, the minimum distance of 1.00 m between one opening and the others is respected. Irregularity in the openings arrangement and their poor spacing from the piers can lead to the formation of important cracks due to the activation of in-plane shear mechanisms, as shown in **Figure 12**.

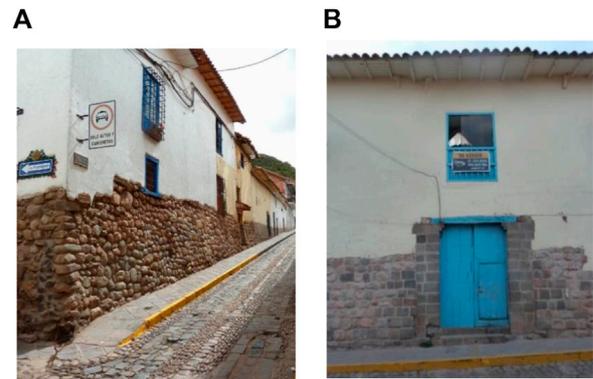
FIGURE 13
Construction details in Cusco. (A) Traditional enlargement of the stone wall at the bottom to act as a buttress and (B) Typical wooden lintels.

Cusco, these structural elements are common and applied at a large extent; however, they do not have a well-defined geometry. As shown in **Figure 13A**, they consist of a simple enlargement of the wall near the base to ensure more excellent stability to the structure.

structural elements would be stone. However, since it is not readily available and expensive, it is reserved only for public or prestigious buildings. It is replaced by wood for ordinary buildings, as shown in Figure 13B.

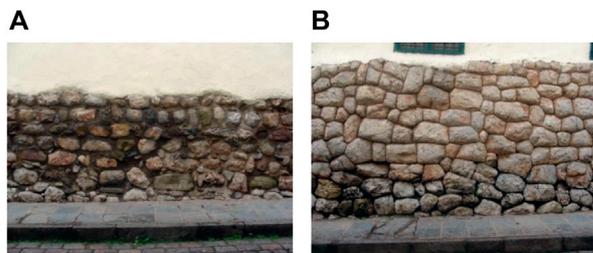
FIGURE 14
Traditional foundation system in Cusco, made with (A) cyclopean concrete or with (B) stone masonry and cement mortar.

Generally, adobe walls are susceptible to capillary rising damp and, for this reason, the foundation systems extend beyond the street level. This extension is known as “sobrecimiento,” and it shows the material composition of foundations, mainly made by cyclopean concrete (Figure 14A) or stones assembled with cement mortar (Figure 14B).

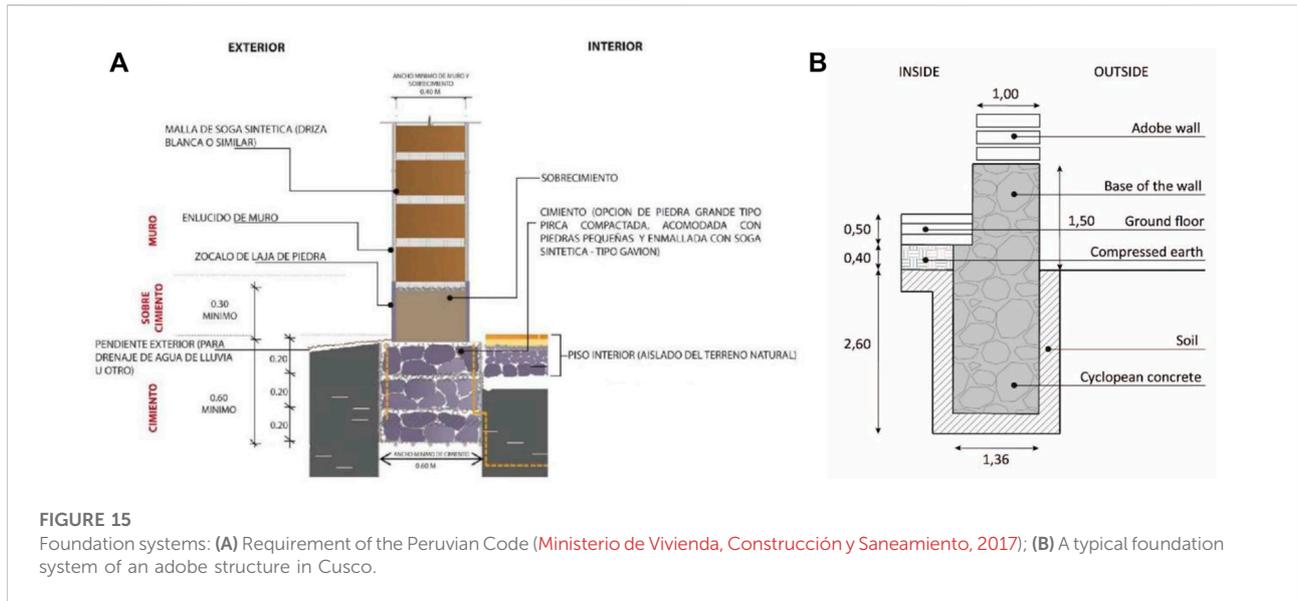
FIGURE 15

Foundation systems: (A) Requirement of the Peruvian Code (Ministerio de Vivienda, Construcción y Saneamiento, 2017); (B) A typical foundation system of an adobe structure in Cusco.

The Peruvian Code (Ministerio de Vivienda, Construcción y Saneamiento, 2017) recommends foundations with a depth and a minimum width of 0.60 m and extensions above the street level for at least 0.30 m (Figure 15A). Foundation systems observed on adobe buildings in Cusco comply with these requirements. Most of them presents stone foundation systems, with a minimum thickness of 0.60 m and an elevation above the street level ranging from 1.00 to 2.00 m (Figure 15B). Of course, the elevation of the “sobrecimiento” varies proportionally to the inter-story height: buildings with an inter-story height from 2.00 to 3.00 m present foundations 1.00 m high; buildings with an inter-story height greater than 3.50 m present foundations rising to 2.00 m above street level.

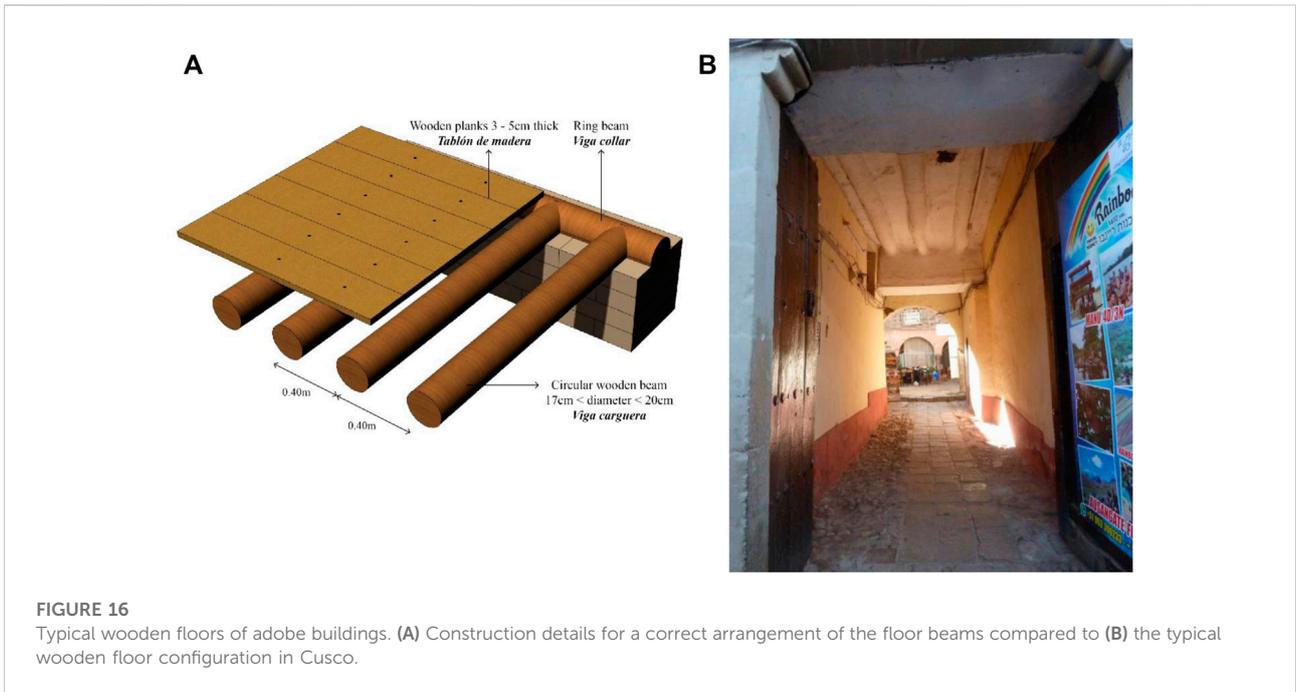
FIGURE 16 Typical wooden floors of adobe buildings. (A) Construction details for a correct arrangement of the floor beams compared to (B) the typical wooden floor configuration in Cusco.

These ring beams, named “viga collar,” should be made of materials compatible with the earth-based walls, like eucalyptus or wood, and all floors and roofs supporting beams should converge on them. In adobe buildings, floor slabs can span 3.00–4.00 m, and they can be composed of circular or squared wooden beams. Circular beams may have a diameter ranging from 0.17 to 0.20 m, while the squared ones have usually sections 0.20 x 0.20 m (Asociación Colombiana de Ingeniería Sísmica, 2004). They generally have a spacing of about 0.50 m. The planking level may be composed of overlapping bamboo canes and earth or simple wooden planks studded to the underlying beams (Figure 16A). Indeed, in Cusco, floor slabs are generally composed of circular beams characterized by an irregular shape, placed at a distance of about 0.40 m from each other and with wooden planks 3–5 cm thick, as shown in Figure 16B. However, in most cases, these circular beams come out from the adobe walls and are visible on the façade. Most likely, this is a constructive expedient to make the beams able to work as tie rods, but the lack of anchor plates allows them to slip off from the wall when severe earthquakes occur. Furthermore, this constructive expedient suggests that no ring beams are present to restrain the beam at the end.

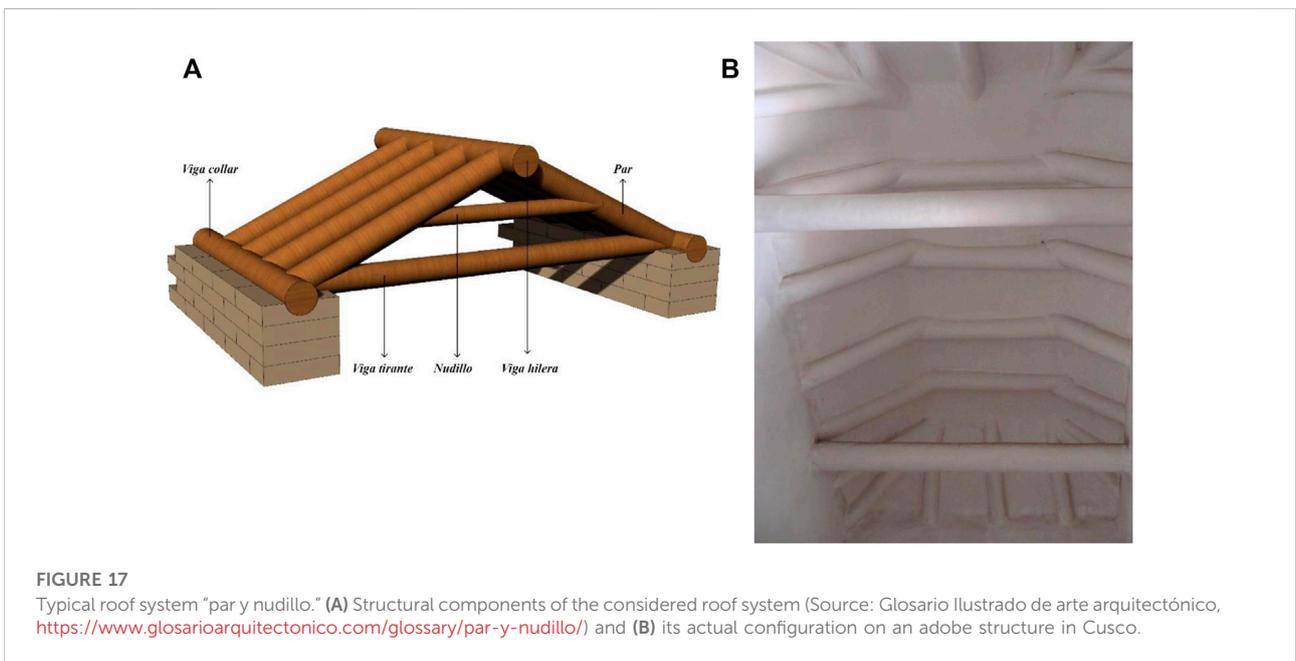
FIGURE 17 Typical roof system “par y nudillo.” (A) Structural components of the considered roof system (Source: Glosario Ilustrado de arte arquitectónico, <https://www.glosarioarquitectonico.com/glossary/par-y-nudillo/>) and (B) its actual configuration on an adobe structure in Cusco.

in the longitudinal direction to the trusses, and they represent the ridge beam and the ring beam of the roof, respectively. Below them, there are the so-called “*viga tirante*” that can keep together the structural roof system acting as tie rod (Figure 17A) (Argumedo et al., 1992).

the City Master Plan (Municipalidad del Cusco and Instituto Nacional de Cultura, 2018). Its most recurrent load-bearing structure has the configuration mentioned above, created with circular wooden beams. Trusses are located every 0.50 m from each other, and a lower tie beam transversally connects the two opposite walls of the building every 2.00 m (Figure 17B). Furthermore, according to the traditional construction

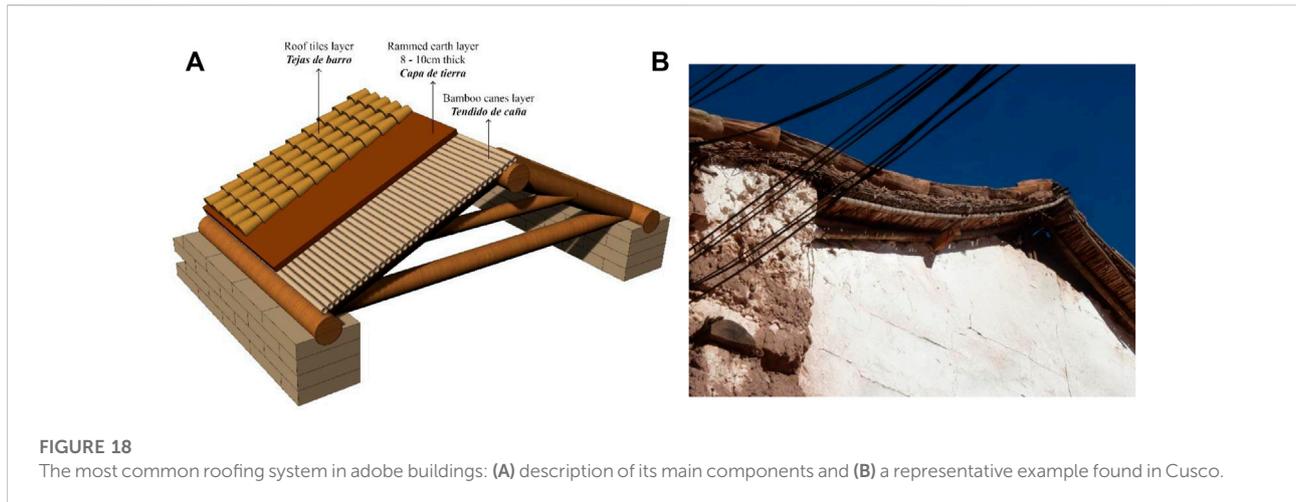
practice (Figure 18A), as observed during the survey carried out in Cusco (Figure 18B), the roofing system is composed of different layers: the first layer of bamboo canes called “*tendido de caña*”, placed transversally to the trusses, a 5–10 cm thick second layer composed by rammed earth, able to isolate the roof from water infiltrations, and a final layer with roof tiles. The lightness of these horizontal wooden slabs and their low in-plane stiffness certainly increase the structural vulnerability of Peruvian adobe buildings. Anyway, Figure 18B shows that one of the main problem is the low bending stiffness of the plank, which provokes undesired flexural deformation of the covering system.
