Enokida R, Fukushima Y, Tang C-H, Pan T-Y,
Kuo C-L, Ikago K, Izumi T and Kuriyama S
(2025) Earthquake disaster resilience in
Taiwan observed from the April 2024 M_L 7.1
Hualien earthquake.
Front. Built Environ. 11:1593942.
doi: 10.3389/fbuil.2025.1593942

Earthquake disaster resilience in Taiwan observed from the April 2024 M_L 7.1 Hualien earthquake

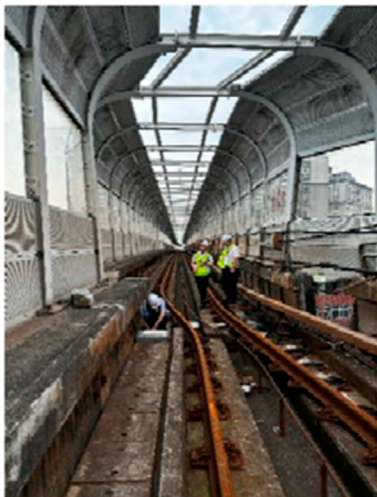
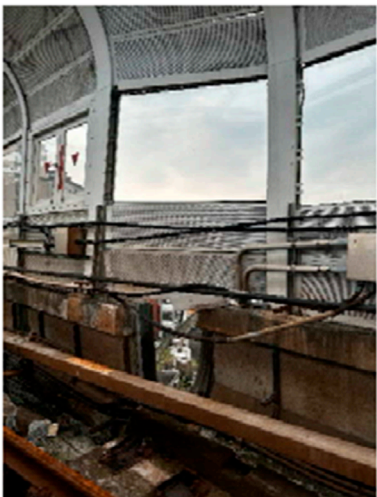
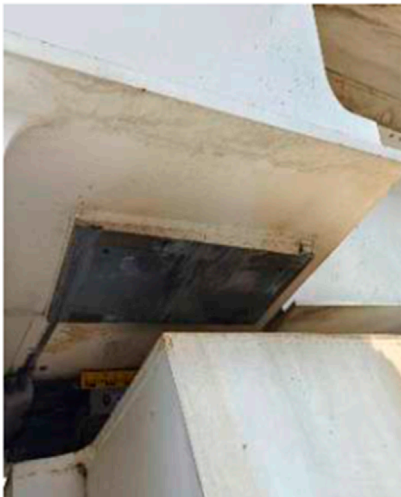
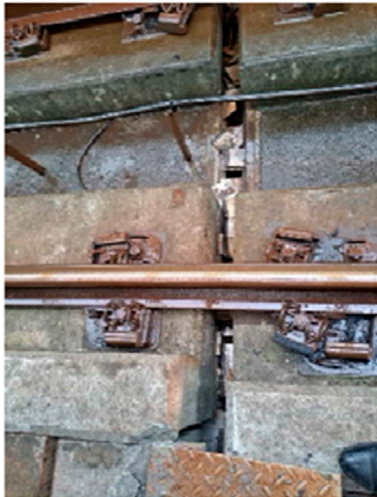
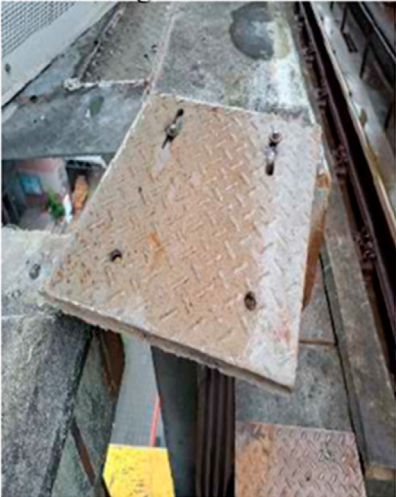
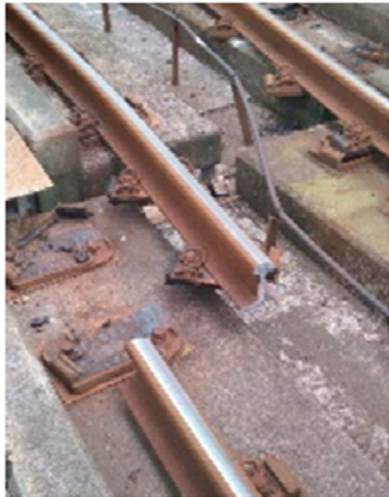
Track displacement and deformation

Sound barrier deformation and damage

Pot bearing damage

Base plate failure/damage

Bridge parapet displacement and damage

Steel rail deformation and fracture

FIGURE 7
New Taipei Circular Line Earthquake Bridge Damage Status of the earthquake on 3 April 2024. (Chinese Society of Structural Engineering, 2025)

- Structural Impacts: The elevated section 1215-1 on Zhongzheng Road (Zhonghe District) experienced horizontal displacement, while a train derailment at Jingan Station damaged

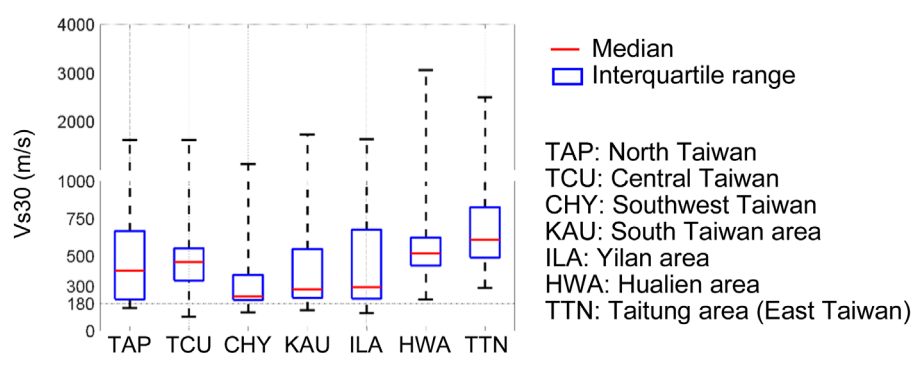
FIGURE 9
Vs30 in the seven major areas of Taiwan.

According to a study on Vs30 of the stations of the Taiwan Strong Motion Instrumentation Program (TSMIP) (Liu and Tsai, 2015), the site conditions in Hualien were clarified by comparison with other areas. Based on this study, the Vs30 in the seven areal categorizations of Taiwan are shown in Figure 9, and the number of stations and median values in the areas are summarized in Table 7.

The median value for the Hualien area (HWA) of 521 m/s was the second best among the seven areas. In addition, according to the interquartile range, the Vs30 values at many sites in Hualien were close to the median value. Thus, many sites in Hualien were less likely to experience amplified ground shaking than in other areas. Strong shaking with large PGVs occurs mainly because of earthquake features or a limited number of soft site conditions. Unfortunately, this occurred during the 2018 Hualien earthquake and resulted in large PGVs (Figure 8b).

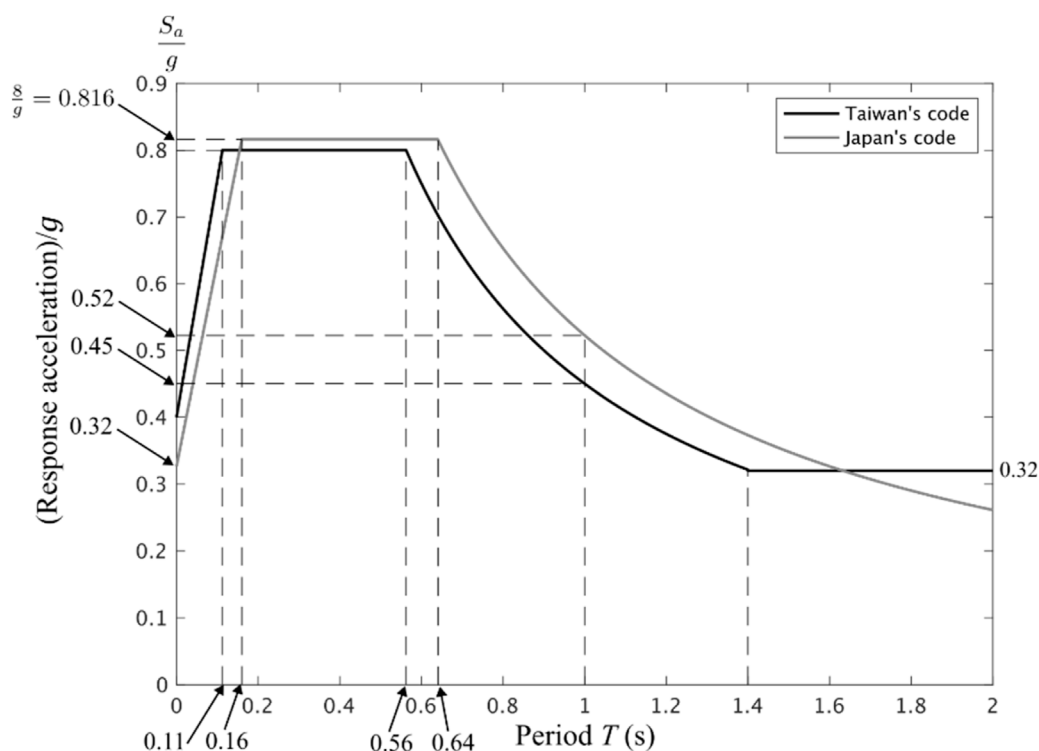
FIGURE 10
Design spectra (damping ratio: 5%).

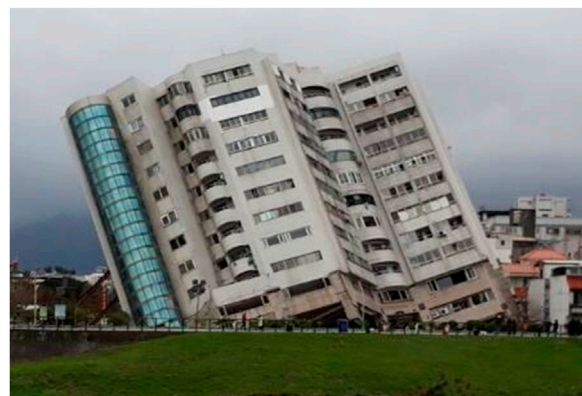
FIGURE 11
Severely tilted soft and weak story building (Yun Men Tsui Ti Building) in the 2018 Hualien earthquake.
