Brief analysis of the development characteristics and deformation mechanism of ground fissures on the MH Highway in the Ethiopian Rift Valley

Weimin Liu^{1*}, Cheng Xu² and Xiaonian Huang²

¹CCCC First Highway Consultants Co., Ltd., Xi'an, China, ²Xi'an China Highway Geotechnical Engineering Co., Ltd., Xi'an, China

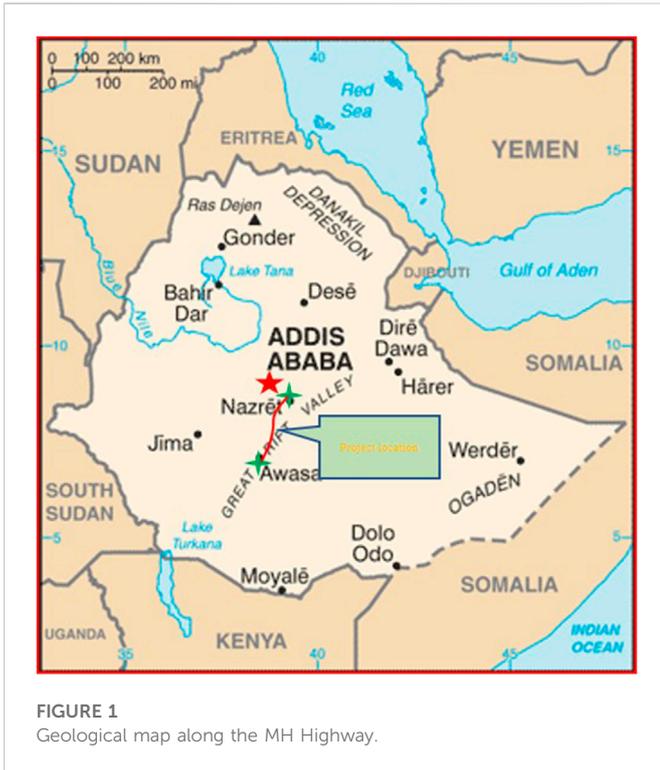
As shown in the geological map of Ethiopia in Figure 1 (Geological Survey of Ethiopia) (Ministry of Mines, 1976), the formation of the area is a binary structure: the upper part is covered by the Quaternary Holocene overburden of alluvial–proluvial powdery clay and silt, which is about 5–20 m thick, and the underlying stratum is

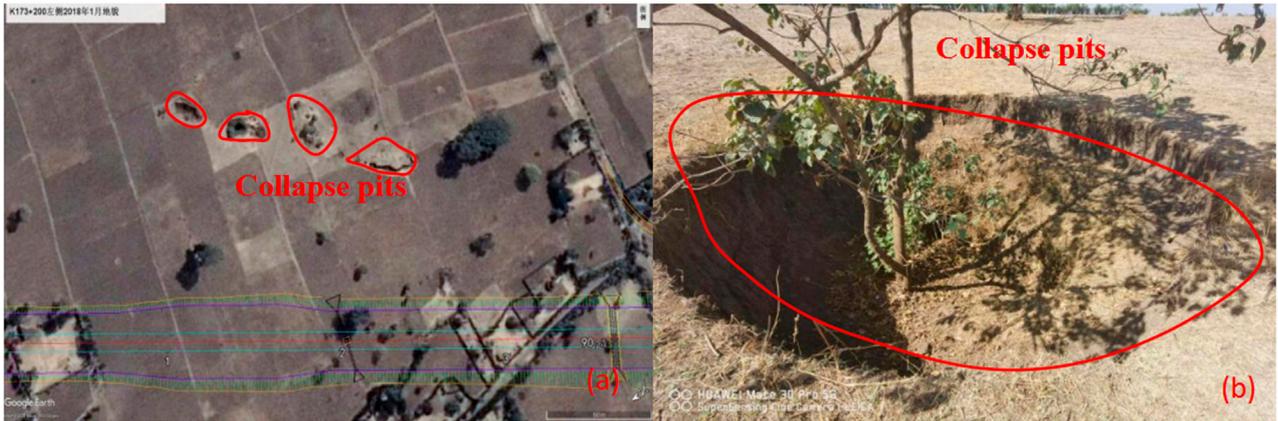
FIGURE 5 String-bead-shaped collapse pits on the right side of K166+300-400.

Three collapse pits are observed on the right side of K166+300–400, which have a diameter of 3–5 m and a depth of about 4–5 m, and are only 10 m from the side boundary of the roadbed.

depressions, there often exist string-bead-like ground collapse pits, rounded on the surface and varying in diameters, and the maximum depth measures up to 10.0 m. As shown in Figure 5, the depression on the right side of the roadbed of the K165+700~K166+450 section is about 500 m long, 50–80 m wide, and 6–8 m in height difference.

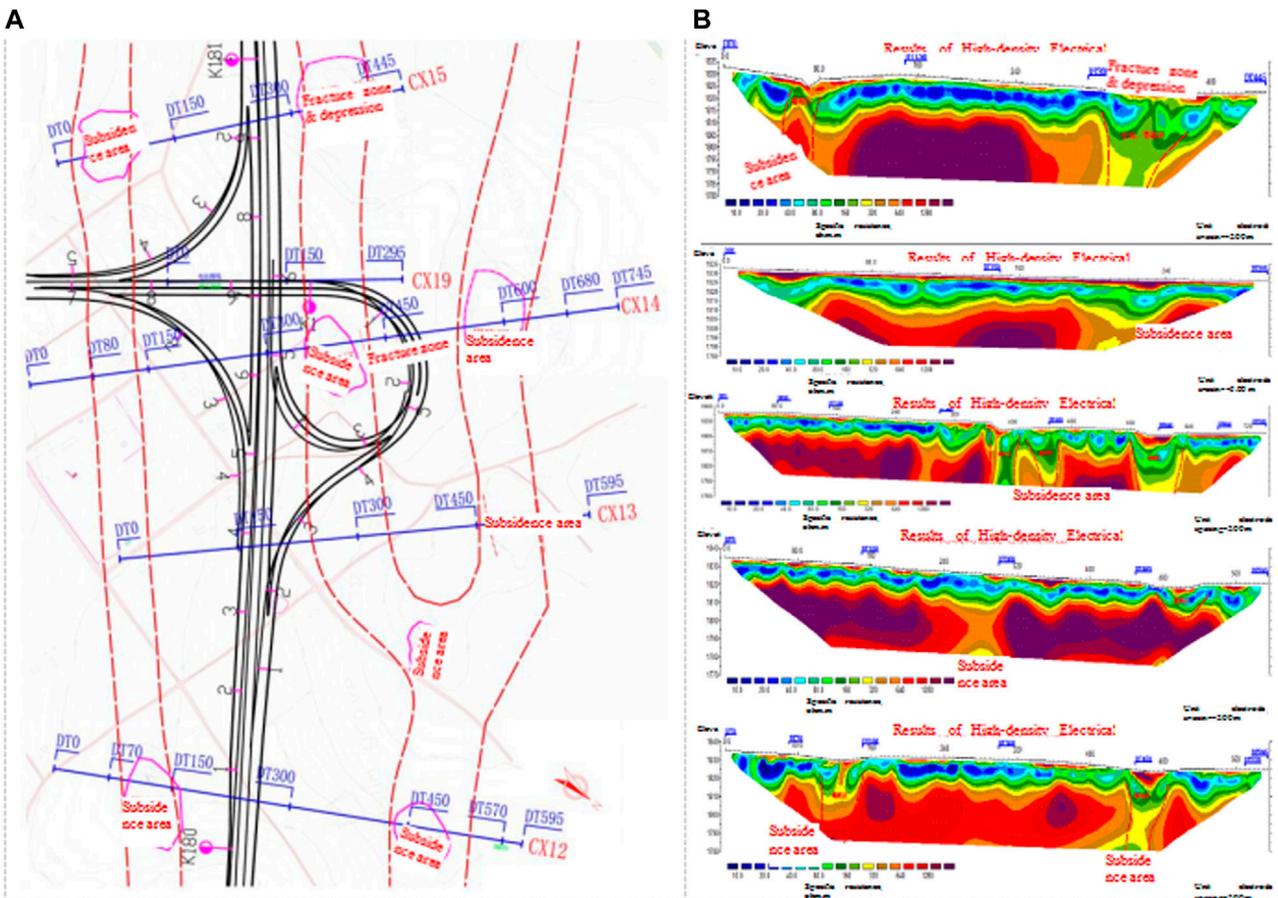
FIGURE 6 Comprehensive geophysical prospecting result map of the K179+400-K181+466 interchange area.

main Rift Valley. There are eight collapsed depressions in the interchange area of K179+400~K181+466, as shown in [Figure 6](#). A geophysical survey reveals that the depressions are interconnected by several parallel fissures, and the overall direction of the ground fissures is N45°E, which is consistent with the direction of the main Rift Valley structure, except for partial intersections.

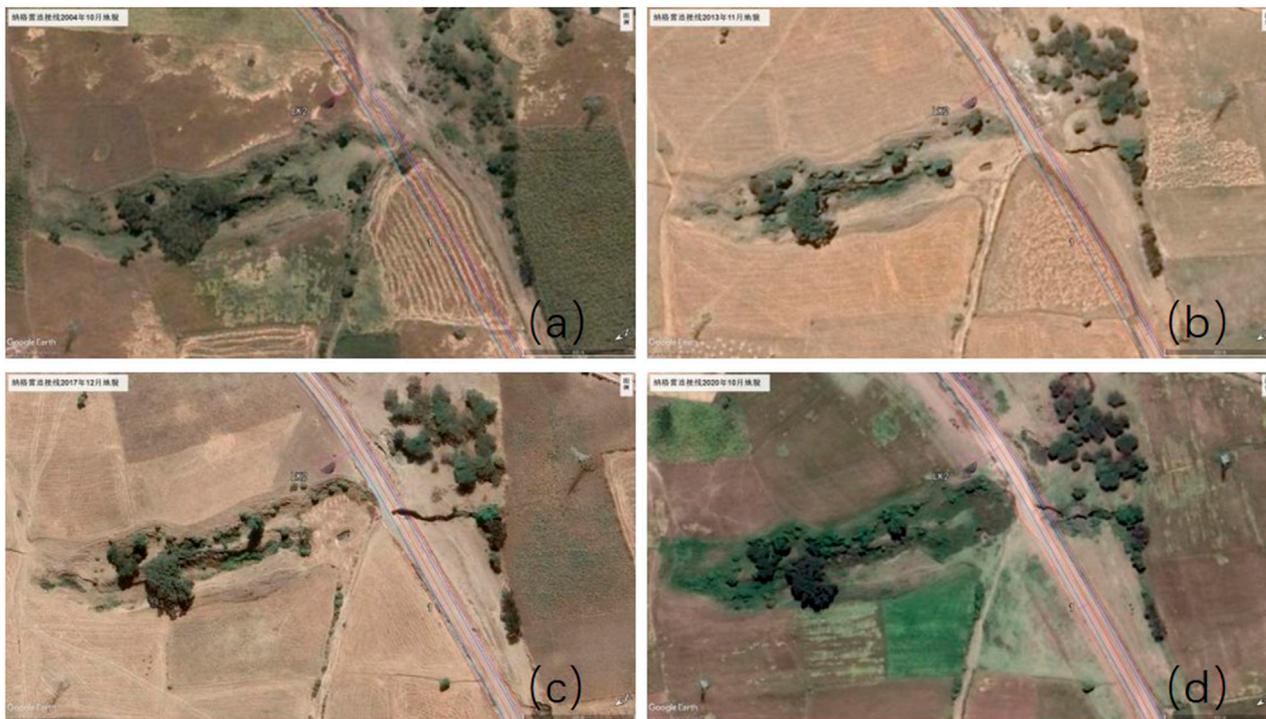
FIGURE 7 Ground fissure development of the Arsi Negele connecting line: (A) remote sensing images, October 2004; (B) satellite remote sensing images, November; (C) remote sensing images, December 2017; and (D) remote sensing images, October.

[Figure 7](#) illustrates the multi-year development characteristics of ground fissures in the vicinity of the Arsi Negele connecting line for the period 2004–2020. From the pictures, it can be seen that in 2004,

there was a band-shaped collapse zone in the area, and distinct collapse and ground fissures had not appeared yet; in 2013, small-scale collapse pits and ground fissures appeared on both sides of the road; in 2017, these cracks kept developing, extending, and widening to the degree that existing roads were cut off and greatly damaged; and in 2020, the roads cracked again under the action of ground fissures despite being repaired and backfilled. Overall, the ground fissures remain in a state of developmental activity at the macro level. Therefore, from the changes in the cracks on the surface, it can be seen that the cracks on the ground are gradually developing and changing over time.

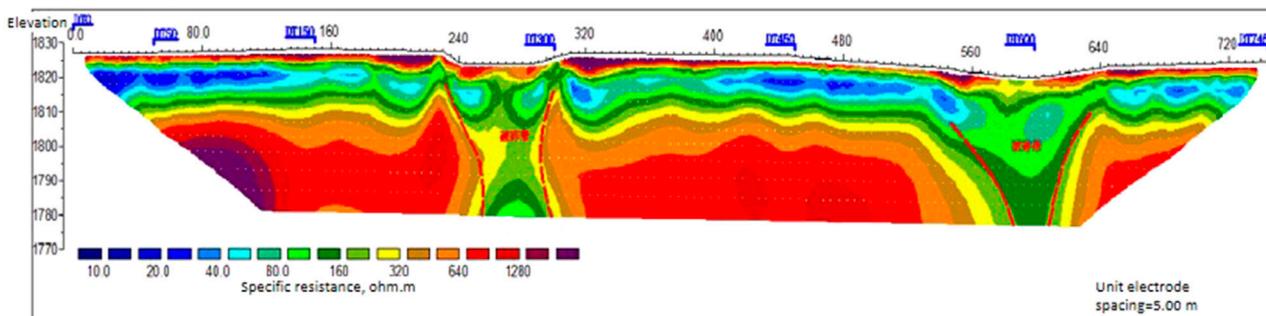
FIGURE 8 Typical profile of high-density electrical method in the K179+400~K181+466 interchange area.

[Figure 8](#) shows the vertical electrical prospecting rate profile along the concealed fissure in the interchange area from K179+400 to

K181+466. According to the exploration results, there are low-resistance anomalies in the DT230–DT310 and DT550–DT640 sections, both low-lying and having obvious collapse pits, which are thus deciphered as ground fissure development zones.

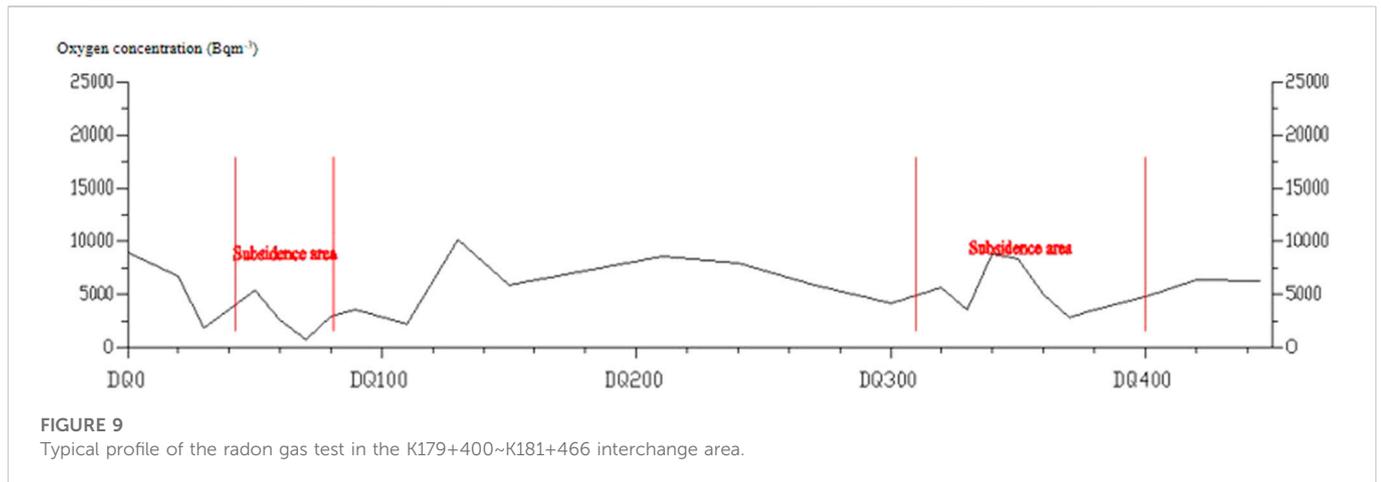
Figure 9 shows the radon gas test profile of the K179+400~K181+466 interchange area arranged perpendicular to ground fissures. The test results show that the radon gas concentration is not highly abnormal near the development position of exposed ground fissures or collapse pits. This is mainly

because the ground fissures are underground radon gas escape channels, but as the ground fissures have developed to the surface, radon gas in the soil leaks to the air, causing the radon gas value at the place directly above the fissures to be slightly lower than that of surrounding areas. So, the radon concentration curve at the location of the fissure is “M”-shaped. Around the fracture zone, the radon concentration will rise steeply, generally more than twice the background value, forming an anomaly zone of high radon concentration. The radon concentration profile fairly reflects the location of ground fissures. In this profile, two radon gas concentration anomalies exist within survey lines DQ40–DQ80 and DQ310–DQ400, wherein DQ40–DQ80 is the location of the collapse pit and DQ310–DQ400 is the location of the fracture zone where the rock masses are shattered and prone to collapse.

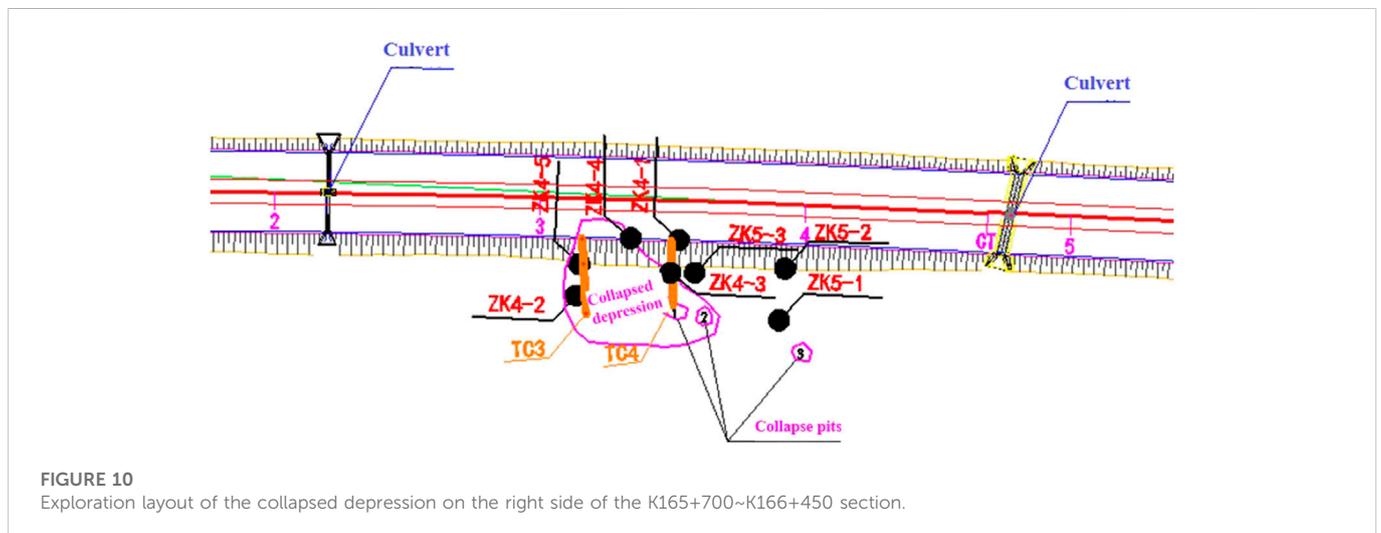
implemented, as shown in Figure 10. The typical drilling results show that the overlying soil is mainly loose, powdery clay and silt, and the core of the lower bedrock, namely, tuff, is basically fragmented, cracked, and porous. Among them, there is a loose layer emerging 9–19 m of the ZK4-1 borehole, and the drilling speed is fast. Other boreholes on the external side of the roadbed do not show any abnormality, which is judged to be the result of filling the main fracture with clay.

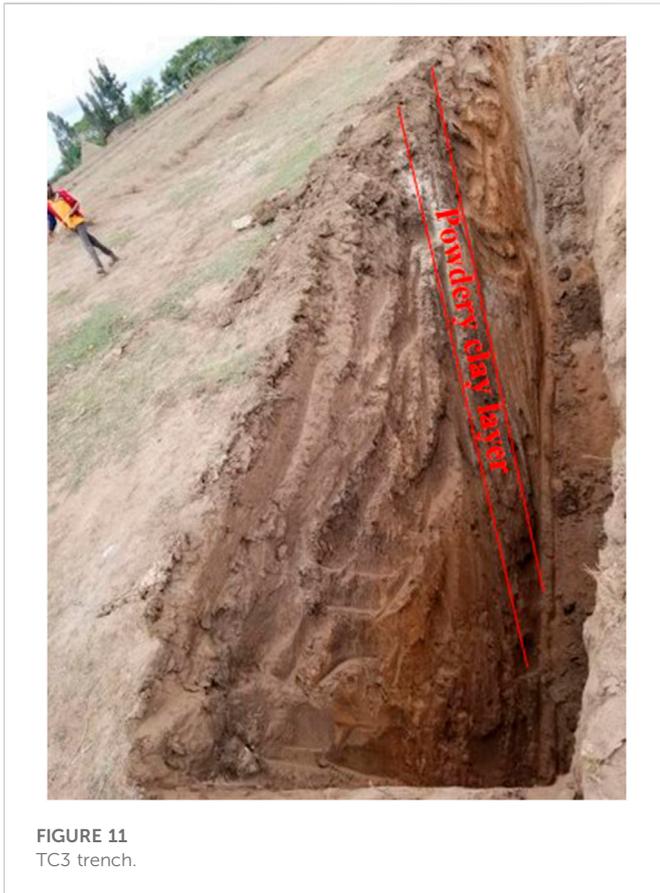
FIGURE 11
TC3 trench.

Trenching was carried out in the middle of the concealed fissure in section K166+300~k166+400. From the T3 trench in Figure 11, it can be seen that there are traces of developed fractures, mostly filled with gray clay. The engineering geological profile of the trench in Figure 12 reveals that the surface layer of the ground is covered with powdery clay, which is about 1–2 m thick at both ends, gradually deepening from the middle part until a maximum of 4 m. At the same time, there is a silt layer deposited at the lower part of the thickest part of the silty clay, as thick as 2 m in the middle, disappearing gradually on both sides. It can be seen that there are signs of later deposition in the stratum exposed in the middle of the trench.

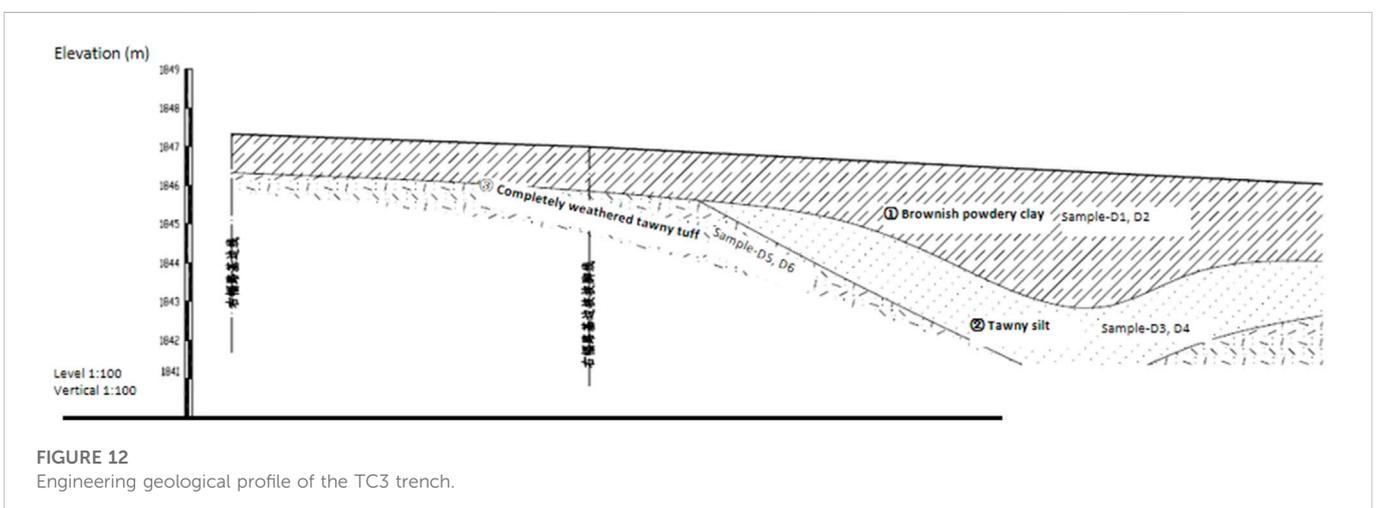
FIGURE 12
Engineering geological profile of the TC3 trench.

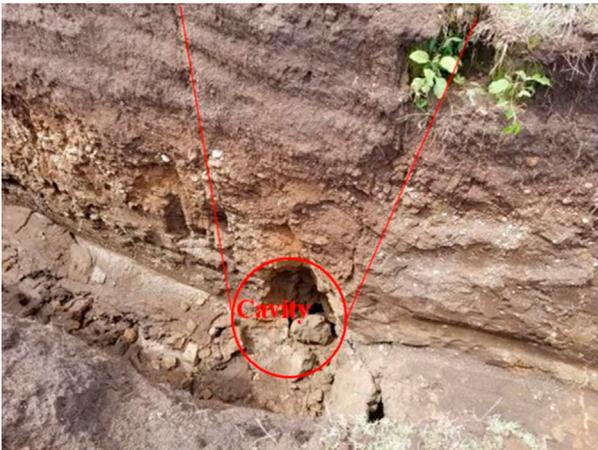
FIGURE 13 TC4 trench.

The photograph of the TC4 trench in Figure 13 reveals that there are two collapse pits. During the wet season, the surface water converges into No. 1 collapse pit and flows away from its bottom, but the sound of the water flow can be heard in No. 2 collapse pit, implying that the bottoms of the two pits are unblocked. In addition, near No. 1 collapse pit, a small hollow with a depth of about 4 m and a fissure penetrating the ground are found in trench TC4. The engineering geological profile of the TC4 trench shows that the surface overburden is 1–2 m and composed of thick powdery clay, as shown in Figure 14. On the left side of the trench is a stratum

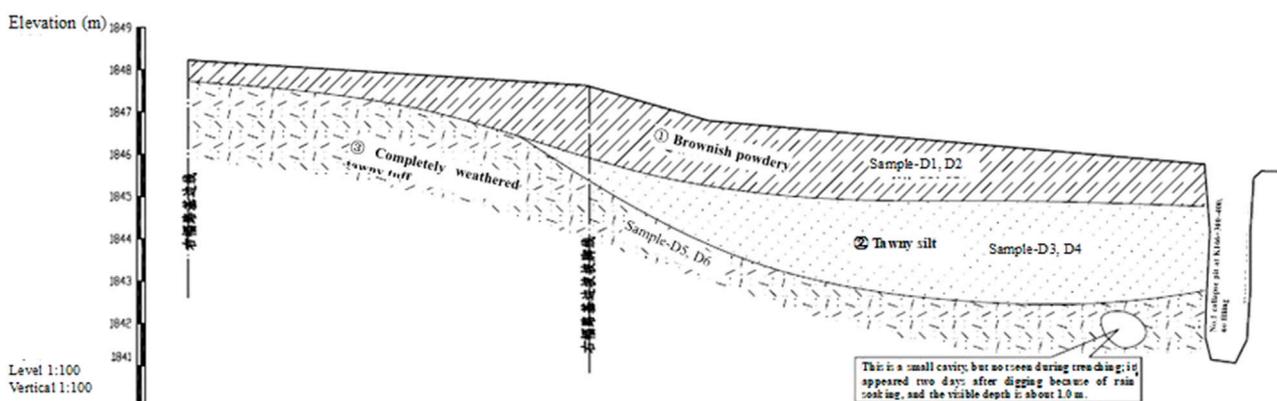
FIGURE 14 Engineering geological profile of the TC4 trench.

consisting of only powdery clay and completely weathered tuff; in the transition to No. 1 collapse pit, a silt layer with a maximum thickness of about 2.5 m gradually appears. This is also caused by later collapse deposition.

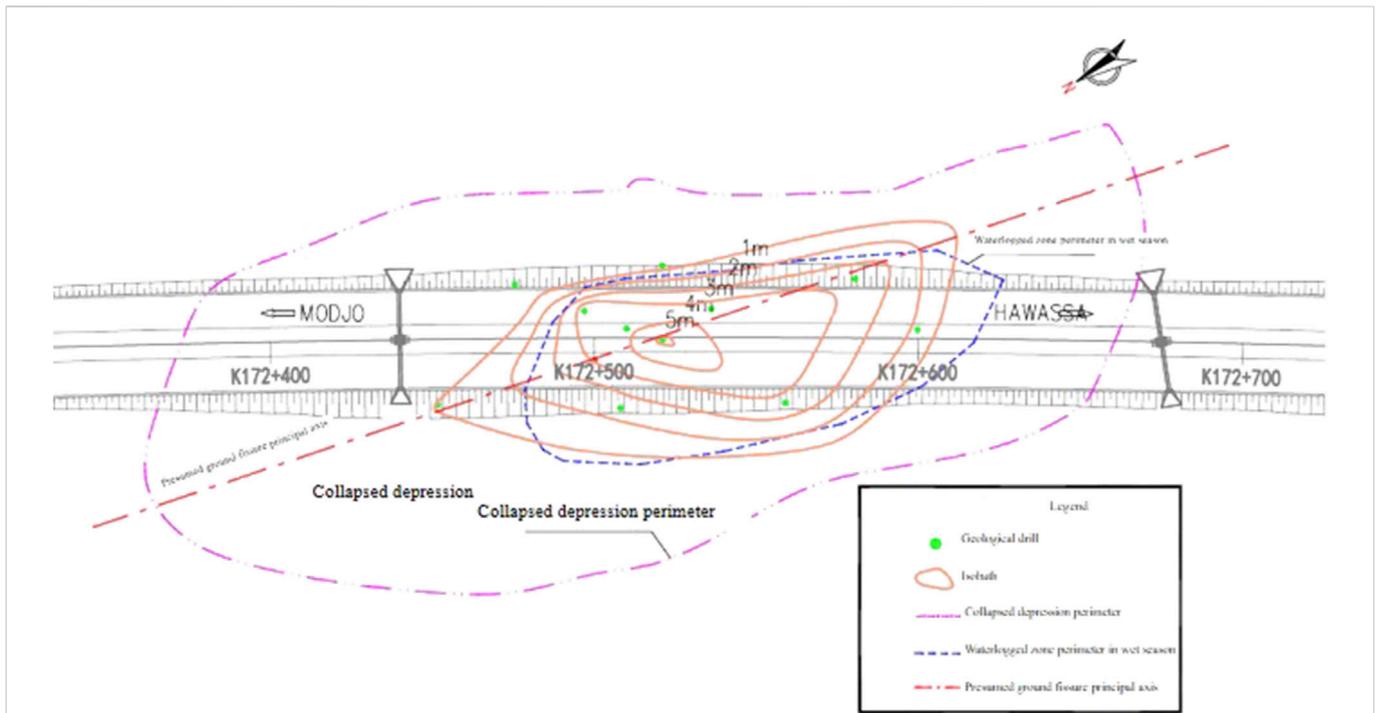
FIGURE 15 Isobath map of the upper clay layer of the collapsed depression in the K165+700~K166+450 section.

Figure 15 shows an isobath map of the clay blanket in the collapsed depression, where the thickness of clay in the collapsed depression takes on a pot-bottom shape, indicating that it was formed due to the sedimentation of clay at a later stage.

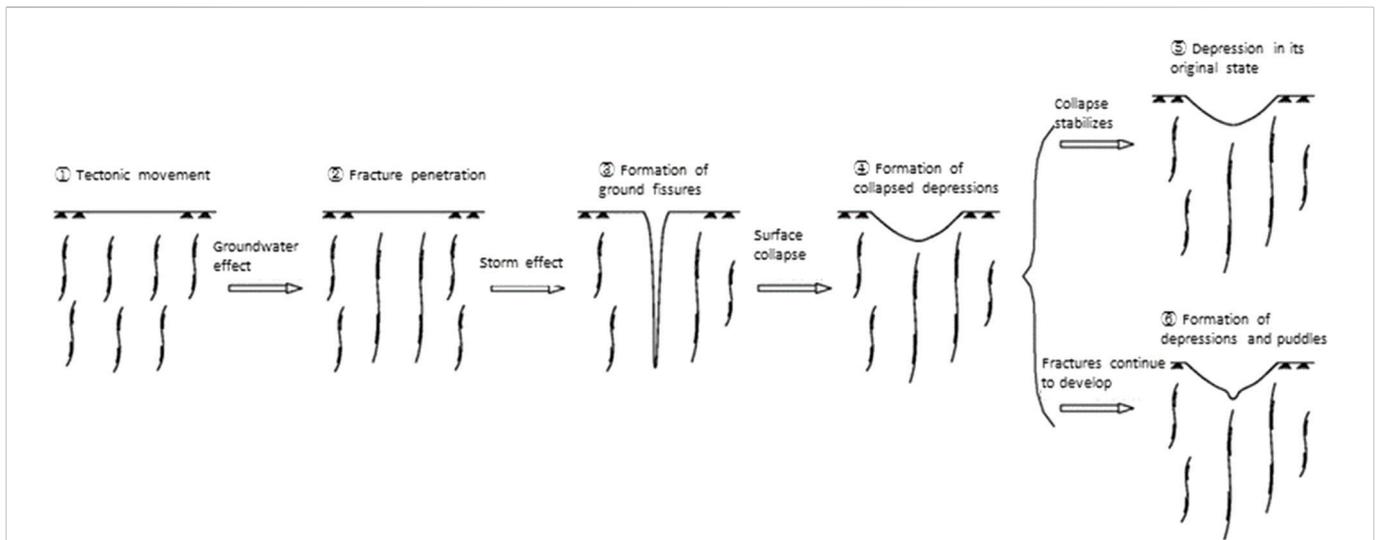
FIGURE 16 Diagram of ground fissure evolution.

According to the stratigraphic texture revealed by trenching, the formation process of ground fissures can be analyzed as follows: first, under the action of tectonic movement and heavy rainfall, outcrop-type cracks are generated. Then, the loose soil begins to subside from the edges of the crack, and the topsoil on both sides will migrate and deposit to the fracture zone. As the composition of the clay granules is carried away by water, a sedimentary silty layer that is thin on the periphery and thick in the middle forms in the center of the fracture. Meanwhile, under relatively stable fracture activities, the fracture zone gradually develops into a collapsed depression, the middle part of which is easily accumulated with water that seeps into the openings of the ground fissures to generate a passage, causing the soil at the upper part of the fracture to subside. This is how collapse pits are formed. As a result, the surrounding soil is further and repeatedly accumulated and carried to the middle low-lying area to expand the collapse pits gradually. Figure 16 shows the ground fissure evolution. Moreover, the development and evolution of ground fissures in the research area are recurrent in nature.
