Experimental study of the particle agglomeration on its mechanical properties of collapsible loess

Loess, distributed all over the world, exhibits the behavior that is related to their formation history, mineralogy, and microstructure, which can cause serious geotechnical engineering problems. This paper presents the Baozhong railway is a key transportation channel for Guyuan city in Ningxia province of northwestern China. Based on field investigations treasure middle section of the railway in the study area, it is found that the more serious diseases subgrade settlement, local roads embankment platform dislocation occurs and lots of cracks were founded. For several years, with the train speed increasing, and due to the influence of widespread flood irrigation on the farmland, the subgrade experienced a degree of settlement. This settlement was not alleviated after three treatments, which seriously affected train safety. In order to analyze the reason for the railway line settlement, soil samples were collected from the collapsible loess subgrade. Consolidation test, particle size analysis test, X-ray diffraction test (XRD), and scanning electron microscopy test (SEM) were perform

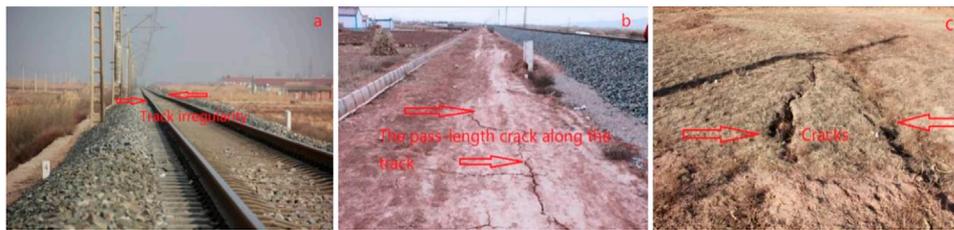
FIGURE 2
Subgrade disease of Baozhong railway. (A) uneven track; (B,C) cracks on both sides of the subgrade.

subsidence, the railway subgrade had produced uneven settlement, which leads to uneven tracks (Figure 2A), and worse: there were many cracks on both sides of the roadbed (Figures 2B,C). The longest extension of the crack was about 600 m long. The warning signs on both sides of the railway sink down with the maximum sinking level being 1.5 m. In addition, traffic safety is seriously threatened. For these reasons, the cause of the uneven settlement for the Baozhong railway subgrade loess is in urgent need of being addressed.

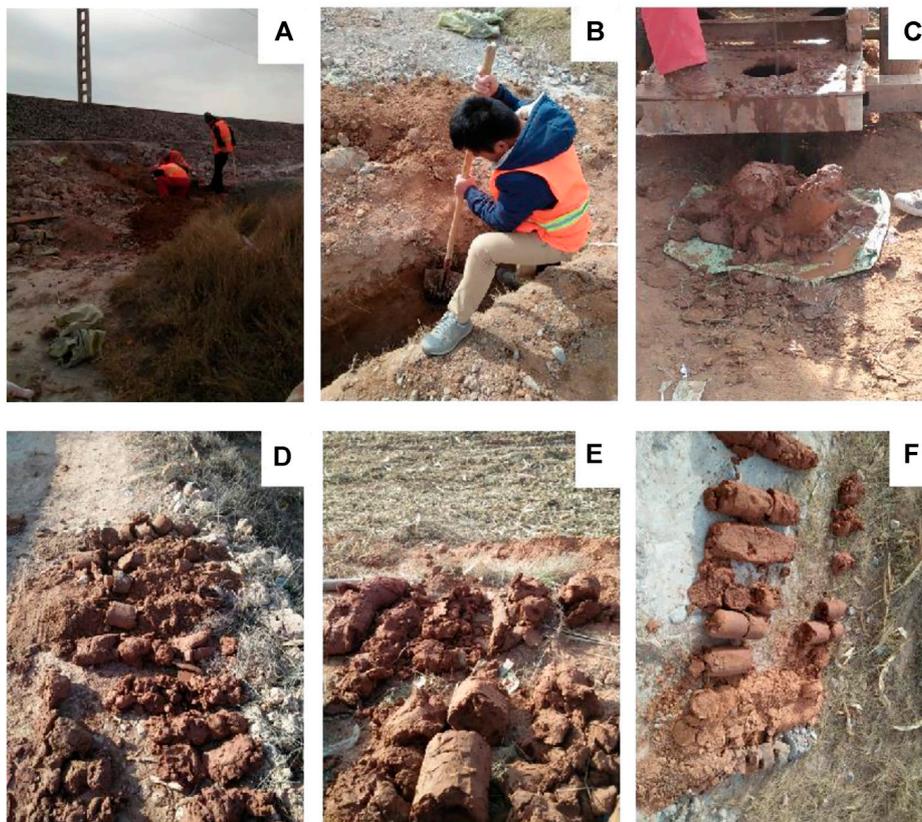
FIGURE 3
Sampling on site.

Three samples (Sample numbers 1, 2, and 3) were selected at Station K331 + 530, where significant roadbed diseases were observed (called the disease segment in this paper) (shown in Figure 3). For comparison, another three samples (Sample numbers 4, 5, and 6) were selected at Station K331 + 585, where no or limited roadbed diseases were observed (called the non-disease segment in this paper) (shown in Figure 3). These six samples were obtained at depths of 3 m, 6 and 9 m. The information of these six samples was shown in Table 1 below.

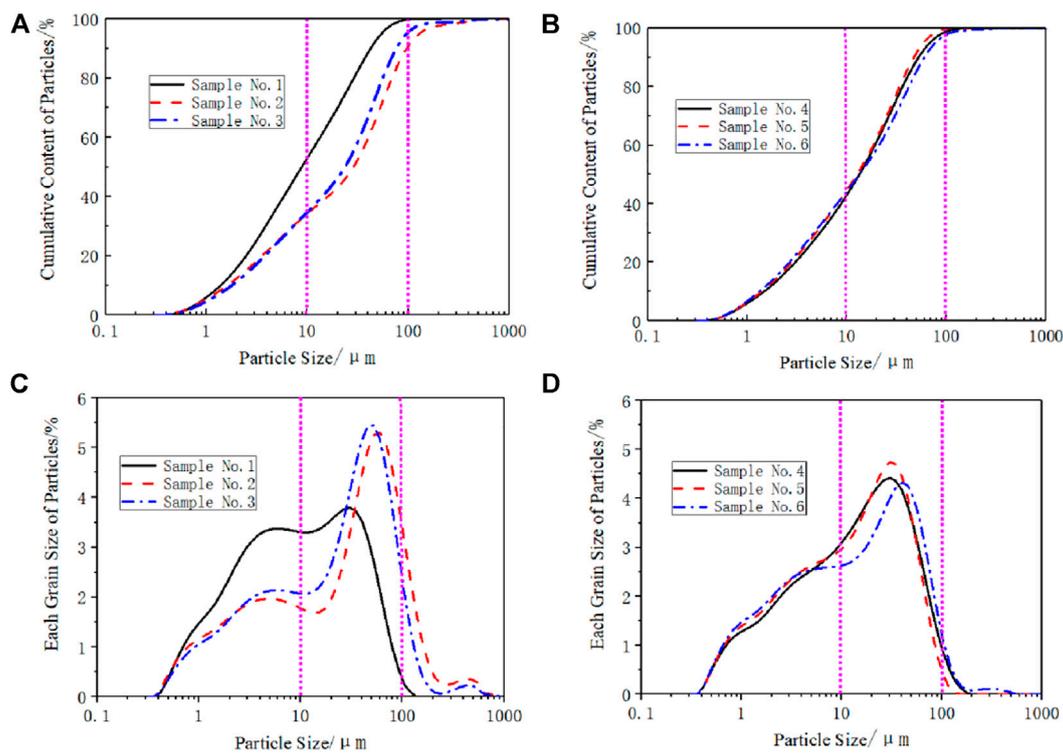
FIGURE 4 (A) Logarithmic curve of the particle size distribution on samples at disease segments, (B) Logarithmic curve of the particle size distribution on samples at non-disease segments, (C) Cumulative logarithmic curve of the particle size distribution on samples at disease segments, and (D) Cumulative logarithmic curve of the particle size distribution on samples at non-disease segments.

The grain size gradation curve and the particle distribution curve of the six test samples were plotted and shown in Figure 4.

As shown in Figures 4A,B, the particle size distribution curves of Samples 2 and 3 in the disease segment appeared to be less smooth than those of Samples in the non-disease segment. As shown in Figures 4C,D compared to samples in the non-disease segment, the

content of the small size particles (<50 μm) of Samples 2 and 3 in the disease segment were relatively low, but the big size particles (>100 μm) of them were relatively high. Therefore, it was considered that due to the low clay contents, the internal molecular attraction in Samples 2 and 3 might be relatively small, resulting in a relatively poor performance of a railway subgrade.

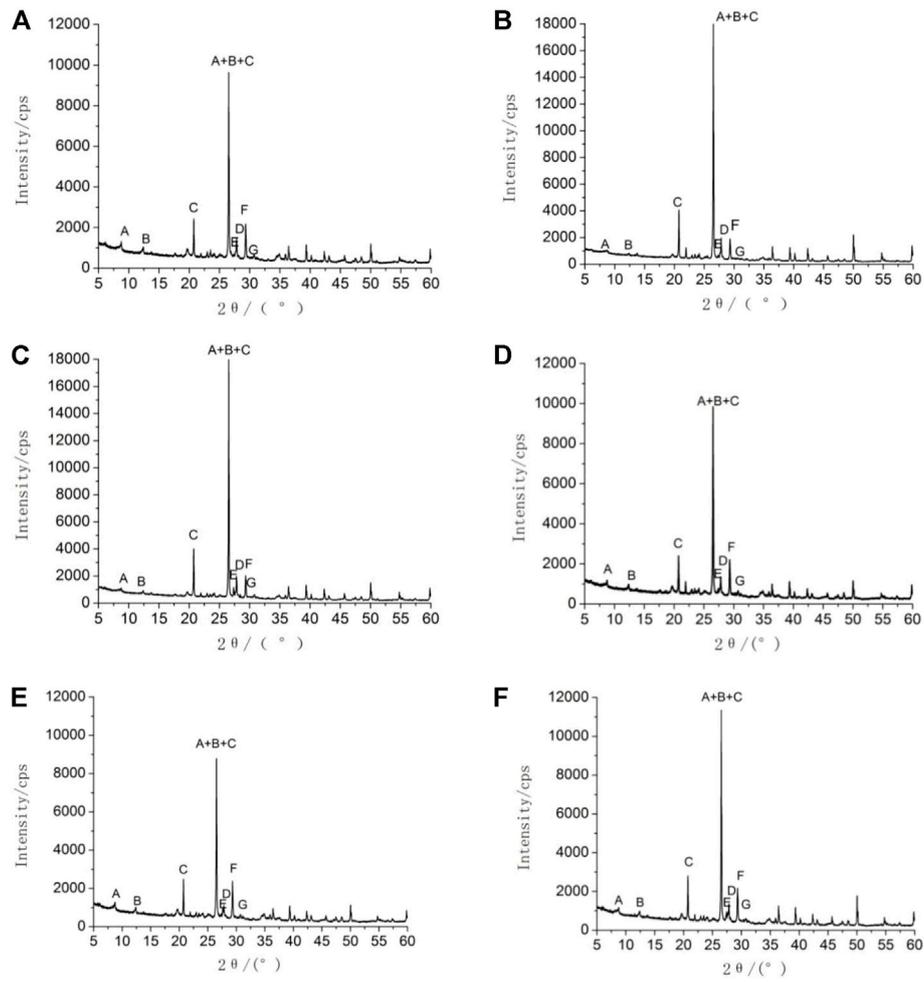
FIGURE 6

A is illite, B is chlorite, C is quartz, D is plagioclase, E is potassium feldspar, F is calcite, and G is dolomite.

XRD diffraction patterns from samples in the disease segment (a, b, c) non-disease segment (d, e, f):(A) sample No. 1,(B)sample No.2, (C) sample No.3, (D) sample No. 4, (E) sample No.5, (F) sample No.6.

XRD diffraction tests were carried out on all samples, and the results were shown in [Figure 6](#). The results indicated that the samples in the diseased area were quite different from those in the non-disease area. Significant differences can be observed on Samples 3 and 3 compared to other samples.

[Figure 6](#) showed that the maximum values was basically the same for all samples. The maximum values of Samples 2 and 3 in the disease segment were relatively higher than others, the maximum values of Samples 1, 5, and 6 were similar, and the maximum value of Sample 4 was the lowest.

The maximum diffraction value ($A + B + C$) was the sum of illite, chlorite and quartz, respectively. This value reflected the degree of crystallization of the sample. Since the degree of crystallization of quartz was greater than that of illite and chlorite, a great maximum diffraction value indicated a relatively great quartz contain of a sample, based on results shown in [Figure 6](#), compared to other samples, Samples 2 and

3 in the disease segment contained more quartz, but less calcite. The content of plagioclase, potassium feldspar, and dolomite in all samples were almost the same. This result indicated that the contents of illite, chlorite, quartz, and calcite might affect the subgrade performance.

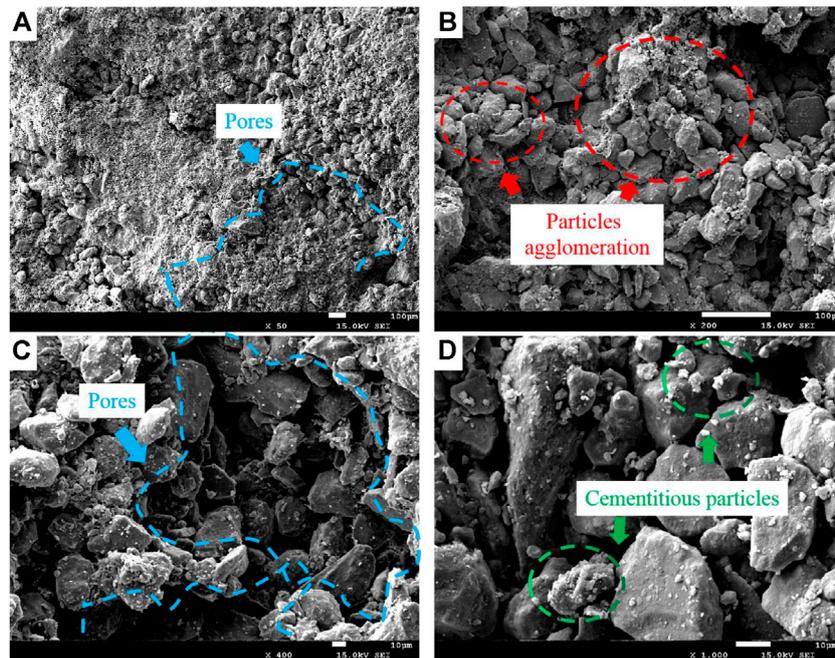
FIGURE 7
 Electron microscopic scanning of the sample at disease segment:(A) Sample No.2–50 times, (B) sample No.2–200 times, (C) sample No.2–400 times,(D) sample No.2–1,000 times.

[Figure 7](#) showed that the microstructure of sample 2 in the diseased area was dominated by the structure type of scaffolds with large pores and micro-cementation or weakly cemented, with low connection strength. The contact surface is very small, and the particles support each other, sometimes in point contact, and sometimes in edge and edge contact, forming relatively large interparticle pores. At the same time, due to the relatively high sand content, there are few clay cements between the particles, and the cements fill the pores between the particles sporadically, showing micro-cementation; the skeleton particles are mainly composed of single granular particles under the microscope. It has the characteristics of sand-like, the shape is relatively clear, and the particle size is relatively uniform.

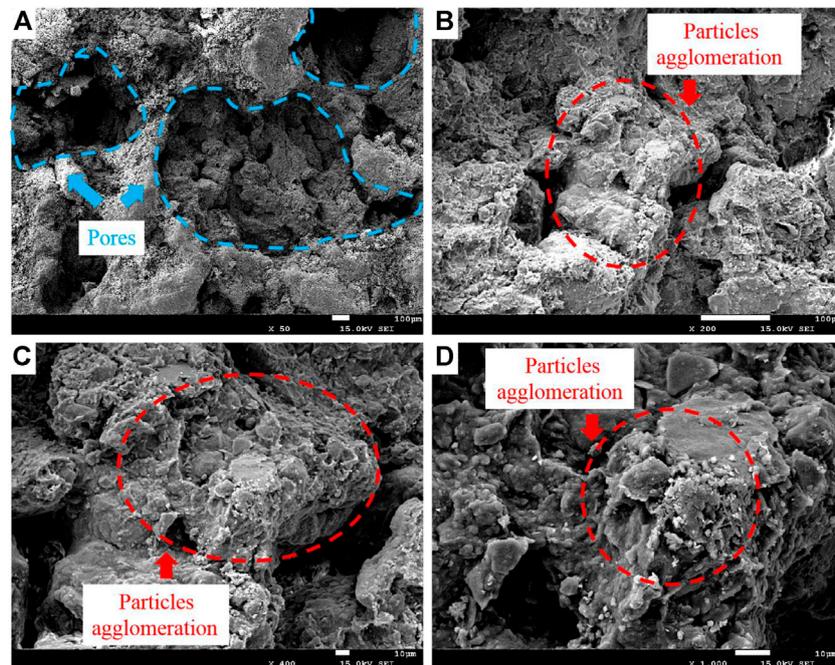
FIGURE 8
 Electron microscopic scanning of the sample at non-disease segment:(A) Sample No.5–50 times, (B) sample No.5–200 times, (C) sample No.5–400 times, (D) sample No.5–1,000 times.

[Figure 8](#) showed that the microstructure of Sample 5 in the non-disease segment was strong and honeycomb. The skeleton particles in the microstructure are composed of agglomerates formed by the agglomeration of small particles, and there are certain large pores and small pores. The agglomerated particles are connected by cementing substances, and the graininess is not obvious. At the same time, the content of clay particles in the cement is the highest, and the particles are aggregated. The skeleton particles are embedded in the cement and do not contact each other. The connection strength is the highest.

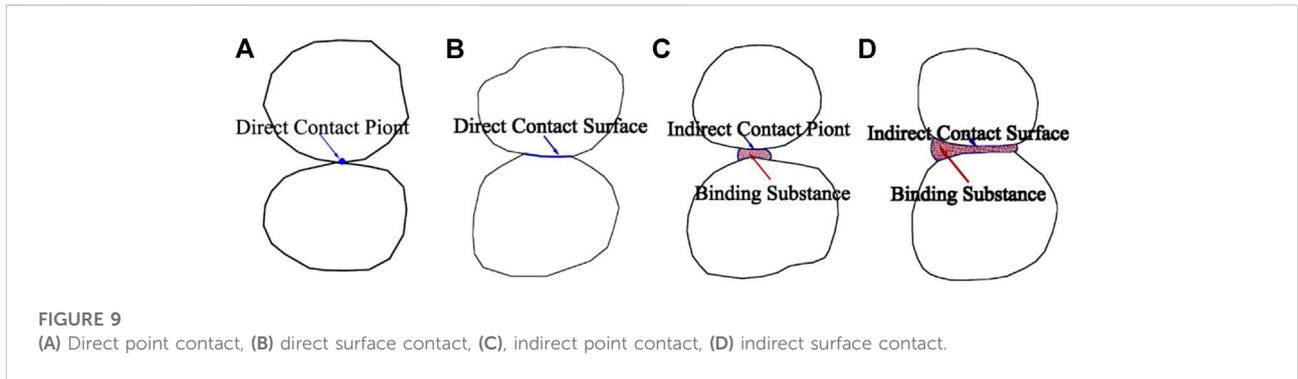
FIGURE 9
 (A) Direct point contact, (B) direct surface contact, (C), indirect point contact, (D) indirect surface contact.

indirect surface contact (Shao et al., 2018). The direct contact refers to the interface between particles with limited cohesion. The indirect contact is the interface between particles having a film which consists of clay and salt crystal. The point and surface contacts stand for particle interfaces with relatively small and large contact areas, respectively. Those contact forms are shown in Figure 9.

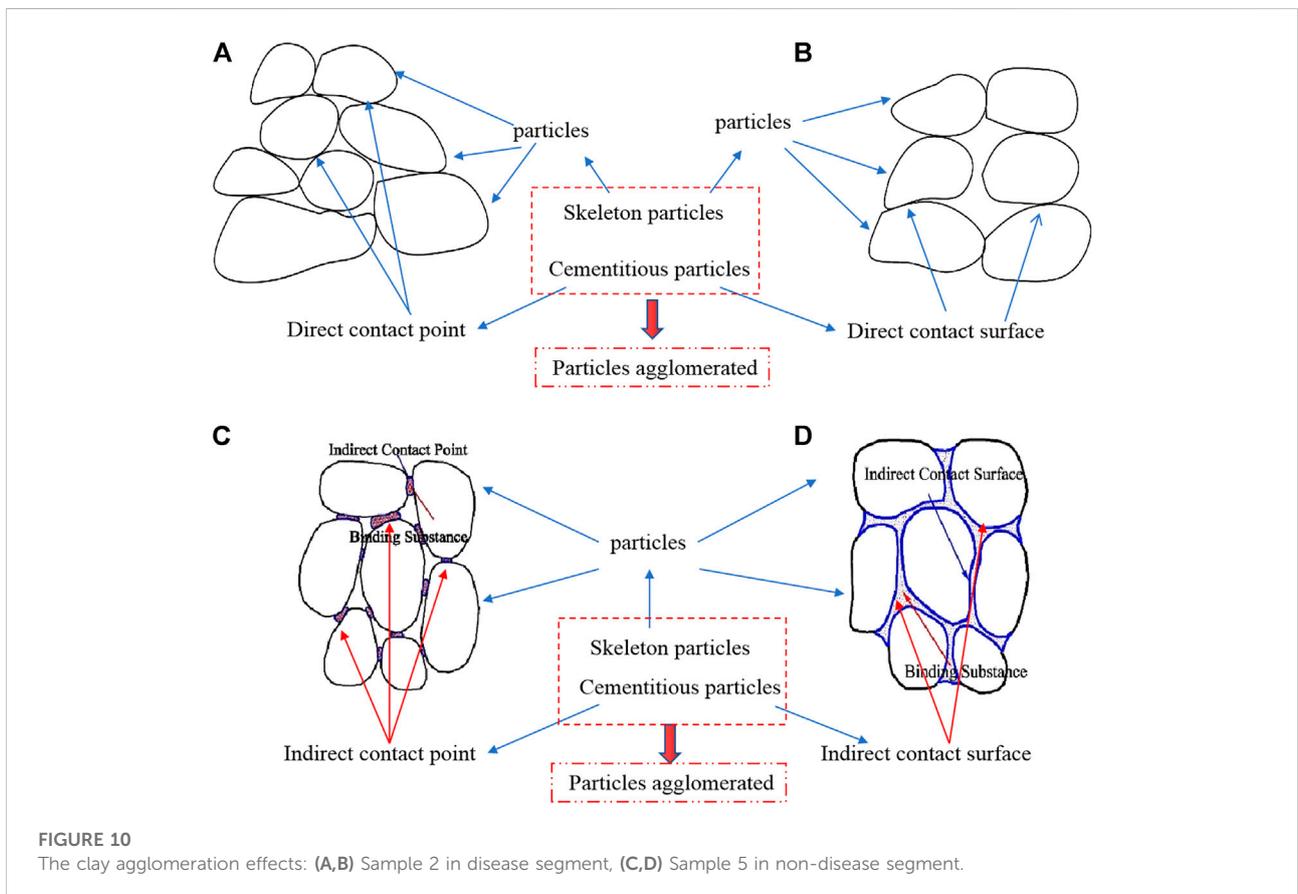
FIGURE 10
 The clay agglomeration effects: (A,B) Sample 2 in disease segment, (C,D) Sample 5 in non-disease segment.

Clay particles with direct or indirect contact surfaces may form a group of soil particles. This is called clay “agglomeration” in this paper. SEM scanning electron microscopy images showed a relatively low content of clay films and sheets of Sample 2 at the disease segment, and thus, the level of clay “agglomeration” of this sample was relatively weak. The voids between soil particles of Sample 5 in the non-disease segment were filled with clay films and sheets and the interfaces between soil particles were mainly surface contacts. Some soil particles in Sample 5 were completely wrapped with clay minerals. Therefore, the level of clay “agglomeration” of Sample 5 was strong. The clay “agglomeration” effects of the two Samples were shown in Figure 10.

As shown in Figures 10A,B, the soil clay mineral content and the clay “agglomeration” level of Sample 2 in the disease segment were relatively low, resulting in a weak cohesion. The structures of such saturated soil might be liquefied and unstable under dynamic loads. It could also be observed from Figures 10C,D that the clay “agglomeration” level of Sample 5 in the non-disease segment was relatively high. A strong connection between soil particles was formed, resulting in a strong cohesion between soil particles. A better performance was expected for such soil used as a railway subgrade.
