# Engineering surveys of Sri Lankan schools exposed to tsunami

The 2004 Indian Ocean tsunami affected 5% of Sri Lanka's schools, severely damaging 108 and destroying 74. The catastrophe highlighted the critical role of schools in providing educational continuity during community recovery. Sri Lanka has since rehabilitated and rebuilt most of the destroyed schools along the coastline. However, there is a limited understanding of current levels of school exposure to tsunami. This hampers preparedness and risk reduction interventions that can improve community and educational tsunami resilience. This paper presents a multi-disciplinary school exposure database relevant to both vulnerability and loss modelling. The repository includes data on 38 schools and 86 classroom buildings, surveyed across the coastal districts of Ampara, Batticaloa and Galle in Sri Lanka, which were heavily affected by the 2004 tsunami. A new engineering rapid visual survey tool is presented that was used to conduct the physical assessment of schools for the exposure repository. School damage mechanisms observed in past tsunami inform the survey forms, which are designed to capture information at both school c

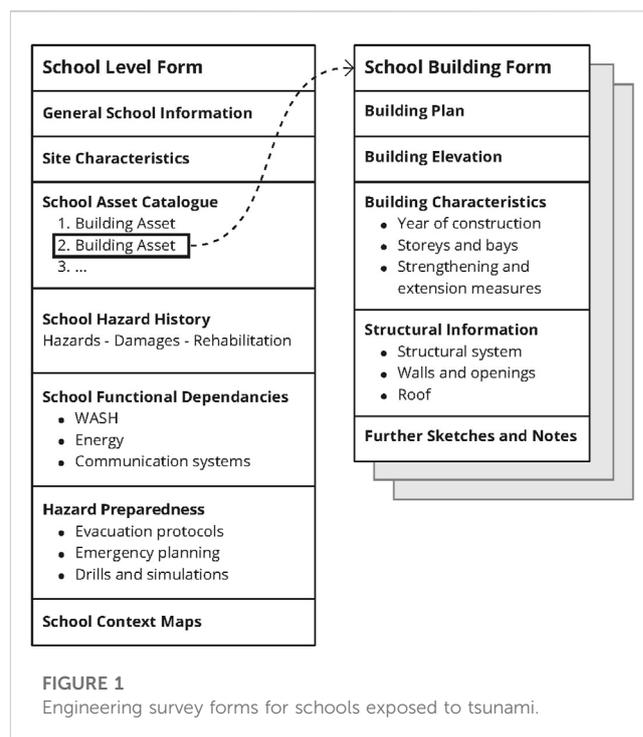
The ReSCOOL RVS tool consists of two survey forms, as illustrated in [Figure 1](#). The first form provides a high-level overview of the school compound and supporting infrastructure (referred to hereafter as the ‘school-level form’). The second form captures the detailed structural characteristics of each school building *within* the school complex (referred to hereafter as the ‘building-level form’). The ReSCOOL RVS tool is fully compatible with GLOSI and GED4ALL taxonomy systems.

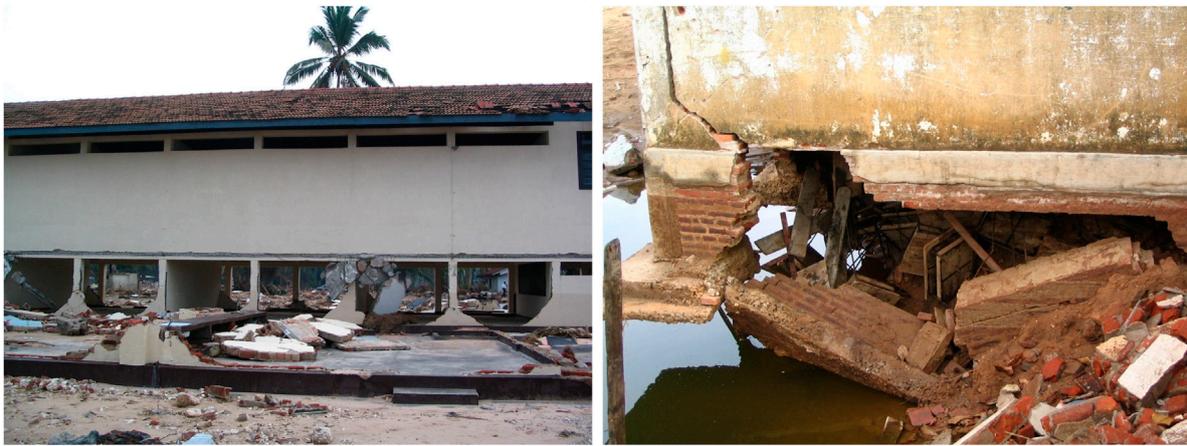
**FIGURE 2**  
(A) Washed away building in front and washed away infills at the rear. (B) Foundation scouring of a corner.

The second section of the school-level form gathers data on the site characteristics of the school complex, including local soil conditions and the presence of perimeter walls. The former is key to the occurrence of scouring. Foundation scouring, as depicted in [Figure 2B](#), was one of the main school building failure mechanisms

observed in Sri Lanka ([Dias et al., 2006](#)). Scouring effectively washes away the soil underneath a structure (typically starting around the corners), undermining the foundations, and eventually leading to its collapse. Perimeter walls can act to block or divert the water flow so long as the wall does not fail. Urban conditions influence localized tsunami flow conditions, including the potential sheltering of one structure by another or as sources of debris ([ASCE/SEI 7-16, 2017](#); [Chock, 2016](#)). To this end, the ReSCOOL RVS proposes the use of indices to characterise the level of urban density and vegetation surrounding the school complex.

No significant differences in structural design have been observed among the surveyed districts. All school buildings surveyed have RC floor slabs which are mostly 125 mm in depth. Most school buildings have gable pitched roofs, supported by either steel (75%), timber (20%), or mixed RC and timber (4%) truss systems, except for one school building with a flat RC roof. Roof coverings are either clay tiles (55%), metal sheets (10%) or asbestos sheets (35%). Most surveyed school buildings have shallow brick strip foundations for walls and pad footings for columns, built on sandy soils, owing to their coastal proximity. This paper thus classifies the foundations as flexible, with an elevated risk of scour, supported by evidence during the 2004 tsunami and depicted in Figure 2B (Dias et al., 2006).

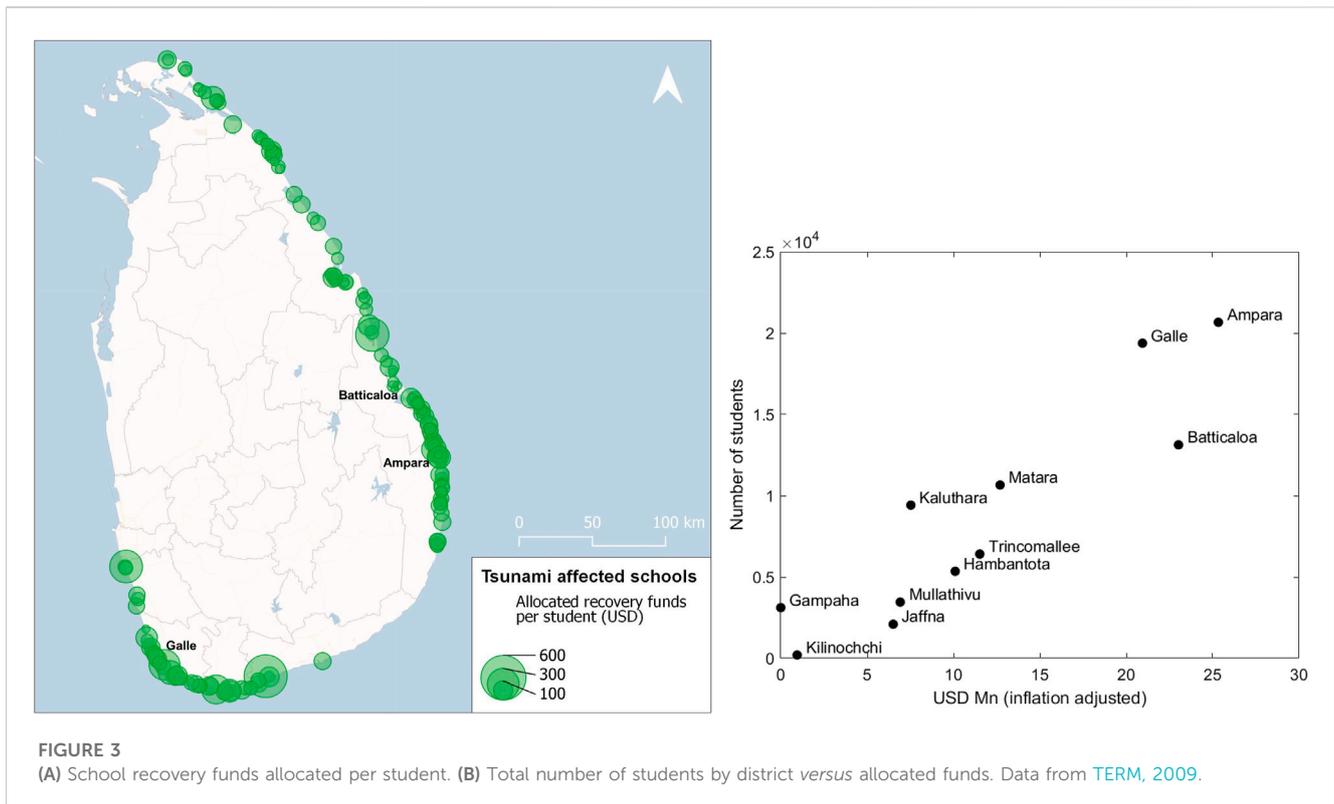
[Figures 3A,B](#), show the recovery funds allocated to 187 of the severely affected schools according to the tsunami reconstruction and rehabilitation program ([TERM, 2009](#)). [Figure 3B](#) shows that the allocated recovery funds (aggregated by district) have an almost linear relationship to the number of students in each district. It also highlights that the three most heavily affected regions in terms of the number of pupils and reconstruction fund allocations are Batticaloa, Galle and Ampara. These three regions were highlighted by post-tsunami field surveys to have sustained some of the greatest losses ([Jayasuriya et al., 2005](#); [Palliyaguru et al., 2007](#); [Rossetto et al., 2007](#)) and largest levels of tsunami inundation following the 2004 event ([Goff et al., 2006](#); [Wijetunge, 2012](#)). They are the regions of focus for the RESCOOL RVS implementation.

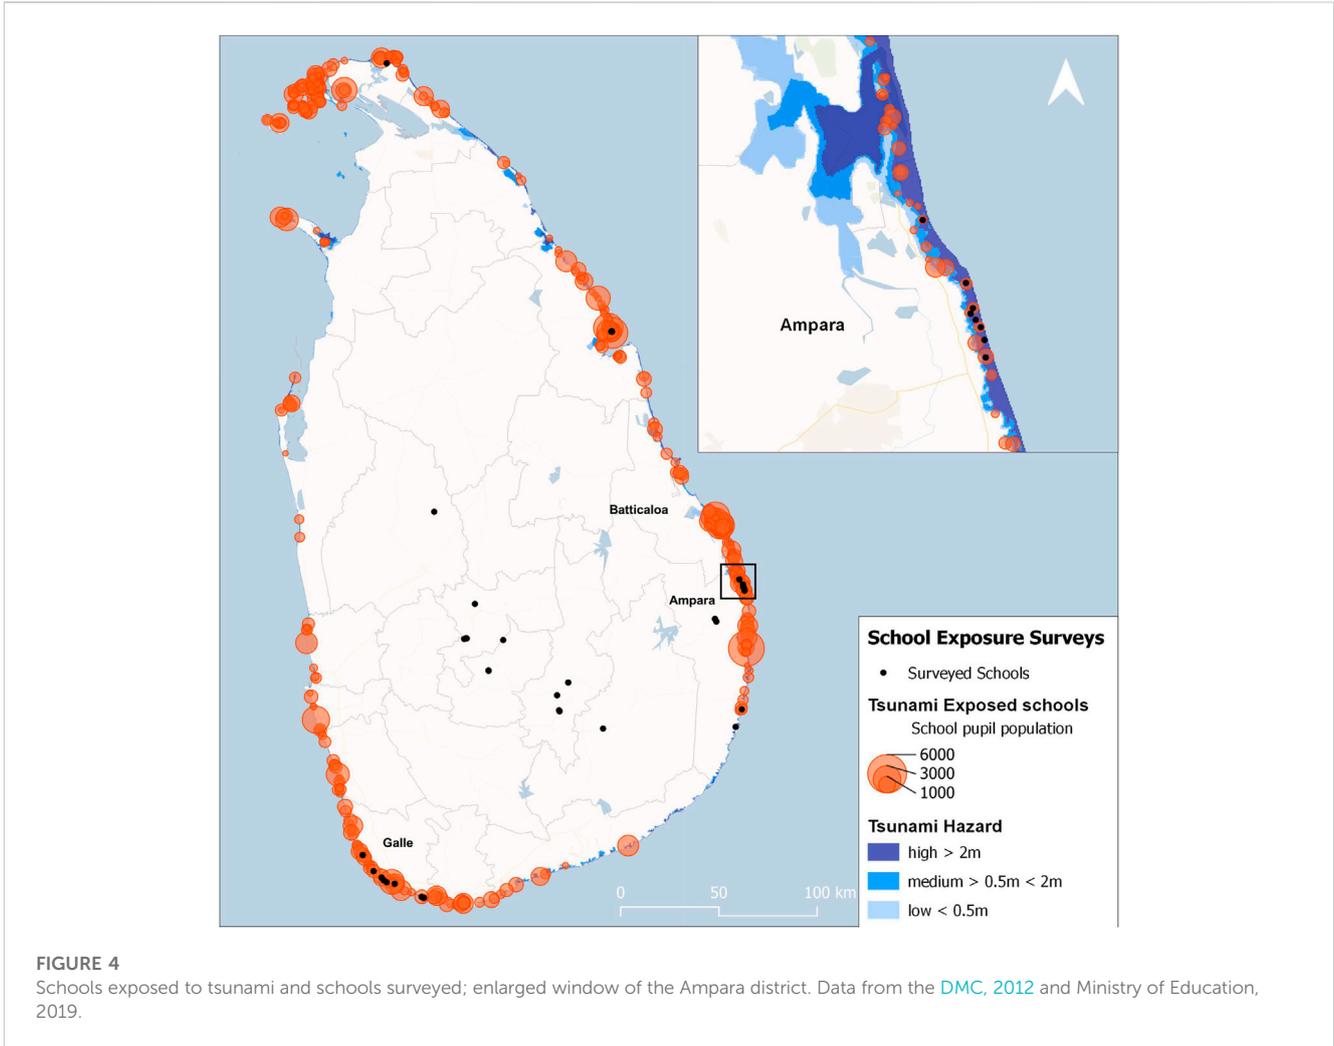
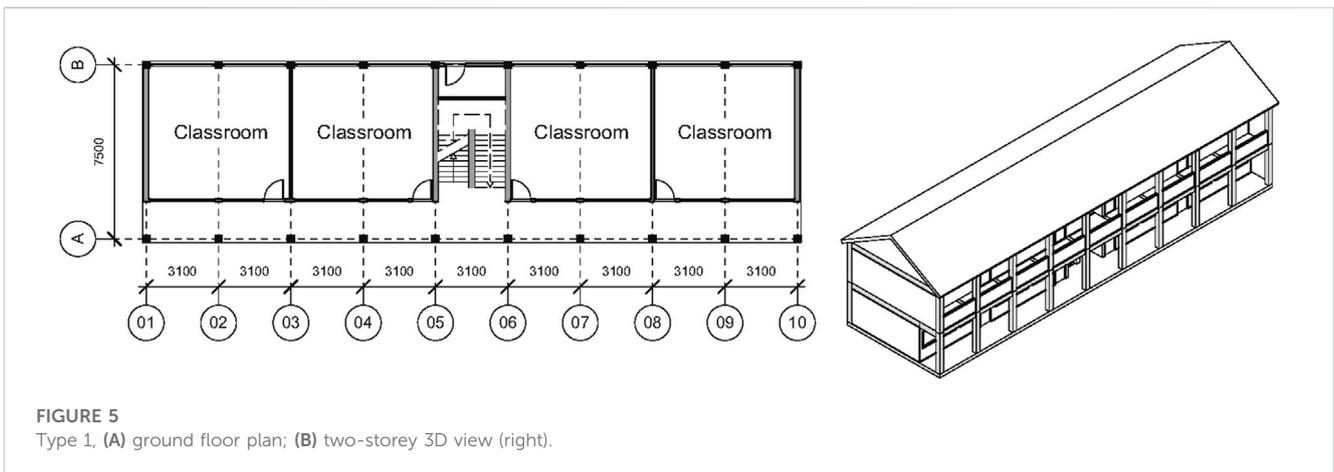
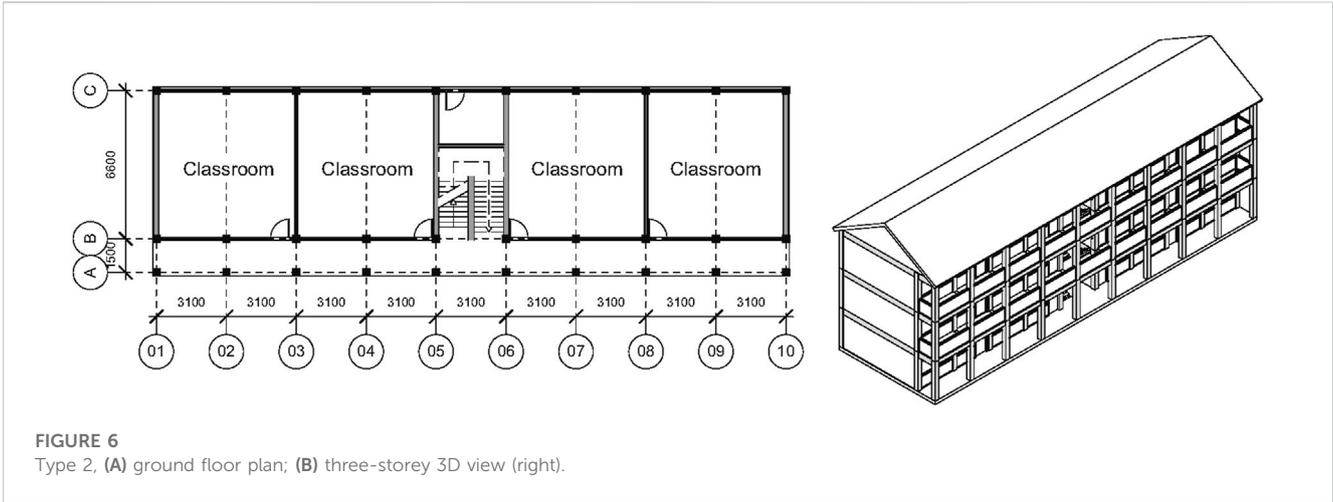
The surveys reveal that most schools in Sri Lanka follow one of three standardized layout arrangements, here denoted as Type 1, 2 and 3 and shown in Figures 5–7, respectively. Type 1 schools have two rows of columns at the perimeter aligned with the longer dimension of the building. Type 2 schools have a similar layout to Type 1 but have an additional row of columns aligned with the corridor. This additional row of columns may improve their seismic and tsunami performance, as they enhance the lateral load resistance of the building. Type 1 and Type 2 schools are typically two to four storeys tall, and their architectural arrangement comprises a central staircase with two or three classrooms on either side connected by a longitudinal corridor. A classroom typically spans two bays, each of which is about 3 m (although classrooms sometimes span three or four bays). Most Type 1 and Type 2 schools have nine bays, i.e., four classrooms. However, the number of bays ranges from seven to 16, i.e., two to eight classrooms. The transverse width of the structure is typically around 7.5–10 m for both Type 1 and Type 2 schools. Type 3 schools, much fewer in number, have a central staircase with four adjoining classrooms, which are used as lab rooms, libraries, staff rooms, or rooms for other supporting functions, see Figure 7. Type 3 school buildings are typically two to three storeys high.

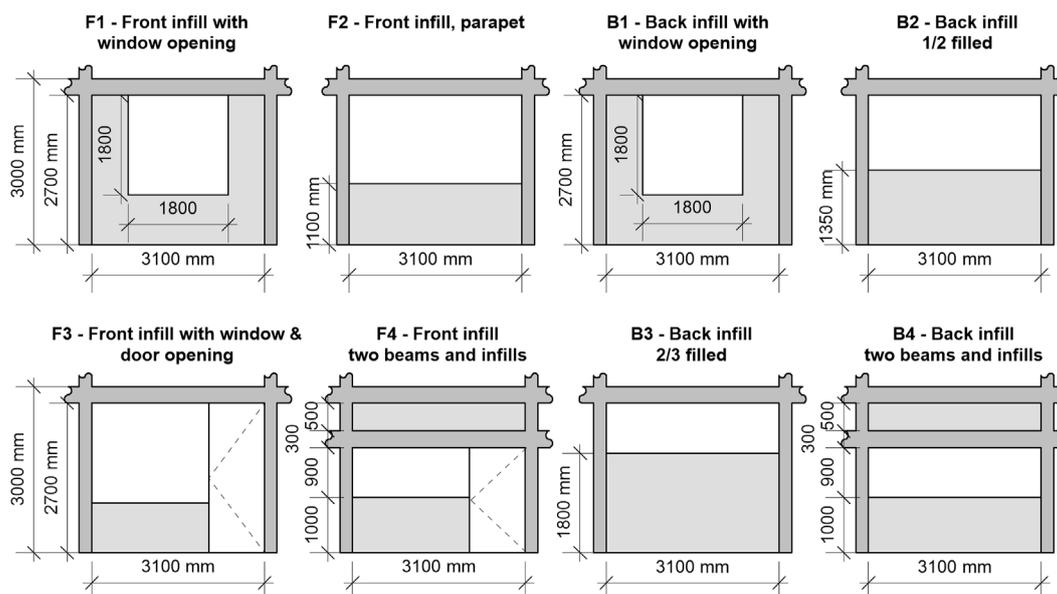
**FIGURE 10**  
Front and rear infill configurations (nominal dimensions; B0: bare frame).

The infills and partitions of all the surveyed schools are mostly unconfined masonry. The surveys show that the infill configurations can be grouped into eight classes, (three classes for the front elevations and five classes for the rear elevations), as depicted in Figure 10. Schools typically have a uniform combination of one front and one rear infill configuration across all bays along the longitudinal direction of the structure. The thicknesses of the infills vary between 125 mm and 230 mm, corresponding to masonry brick (solid clay) or block type used and their bonded thickness (half- and full-brick masonry walls). The gable end walls and the two internal walls abutting the staircase are mostly of full-brick masonry construction; and in some cases, the gable end walls constitute masonry confined on all four sides. Classroom partitions and external walls in the longitudinal direction are typically half-brick masonry.

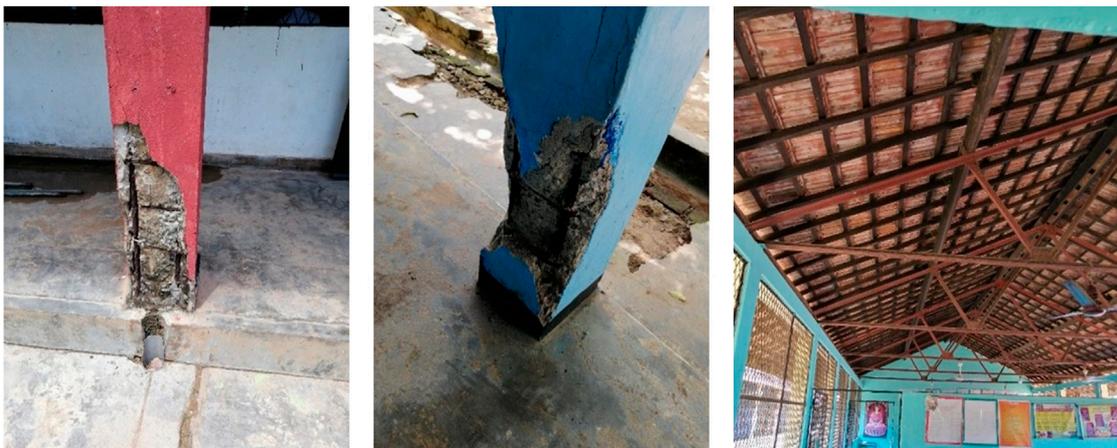
Several schools, mostly in the Galle district, exhibit severe structural and non-structural degradation. The surveys found multiple instances of severe cracking and concrete spalling due to reinforcement corrosion in columns, beams, and floor slabs. Figure 11A depicts examples of severe spalling and reinforcement corrosion observed in some ground floor columns of surveyed school buildings. Typical non-structural degradation was in the form of broken roof sheets or tiles, and water leaks and ingress. In addition, in several school buildings the steel roof trusses displayed significant signs of corrosion and rust, as shown in Figure 11B.

**FIGURE 11**  
(A) Left and centre, Structural degradation: Severe corrosion of columns (B) Right, Roof degradation: Corrosion of steel trusses.

The lack of systematic maintenance, however, is likely to be the main contributing factor to the poor structural health of the building stock. Several school principals expressed concerns during the building surveys regarding the lack of funds available to conduct maintenance works. Moreover, multiple schools contain abandoned and severely dilapidated buildings on school grounds. The principals of these schools indicated that they had not obtained the funds for their demolition and stressed that they constitute a safety hazard (which, objectively, they do). In an independent investigation that looked at the level of

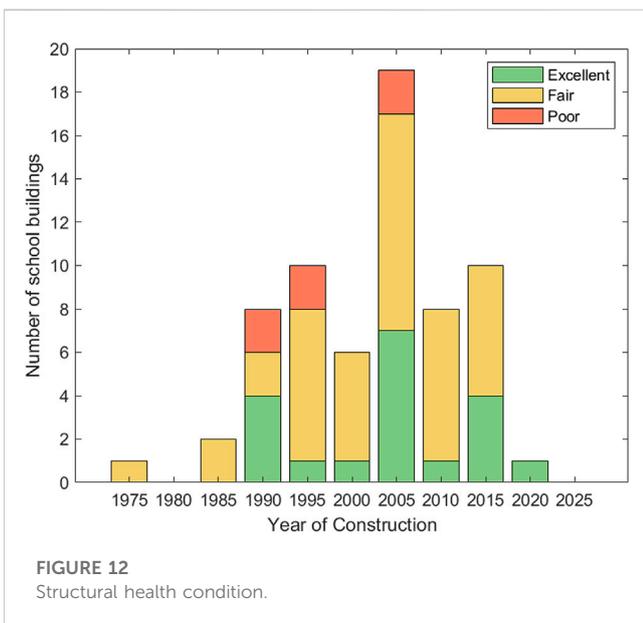
Figure 12 plots the distribution of the surveyed buildings according to their structural health conditions and building age. As expected, age is a reasonable predictor of condition. None of the buildings constructed after 2005 are in a *poor* condition. A *poor* structural health condition denotes significant degradation to the structure and threatens the structural integrity of the building if not addressed (like in Figure 11A). A *fair* health condition denotes minor degradation to structural members (hairline cracks), and some lack of maintenance to non-structural members. Multiple factors may explain the elevated levels of building degradation of such a young building stock - ‘young’ because the mean year of construction of the surveyed buildings in both the Galle and Ampara districts is 2003. One plausible factor is the proximate locations of the schools to the coast. There is some indication, for example, that the proximity to the coast may influence the level of corrosion of RC members and steel roof trusses. This is especially the case in the Galle district, where four schools have poor structural health conditions, and the others have fair conditions. Conversely, in Ampara only one school is in a poor state of structural health, while 27 have fair and six have excellent conditions. In Batticaloa

**FIGURE 12**  
Structural health condition.

and the other surveyed districts, only one school has a poor structural health condition, 26 have fair conditions and four have excellent conditions. The discrepancy between the Galle and the other districts may be due to regional differences in construction materials, building construction and maintenance practices.
