Reyes-Hardy M-P, Biass S, Dominguez L,
Di Maio LS, Frischknecht C, Bonadonna C and
Pérez N (2024), Temporal evolution of roof
collapse from tephra fallout during the 2021-
Tajogaite eruption (La Palma, Spain).
Front. Earth Sci. 11:1303330.
doi: 10.3389/feart.2023.1303330

Temporal evolution of roof collapse from tephra fallout during the 2021-Tajogaite eruption (La Palma, Spain)

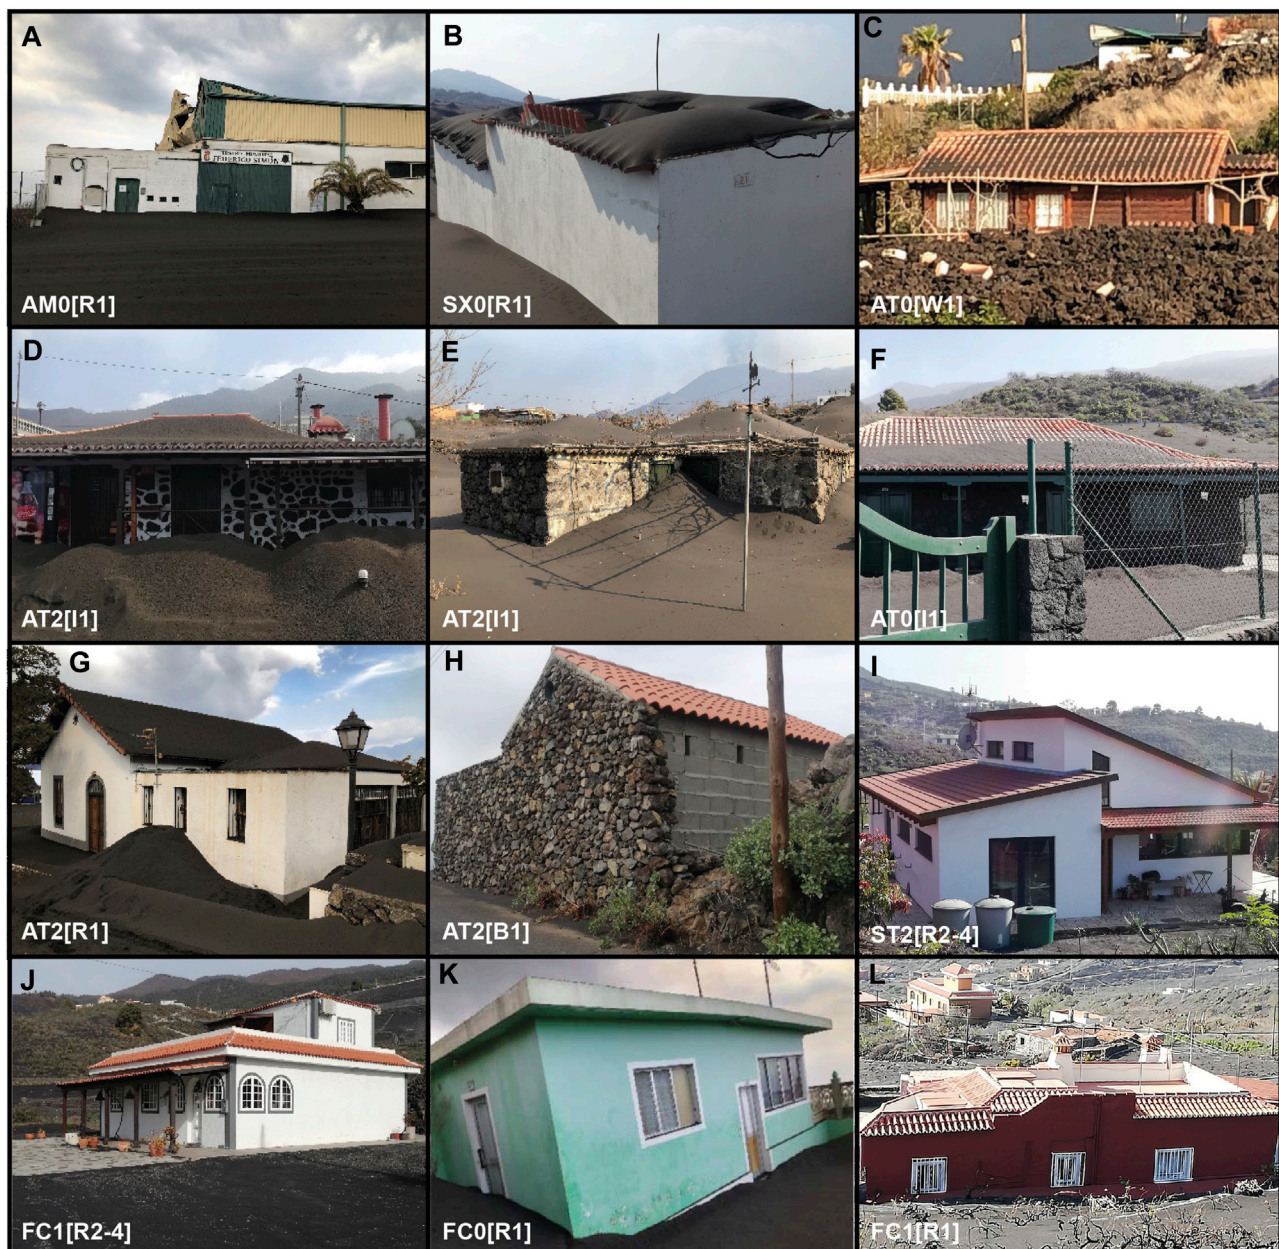
FIGURE 3
Roof and building types identified in our survey. Examples of Weak, WE (A–C); Medium Weak, MW (D–F); Medium Strong, MS (G–I); and Strong, ST (J–L) classes are displayed.

Based on the 764 primary buildings surveyed, we defined four roof types (Figure 3):

- Type 1: Roofs with two or more pitches, single pitch, or flat angles made of metallic, fiber cement, zinc, or plastic sheets, regular plan and simple design or irregular plan/composite design, and regular (i.e., cement bricks), irregular (i.e., broken stone), or combined bearing masonry. Tiled roofs with two or more pitches, regular plan and simple design or irregular plan/composite design and wooden masonry.

- Type 2: Tiled two or more pitches, single pitch, or flat roof (old or new) visibly in good condition, regular plan and simple design or irregular plan/composite design, and irregular bearing masonry.

- Type 3: Tiled two or more pitches and single pitched roof with infill in concrete blocks visibly in good condition, regular plan and simple design or irregular plan/composite design and reinforced concrete and/or masonry structure with regular or combined bearing masonry and/or infill walls.

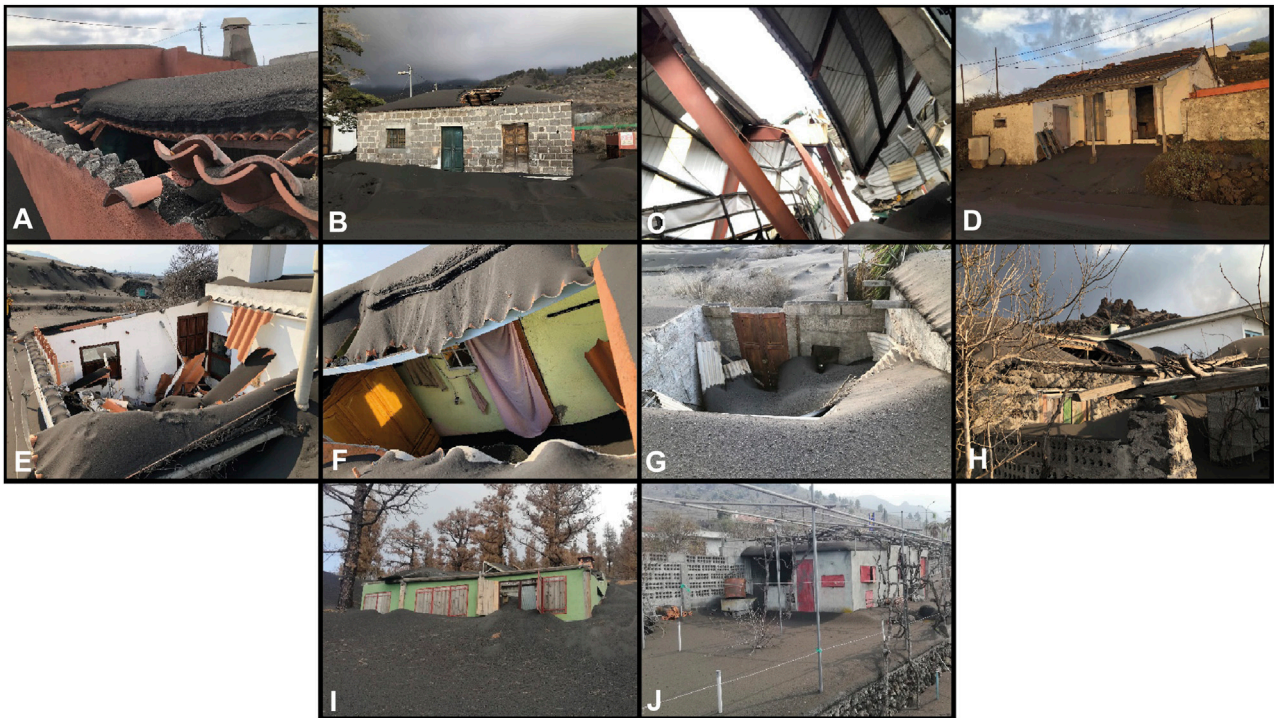
FIGURE 5 Collapsed roofs of primary structures as observed in the field. **(A)** tiled single pitch irregular plan/composite design roof with one storey regular masonry (MS, zone L), **(B)** tiled two or more pitches, regular plan and simple design, with one storey regular masonry (MS, zone B), **(C)** two or more pitches, metallic, regular plan and simple design, with one storey, mixed structure (WE, zone L), **(D)** tiled two or more pitches, regular plan and simple design, with one storey regular masonry (MS, zone H), **(E)** pitched roof of fiber cement/zinc, irregular plan/composite design roof with one storey regular masonry (WE, zone L), **(F)** single pitch of fiber cement/zinc, regular plan and simple design roof with one storey regular masonry (WE, zone L), **(G)** single pitch metallic regular plan and simple design roof with one storey regular masonry (WE, zone L), **(H)** tiled two or more pitches, regular plan and simple design, with one storey irregular masonry (MW, zone L), **(I)** single pitch metallic irregular plan and composite design roof with one storey regular masonry (WE, zone TTLL), **(J)** flat fiber cement/zinc regular plan and simple design roof with one storey regular masonry (WE, zone B).

Overall, 10 roofs out of the 764 surveyed primary buildings were observed to have collapsed due to tephra (Figure 5). One of these roofs was observed to have collapsed during the first field visit and it was later buried by lava (Figure 5H). Out of the remaining nine roofs, seven were observed to have collapsed during the first visit (October 2021, Figures 5A–G) and two were observed to be collapsed after the eruption (Figures 5I, J). The collapsed roofs described in Figure 5 were mainly characterized by metallic, fiber cement/zinc/plastic sheets or tiles. Estimated loads at the time of field observations range between 0.7 and 15 kPa (Figures 6A, B, detailed by zone in Supplementary Figure S3).

Regarding the isolated collapsed roof located in the East of the area, close to the vent (Figure 5I), we cannot constrain the tephra load that collapsed it, since we only observed it after the end of the eruption, and it was never cleaned (red line in Figure 6) (see detailed loads accumulation over time by zone in Supplementary Figure S3).

1–10 cm. Among these only 27 suffered severe roof or building collapse (e.g., clay-tiled roof, supported by timber or bamboo framing), with the heaviest tephra loads being equivalent to 1.4 kPa (Williams et al., 2020). During a post-event damage state framework of the 2015 Calbuco eruption (Chile) for buildings, Hayes et al. (2019) found that total roof collapse occurred with tephra loads of 1.0–3.2 kPa, but also that partial roof collapse may have occurred for tephra loads of 0.2–0.3 kPa. Houses around Calbuco were predominantly timber-framed with metal sheet roofs, and variability in roof pitch, construction quality, and building age (Hayes et al., 2019), which would correspond to a MW roof class, i.e., mean loads of 3.0 kPa. This means these roofs also had little or no probability of collapse following published fragility curves (e.g., Spence et al., 2005; Jenkins et al., 2014). The differences in composition between these eruptions (i.e., Kelud 2014, basaltic andesitic (Cassidy et al., 2019); Calbuco 2015, andesitic (Castruccio et al., 2016); Tajogaite 2021, Tephritic-basanitic (Day et al., 2022b)), have no clear effect in deposit densities, as in agreement with conclusions of Osman et al. (2022) on experiments with different magma compositions and eruption size. This suggests that while roof strengths are predicted reasonably well for previous studies at Vesuvius, Sete Cidades, Soufriere, and Teide (Spence et al., 2005), they may be overestimated for other locations in Europe and construction standards such as some of the buildings we observed in La Palma (i.e., b, d, and j in Figure 5).

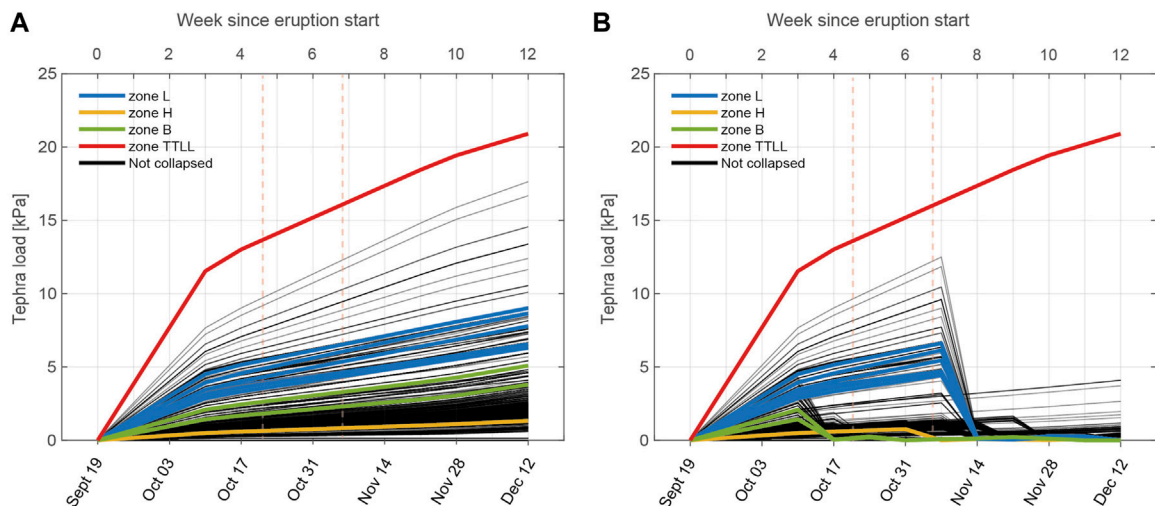
FIGURE 6 Accumulated tephra load (in kPa) over time at the location of the 764 studied buildings (dates on the primary-bottom x-axis and weeks since the beginning of the eruption on the secondary-top x-axis). All surveyed buildings and zones are considered. Estimated expected loads **(A)** not accounting for clean-up operations; and **(B)** accounting for clean-up operations. Red, blue, green and yellow lines are associated with the buildings with collapsed roofs per UME zone observed in the field. Vertical dashed lines indicate the duration of our first field campaign (21 October–5 November).

Collapsed roofs observed during the 2021 Tajogaite eruption provide a comparison with existing fragility curves developed for Europe (Spence et al., 2005). Assuming that no clean-up operations were carried out in zone L prior to our visit in October 2021, the temporal evolution of tephra loads inferred from Figure 6 suggests that roofs in this zone would have collapsed under a load ranging between 4.0 and 6.0 kPa (blue lines in Figure 6). According to the fragility curves of Spence et al. (2005) this range of loads results in collapse probabilities of 100% for all four WE, 92%–100% for the 1 MW roof, and 28%–92% for the single MS building observed in this zone. Conversely, clean-up operations in zones B and H were performed prior to our visit. In the absence of precise constraints on roof collapse dates, we infer maximum loads for the three collapsed roofs in these zones before clean-up (green and yellow lines in

Figure 6B). In zone B, a load of 3.0 kPa translates to roof collapse probabilities of 98% for the single WE and 2% for the single MS roofs. In zone H, the collapsed MS roof had a virtually null roof collapse probability associated with a load of 0.8 kPa. Although the fragility curves of Spence et al. (2005) performed well in zone L, we attribute the discrepancies observed in zones B and H to four main reasons.

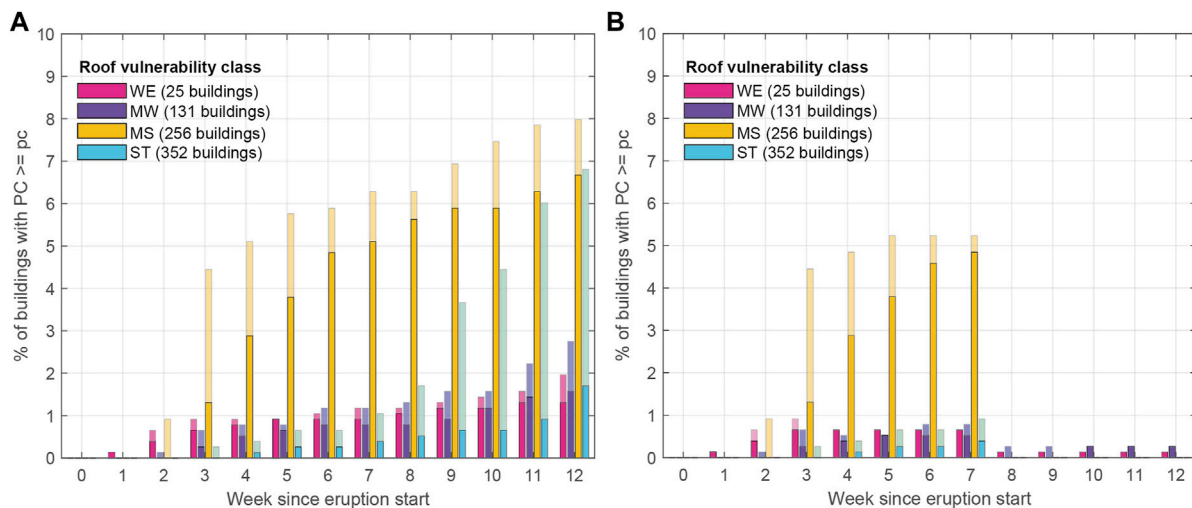
FIGURE 9 Evolution in time (weeks since the beginning of the eruption) of the percentage of the count of buildings that equaled or surpassed a threshold of 25% (light colors) and 75% (dark colors) probability of roof collapse considering two scenarios: (A) no clean-up operations carried out; and (B) clean-up operations carried out by UME. The surveyed buildings are separated by our vulnerability classes assigned (WE, weak in pink; MW, medium weak in purple; MS, medium strong in yellow; ST, strong in blue).
