Physical vulnerability of masonry building to the slow-moving landslide: insight from numerical simulation

Haojie Wang^{1,2,3} and Jiarui Mao^{2,4*}

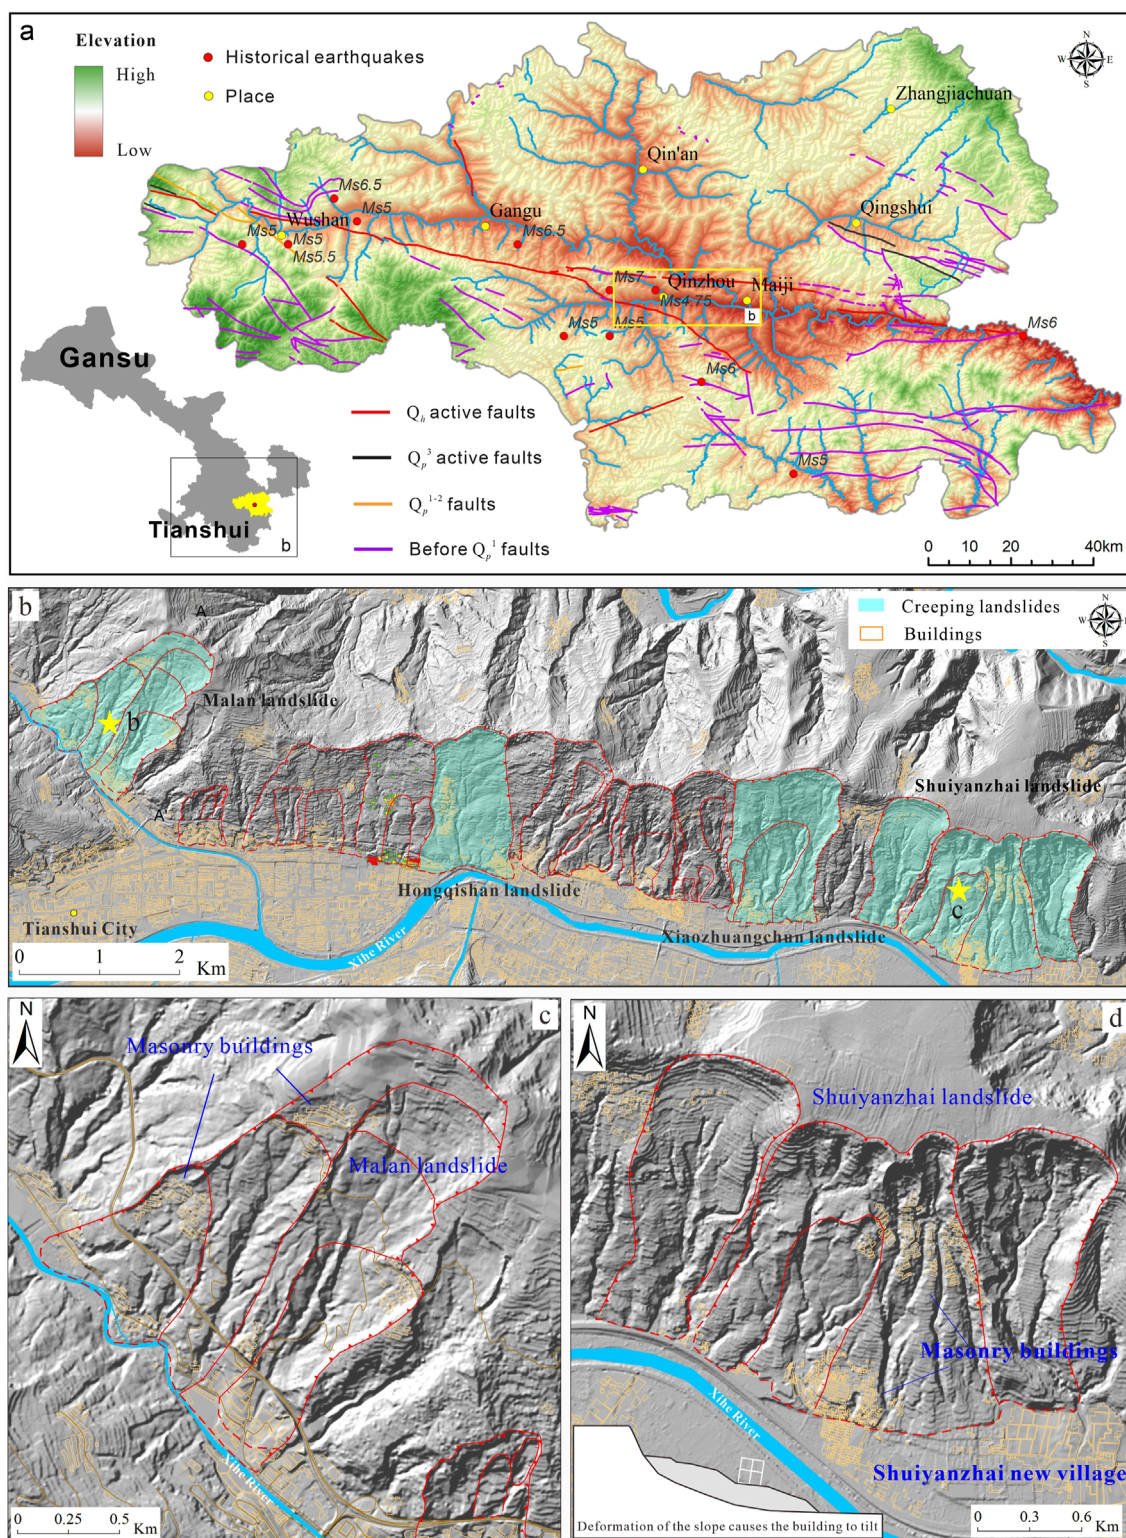
FIGURE 1
(a) Location of the Tianshui Beishan; (b) Distribution of slow-moving landslides in Tianshui Beishan; (c) Malan landslide; (d) Shuiyanzhai landslide.

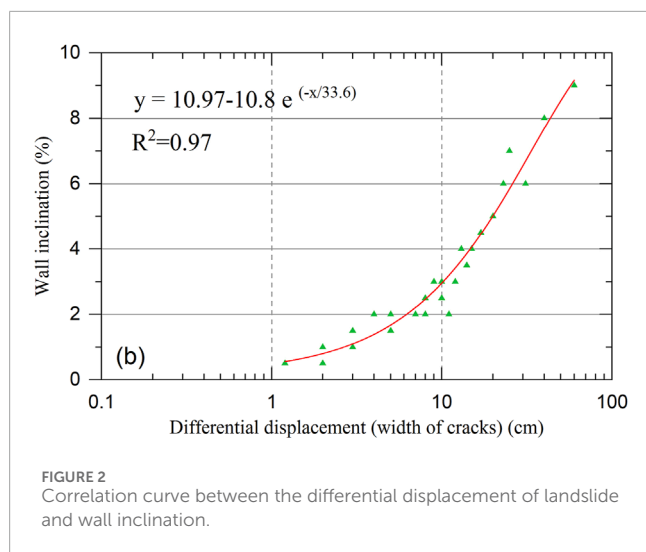
FIGURE 2
Correlation curve between the differential displacement of landslide and wall inclination.

of ground cracks (Figure 2). The continuous creep of Malan village landslide in Qinzhou District, Tianshui City caused many cracks on the landslide surface. These cracks are about 9~15 cm in width, and most of them are tension and settlement cracks (Figure 3a). The

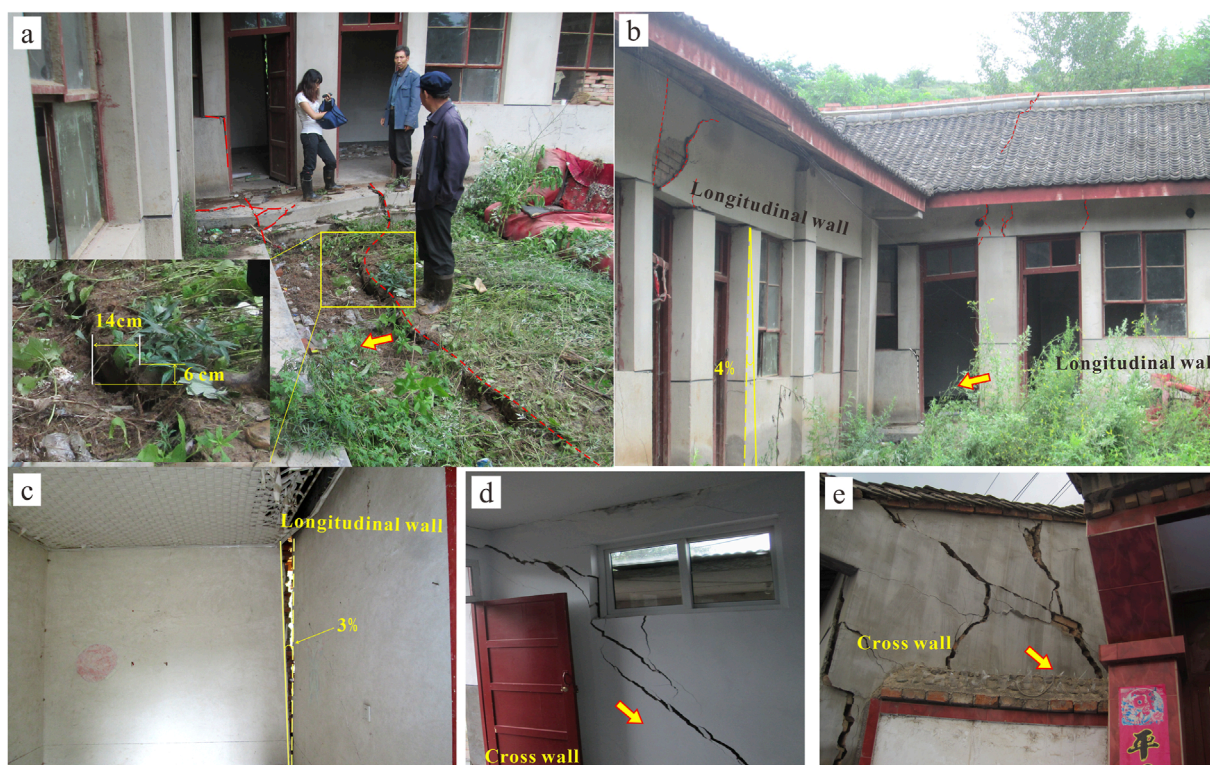
FIGURE 3

Damage of masonry buildings on Malan landslide in Tianshui City. (a) Tension cracks on the ground; (b,c) Inclined deformation of building walls; (d,e) Cracks on the cross wall.

longitudinal walls perpendicular to the slide direction show obvious inclination, and the inclination rate is about 2~4% (Figures 3b,c). The cross walls parallel to the slide direction mainly present 45°~80° shear and inclined cracks, which generally extend upward

from the corners of doors, windows and walls (Figures 3d,e). Wamuchi Landslide in Minxian County, Gansu Province, is a typical slow-moving loess landslide. There are many composite tension and subsidence cracks on the landslide surface, which are about 41–43 cm in width and 9–13 cm in depth (Figures 4b–d). The cross walls parallel to the main slide direction mainly show shear inclined cracks, which extend upward from the corners of doors and windows (Figure 4b). The longitudinal walls perpendicular to the slide direction are seriously damaged, with obvious inclination and cracking, and the wall inclination rate is about 6%–8% (Figures 4a–c). In addition, affected by the differential deformation of the landslide surface and the length of the longitudinal wall, several inclined cracks extending from bottom to top appear in the longitudinal wall (Figure 4a).

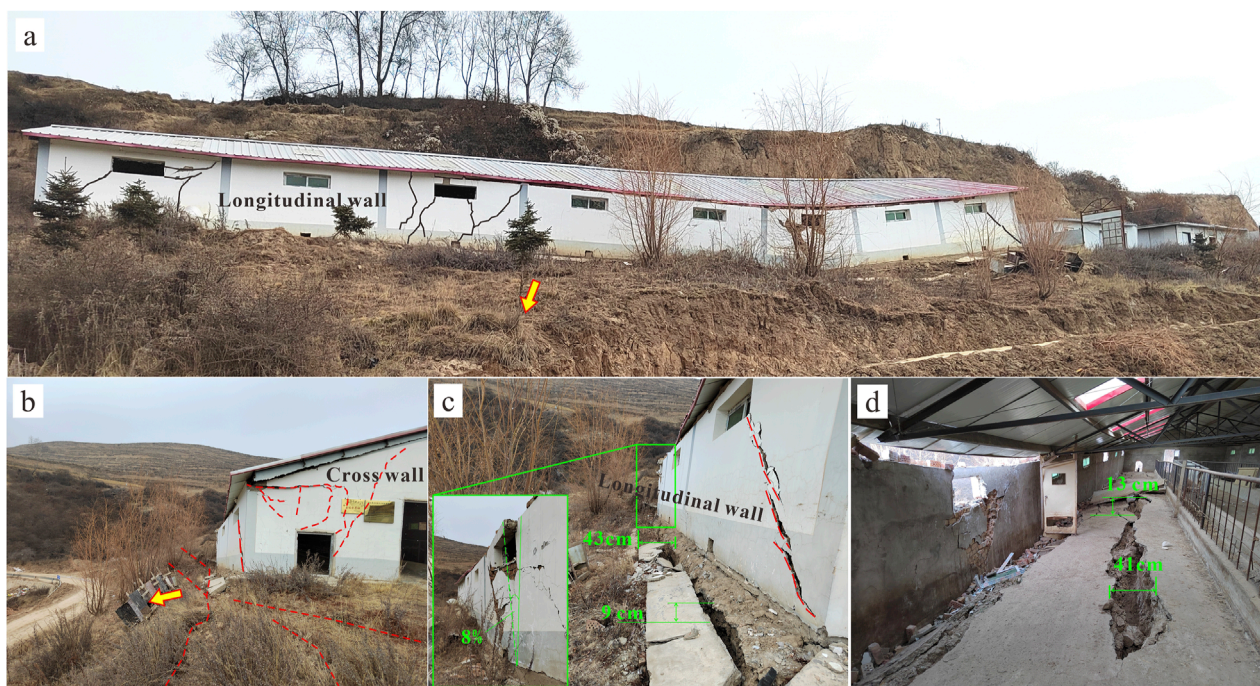
FIGURE 4

Damage of masonry building on Wamuchi landslide in Minxian, Dingxi City. (a) The integral deformation of the building; (b) Shear cracks on the cross wall; (c) Inclination of the longitudinal wall; (d) Tensile cracks on the ground.

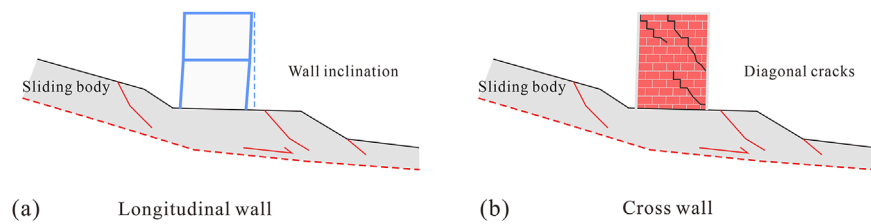
FIGURE 5
Damage patterns of (a) longitudinal wall and (b) cross wall.

The slow-moving landslide mainly shows horizontal tension deformation and vertical settlement deformation. The mechanism of masonry buildings subject to landslide deformation is complex, and the damage characteristics and types can be summarized into two categories. (1) The longitudinal wall perpendicular to the slide direction mainly shows the characteristics of overall inclined failure. In addition, cracks may appear in the wall due to uneven landslide deformation (Figure 5a). (2) The cross wall parallel to the slide

direction are prone to oblique cracks extending from bottom to top along the mortar joints, and the dip angles of these cracks are generally greater than 40° (Figure 5b).

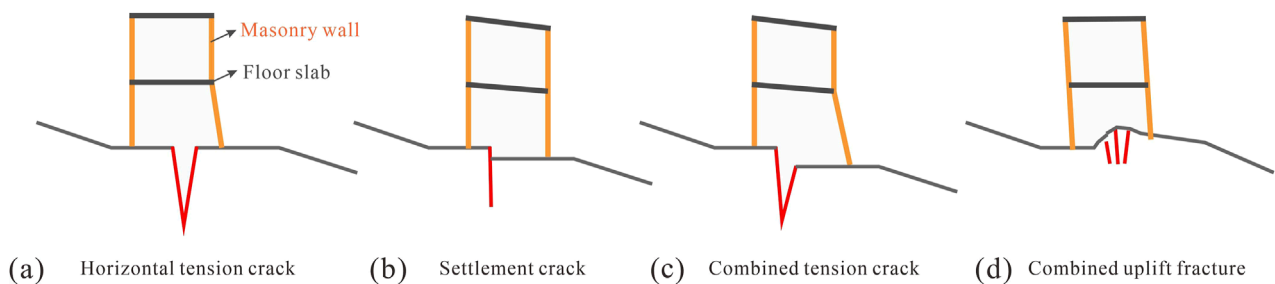
FIGURE 6
Schematic diagrams of building damage subject to ground cracks. (a) Horizontal tension crack; (b) Settlement crack; (c) Combined tension crack; (d) Combined uplift crack.

Based on the above analysis, this study summarizes four schematic diagrams of building damage subject to ground cracks (Figure 6).

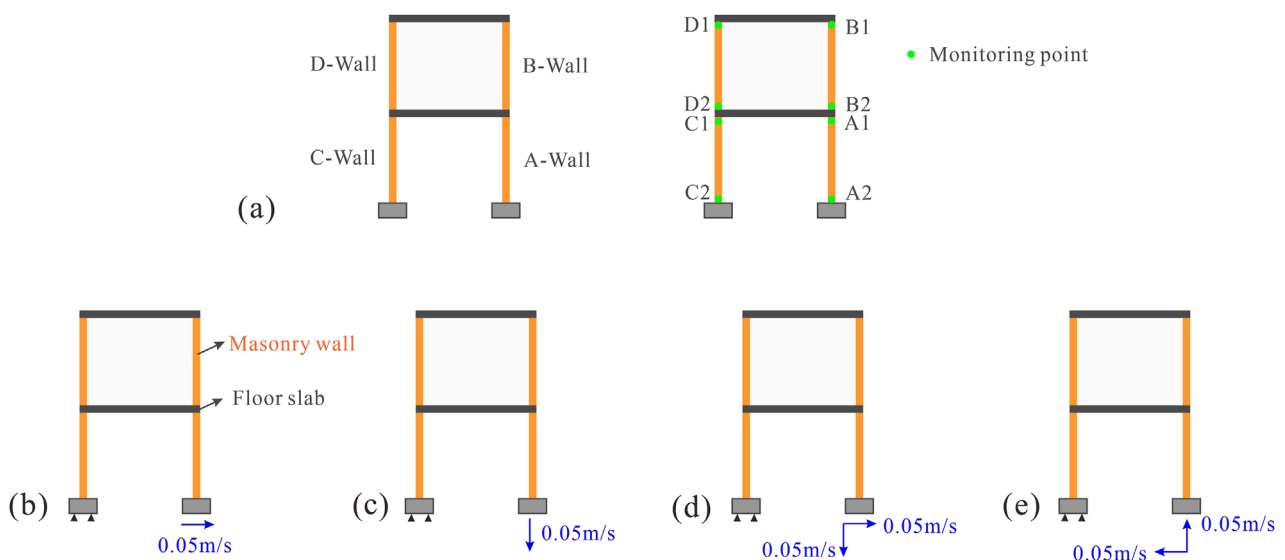
FIGURE 7
Structural model of the masonry building used in this study, consisting of masonry walls and floor slabs without ring beams or structural columns. (a) Layout of monitoring points; (b–e) Schematic diagram of four crack scenarios simulation.

In this study, different types of ground cracks are simulated by applying different velocity boundary conditions at the base of the building. The vertical movement of the left foundation of the building is fixed, and horizontal rightward velocity is applied to the right foundation of the building to simulate the generation of horizontal tension cracks on the ground; Vertical downward velocity is applied to the right foundation to simulate the formation of subsidence cracks; Horizontal rightward and vertical downward velocity are applied to the right foundation to simulate the generation of combined tension cracks; Horizontal leftward and vertical upward velocity are applied to the right foundation to simulate the generation of combined uplift cracks. On this basis, the effects of different crack types on the failure process of building structures are analyzed. The monitoring points and boundary conditions of the model are shown in Figure 7.

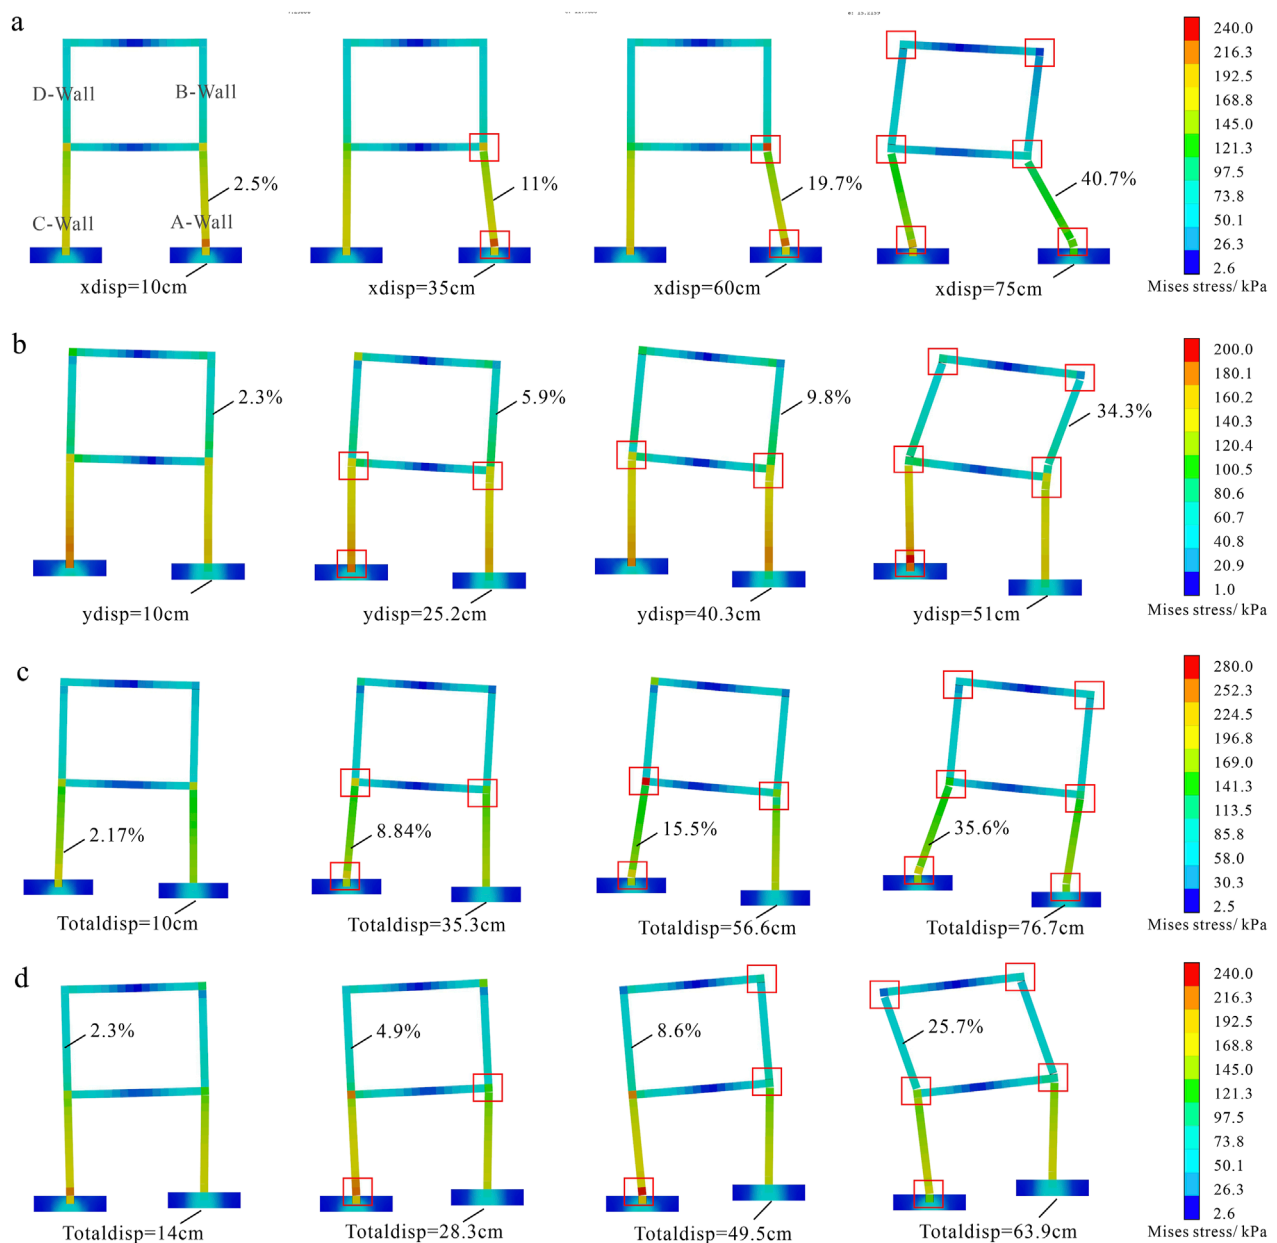
FIGURE 8
Mises stress evolution and structural failure process of building under different crack conditions (The % represent the inclination rates of building walls).
(a) Horizontal tension crack; (b) Settlement crack; (c) Combined tension crack; (d) Combined uplift crack.

According to Figure 8, with the continuous expansion of cracks, the walls of the building show obvious inclination, and the Mises

stresses of the first-floor walls are also significantly higher than that of the second floor. Plastic hinges and cracks also appeared in the contact parts of wall and floor. Under the scenarios of horizontal tension cracks and combined tension cracks, the inclination of the walls on the first-floor is higher than that of the second-floor. Under the conditions of settlement cracks and combined uplift cracks, the inclination of the walls on the second floor is higher than that of the first floor.

According to Figure 8a, with the expansion of horizontal tension crack, wall A on the first floor was inclined first, and when the width of the crack exceeded 60 cm, walls C, B, and D also inclined in turn. The junction between wall A and the foundation first failed, and then the junction between wall A and the upper floor slab also failed and fractured, and the maximum Mises stress of the failure node was about 240 kPa. According to Figure 8b, with the vertical expansion of the settlement cracks, walls B and D of the second-floor were inclined preferentially, and the plastic hinges and cracks also occurred at the contact nodes between the second-floor wall and the floor slab. When the settlement exceeded 40 cm, the first-floor wall also inclined, and the Mises stress near the contact node between the wall C and the foundation was the largest, about 200 kPa. According to Figure 8c, with the expansion of the combined tension cracks, the wall C of the first floor was inclined preferentially, and when the total displacement of the crack exceeded 56 cm, walls A, B and D also inclined in turn. The contact node between wall C and the upper floor slab first failed and fractured, then the contact node between wall A and the foundation also failed, and the maximum Mises stress of the failure node was about 280 kPa. According to Figure 8d, with the expansion of the combined uplift crack, wall C on the first floor was inclined preferentially, followed by walls B and D on the second floor, and wall A on the first floor was almost not inclined. The contact node between the wall C and the substructure preferentially failed and fractured, and the maximum Mises stress of the failure node was about 280 kPa.

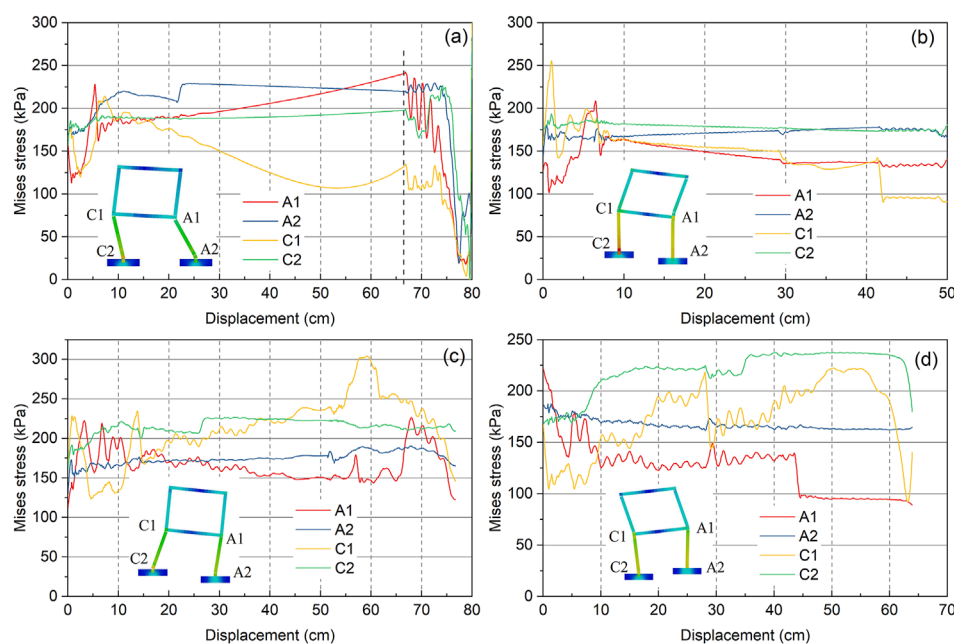
FIGURE 9

Mises stress change curves of the monitoring points under different crack conditions. (a) Horizontal tension crack; (b) Settlement crack; (c) Combined tension crack; (d) Combined uplift crack.

Figure 9a shows that the Mises stress of the A1 and C1 nodes increases instantaneously at the initial stage of tension crack expansion (displacement < 10 cm), and the stress increment is about 90–100 kPa. After that, the Mises stress of A1 slowly increases to 240 kPa, and the Mises stress of C1 slowly decreases to 125 kPa. The Mises stress of A2 increases from 175 kPa to 225 kPa within 30 cm of tension crack extension, and then remains stable. When the crack displacement exceeds 70 cm, the Mises stress of all the bottom joints decreases suddenly, which is mainly due to the fracture of the plastic hinge elements of the A and C walls, resulting in the stress release inside the elements. Figure 9b shows that the Mises stress of the A1 and C1 nodes increases instantaneously at the initial stage of settlement crack expansion (displacement < 10 cm), and the stress increment is about 70–80 kPa. After that, The Mises stress of A1 and C1 decreases to 150 kPa and tends to be stable. When the

crack displacement exceeds 40 cm, the Mises stress of C1 suddenly decreases to 100 kPa, which is mainly due to the fracture of the plastic hinge element at the C1 node with the continuous tilt of the building wall, resulting in the stress release inside the element. The stresses of A2 and C2 remain basically stable during the settlement crack expansion. Figure 9c shows that the Mises stress of A1 and C1 nodes fluctuates significantly at the initial stage of combined tension crack expansion (displacement < 15 cm), with the stress variation range of about 70–100 kPa. With the crack displacement increasing to 50 cm, the Mises stress of C1 slowly increases to 240 kPa, and that of A1 slowly decreases to 150 kPa. When the crack displacement exceeds 53 cm, the Mises stress of C1 suddenly increases to 300 kPa,

and then decreases to 150 kPa with the fracture of plastic hinge element. When the crack displacement exceeds 65 cm, the Mises stress of A1 suddenly increases to 225 kPa, and then decreases to 150 kPa with the fracture of plastic hinge element. The stresses of A2 and C2 remain basically stable during the combined tension crack expansion. Figure 9d shows that at the initial stage of combined uplift crack propagation (displacement < 20 cm), the Mises stress of C1 increases by about 110 kPa, that of C2 increases by about 50 kPa, and that of A1 decreases by about 100 kPa. With the crack displacement increasing to 43 cm, the Mises stress of A1 decreases to 100 kPa due to the fracture of plastic hinge element. As the crack displacement exceeds 65 cm, the Mises stress of C1 and C2

In summary, the stress changes of the joints of wall A and wall C can be divided into three stages under different crack expansion scenarios: stress increase stage, stress stable stage and the stress sudden drop stage. In the initial stage of crack expansion (displacement < 20 cm), with the slight inclination of the building, the Mises stress of the bottom wall nodes fluctuates greatly and shows the tendency of stress increase during the process of internal deformation and coordination of the structure. In this stage, plastic hinges are also formed at the upper and lower ends of the building walls. With the continuous expansion of the crack, the inclination of the building structure gradually increases, and the Mises stress inside the structure changes slowly and the change amplitude is small. As the crack expands to a certain threshold, the plastic hinge elements at both ends of the building wall break, resulting in a sudden decrease of Mises stress. In addition, under the four crack expansion scenarios, the stress of A1 and C1 nodes at the top of walls A and C changes greatly, while the stress of A2 and C2 nodes changes little. Therefore, the buildings exposed to slow-moving landslides need to focus on reinforcing the contact areas of walls and floors.

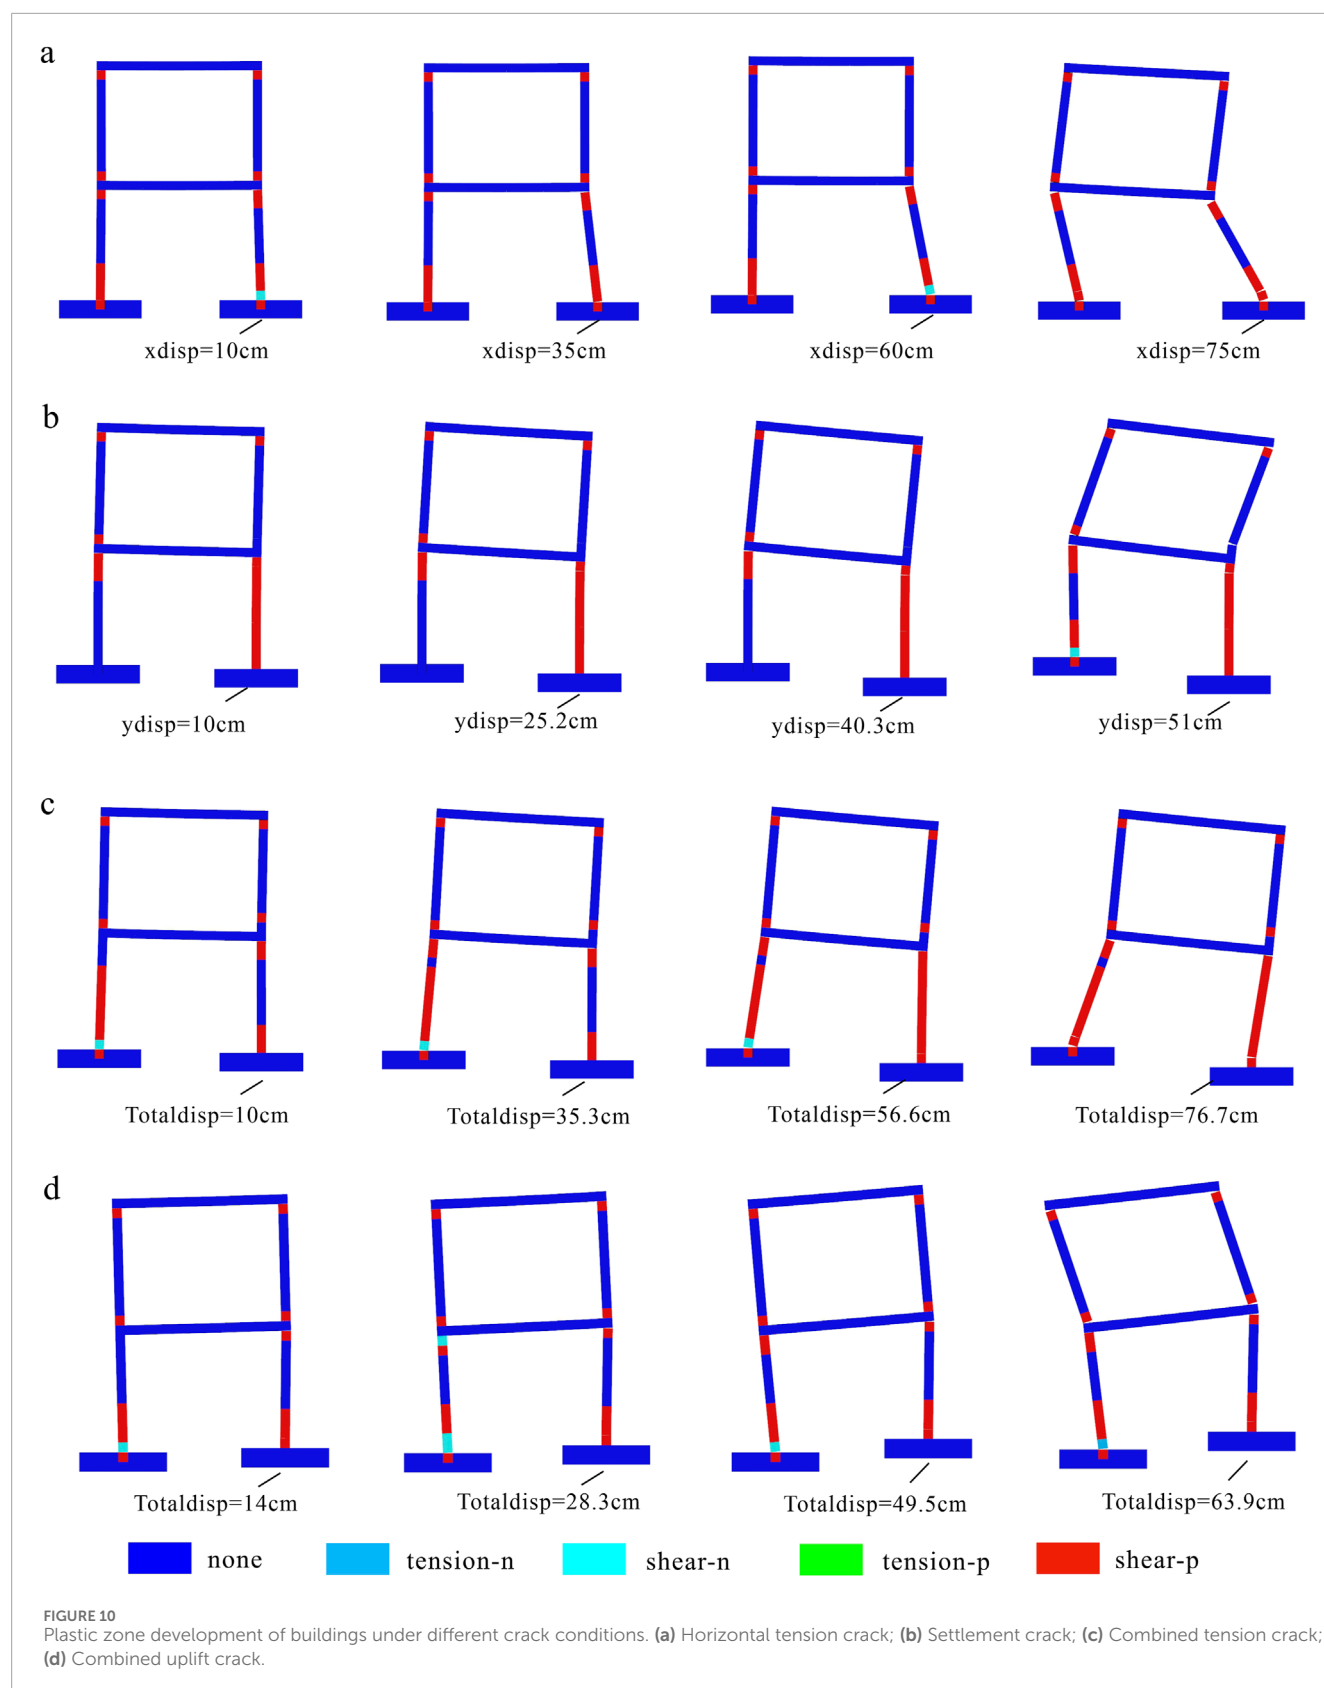
According to the Figure 10, at the initial stage of crack propagation, the plastic zone of the building mainly appears in the hinge part of the floor slab and the bearing wall, and the failure mode is mainly shear failure. With the increase of crack displacement, the inclination rate of the building increases gradually, so does the plastic zone area. The plastic zone of the second-floor wall of the building only develops in the contact part of the wall and the floor. From the perspective of plastic zone, the development area of plastic zone of the building is smaller under the scenario of horizontal tension crack and combined uplift crack, and that is the largest under the combination tension crack scenario.

Under the horizontal tension crack scenario, the greater the ground crack displacement, the greater the traction force in the first floor wall, resulting in obvious tension and inclination phenomenon of the wall; When the crack displacement is less than 70 cm, only the inclination rate of wall A increases linearly with the increase of the crack expansion (Figures 10A, 11a), and the inclination rates of walls B, C and D are almost 0; When the crack displacement exceeds 70 cm, the inclination rates of walls A~D increase rapidly, and when the crack displacement reaches 78 cm, the inclination rates of walls A~D exceed 40% (Figure 11a). Under the vertical settlement crack scenario, only walls B and D are inclined significantly with the expansion of the crack, while walls A and C are inclined slightly, with the inclination rates of less than 2% (Figures 10b, 11b); When the crack displacement is less than 43 cm, the inclination rates of walls B and D increase linearly with the increase of crack displacement; When the crack displacement exceeds 43 cm, the inclination rates of walls B and D increase exponentially (Figure 11b). Under the combined tension crack scenario, when the crack displacement is less than 70 cm, the inclination rates of walls A~D increase linearly with the increase of crack displacement (Figures 10c, 11c), and those A~D increase in

(Figures 10d, 11d), and the growth rates are almost the same; When the crack displacement is greater than 55 cm, the inclination rates of walls B and D increase exponentially (Figure 11c), and wall C still maintains a linear growth trend. During the expansion of the combined expansion crack, the inclination rate of wall A hardly changed. In addition, the roof load and the RC floor slab significantly influence the stress and deformation of masonry walls. The roof load increases the axial compression on the walls, enhancing their shear strength but potentially exacerbating uneven settlement under ground crack propagation. The high stiffness of the RC slab restricts the relative displacement of the walls, affecting their inclination and cracking patterns. The inclusion of these factors enhances the consistency between the simulation results and field observations.

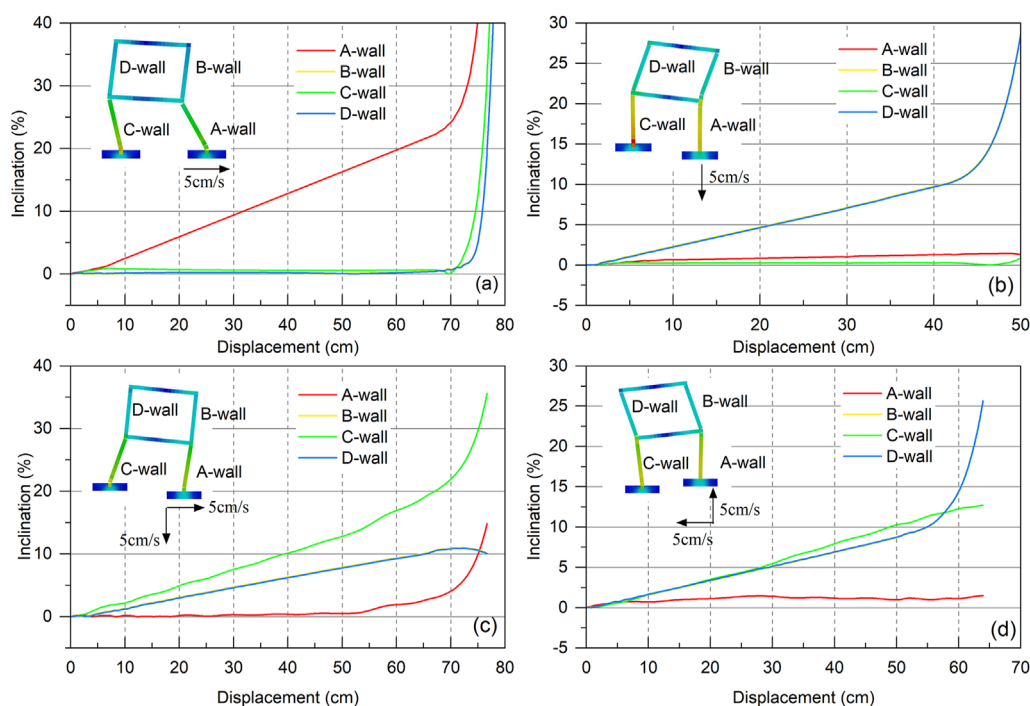
FIGURE 11

The variation curve of the building inclination with the displacement of the ground crack. (a) Horizontal tension crack; (b) Settlement crack; (c) Combined tension crack; (d) Combined uplift crack.

order from large to small are: C wall > D wall = B wall > A wall; When the crack displacement exceeds 70 cm, the inclination rates of walls A and C show an exponential growth trend with the increase of crack

displacement (Figure 11c). Under the combined uplift crack scenario, when the crack displacement is less than 55 cm, the inclination rates of walls B-D increase linearly with the increase of crack

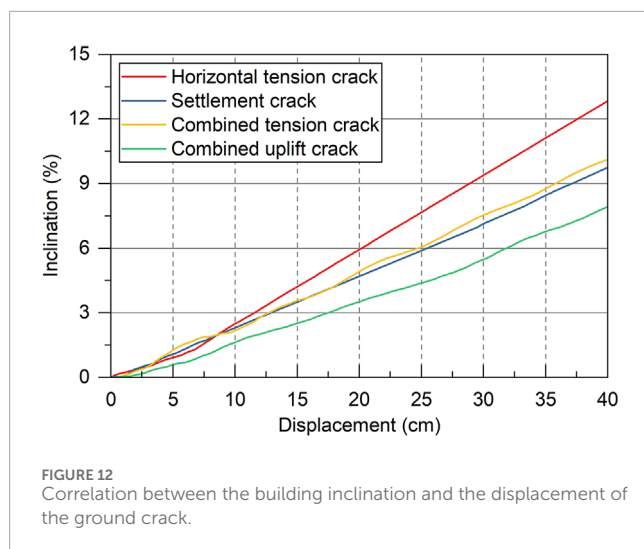
Figure 12 shows the change curve of the inclination rate of the most dangerous wall with the fracture displacement under four crack scenarios. For crack displacements below 40 cm, the linear correlation between inclination and displacement indicates a consistent structural response. Under the same crack displacement conditions, the inclination rate of the building wall caused by the horizontal tension crack is the highest, that caused by the combined uplift crack is the smallest, and that caused by the settlement crack and the combined tensile crack is in the middle, which are basically consistent with the results of Chen (2022). Horizontal tension cracks induce the highest inclination due to direct tensile loading parallel to the slide direction. In contrast, combined uplift cracks mitigate tilt via vertical displacement counteracting horizontal strain, delaying failure.

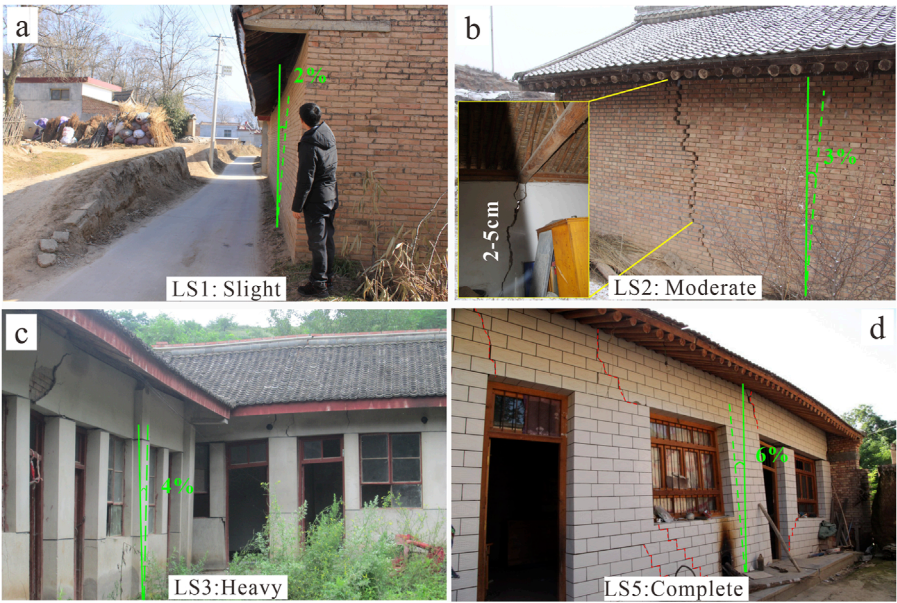
FIGURE 13 Damage grade of masonry buildings. (a) Slight damage; (b) Moderate damage; (c) Heavy damage; (d) Complete damage.

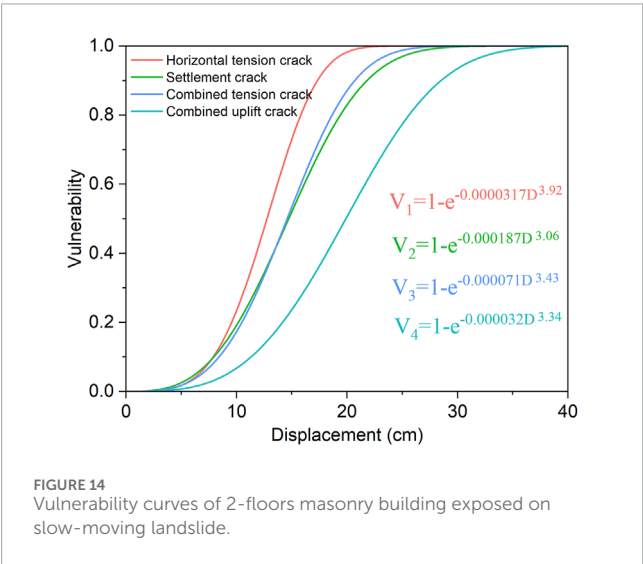
Based on the quantitative criteria of damage degree of masonry structure and correlation between the building inclination and the crack displacement, the vulnerability curves (Figure 14) of masonry building under landslide ground cracks are obtained by Weibull function (Equation 2). The results show that there is a high correlation between the ground crack displacement and the physical vulnerability, and the R^2 exceeds 0.95. It should be noted that Figure 14 is only the vulnerability curve of a specific structural building (2-story masonry structure, mortar strength = M7.5). Similarly, the method proposed in this study can be used to establish vulnerability assessment models for buildings with different structures and stories. This method has a great prospect of popularization and application.

According to Figure 14, the vulnerability curves of the building exposed to slow-moving landslide are S-shaped. Table 5 shows the limit displacement assumed for each damage state (DS) under four crack scenarios. The ground crack displacement thresholds for building vulnerability reaching 1 under four crack scenarios are 22 cm, 26 cm, 27 cm and 37 cm, respectively. When the displacement of ground crack is less than 10 cm, the vulnerability of the building under the four crack scenarios is less than 0.2, which belongs to the slight damage level. When the displacement of ground crack reaches 20 cm, the vulnerability of the building under the horizontal tension crack scenario is 1, which reaches the level of complete damage; Under the scenario of settlement crack and combined tensile crack, the vulnerability values of the building are 0.8, which reaches the level of extreme damage. Under the scenario of combined uplift crack, the vulnerability of the building is 0.5, which belongs to the level of moderate damage. When the displacement of ground crack reaches 30 cm, the buildings are completely destroyed under the scenarios of horizontal tension crack, settlement crack and combined tension cracks; While under the scenario of combined uplift crack, the vulnerability of the building is 0.9, which belongs to the level of extreme damage. When the displacement of ground crack exceeds 37 cm, the building is completely destroyed under the combined uplift crack scenario, and the vulnerability value reaches 1.
