Jia J, Dong Y, Guo X, Liu G and Gu Q (2025)  
Failure behaviors of terraced loess slope  
induced by intermittent heavy rainfall:  
centrifuge model test and numerical  
simulation.  
*Front. Earth Sci.* 13:1696569.  
doi: 10.3389/feart.2025.1696569

# Failure behaviors of terraced loess slope induced by intermittent heavy rainfall: centrifuge model test and numerical simulation

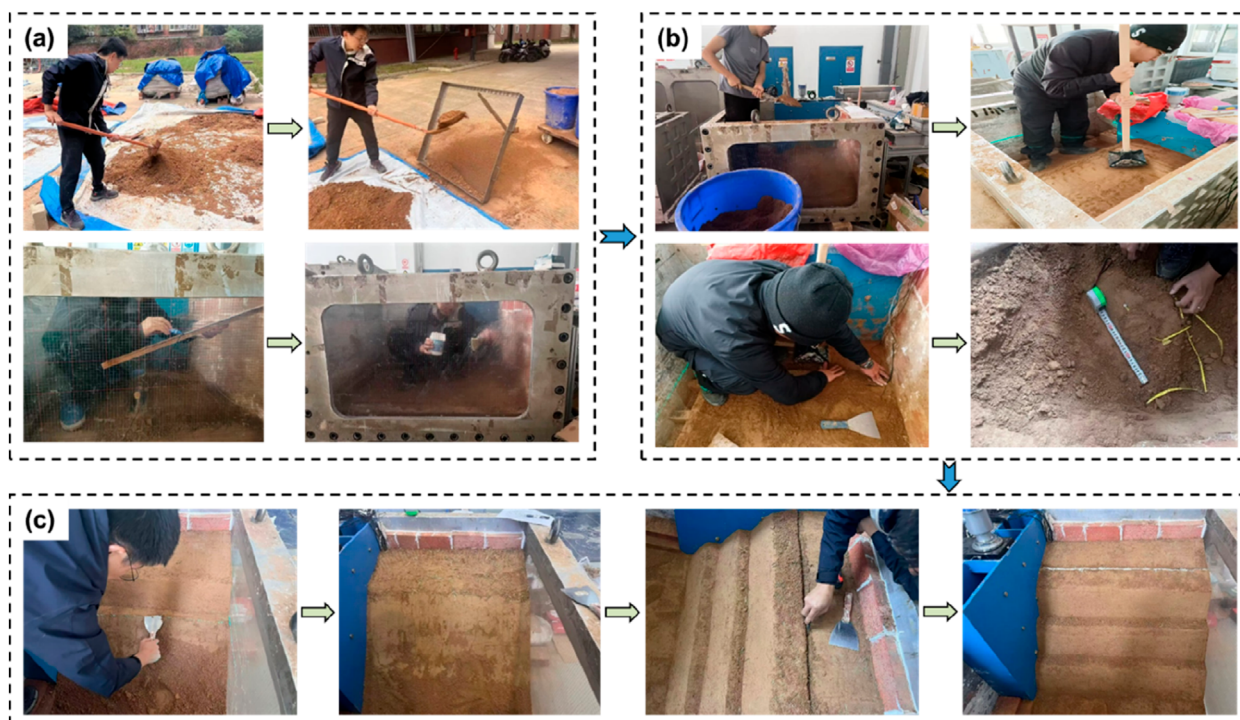
**FIGURE 6**  
Construction process of the terraced loess slope model: (a) Preparation of soil and model box, (b) Filling soil and sensor arrangement, and (c) Slope excavation and crack construction.

2. Filling soil. Weigh a certain mass of loess, and then spread it in the model box, scrape the surface of the soil with a scraper, and then use a tamper to tamp the filling soil. Measure each layer of filled soil after tamping to ensure that a uniform degree of compactness is achieved. To ensure that the laboratory loess accurately represents *in-situ* conditions, both the moisture content and compactness of the soil were strictly controlled throughout the experiment.

4. Slope excavation and leveling. Repeat the above (2) and (3) steps until the total height of the slope reaches 587 mm, at which time the filling process of the slope model is completed. After the filling is completed, the slope is excavated with scrapers at a graded level (three-stage slope), and then the surface of the excavated slope is repaired and leveled. After that, the surface was covered with plastic film and maintained for 24 h.
5. Crack construction. After steps (1), (2), (3) and (4) are completed, a crack parallel to the direction of the slope is excavated with a tool knife on the leveled slope surface, and then medium-coarse sand is filled into the crack to facilitate the infiltration of rainwater and to prevent the soil around the crack from collapsing. After that, the surface was covered with plastic film and maintained for 24 h.

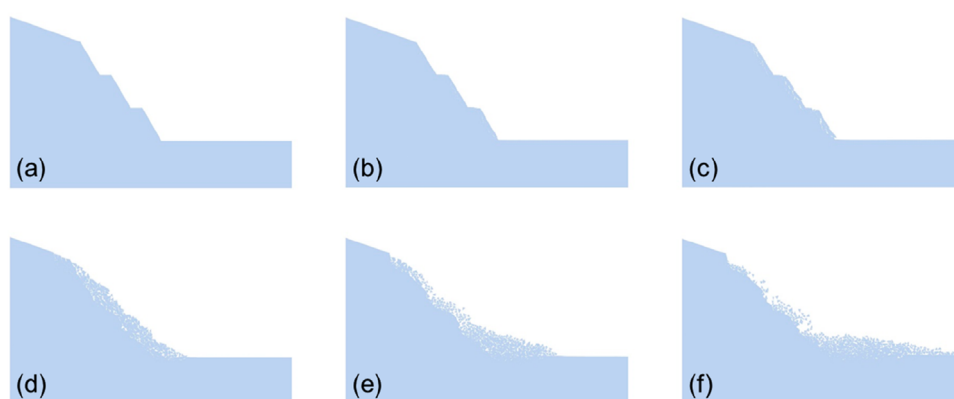
FIGURE 15 Deformation and failure processes of the terraced loess slope during rainfall. (a) step 0; (b) step 40000; (c) step 75000; (d) 130000; (e) 215000 and (f) 405000.

Figure 15 shows the deformation and failure process of the terraced loess slope obtained from the FDEM numerical simulation. The deformation and failure process of the terraced loess slope under rainfall can be mainly divided into three stages: shallow soil spalling, local collapse, and overall collapse. In the early stages of rainfall, the shallow soils experience peeling, and the surface soil becomes loose (see Figures 15b,c). As the rainfall continues, the potential sliding surfaces in sublevels of slope gradually connect, and the soil begins to collapse and accumulate towards the toe of the slope (Figure 15d). Then tension cracks appeared at the

top of the slope, and the collapse range increased. The thickness of soil accumulation near the toe of the slope increased and slid further away (see Figure 15e). Finally, the loose soil on the slope slid down to the toe of the slope, causing the overall collapse of the slope, but the collapse boundary at the top of the slope was controlled by the prefabricated crack on the top of the slope (Figure 15f).
