Xiong Y, Du J and Qiu G (2022),
Conserving the unique aquatic
ecosystem of the Jiuzhai National
Heritage Site after the 2017 earthquake:
Achievements and challenges.
Front. Environ. Sci. 10:990185.
doi: 10.3389/fenvs.2022.990185

Conserving the unique aquatic ecosystem of the Jiuzhai National Heritage Site after the 2017 earthquake: Achievements and challenges

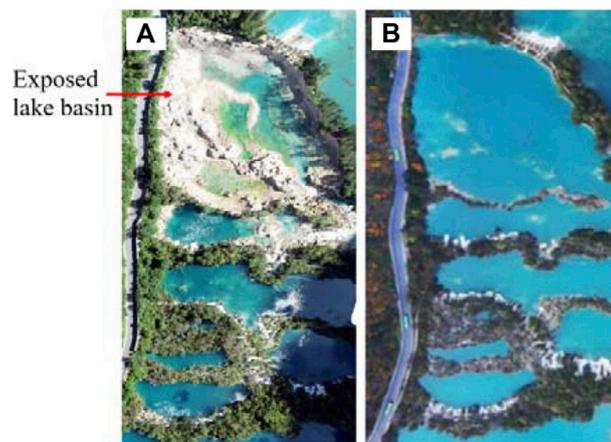
FIGURE 2

Sparkling Lake in the Jiuzhai World Natural Heritage Site after the 2017 earthquake (A) and restoration (B). Note: photos were taken by unmanned aerial vehicles in 2020 and 2021.

caused underground funnels or cracks. A typical case was the collapse of the natural travertine dam break at Sparkling Lake (Huohua Hai in Chinese) (Figure 2), a major tourist attraction in the Jiuzhai NNR. In particular, the earthquake caused a 14 m depth breach, and the lake nearly dried up with obvious lake basin exposure due to the water level dropping by approximately 13 m (Wang et al., 2021). An additional example is the Norilang Waterfall, the widest travertine topped waterfall in the world. The earthquake damaged the dam and connectivity of the waterfall and upstream river, leading to waterfall disappearance (Figure 3) (Zhang et al., 2021). Due to the earthquake, several rivers and lakes were blocked, especially in the region from Arrow Bamboo Lake (Jianzhu Hai) to Mirror Lake (Jing Hai) in the Rize Gully, covering several famous attractions.

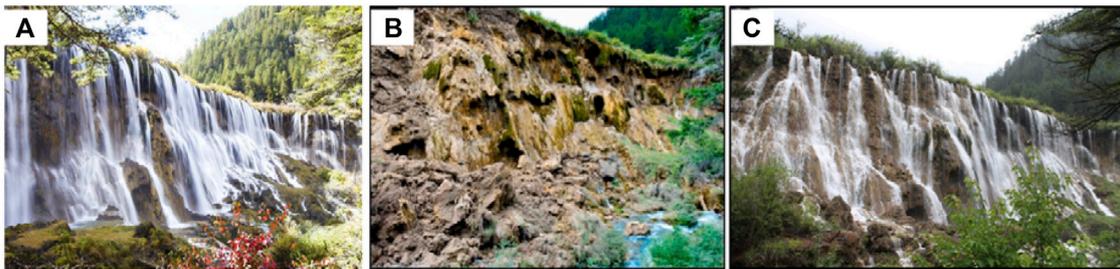
FIGURE 3

Nuorilang Waterfall in the Jiuzhai World Natural Heritage Site before (A) and after the 2017 earthquake (B) and after restoration (C). Note: the image in panel b taken from Zhang et al. (2021) shows that the waterfall dried up due to direct destruction of the connectivity between the upstream and downstream river systems; the photograph in panel c was taken in June 2020 by the authors.
