Cosic F, Ernstbrunner L, Hoy GA, Ooi KS and Ek ET (2022) Case Report: Midshaft clavicle fracture with concomitant high grade (Type V) acromioclavicular joint dislocation. Front. Surg. 9:885378.

Case Report: Midshaft clavicle fracture with concomitant high grade (Type V) acromioclavicular joint dislocation

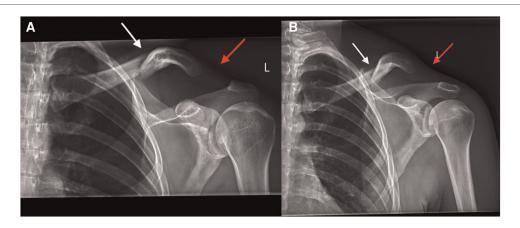
FIGURE 2
Radiographs demonstrating midshaft clavicle fracture with associated acromioclavicular joint dislocation (white arrow demonstrating the fracture site, red arrow demonstrating the dislocation site).

cyclist, both travelling at approximately 30 km/h and was thrown from his bicycle. Examination revealed deformity of the shoulder girdle and abrasion over the posterior aspect of the shoulder. The upper limb was neurovascularly intact. The patient had a past medical history of ankylosing spondylitis and IgA nephropathy. Radiographic examination of the right clavicle demonstrated a displaced midshaft clavicle fracture with a Rockwood Type V acromioclavicular joint dislocation (Figure 2) (9). The injury was confirmed on computed

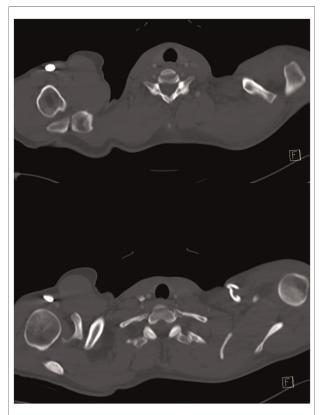
FIGURE 3

Axial computed tomography demonstrating concomitant midshaft clavicle fracture and Rockwood Type V acromioclavicular joint dislocation

tomography (CT) scan undertaken as part of the routine trauma protocol (Figure 3). Operative management of the injury was recommended and this was undertaken as outpatient treatment five days following the initial injury.

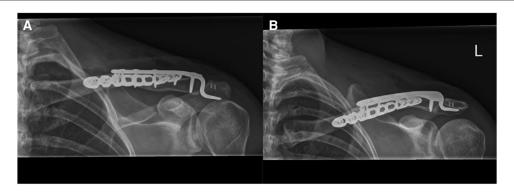
FIGURE 4
Radiographs demonstrating fixation of the fracture and dislocation with a hook plate and anterior clavicle plate.

complete disruption of the acromioclavicular joint capsule and ligaments, and coracoclavicular ligaments. The fracture fragments were identified and reduced with bone reduction forceps. The reduction was held with a lag screw applied using standard AO techniques. The acromioclavicular joint was then reduced and a precontoured 3.5 mm hook plate

(Synthes, West Chester, PA, USA) applied to hold the AC joint reduction. This reduction and fixation was then augmented with a precontoured mid shaft clavicle locking compression plate (Synthes, West Chester, PA, USA) applied to the anterior surface of the clavicle bridging the fracture site. This provided a strong orthogonal construct stabilizing both the clavicle and the AC joint complex. Suture anchor repair of the acromioclavicular ligaments was then undertaken to augment the repair of the AC joint complex (Figure 4).
