Davis J, Whitfield P, Giannelli R,
Golden R, Greene M, Poussard L and
Whitbeck M (2024) Beneficial use of
sediments to restore a Chesapeake Bay marsh
island.

Beneficial use of sediments to restore a Chesapeake Bay marsh island

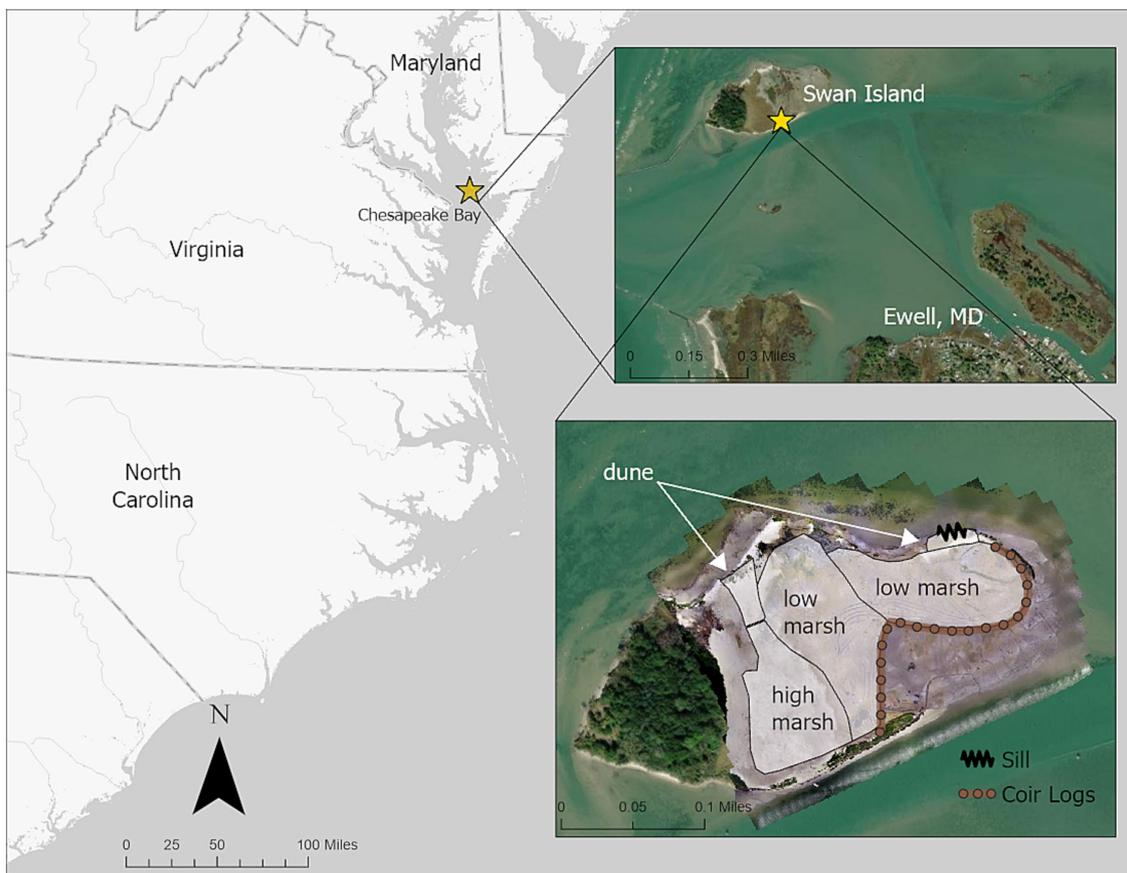
FIGURE 1

Project location. Swan Island location within Chesapeake Bay (top), Swan Island position relative to the town of Ewell, MD (middle), placement of coir log containment barrier, sill, and planned distribution of habitats. Map images are the intellectual property of Esri and are used under license.

constructed along the north and western edge of the subtidal bight on the southeast portion of the island (Figure 1). The goal of this structure was to restrict the placed sediments from spreading into the bight which was vegetated with *Ruppia maritima*, the dominant SAV species in the region.

southeastern corner of the island that was separated from the intended placement area by coir logs (Figure 1, bottom). Briefly, two transects were established, one in each “lobe” of the bight by stretching a transect tape across the full length of the SAV bed. Ten fixed monitoring plots (0.25 m² quadrats) were distributed at equal distances (full length of transect/10) across each transect. Total percent cover of SAV within each plot was estimated visually and the length of 5 randomly selected shoots were recorded. Relative water depth was also recorded for each plot. Orthometric elevation was determined by RTK-GPS at 5 m intervals along the full length of each transect.

The coir log structure, installed to form a protective barrier to sediment movement between the placement area and the SAV bed to the south (Figure 1, bottom), was not effective in limiting the spread of sediment into the bight. The material that leaked across this structure ultimately buried over 2 acres of SAV habitat by an average depth of 30 cm. The initial hypothesis was that this material would be rapidly removed by tidal action due to the lack of vegetative canopy present to stabilize it. Between 2019 and 2022, the average sediment surface elevation within the previous SAV bed decreased by 8 cm. The elevation profile within that region is undoubtedly influenced by inputs of new sediments which are eroding from the northern shoreline and migrating southward across the island surface. In the last two years, a large portion of this area has been colonized by *Liliopsis chinensis*, a common inhabitant of brackish intertidal mudflats. Development of this patch seems to signify that conditions are stabilizing within the bight region, but at higher elevations not suitable for SAV.

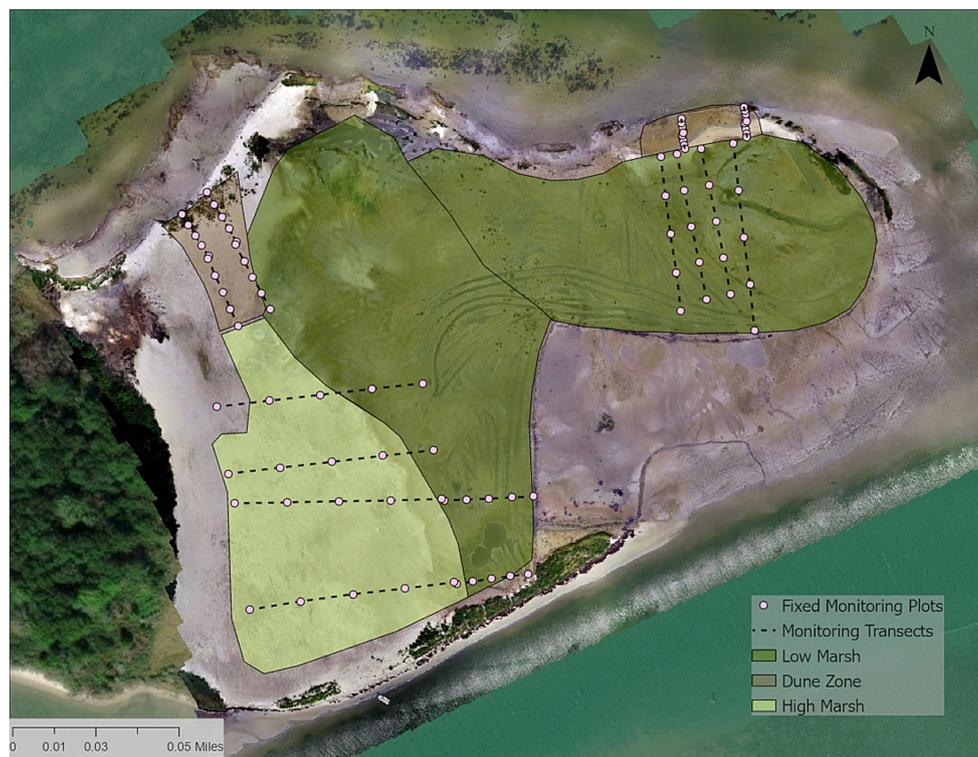
FIGURE 2

Plot-based sampling scheme. Fixed monitoring plots were evenly distributed along transects in each of the created habitat types. Map image is the intellectual property of Esri and is used under license.

The post-placement survey strategy was designed to track changes in each of the created habitats (Dune, High Marsh, Low Marsh) over time. A series of permanent vegetation monitoring transects were established using a stratified random sampling approach to capture the full range of elevations and vegetative species present within each created habitat type. All transects extended the full length of the created habitat or 100 m, whichever was greater. Five long-term monitoring plots were established at equal distances along each transect. In all, 90 fixed monitoring plots were established (Figure 2).

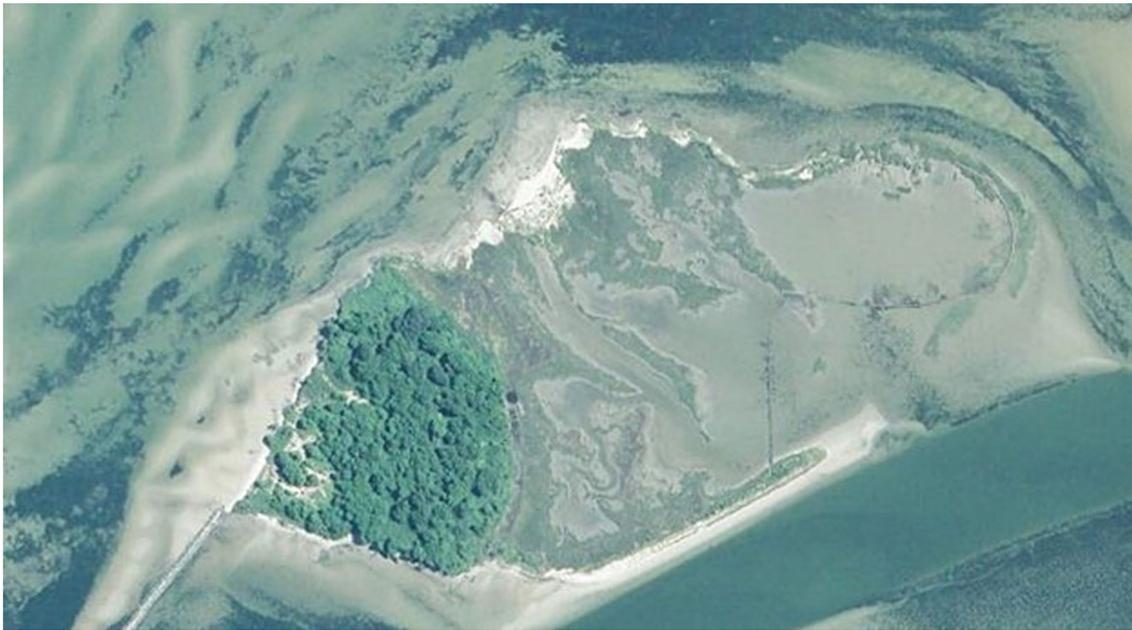
FIGURE 4
Pre-placement aerial imagery of Swan Island (2018) indicates a highly fragmented marsh with large areas of sparsely vegetated subtidal habitat within the “bight.” Image courtesy of Virginia Institute of Marine Science.

Prior to sediment placement, the interior region of the island was a mosaic of *S. alterniflora* marsh and subtidal habitat (Figure 4). A 2015 survey of the island commissioned by the USACE Baltimore District indicated that elevation of the intertidal regions within the project footprint varied from -0.2 to 0.4 m NAVD88, while elevations of the subtidal regions ranged from -0.43 to -0.31 m NAVD88. Sediment application resulted in elevation gains that ranged from ~ 0.15 m to >0.5 m and resulted in the entire project area being raised to a minimum of 0.2 m NAVD88. Analysis of the SfM-generated Digital Elevation Model (DEM) from 2019 indicated that areas that were intended to serve as high marsh were raised to an average elevation of 0.59 m while those areas intended to serve as dune habitat were raised to average elevations of 0.63 m (Dune East) and 0.89 m (Dune West).

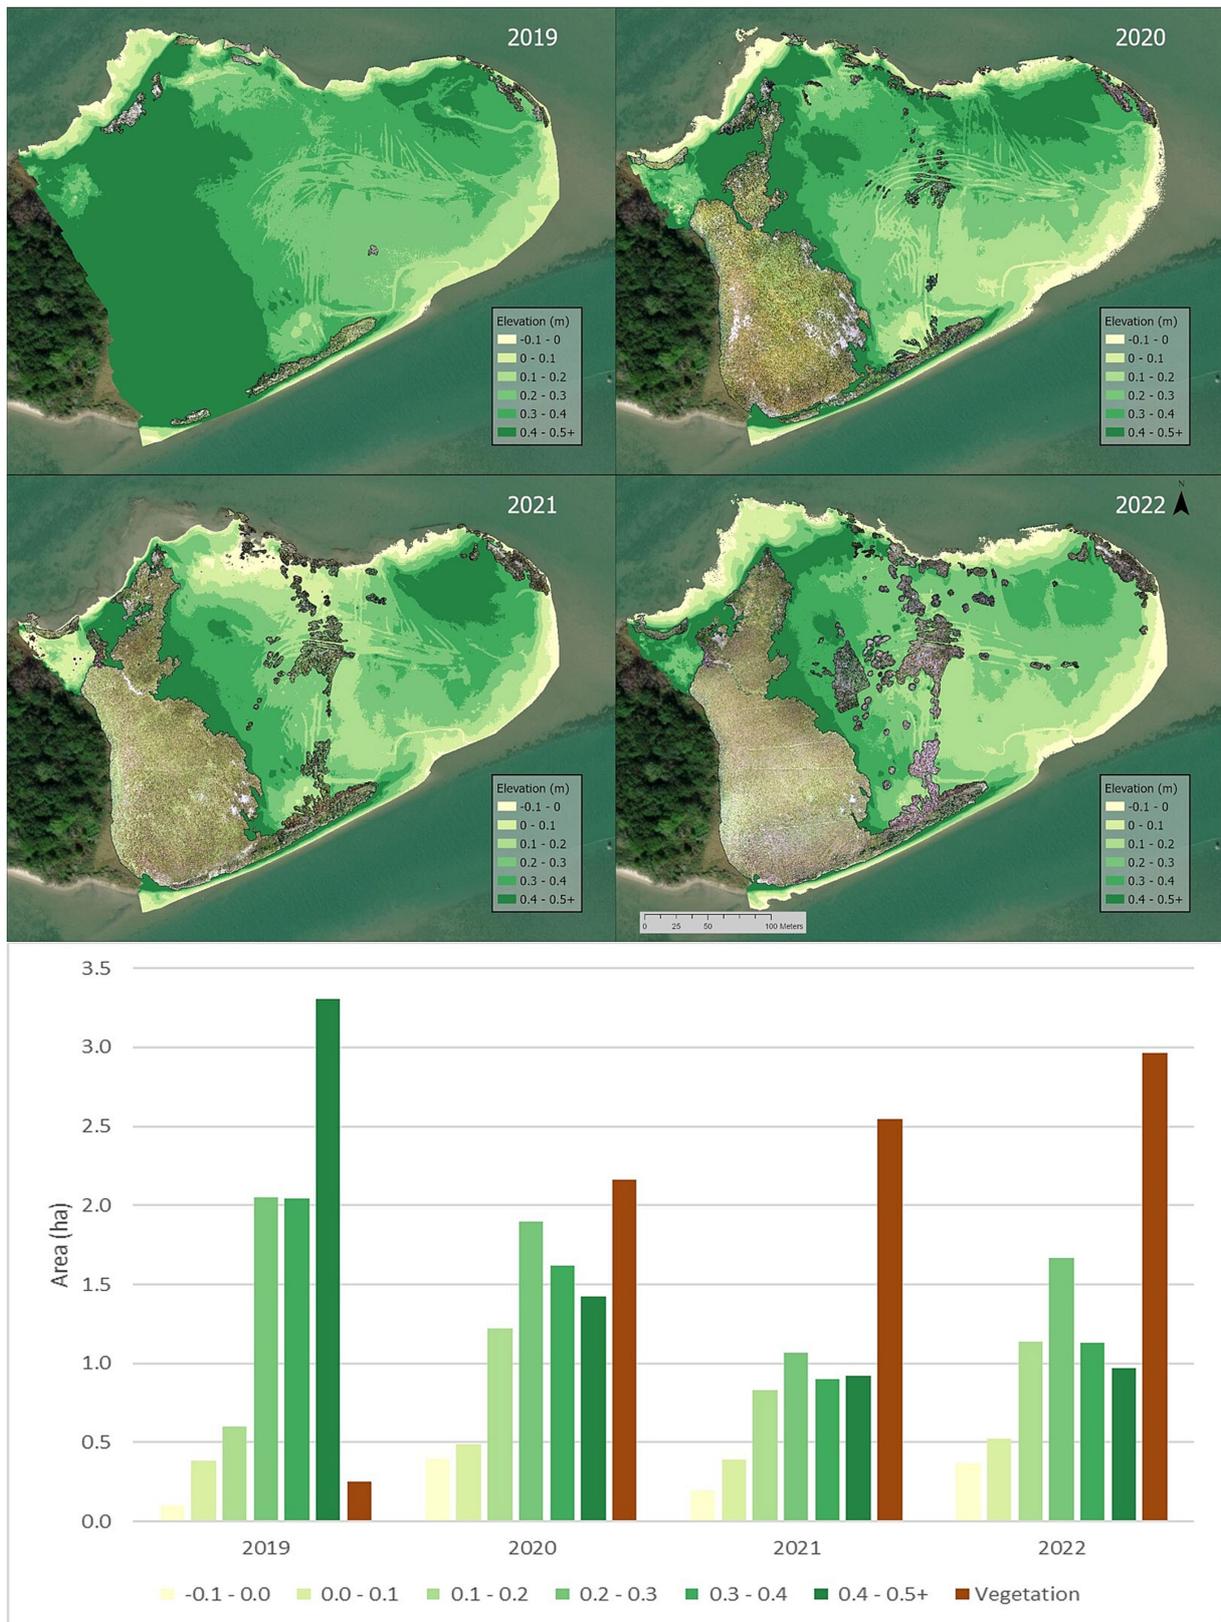
FIGURE 5 Topography and extent of vegetation by year determined from analysis of UAS-generated orthomosaic images and associated 3D surface models. Graph shows total extent of project area within each elevation bin by year. The elevation bins correspond to the ranges illustrated in the 4 image panels above. All elevation values are in units of m NAVD88.

Year-to-year comparison of SfM-generated DEMs highlights topographic changes in the island surface and the ingrowth of vegetation over time (Figure 5). Visual analysis of changes in the topography across the unvegetated platform highlights some consistent trends among years. First, the northern shoreline of Swan Island is eroding. This trend is particularly noticeable along the eastern stretch that falls behind the sill. Second, the material

occurred in these areas, and large portions remained unvegetated as of 2022 (Figure 5, 2022).

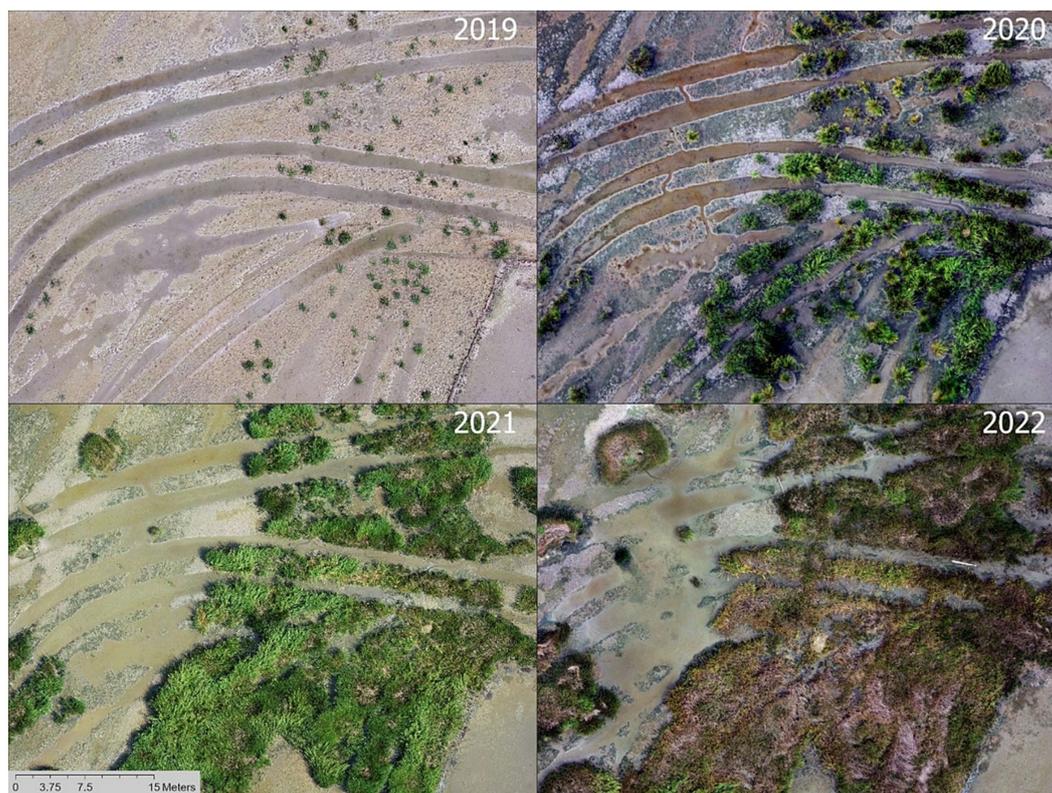
FIGURE 6 Analysis of UAS image orthomosaics illustrates expansion over time of low marsh vegetation that survived the initial deposition.

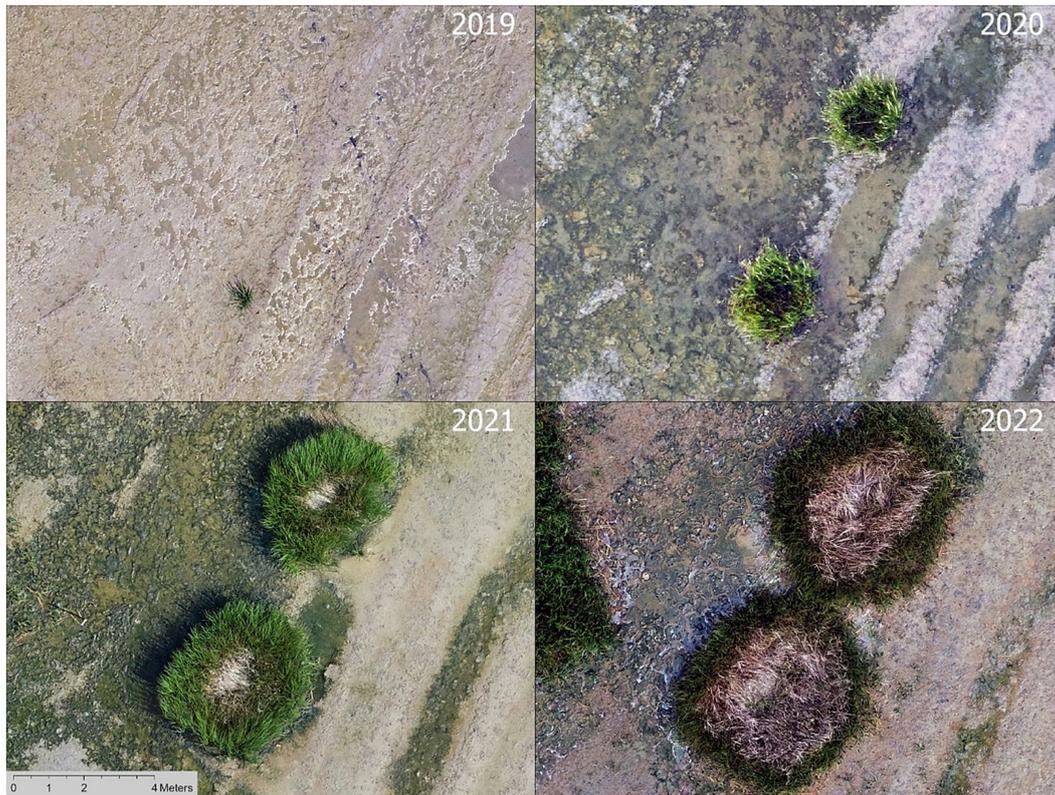
FIGURE 7 UAS image-generated orthomosaics illustrate growth of circular marsh tussocks from a few individual plants.

By 2020, a large number of circular patches of marsh had begun to form in the central part of the island. Many of these patches appear to have grown from the vegetative spread of one or a few *S. alterniflora* plants (Figure 7). Over time, as these patches of marsh have expanded laterally, their interior elevations have increased by 20 cm or more, and in many, the centers are either unvegetated, or vegetated by species other than *S. alterniflora*. In 2022, we observed *A. breviligulata* and *Cakile edentula* (American searocket) growing in the center of several of the larger patches, indicating that some of these features have trapped enough sediment to outgrow intertidal marsh elevation.

Figure 7) represents the outward expansion of the mound. While the cause of the dieback at Swan Island is not known, it does appear to be following the pattern detected at Poplar Island, thus we anticipate recovery in 2023, potentially followed by rolling age-based diebacks as vegetative cover continues to expand.

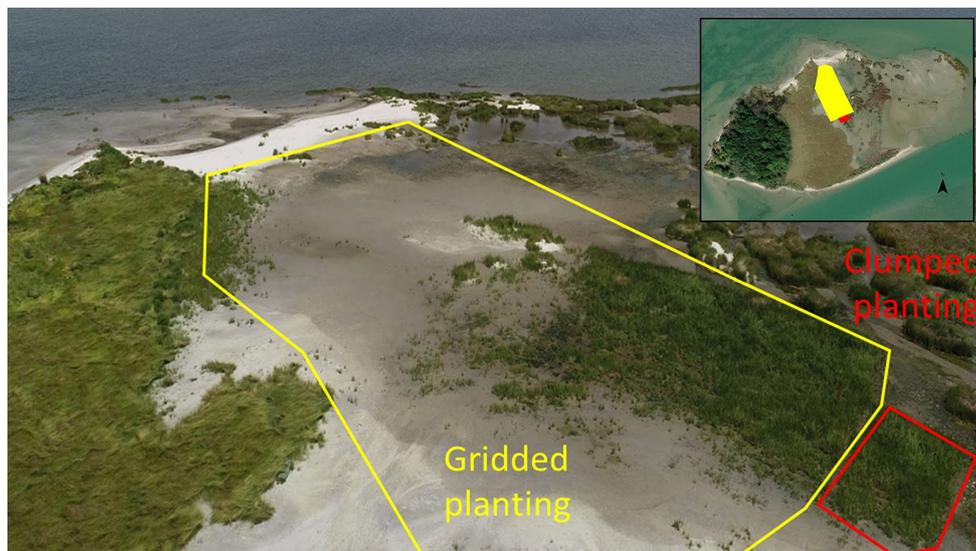
FIGURE 8 Additional areas of *S. alterniflora* planted in 2021 as part of the adaptive management action. Image taken in 2022.
