# Testing, Analysis and Classification of No-Dig Manhole Rehabilitation Materials

Vinayak Kaushal\*, Mohammad Najafi and Alimohammad Entezarmahdi

Center for Underground Infrastructure Research and Education (CUIRE), Department of Civil Engineering, The University of Texas at Arlington, Arlington, TX, United States

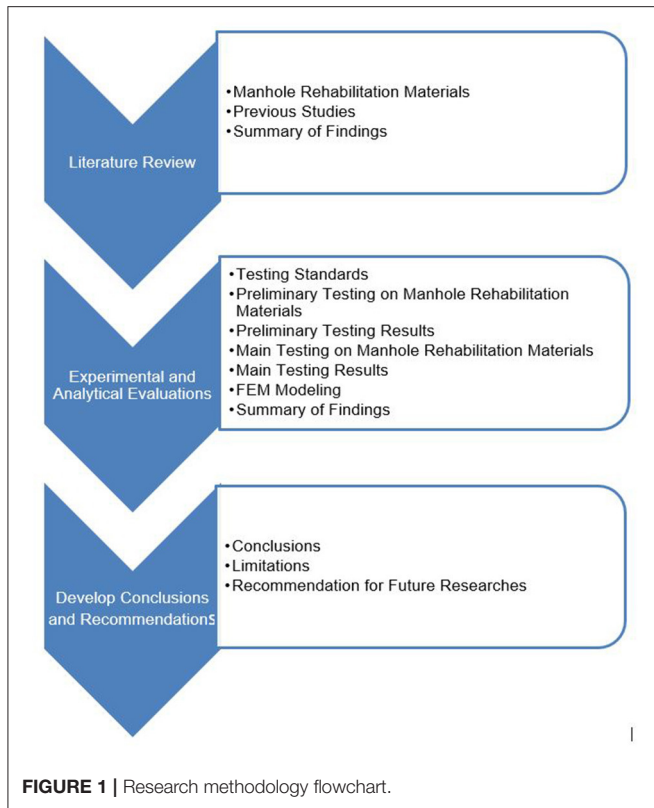
**Figure 1** outlines the process flow for the research tasks.

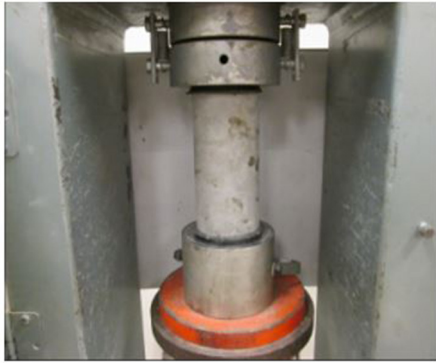
**FIGURE 6** | Unlined (control) cylinder prior to compression testing.

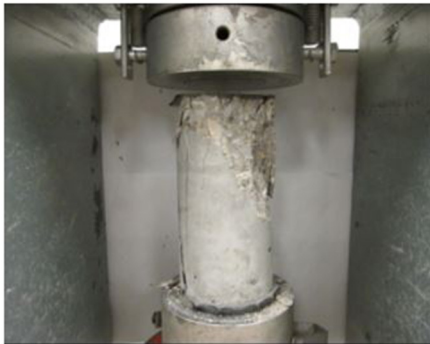
**FIGURE 7** | Unlined (control) cylinder after compression testing.

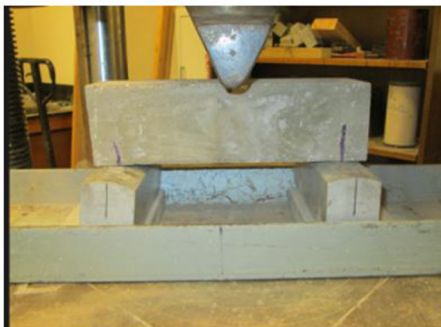
**FIGURE 8** | Unlined (control) beam prior to flexural testing.

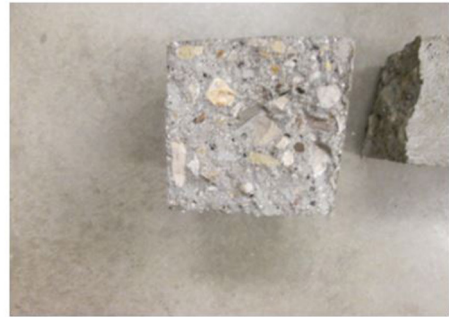
**FIGURE 9** | Unlined (control) beam after to flexural testing.

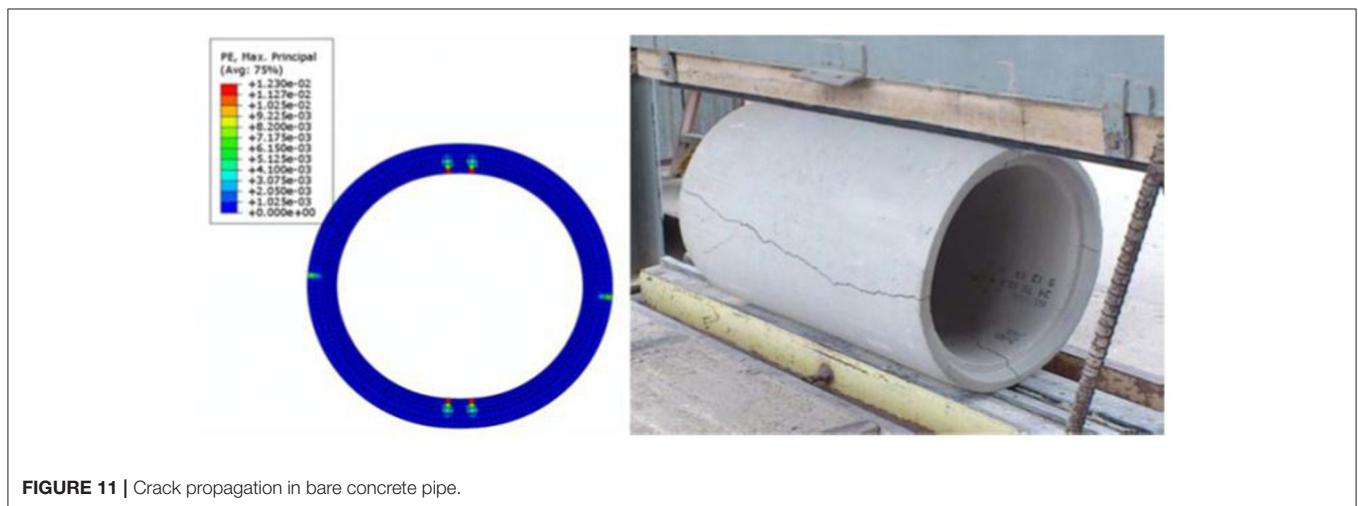
FIGURE 11 | Crack propagation in bare concrete pipe.

As it is illustrated in Figure 11, the bright areas in the plastic strain contour which represent the predicted cracks match with the cracks occurred in the Three-edge-bearing tests. Pressure-deformation curves obtained from the simulations in this case are shown in Figure 12 which indicates a peak pressure of 17.8 psi at 0.021 in. deformation for bare concrete pipe.

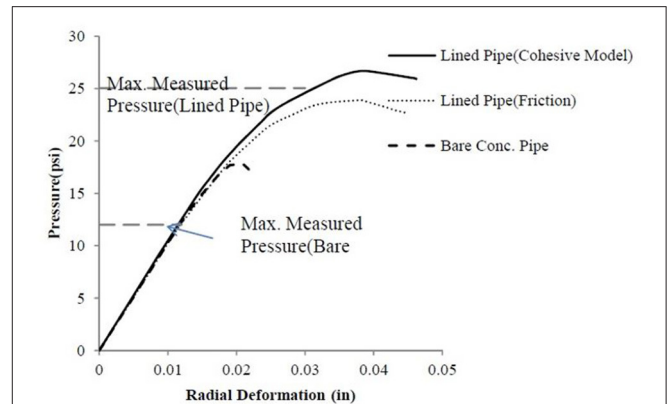
FIGURE 12 | Pressure deformation curve of bare and lined concrete pipes.

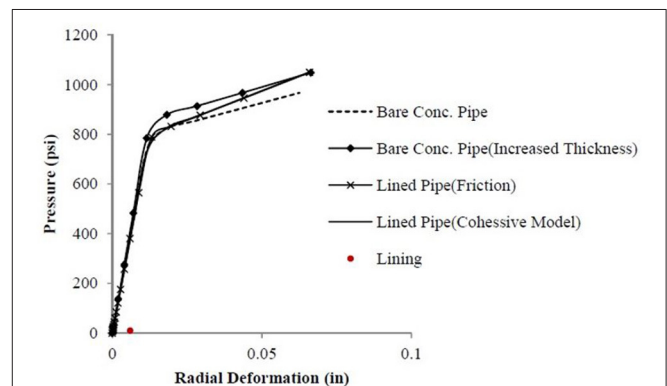
FIGURE 13 | Pressure deformation curve for bare and lined concrete pipes under uniform pressure.
