Socio-hydrology and sustainable tank management: empirical case from a Mailam tank cascade, Tamil Nadu, India

Raj Rengalakshmi^{1*}, Perumal Thamizoli², Rajendiren Nagarajan¹
and Pasuvanna Nandeesa¹

Introduction: The tank cascade system is an interconnected tank/pond managed with local norms and social capital governed by informal institutions. These linkages closely connect people, water, and the environment in the interface of resource management for livelihoods and ecosystem services. However, in the recent past, these cascading structures have been disrupted at the hydrological and social levels, leading to complex issues with increasing climate risks and farmers' vulnerabilities.

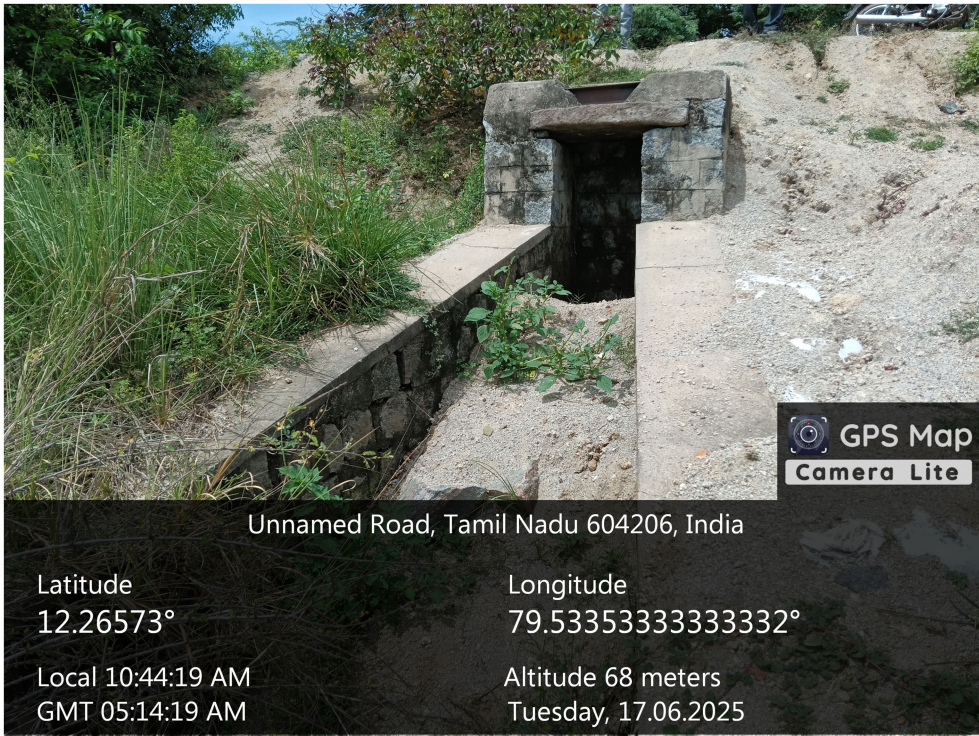
FIGURE 3
Closed sluices using soil.

This section details the status and condition of the tank infrastructures in the cascade. It also covers the condition of the hydrological components such as catchment area, foreshore, supply channel, water spread area, tank bunds, sluices, and surplus weirs. From the FGDs and transect walk, it is evident that the maintenance and management of the tanks and associated systems are in a poor state and degraded (Table 5). The bunds of all the WRD tanks are in very bad condition, with a narrow top surface and several gullies that are weakening them. Big trees with large roots on the inner surface of the tanks are altering the bund structures. In two tanks, the bunds are fully covered with trees and shrubs and completely block the way. Only in four panchayat union tanks are the bunds well maintained using local funds. Of the 14 tanks, only two have the sluices in working condition, and the rest of the tanks are almost dysfunctional; shutters are damaged/stolen, and the sluice is closed using sandbags and clay to stop the water flow (Figure 3). However, leakages were observed, leading to water loss.

The dysfunctional shutters and sluices are the next important infrastructures that impacted the regulation of the irrigation system in the *ayacut*. It led to unreliability in obtaining water for irrigation. Two of the WRD tanks were renovated during the last 5 years, but there is still continuous leakage in the sluices, resulting in water being drained continuously and impacting storage. A similar issue was reported by Steiff (2016), who studied water storage and release dynamics of the Thirumalsamudram cascade, Guntur basin in Tamil Nadu, and reported that sluice outflow was the highest part of the water budget, ranging from 19 to 55%, with 15 to 50% of the outflow not being utilised (Van Meter et al., 2016). The farmers with access to wells manage to irrigate their fields; however, marginalised farmers

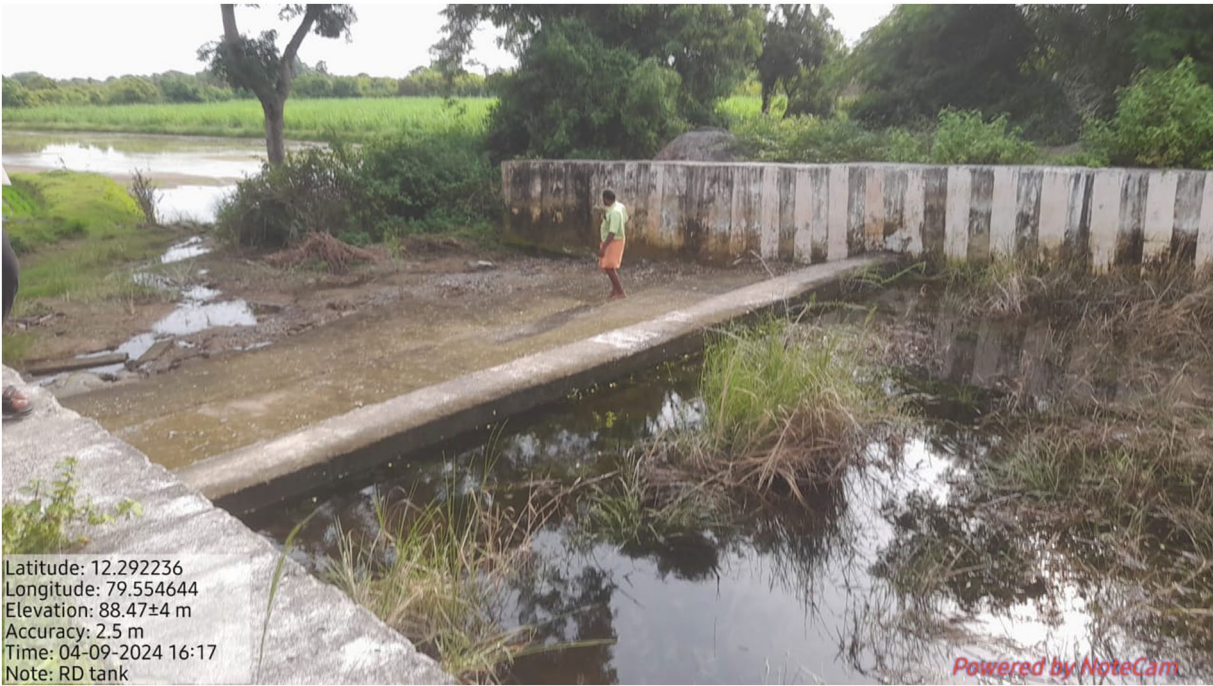
FIGURE 4
Leaking surplus weir.

The surplus weir is the facility provided to allow the flow of water beyond the storage capacity of the tank, causing damage to the weir

and the flow of water instead of storing the expected quantity of water (Figure 4). In almost all the tanks, the surplus weirs are not given attention, and structures are damaged due to the roots of the vegetation, with five tanks being completely covered by the *Prosopis* species. The transect walk and interaction with WUA leaders pointed out that invariably in all the tanks, 10 to 25% of the storage area has been reduced, mainly due to siltation as well as due to the growth of weeds and other vegetation in the tank water spread area. The field data revealed that desiltation has not been carried out for more than a decade in all the tanks, which has significantly reduced storage capacity by up to 25%. The condition of supply channels is also poor due to a lack of maintenance, leading to siltation, weed growth, and disruption due to roads and encroachments. As per ownership, the bund area is under WRD or RD control, and the water spread area is under the control of the District Revenue Department. The key informant interview with the local panchayat leaders revealed that while removing encroachments in the water spread area, the District Revenue Department should be involved as a key stakeholder. Moreover, politically influential or well-off farmers are the main encroachers, and removing them is a political challenge, which was expressed by both WUA leaders and panchayat leaders during the transect walk and key informant interviews. For five of the RD tanks, there are no proper supply channels, and water is drained to the next tank in the lower gradient through agricultural fields, which was also evident during the transect walk to the tanks.

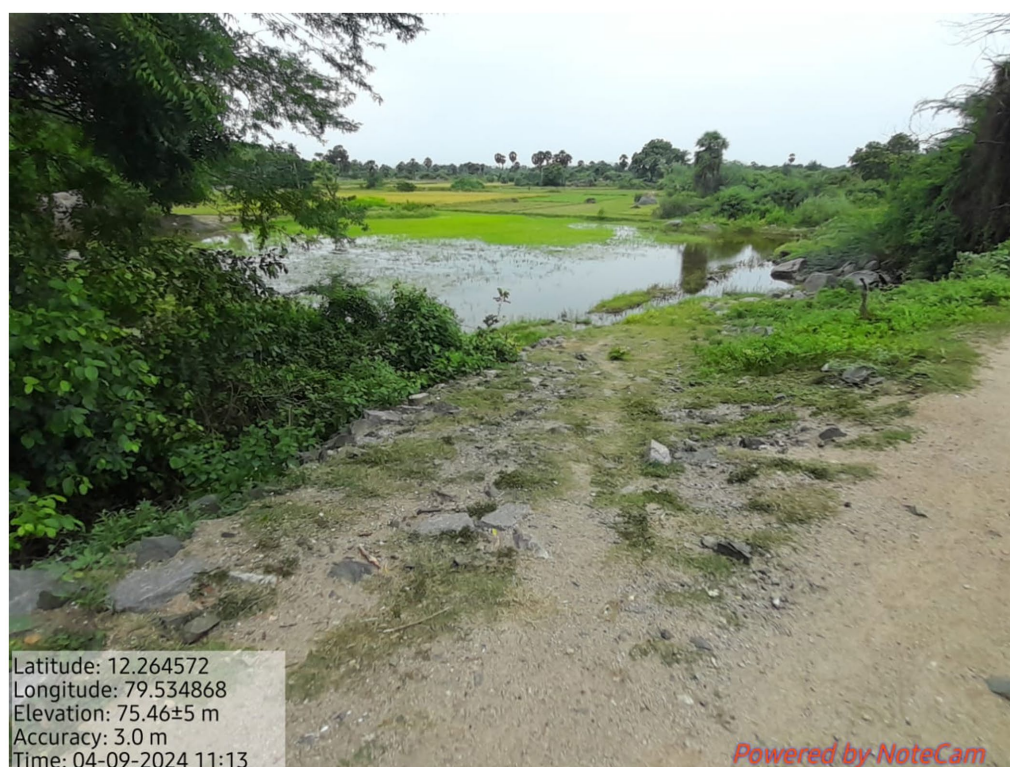
FIGURE 5
Disappeared field channels.

The catchment area of all the tanks is also undergoing severe degradation. The main challenges are encroachment by the farmers, division due to a permanent village road without many drainage points, growth of *Prosopis* (an invasive deep-rooted tree species that grows quickly inside the tank), soil mining, construction of public utilities in the upper ridge, and degradation of grazing space. The boundary lines of the tanks were intact until the local communities managed the tanks. When management control was shifted to the government, encroachments by local farmers started, leading to a reduction in the water spread area. The control measures by the government system were inadequate to stop such malpractices. However, in the recent past, corrective measures have been put in place to address such issues. An example is from the TNIAM project launched in 2017–18, where protocols were evolved to demarcate the boundary mark, remove encroachments, and plant boundary stones. The field channels in the *ayacut* area play a critical role in safely guiding the flow of water from head to tail and support all the farmers equitably. However, except in three RD-managed tanks, the field channels were closed in the *ayacut* regions of the remaining tanks (Figure 5). This change is coupled with a steep increase in the use of groundwater through open or bore wells. In those three tanks, the field channels are maintained only in the head portion of the *ayacut* area.

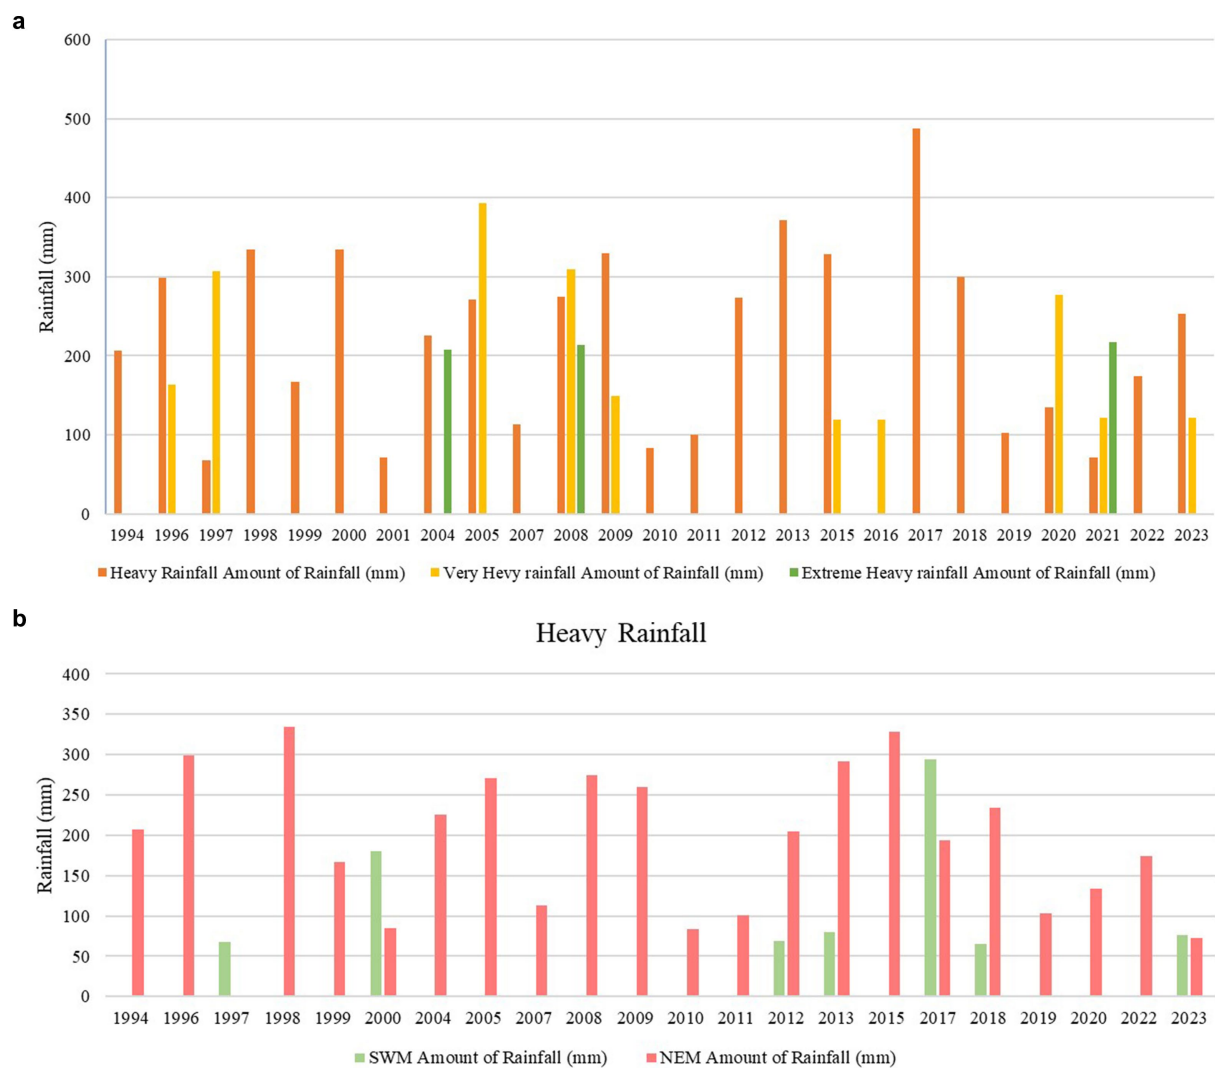
FIGURE 7
(a) Heavy rainfall events during 1994 to 2023. (b) Season wise heavy rainfall events from 1994 to 2023.

Besides the seasonal shifts, between 1994 and 2023, a total of 63 heavy rainfall events, 15 very heavy rainfall events, and 3 extreme heavy rainfall events were recorded (Figures 7a,b). Before the year 2000, only heavy and very heavy rainfall events were observed, with no extreme events reported. However, from the 2000s onward, all three categories began to occur more frequently, reflecting a shift in rainfall intensity patterns. Years like 2008 and 2021 stand out, as they recorded all three rainfall events, indicating an increasing variability and intensification of extreme weather events. The year 2017 witnessed the highest number of heavy rainfall days (5), whereas 2005 and 2008 experienced the highest total rainfall amounts, highlighting a trend of intensifying and localised extreme rainfall events in recent decades. The data indicate increasing rainfall extremes and seasonal unpredictability, suggesting a shift in monsoon patterns over the decades. Overall, the data suggest a trend of increasing rainfall extremes, both deficient and excessive, highlighting the growing climatic variability in monsoon behaviour, which has implications for tank-based irrigation and infrastructure management, and its hydrological parameters.
