SEISMIC ANALYSIS AND RETROFITTING OF HISTORICAL BUILDINGS

EDITED BY: Antonio Formisano and Michele D'amato
PUBLISHED IN: Frontiers in Built Environment

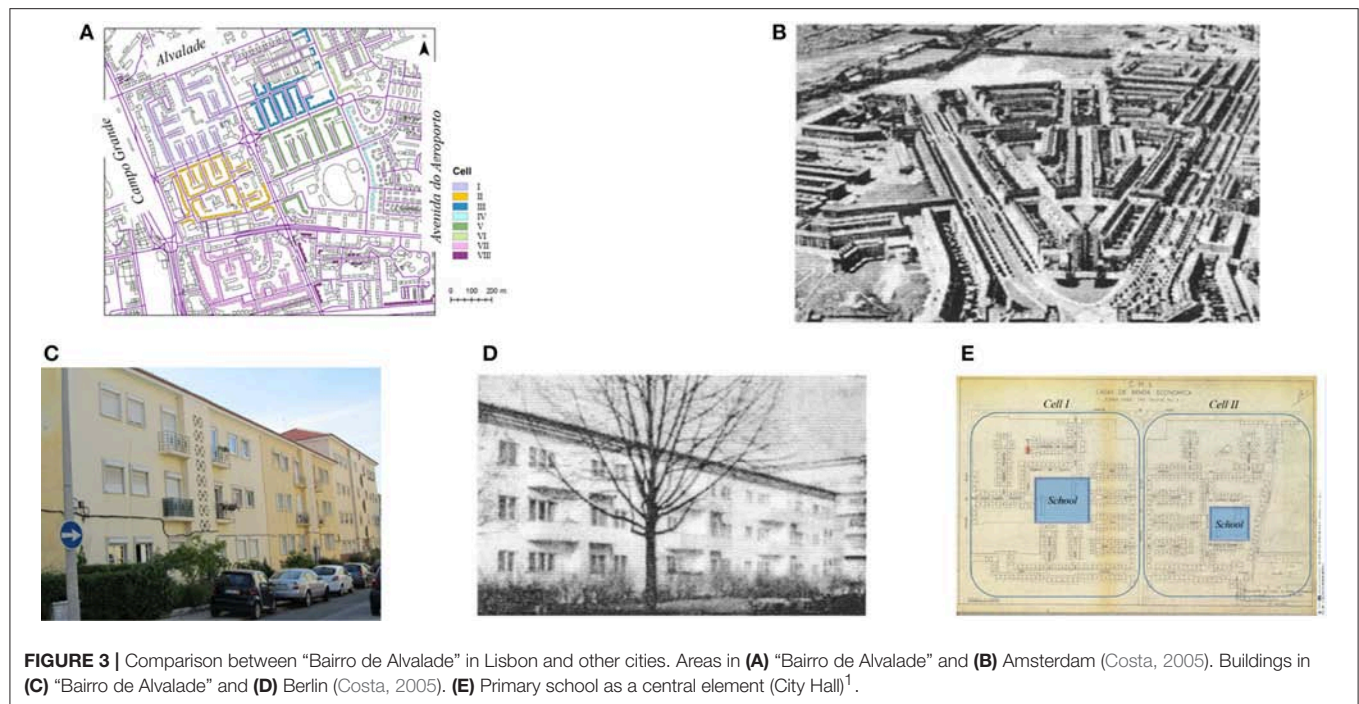
FIGURE 3 | Comparison between “Bairro de Alvalade” in Lisbon and other cities. Areas in (A) “Bairro de Alvalade” and (B) Amsterdam (Costa, 2005). Buildings in (C) “Bairro de Alvalade” and (D) Berlin (Costa, 2005). (E) Primary school as a central element (City Hall)¹.

functions (Alegre and Heitor, 2004). The “neighborhood units” were designed around a central element, the primary school, not exceeding the distance of 500 m from house to schools (**Figure 3E**). Pedestrian circulation is enabled by paths that cross the backyards of housing blocks. Other public facilities, particularly the market and the civic center, are distributed to be easily accessible by the dwellers of each cell. Public parks and gardens were designed as large common outdoor spaces for the enjoyment of residents (Alegre and Heitor, 2004).

The organization of “Bairro de Alvalade” (**Figure 3C**) resembles some Amsterdam areas (**Figure 3B**) and some proposals developed in Berlin (**Figure 3D**) for economic construction in the 1920–1930 decades (Costa, 2005). This is surely related with the international academic education of the Portuguese urban planner but also with research that was made by the city hall technicians, as presented in contemporary papers and reports edited by LNEC (the Civil Engineer National Laboratory).

Firstly, the main characteristics of the buildings that belong to the area of “Alvalade” are analyzed in this work, whereas the detailed information regarding the constructive details and material used in these buildings is presented in Milosevic et al. (2018a). Initially, a database was prepared in a Geographic Information System (GIS) with the ArcGIS® program (ESRI, 2014; **Figure 3A**).

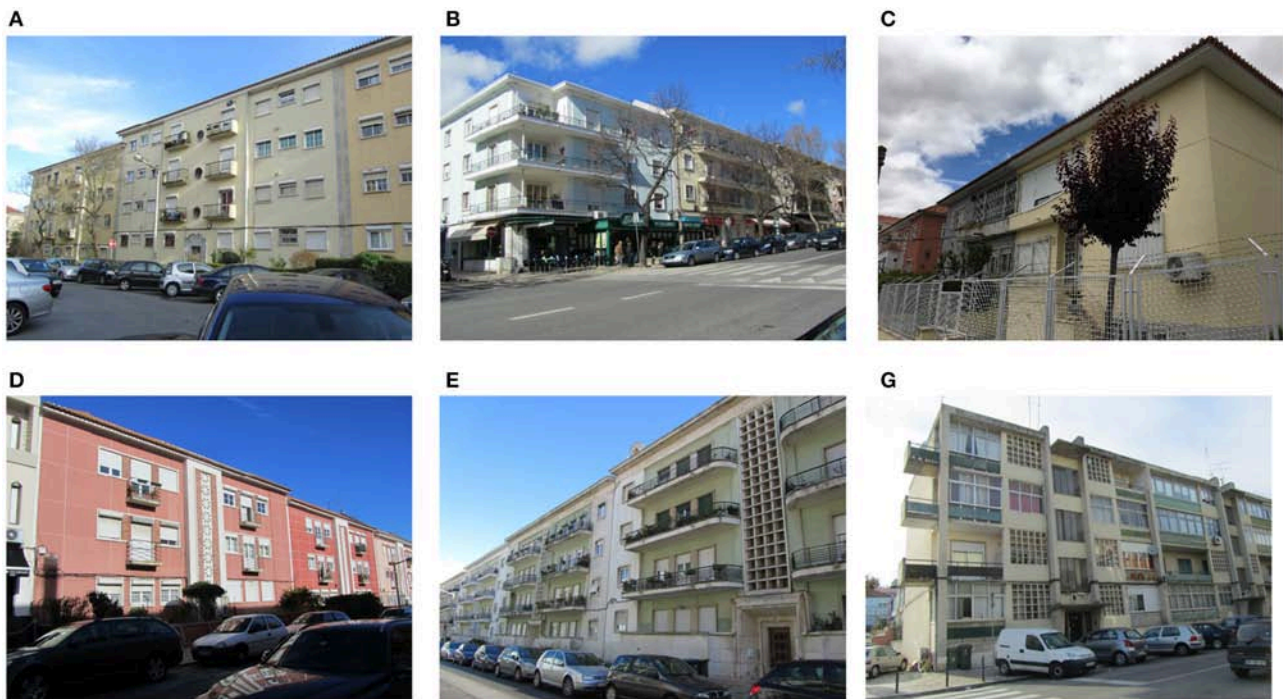
FIGURE 4 | Buildings from different cells. **(A)** Buildings in Cells I and II. **(B)** Buildings in Cell III. **(C)** Buildings in Cell IV. **(D)** Buildings in Cell V and VI. **(E)** Buildings in Cell VII. **(F)** Buildings in Cell VIII.

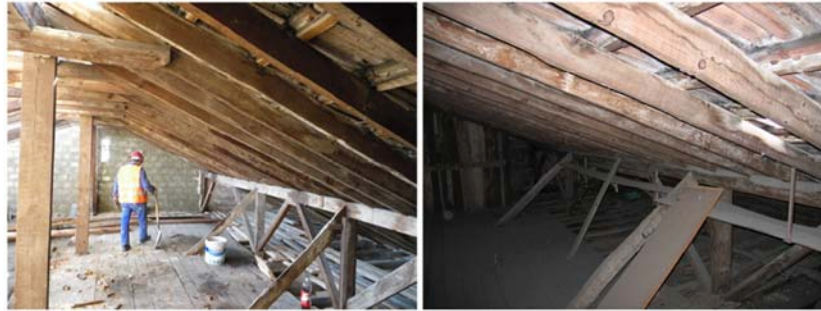
FIGURE 7 | Timber roofs.

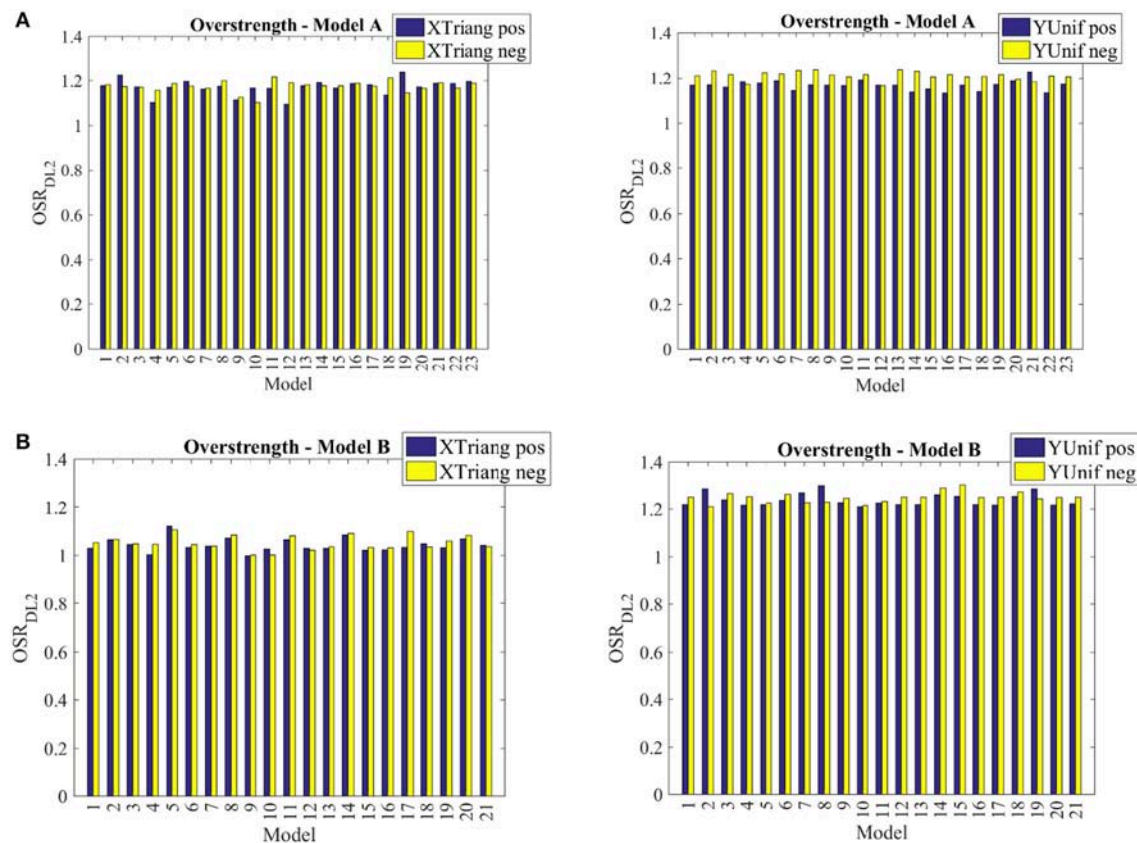
FIGURE 14 | Overstrength for X and Y direction for Model A (A) and Model B (B) adopting DL2.

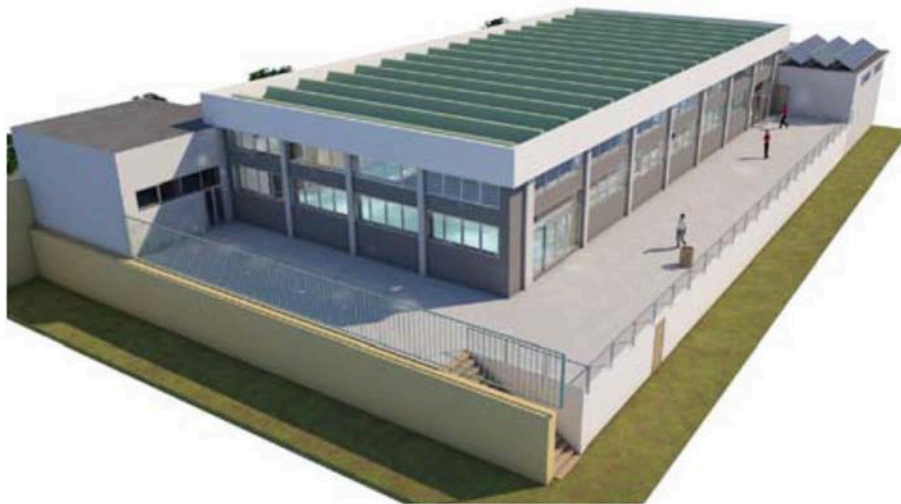
FIGURE 1 | Lateral view of the building.

The building is roughly rectangular in plan and consists of a pool block of consistent height, equal to about 6.50 m, with a surface area of about 600 m². In adjacency on the two sides of the pool body there is the stripped area, with a plant area of 500 m², with a height of about 3.50 m above ground and, limited to one of the service areas, 5.30 m. The covered area of the entire structure is about 1,200 m² and, in addition to the two bodies described, there is also a technical room of about 60 m². Access to the pool, as well as from inside the stadium, is allowed directly from the street, with respect to which the footfall is slightly higher. There is also an underground floor, done with RC walls at different quotes and directly connected to the foundation system, but the design project regards only the upper floor. However, it was possible to note that no damages or cracks are present in the underground floor. **Figure 1** shows the lateral view of the building.

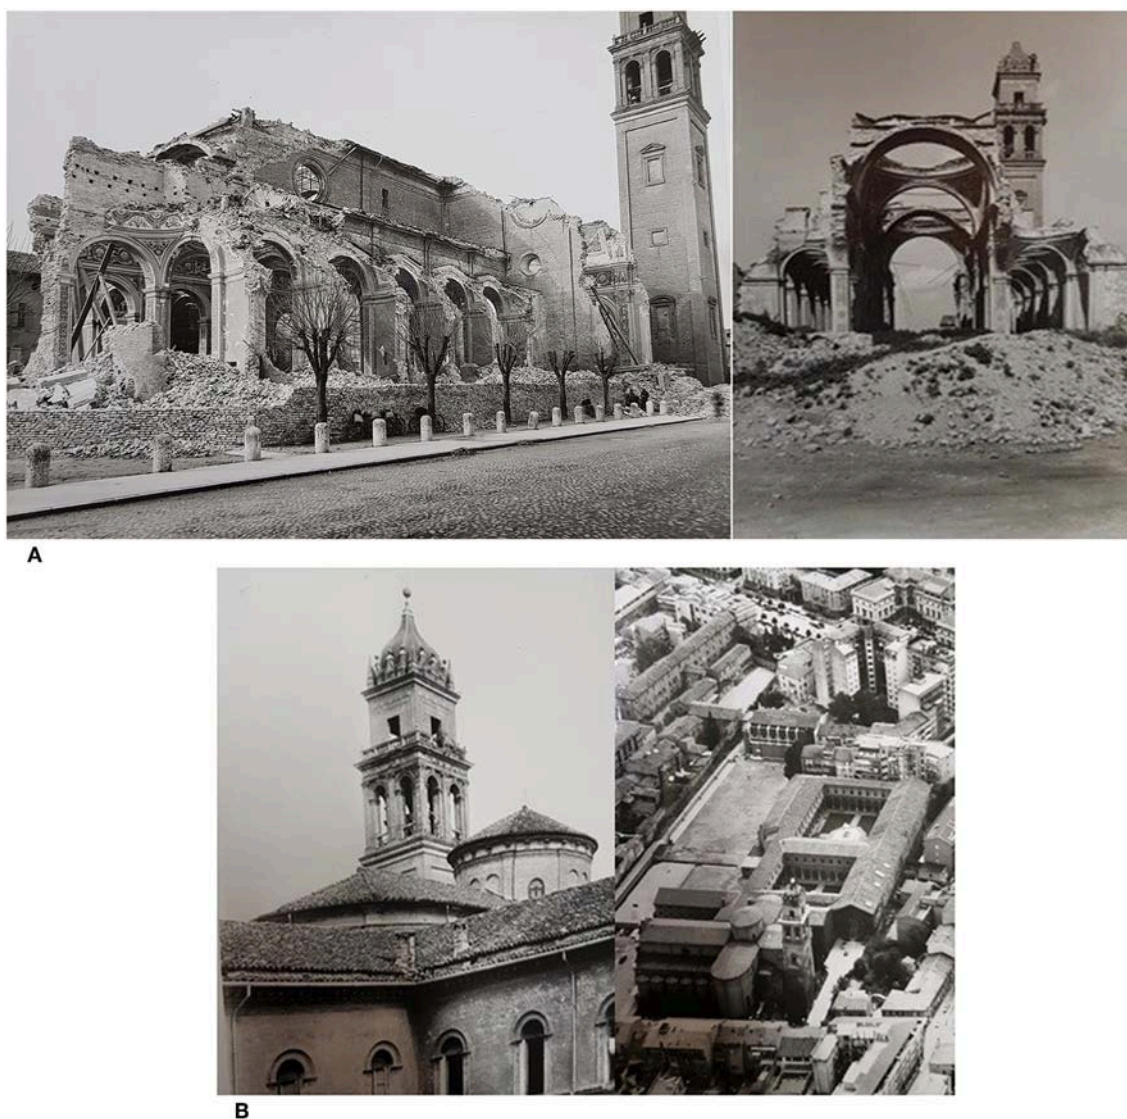
FIGURE 2 | Complex of San Benedetto in Ferrara (Italy) after the bombing of the World War in 1944 **(A)**, a view of the bell tower and the complex after rebuilding **(B)**.

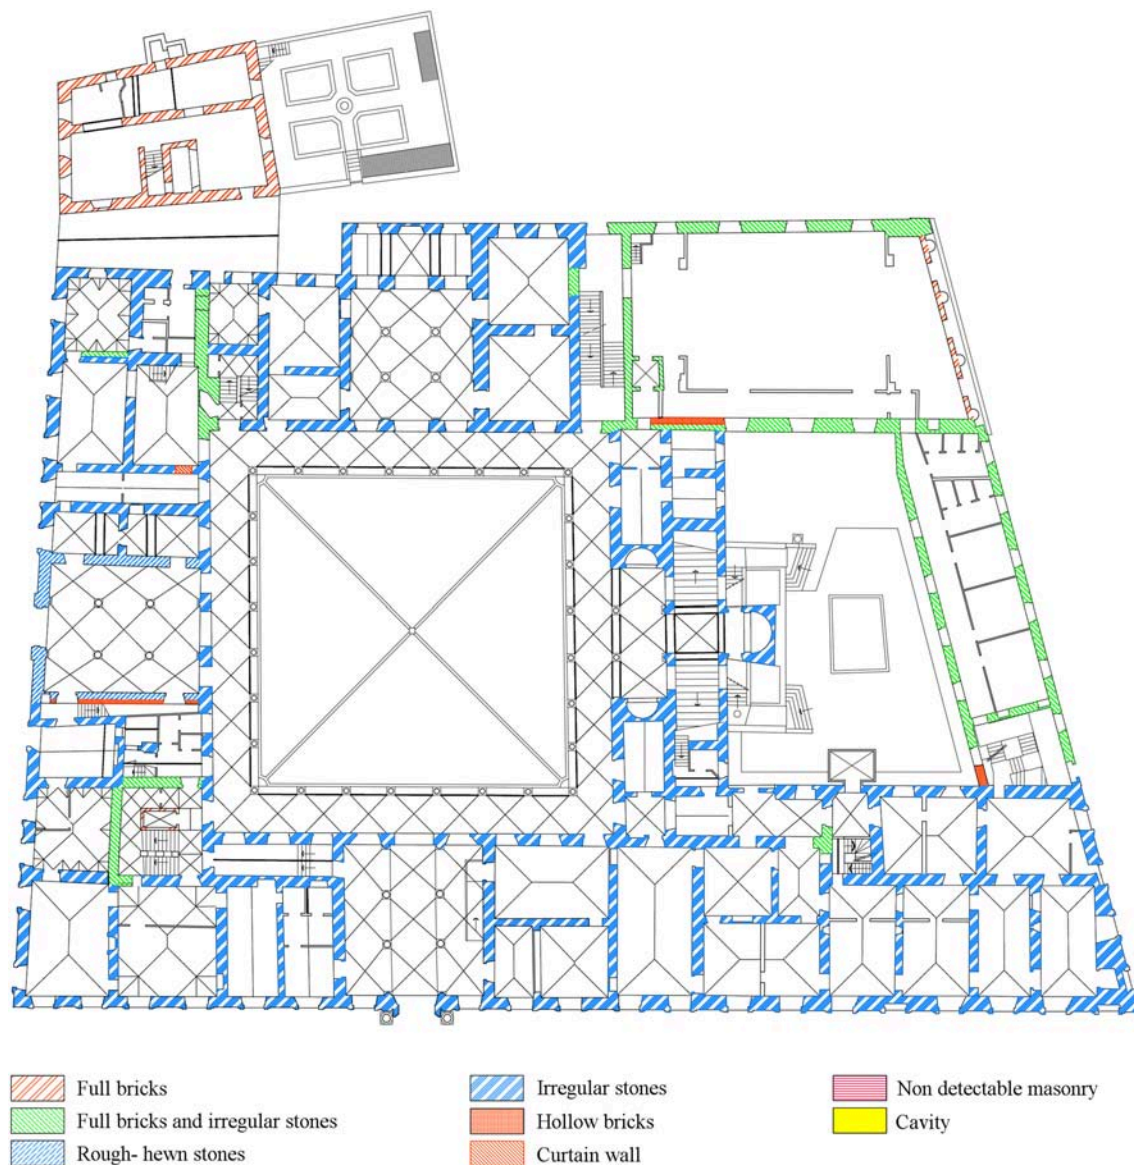
FIGURE 10 | Masonry typologies surveyed in Palazzo Ducale.

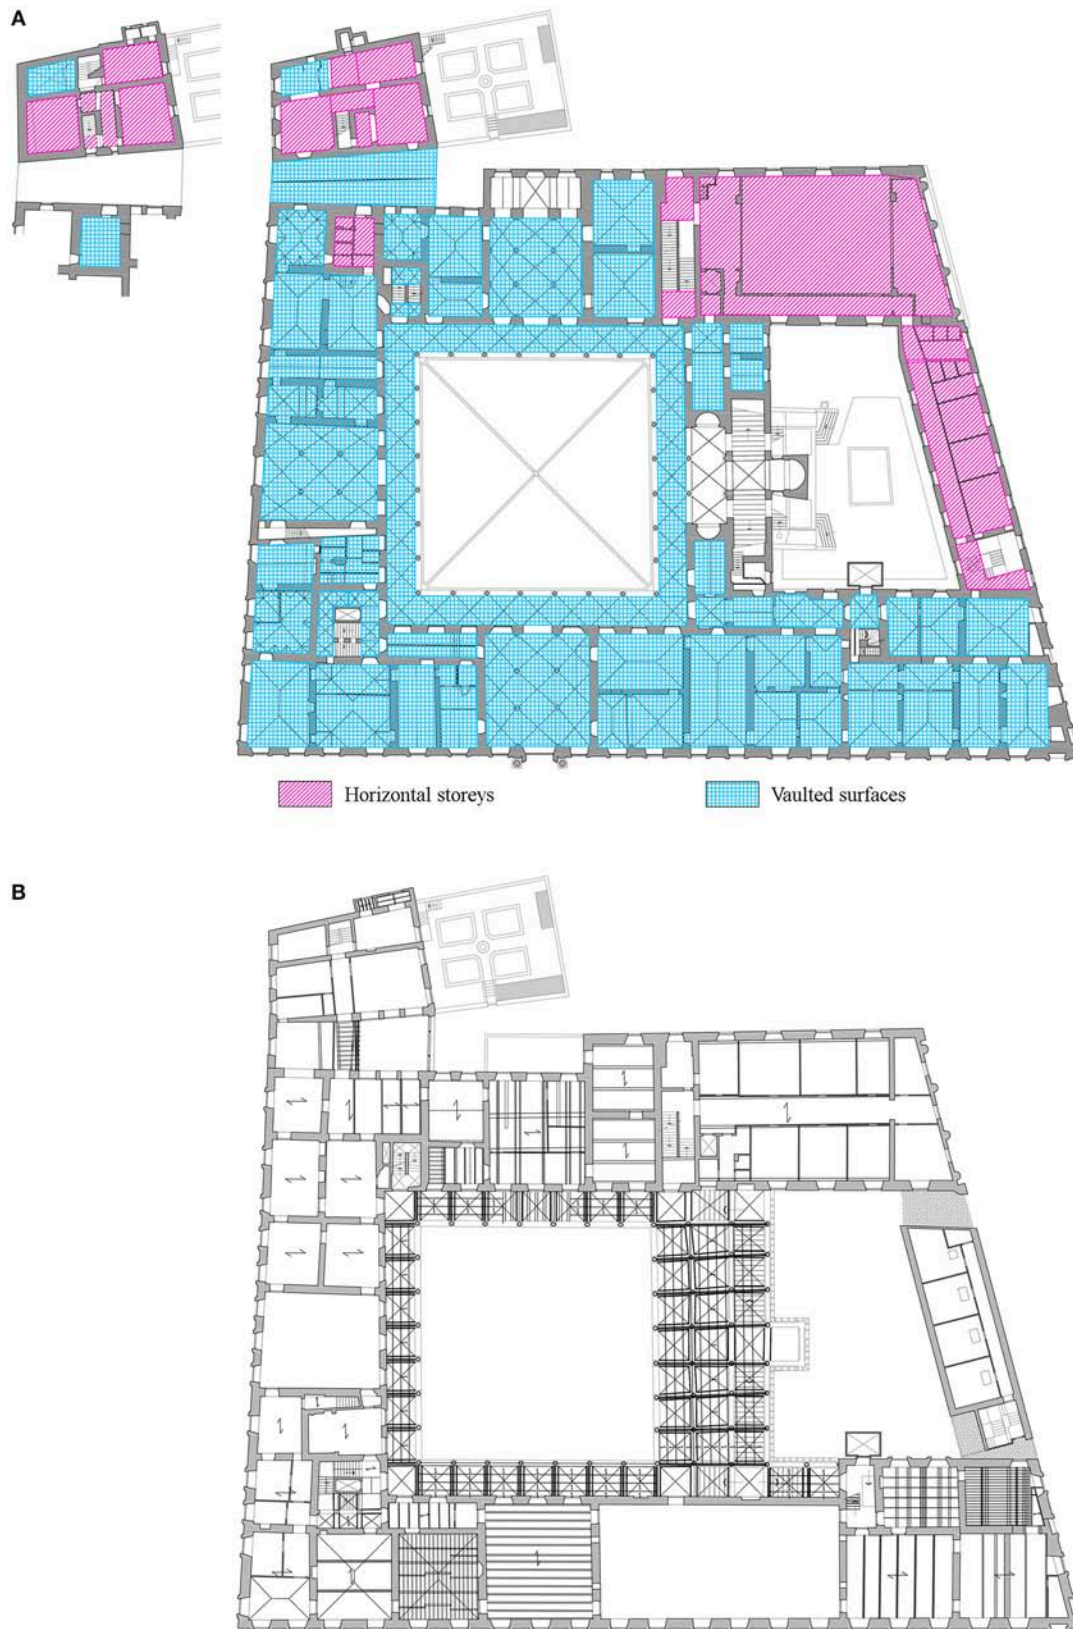
FIGURE 11 | (A) Floor typologies (flat or vaulted) surveyed in correspondence to the second level of Palazzo Ducale. **(B)** Floor typologies surveyed in correspondence to the third level of Palazzo Ducale.

Floor at the third level of Palazzo Ducale, partially composed by timber- frame structures and partially composed by steel-frame structure.

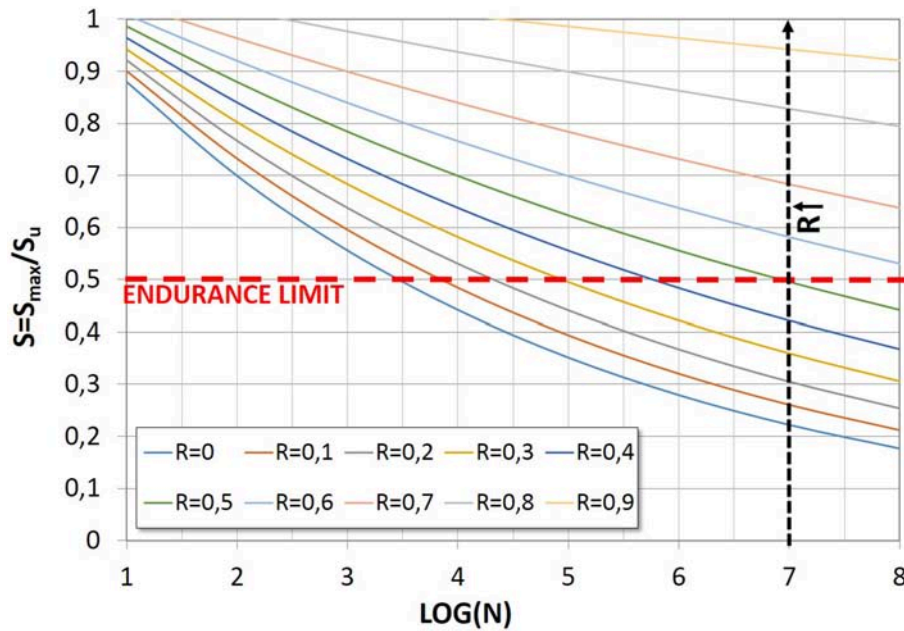
FIGURE 2 | Casas (2009) fatigue curves, referred to a 5% of failure probability.

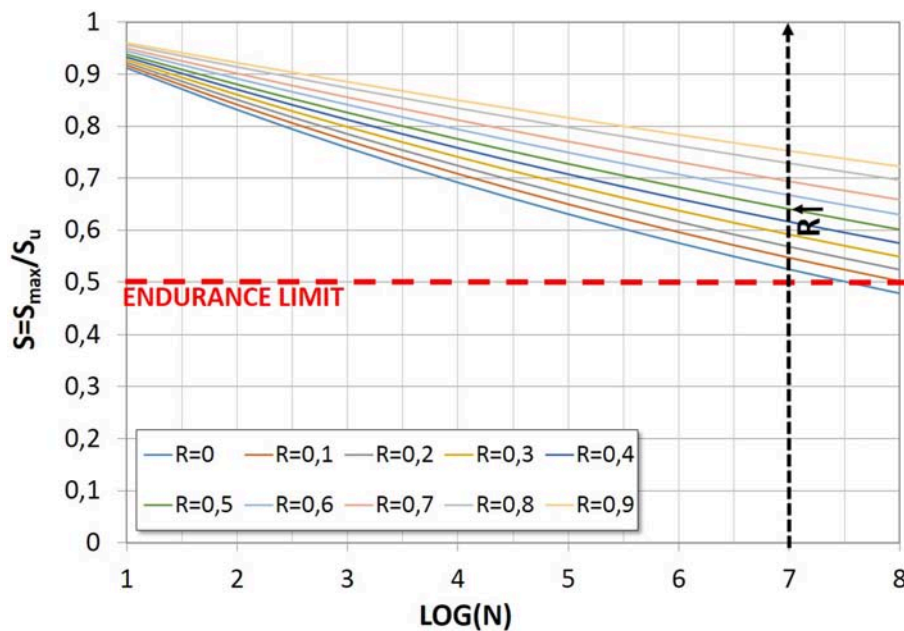
FIGURE 3 | Tomor and Verstryngne (2013) fatigue curves, referred to a 5% of failure probability.

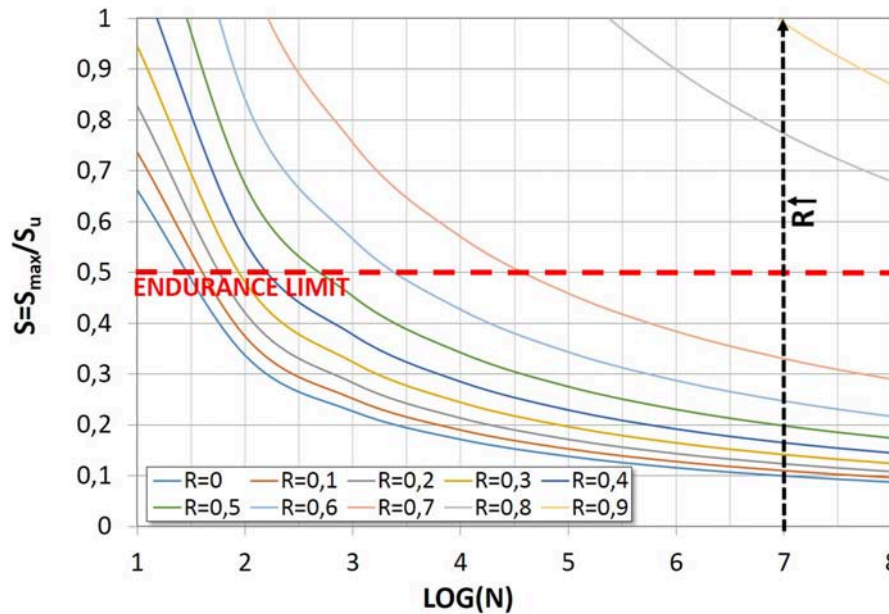
FIGURE 4 | Koltsida et al. (2018a) fatigue curves, referred to a 5% of failure probability.

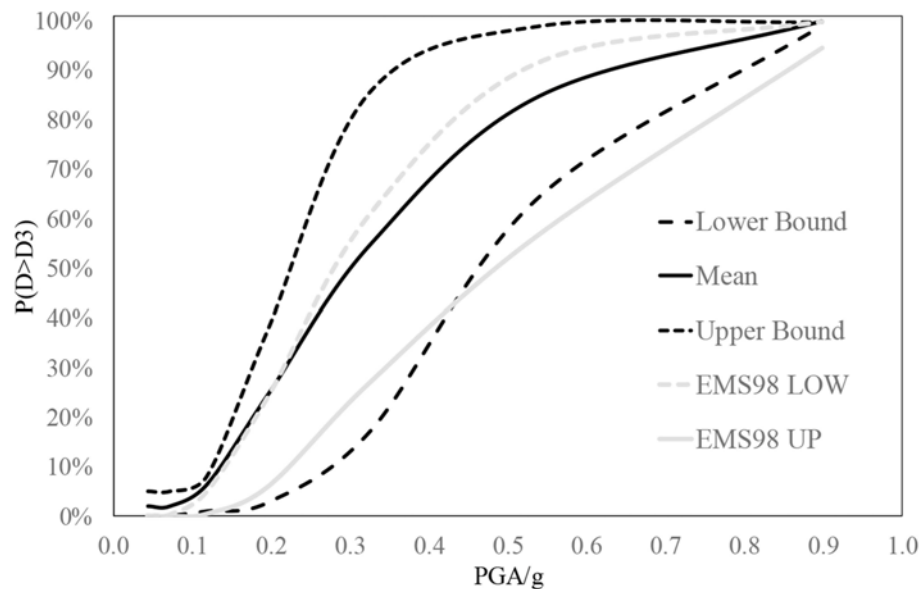
FIGURE 17 | The fragility curves given by Vulnus for a damage grade higher than D3.

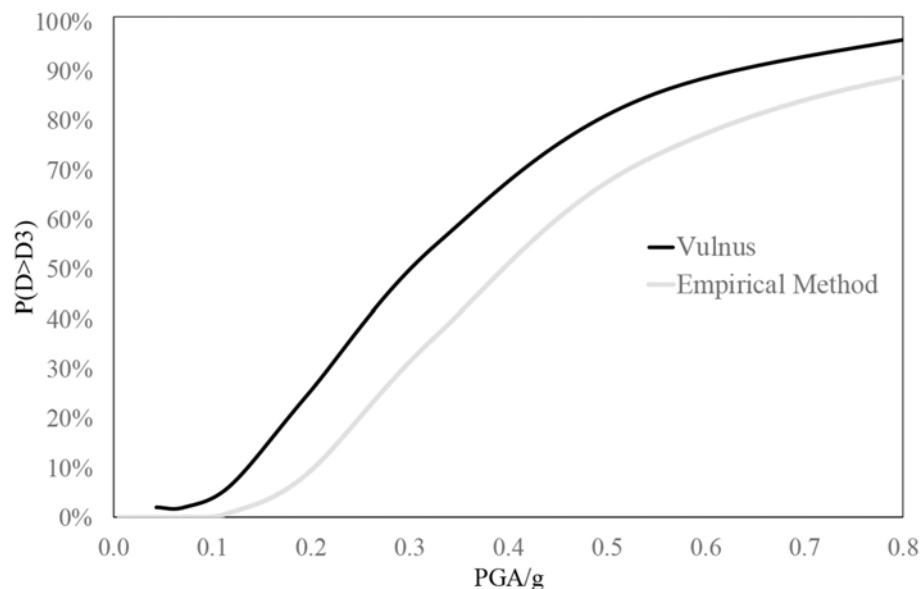
FIGURE 18 | Comparison between the fragility curves given by Vulnus and by the empirical method for a damage grade higher than D3.

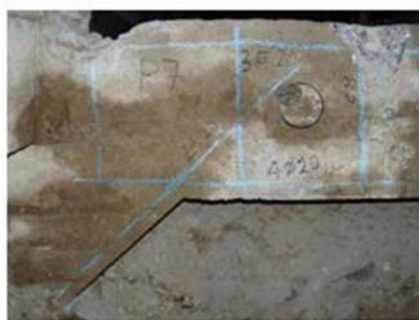
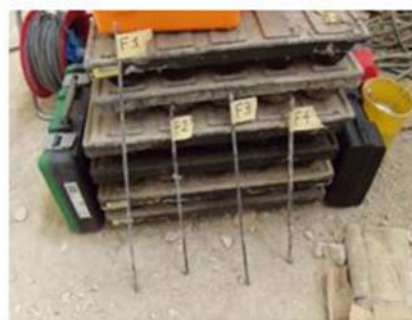
FIGURE 2 | Investigation campaign: (A) Material properties derived from extracted samples. N, number of samples; CV, coefficient of variation; f_{cm} , average compressive strength; f_{ym} , average tensile strength; (B) steel reinforcements disposition obtained through pacometric investigations and sampling of concrete specimen, (C) steel samples collected.

Concrete core samples			
Group	n.	CV	f_{cm} [N/mm ²]
1	11	0.2	24.2
2	10	0.1	18.8
Steel bar samples			
Diameter	n.	CV	f_{ym} [N/mm ²]
ϕ10 - ϕ 20	10	0.084	353.18
ϕ 6	3	0.09	352.7

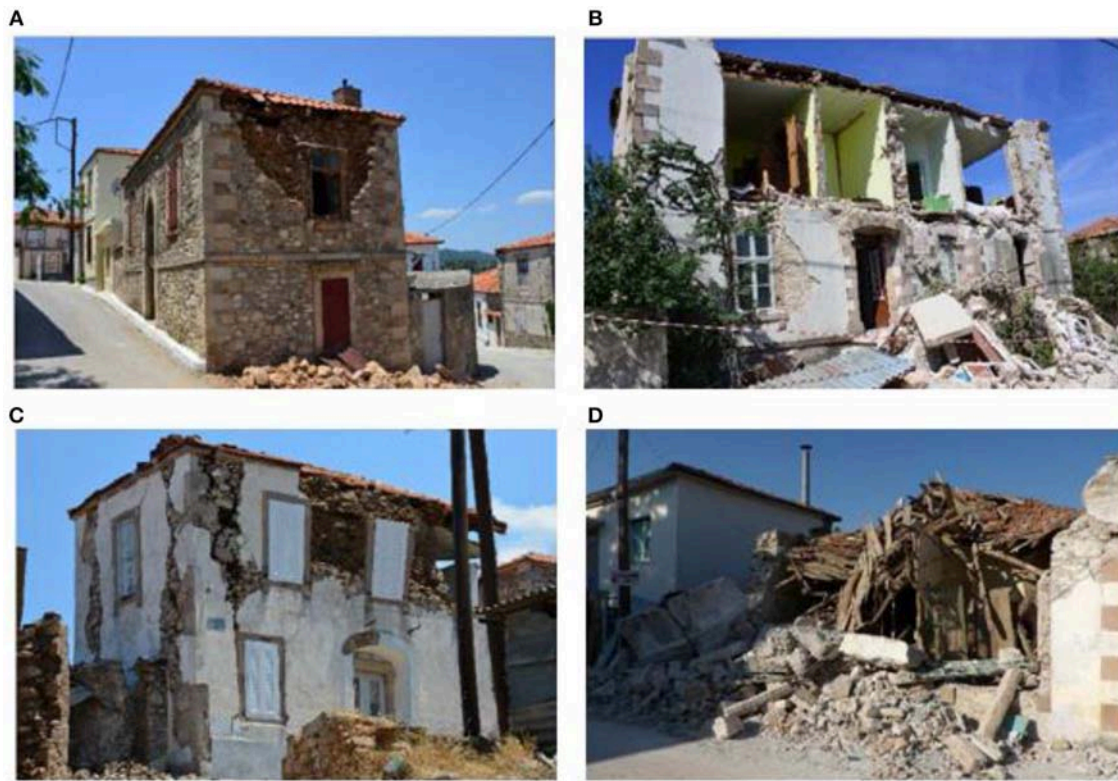
FIGURE 1 | Typical damage to unreinforced masonry buildings that underwent partial or global collapse during the 2017 Lesvos earthquake (Lekkas et al., 2017; Reproduced with the permission of the authors). **(A)** The masonry failed under out-of-plane bending due to lack of a rigid diaphragm at the top. **(B)** The longitudinal masonry walls failed under out-of-plane bending due to their poor connection to the transverse walls. **(C,D)** Failures attributed to poor material properties and construction techniques.

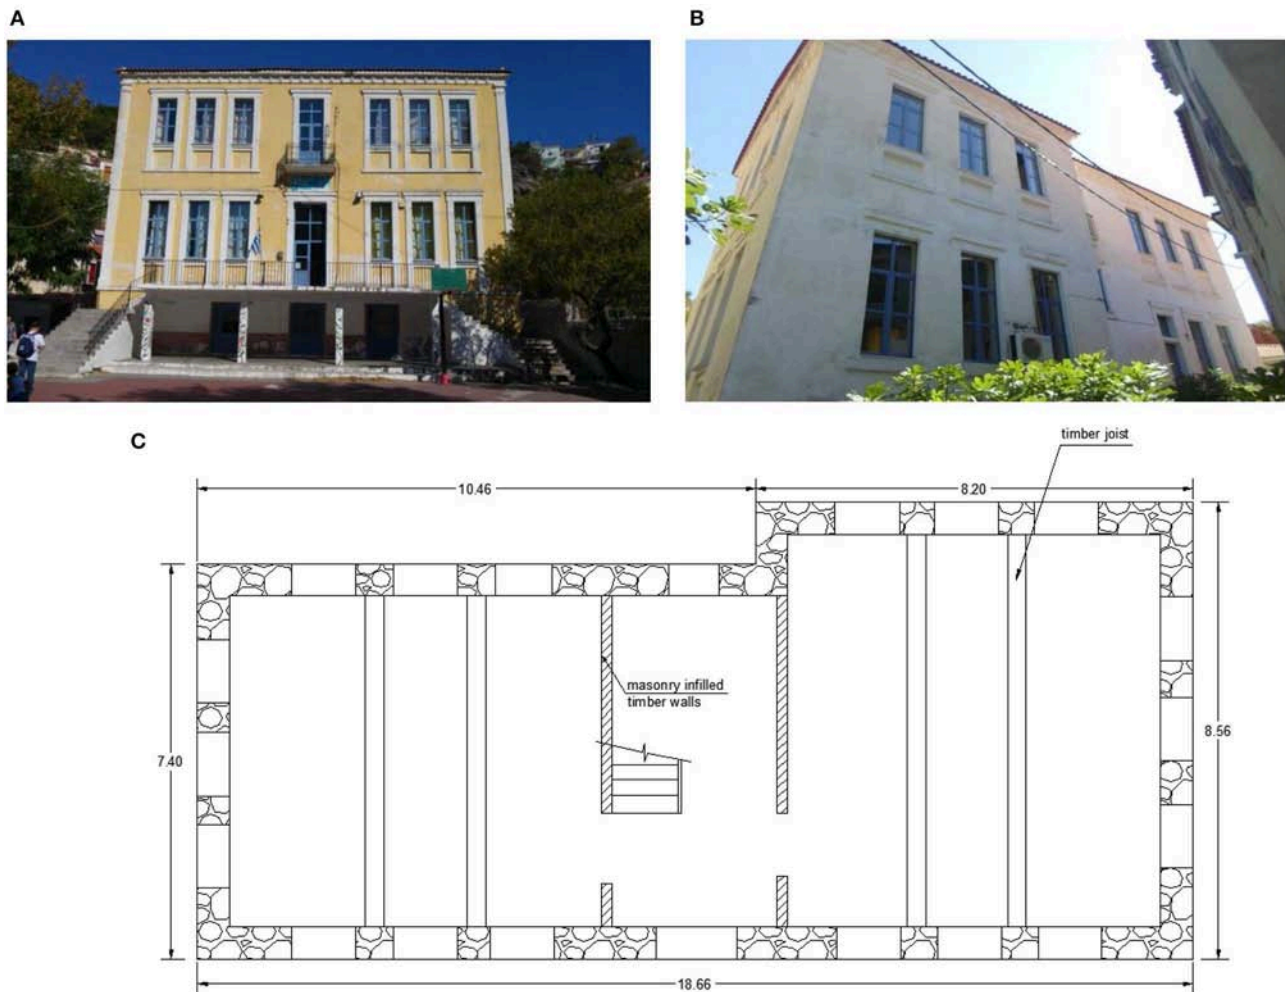
FIGURE 2 | (A) Front view, (B) rear view, (C) typical plan.

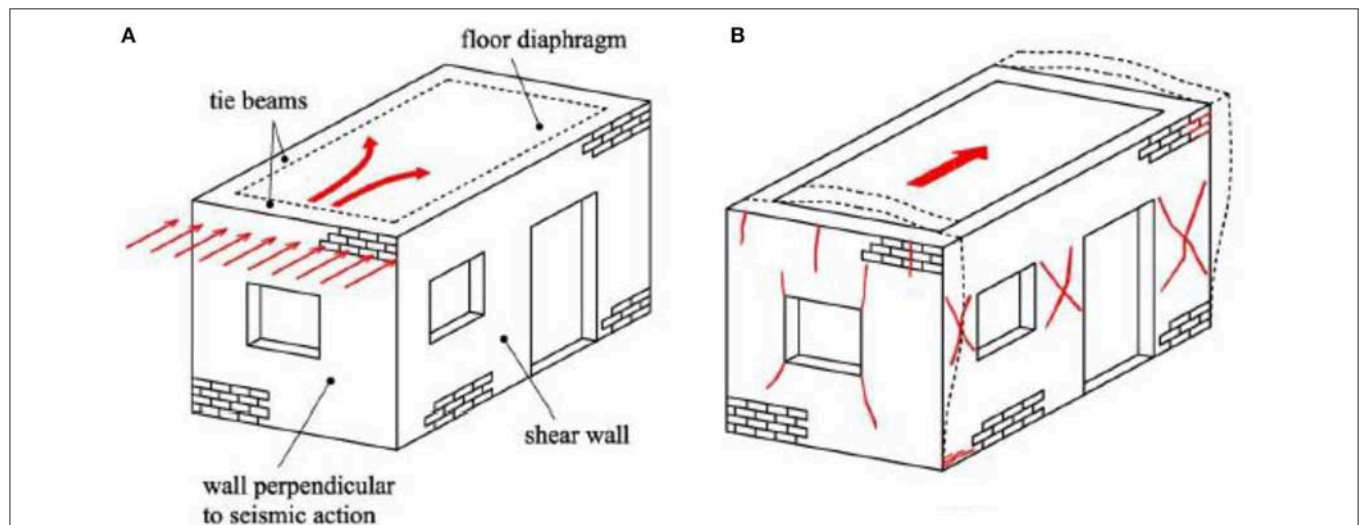
**FIGURE 4** | (A) Flow of forces in an unreinforced masonry building with rigid diaphragm. (B) Failure mechanisms to be considered when rigid diaphragm is absent (Tomažević, 1999; Reproduced with the permission of the authors).

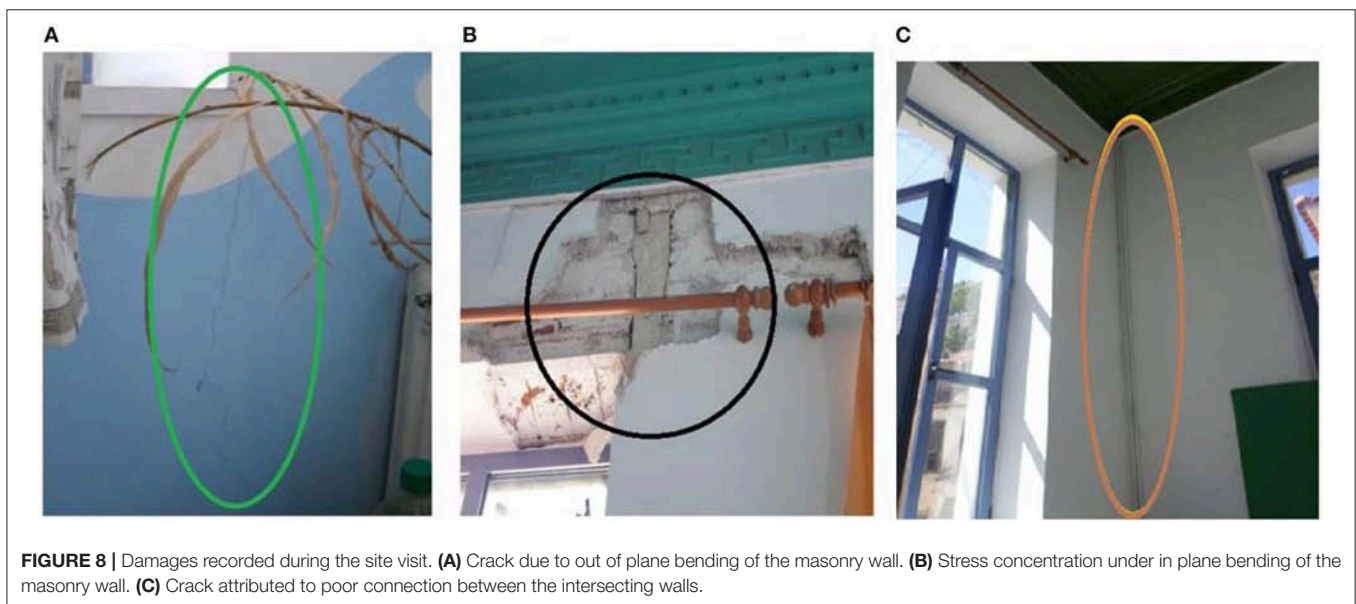
FIGURE 8 | Damages recorded during the site visit. **(A)** Crack due to out of plane bending of the masonry wall. **(B)** Stress concentration under in plane bending of the masonry wall. **(C)** Crack attributed to poor connection between the intersecting walls.
