Lessons for Remote Post-earthquake Reconnaissance from the 14 August 2021 Haiti Earthquake

Keywords: remote reconnaissance, earthquake, building damage, remote sensing, landslides, data collection, InSAR, multispectral imagery

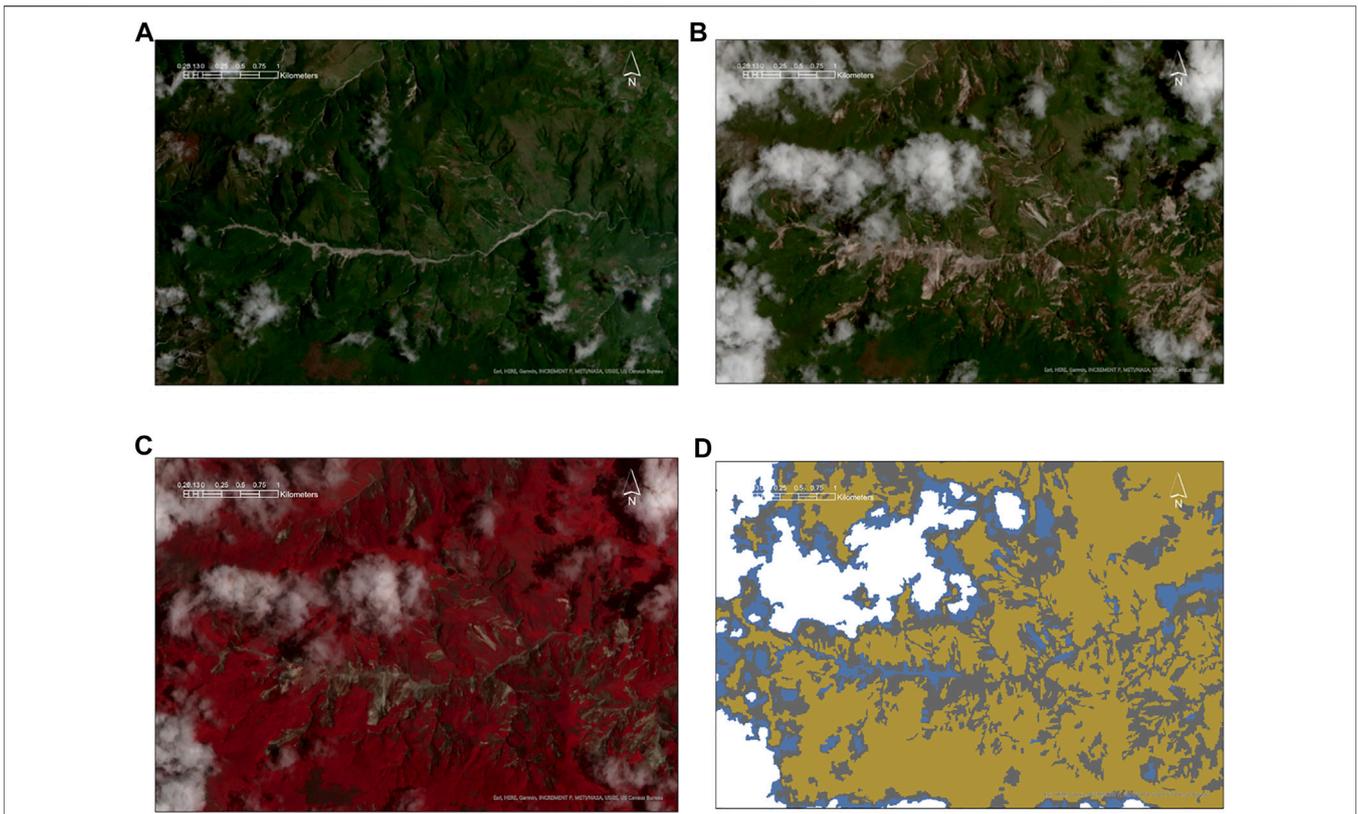
Figures 8C,D show some example outputs from the analysis. However, we found that these automated approaches could not adequately distinguish between landslides and cloud cover, despite training the system to classify landslides and clouds separately. Therefore, we mapped the landslides manually in the post-earthquake true-colour Sentinel-2 imagery.

FIGURE 8 | Sentinel-2 true colour Imagery **(A)** before and **(B)** after the earthquake. **(C,D)** processed multi-spectral Sentinel-2 imagery change detection images.

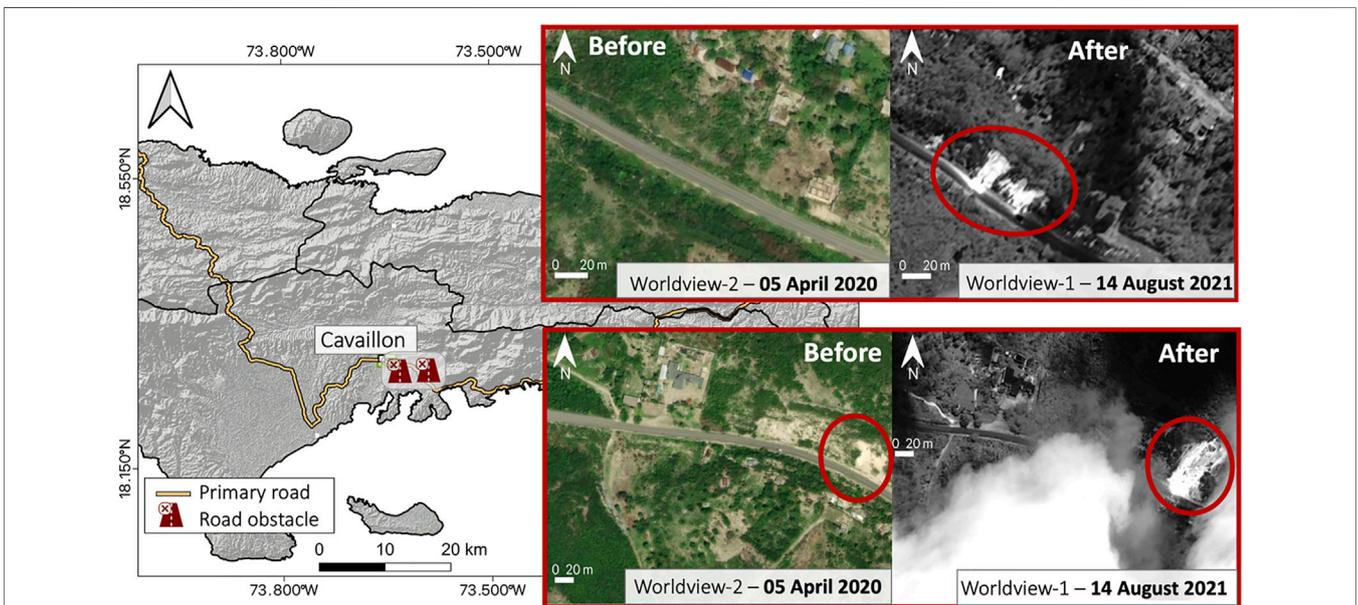
2 days after the earthquake, as part of the MAXAR Open Data Program. Such images have a resolution between 30 and 90 cm. The OSM road database contains vector data of road centrelines in the Tiburon Peninsula and includes information on the road length, road name, and road type, e.g., primary and secondary. We observed that some of the detected landslides had had a direct impact on adjacent infrastructure, causing damage and blocking roads. For example, **Figure 9** shows two landslides blocking a primary road a few kilometres outside Cavaillon, in the South Department of Haiti. The affected infrastructure is the National Road 2, which is a key route linking the South and Nippes Departments. A visual comparison between pre- and post-earthquake optical images shows that in the first location the earthquake likely activated a new sliding body, while for the second road obstacle, the presence of an existing sliding body was already visible in April 2020, i.e. the landslide hazard could potentially have been recognised in advance.

FIGURE 9 | Worldview 1 and 2 imagery used to evaluate impact of landslides on infrastructure. Optical imagery are from the MAXAR Open Data Program.
