Inventory of transitions on sea dikes at the German coast: spatial analysis, design and damages

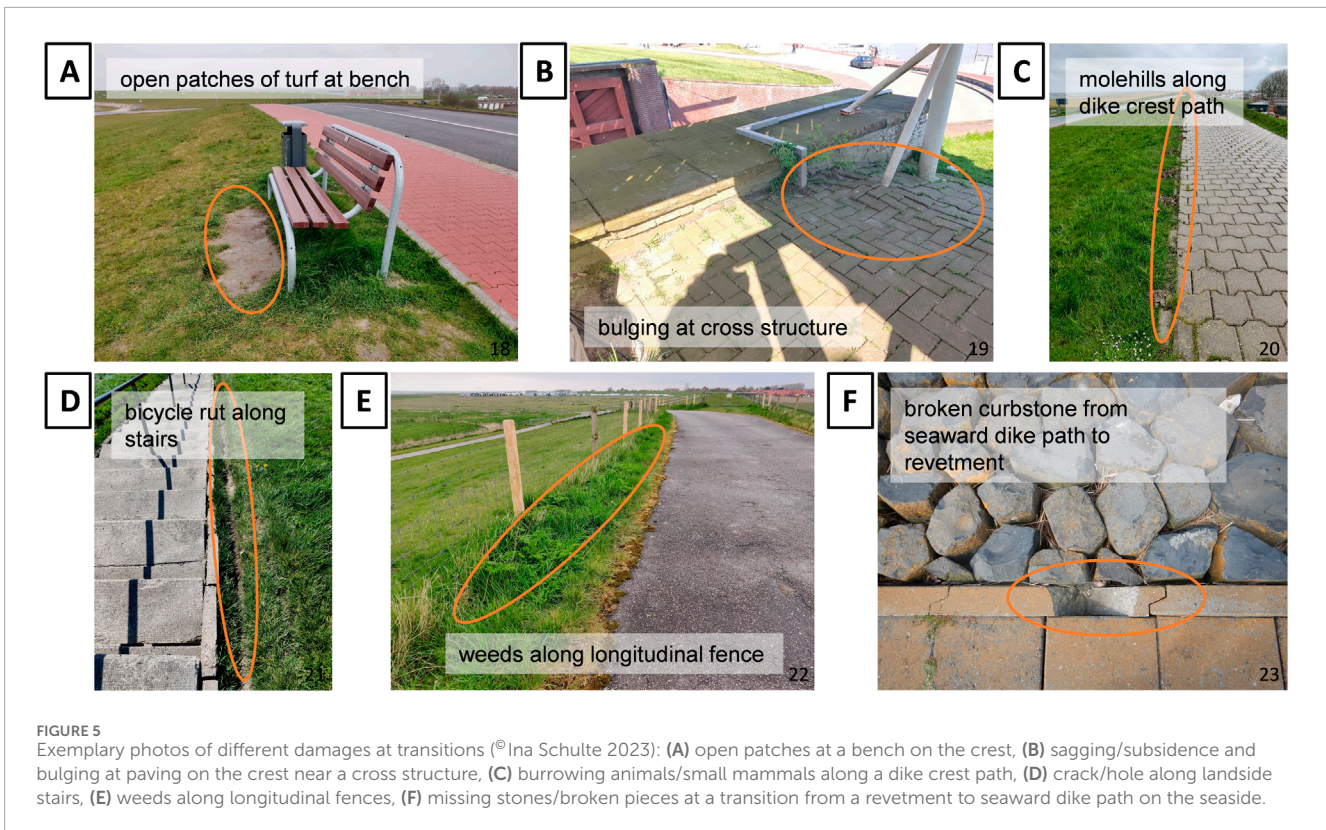
FIGURE 5
Exemplary photos of different damages at transitions (©Ina Schulte 2023): **(A)** open patches at a bench on the crest, **(B)** sagging/subsidence and bulging at paving on the crest near a cross structure, **(C)** burrowing animals/small mammals along a dike crest path, **(D)** crack/hole along landside stairs, **(E)** weeds along longitudinal fences, **(F)** missing stones/broken pieces at a transition from a revetment to seaward dike path on the seaside.

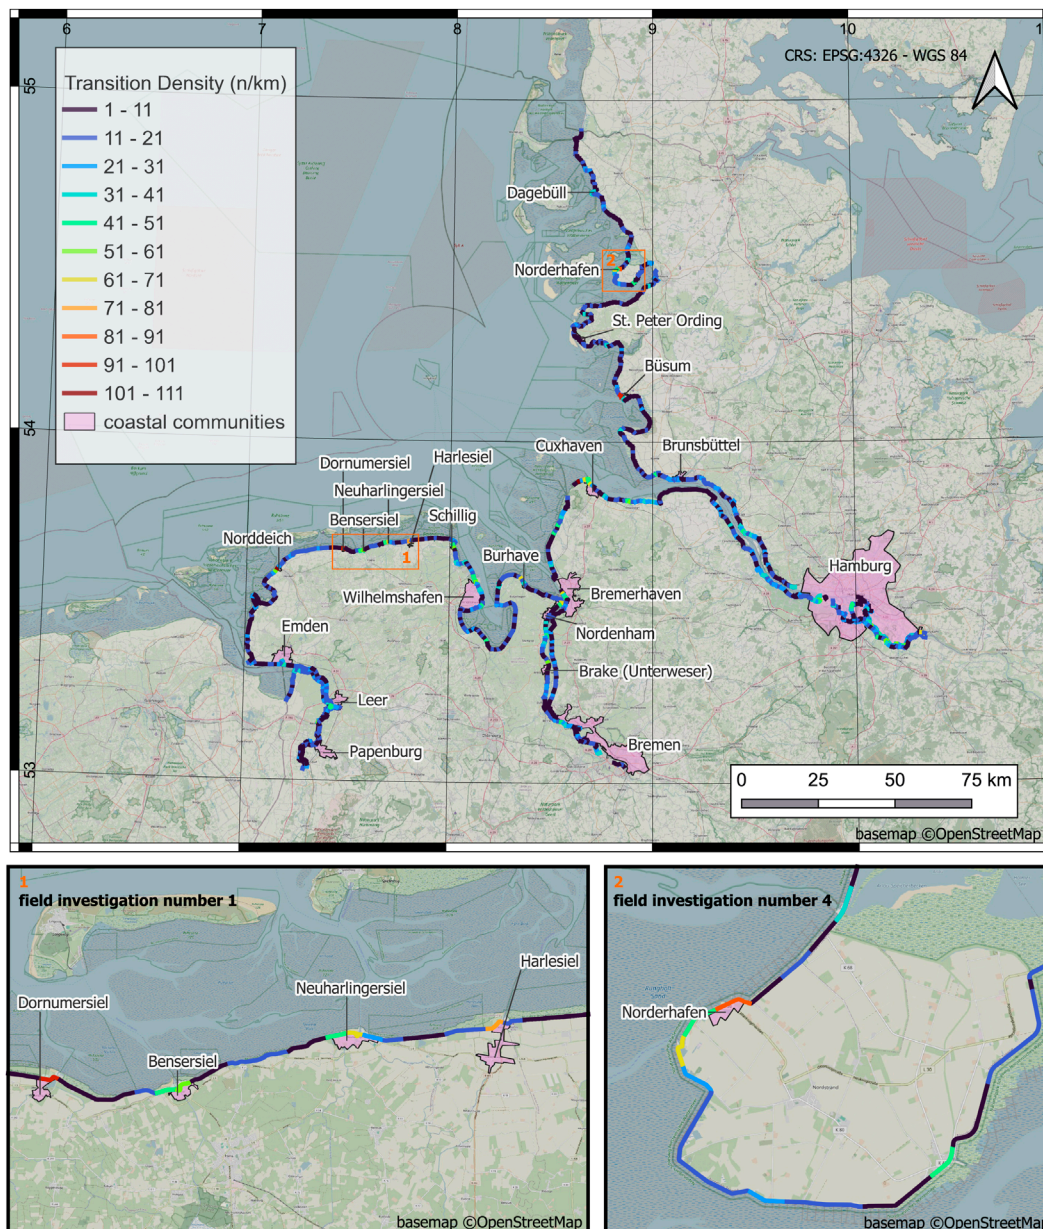
is between 1-21 transitions per kilometer, up to 111 transitions per kilometer can be found on dike sections close to touristic communities and cities like Norddeich, Neuharlingersiel, Cuxhaven, Büsum or Norderhafen (Figure 9). In the large metropolitan areas of Bremen and Hamburg along the tidal rivers Weser and Elbe, the transition densities are, contrary to expectations, not as high as anticipated. In the densely populated inner city areas, there are no classic green dikes but flood protection walls, and in many other places, for space reasons, there are combined structures consisting of dikes and angled supporting walls. However, the densely populated surroundings of Hamburg in the area of the tidal Elbe with classic green dikes are categorized by a high transition density of about 11-61 transitions per kilometer.

FIGURE 9
Density analysis of transitions at sea and estuary dikes at the German North Sea Coast (basemap: www.openstreetmap.org/copyright).

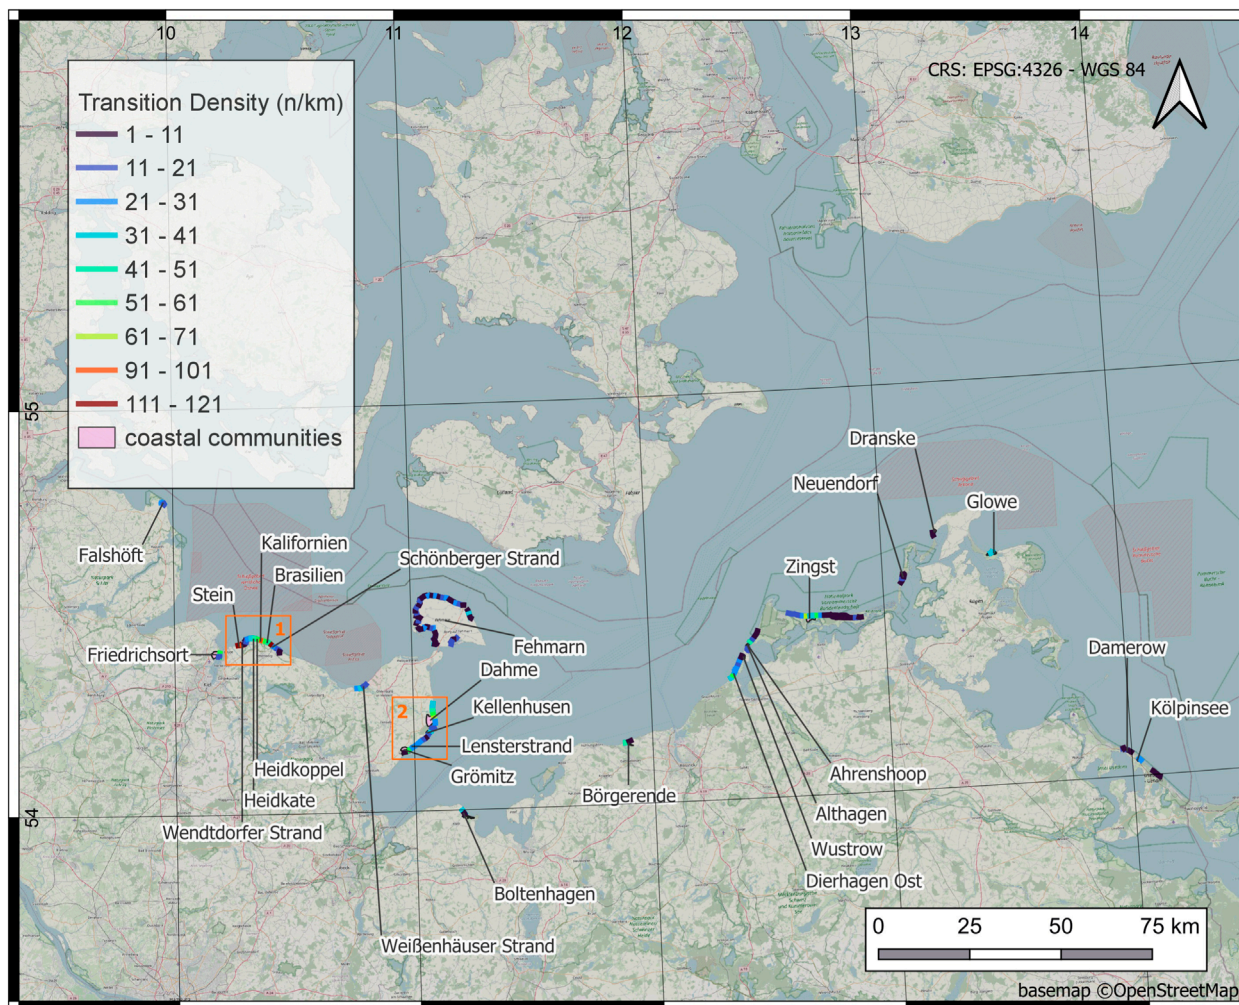
FIGURE 10
Density analysis of transitions at sea dikes at the outer German Baltic Sea Coast (basemap: www.openstreetmap.org/copyright).

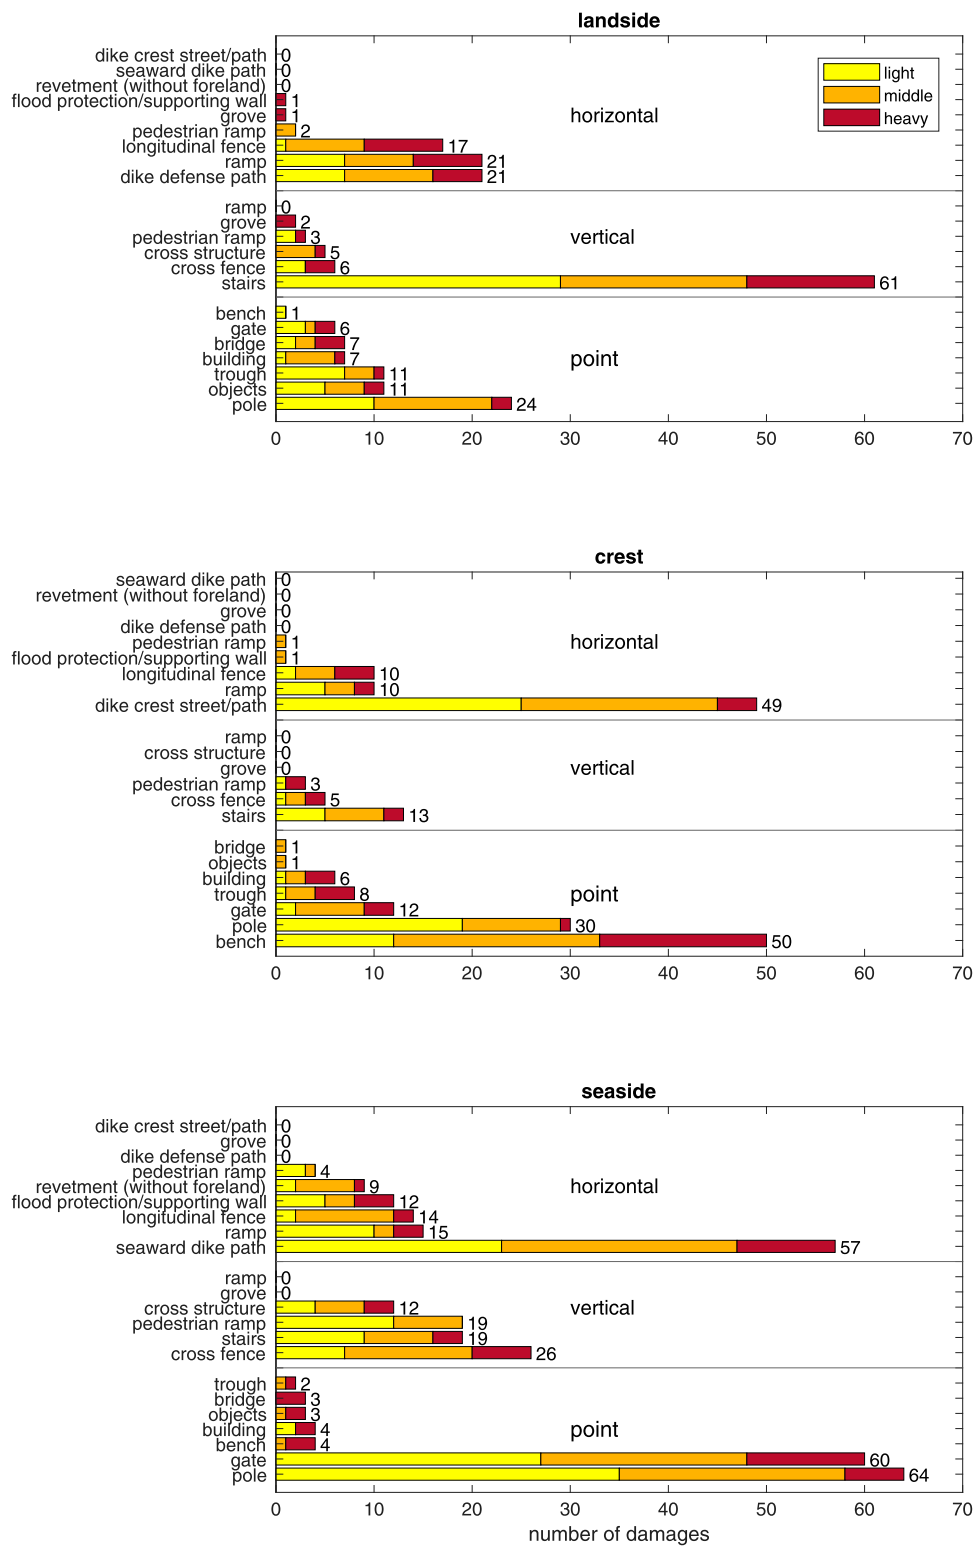
In addition to the location of the damage and the type of transition where the damage occurred, Figure 12 also shows the

extent of damage to the respective transition type. The distribution of the three damage classes light (yellow), medium (orange) and heavy (red) are shown with the absolute number of recorded damages on the landward side, crest and seaward side.

FIGURE 12
Absolute number of damages at transitions classified by damage class and location on the dike.

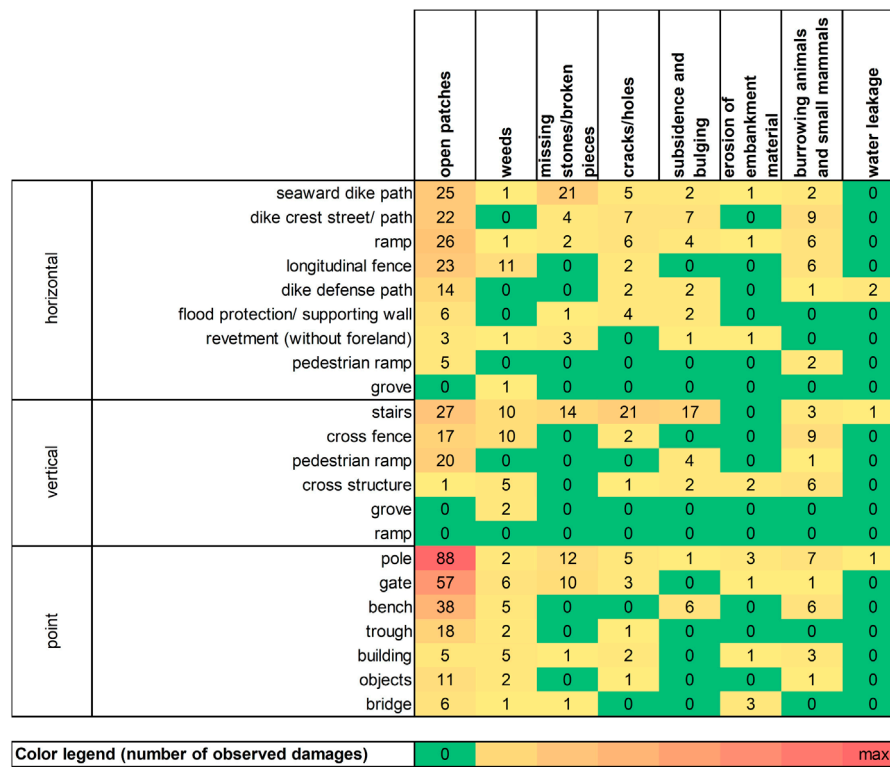
The type of damage depends on the type of transition and is not uniformly distributed. The presentation in matrix form in Figure 13 makes it possible to show the relationships between damage category and transition type. By far, the most common type of damage is damage to the vegetated top layer in the form of open patches, accounting for 56% of all damage recorded (Figure 13). Missing stones and break-offs, weeds, burrowing animals and small mammals as well as cracks and holes are responsible for further damage with 8%-9.5% each. Damage caused by subsidence/settlement and bulging was identified at 6.5%, erosion of the dike body material at 1.8% and water leakage at only 0.5%.

Most of the damages are found at poles, where 74% of the damages are due to open patches. Other point transitions that showed high damage rates were gates and benches, which were also mainly characterized by open patches in the turf. For vertical transitions most damage was observed at stairways, where especially

FIGURE 13
Heat map showing the most frequent forms of damage per transition type in absolute numbers of damages observed in the field (see Legend: from green = no damage to red = most frequent combination of damage form and transition type).
