Framing Failures in Wood-Frame Hip Roofs under Extreme Wind Loads

Sarah A. Stevenson¹, Gregory A. Kopp^{1*} and Ayman M. El Ansary²

Stevenson SA, Kopp GA and
El Ansary AM (2018) Framing Failures
in Wood-Frame Hip Roofs under
Extreme Wind Loads.
Front. Built Environ. 4:6.
doi: 10.3389/fbuil.2018.00006

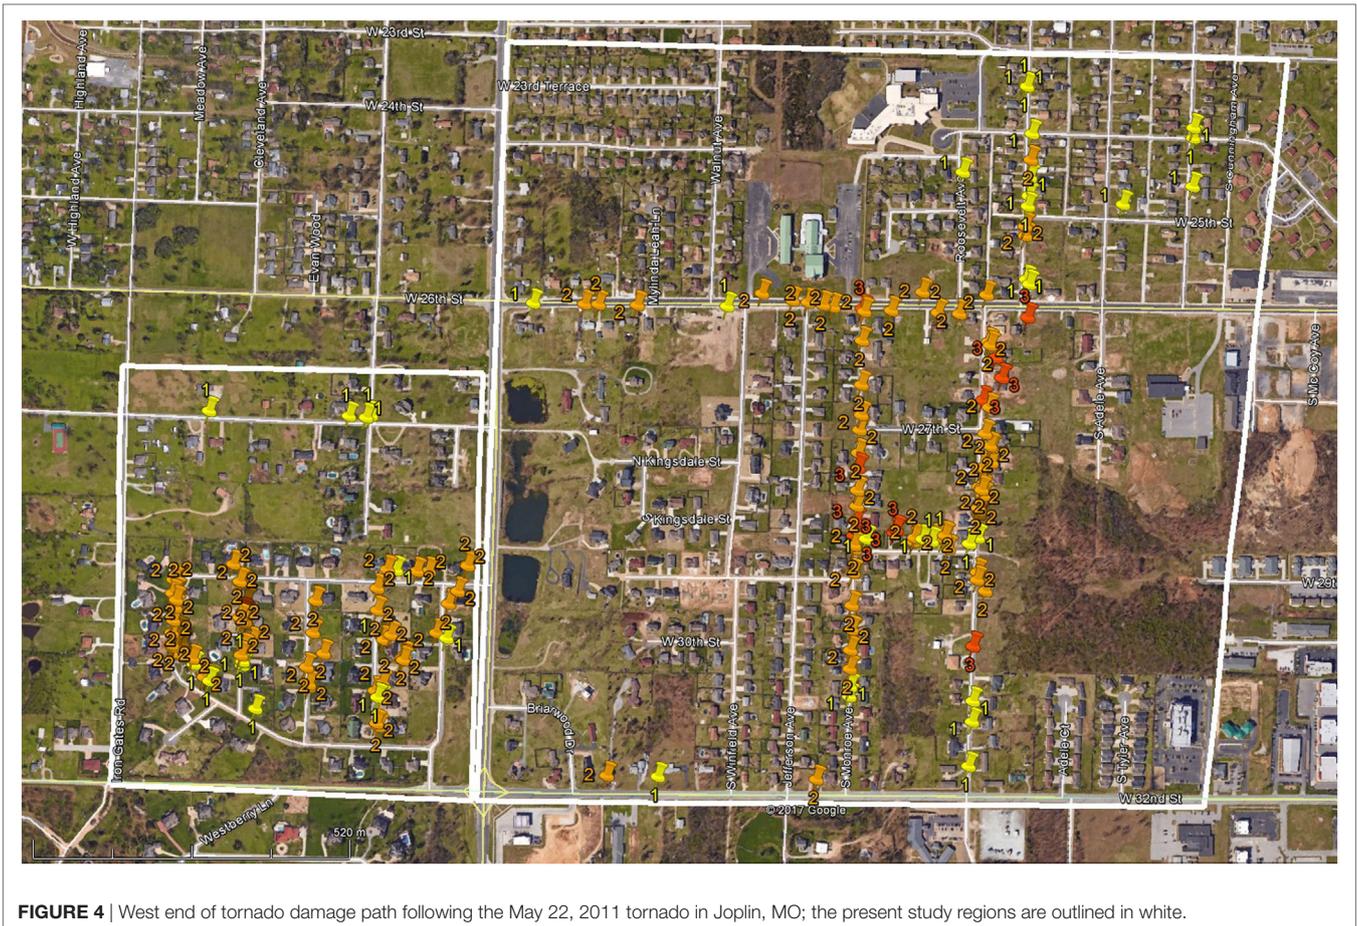
Two study areas, outlined in white on **Figure 4**, are analyzed and the occurrence of different failure modes is assessed. The damage photos at the marked locations were inspected and the perceived mode of failure is noted. In this pass through the data, each separate residence was assessed as to whether the damage appeared to be RTWC, sheathing, or framing failure. Beyond roof damage, wall failures corresponding to DOD-7 are included. The study areas were selected based on the characteristics of the houses. Historical imagery from Google Earth is used to identify the original shape of the studied roofs. Region 1, on the left side of **Figure 4**, is found to contain houses that appeared to be newer, most with steep-sloping hip roofs and large building footprints. The homes in Region 2 mostly appear to be older, masonry homes with shallow wood-framed roofs.

FIGURE 4 | West end of tornado damage path following the May 22, 2011 tornado in Joplin, MO; the present study regions are outlined in white.

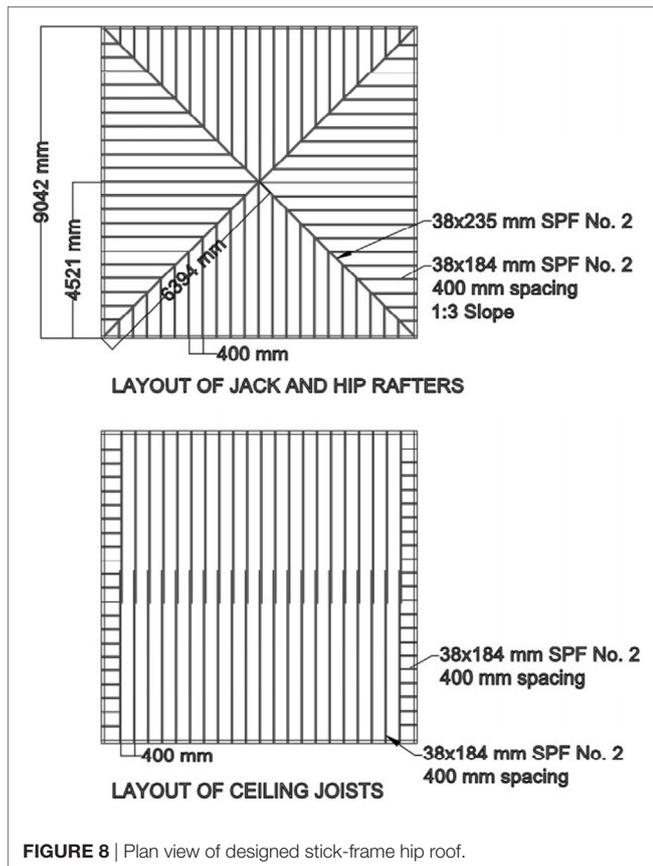
For the stick-frame roof, Section 9.23 of the NBCC (Canadian Commission on Building and Fire Codes, 2010) is used to determine the appropriate member placement and sizing requirements, in addition to the minimum number and direction of nails in each joint. The resulting structure is illustrated in **Figure 8** with member sizes and spacing labeled. The member layout of stick-frame roofs induces load sharing between the faces and individual members of the roof. The hip rafter transfers loads between members on adjacent faces of the roof and the sheathing plays a role in the member-to-member system effects across a single face.

FIGURE 8 | Plan view of designed stick-frame hip roof.

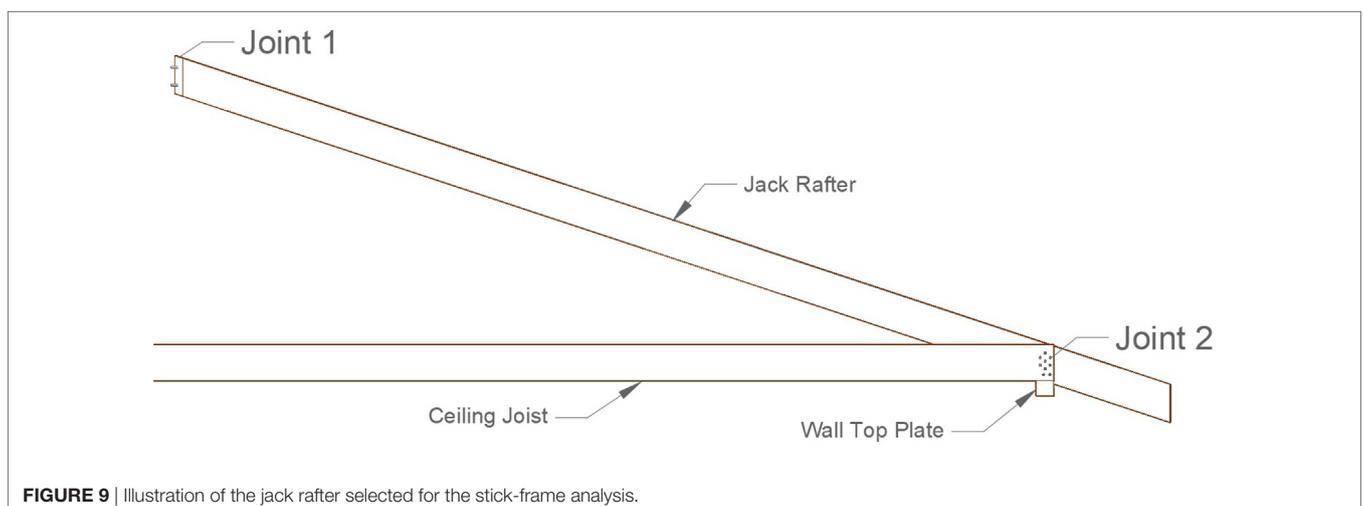
Due to this layout, it is not possible to extract a two-dimensional cross-section from the roof for analysis, as was effectively done in the trussed roof. Instead, the present analysis of the stick-frame roof is simplified by studying a single, representative jack rafter. Upon inspection, the rafters nearest to the center of the roof are deemed to be under the highest demand under roof pressures, due to having the longest unsupported spans. The central jack rafters are expected to experience the highest moments and shear internal forces, and their joints will need to resist the largest support reactions. The faces of the roof are identical and so the selected jack rafter, shown in **Figure 9**, represents four different jack rafters within the roof.

FIGURE 9 | Illustration of the jack rafter selected for the stick-frame analysis.
