Aslan H, Kocaman H, Sikar RB and Turan İC (2025) Impact and GNSS-based deformation analysis of the earthquake in Türkiye on 6 February, 2023: a case study of the TAG (Tarsus–Adana–Gaziantep) motorway and Hatay airport.

Impact and GNSS-based deformation analysis of the earthquake in Türkiye on 6 February, 2023: a case study of the TAG (Tarsus–Adana–Gaziantep) motorway and Hatay airport

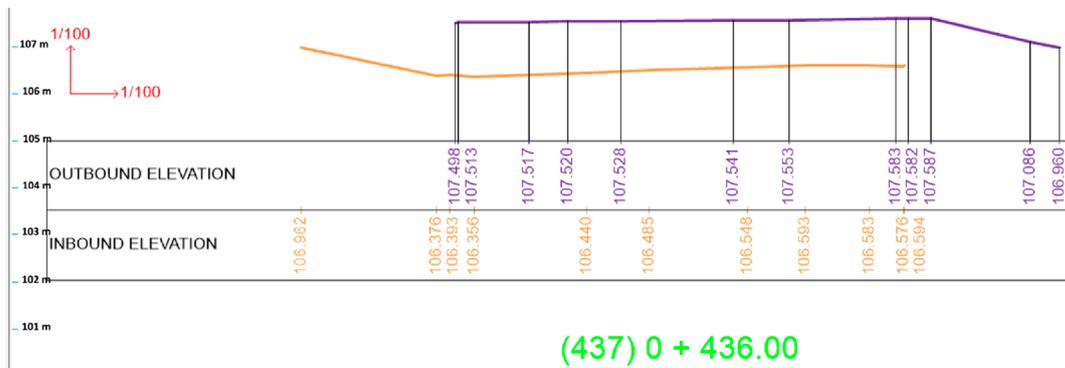
FIGURE 19 Comparison of inbound and outbound roadway cross-sections (0 + 436).

In Figure 19, the cross-sections of the ingoing and outgoing roads were compared, and it was seen that the ground level difference between the two roads at the chainage point of 0 + 436 is over 1 m. The projection of this situation at 0 + 436 on both profiles is compared in Figure 20.

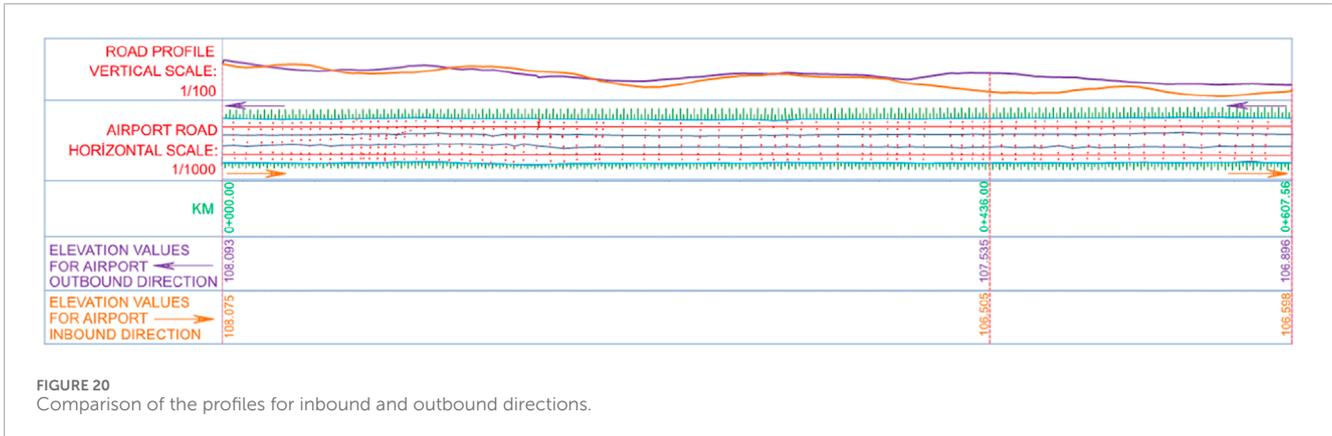
FIGURE 20
Comparison of the profiles for inbound and outbound directions.

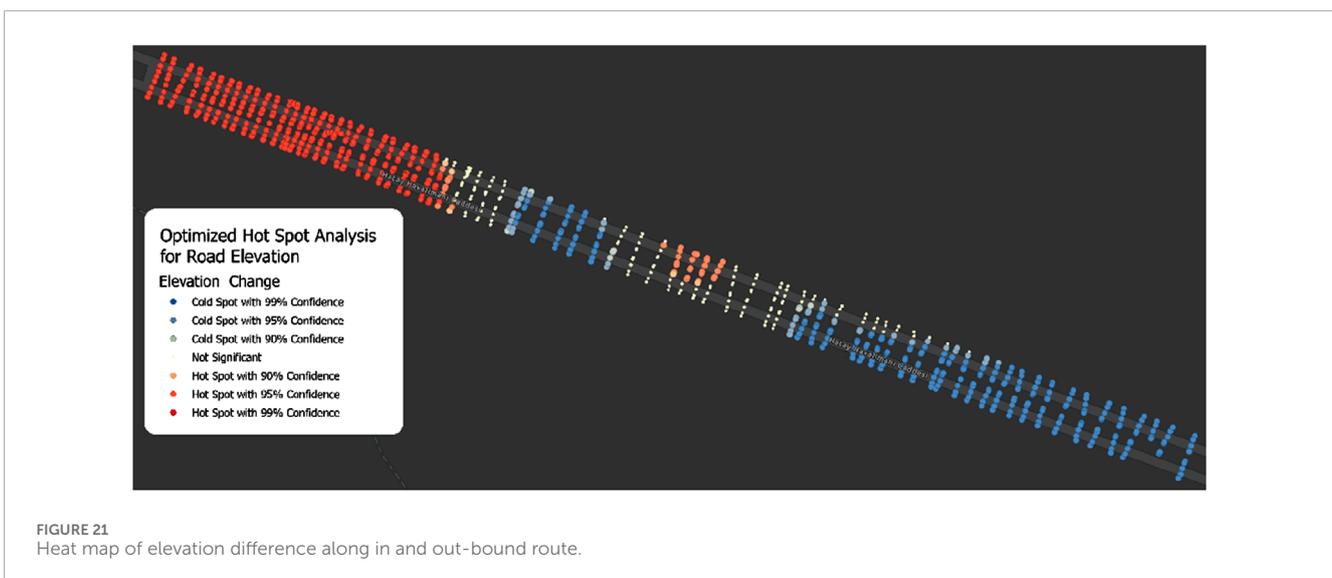
The elevation changes measured along in and out-bound routes were analyzed using the Optimized Hot Spot Analysis tool of ArcGIS Pro. Accordingly, a hot spot analysis map of the change was created (Figure 21).

FIGURE 21
Heat map of elevation difference along in and out-bound route.
