Zhang L, Wang Z, Zhang W and Liu S  
(2023), Sandy aquifer collapse  
mechanism and accident treatment of  
the Qingdao metro tunnel.  
*Front. Earth Sci.* 11:1293258.  
doi: 10.3389/feart.2023.1293258

# Sandy aquifer collapse mechanism and accident treatment of the Qingdao metro tunnel

The tunnel collapse occurred during the construction of the Qingdao Metro Line I, resulting in a pit measuring approximately 10 m in diameter and 7 m in depth on the ground surface. The collapse inflicted substantial economic losses, casualties, and subsequent disruptions to ongoing construction activities. To clarify the causes of this collapse and investigate the underlying factors, a comprehensive approach combining field surveys and numerical simulations was undertaken. The results show that the collapse was primarily attributed to inadequate support when facing the challenging geological conditions, poor surrounding rocks (Grade VI) and a high volume of groundwater. The combination of abundant water and sand seeped into the tunnel, culminating in a catastrophic ground collapse. Notably, the arch roof experienced extensive deformation and damage due to the significant seepage pressure, which w

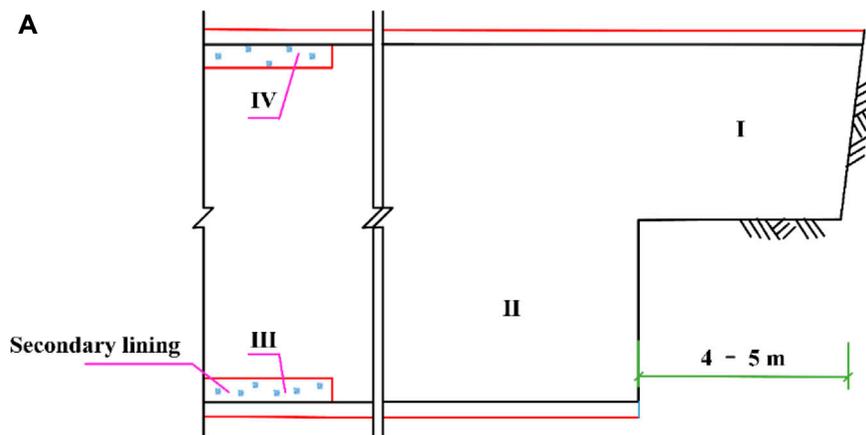
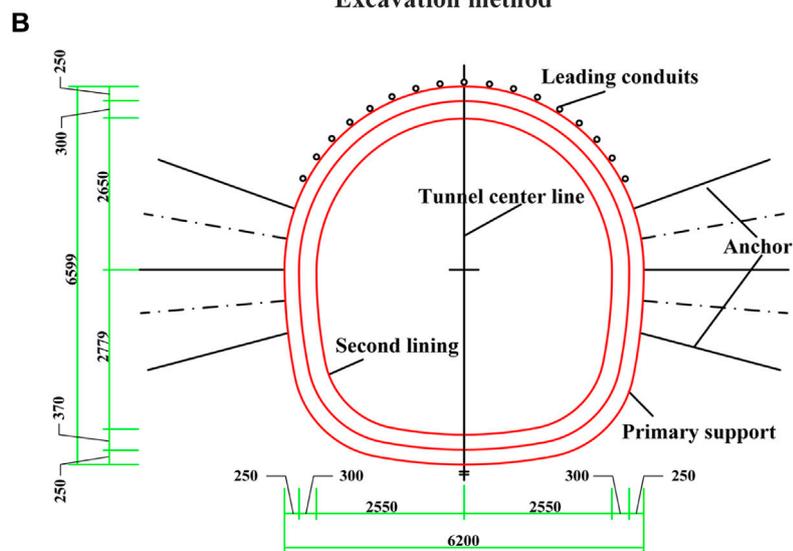
FIGURE 2

The mainly tunnelling method in Kai-sheng section is the benching method, as shown in Figure 2A. It is about 3.2 m high for upper bench, 3.4 m high for lower bench, and 4–5 m long for each bench. The circular excavation footage is adjusted according to different surrounding rock grades, which is 0.5 m in the areas with V and VI surrounding rocks, 0.75 m in the areas with IV surrounding rocks and 1.0–1.5 m in the areas with II and III surrounding rocks. The excavation section was approximately 6.2 m wide and 6.6 m high. The parameters of the tunnel support are shown in Figure 2B. The initial support of the tunnel is composed of grid arches with a vertical spacing of 0.5 m and shotcrete of 300 mm thick C25. The advanced support was performed in such a way that 42 mm leading conduits with a length of 3.0 m and inclination of 15°, were mounted into the rock in the 120° range around the extrados of the tunnel. The secondary lining is the reinforced concrete lining composed of C45 waterproof concrete and steel bars. In the areas with VI

The excavation method and tunnel support. (A) Excavation method. (B) Tunnel support parameters (unit: mm).

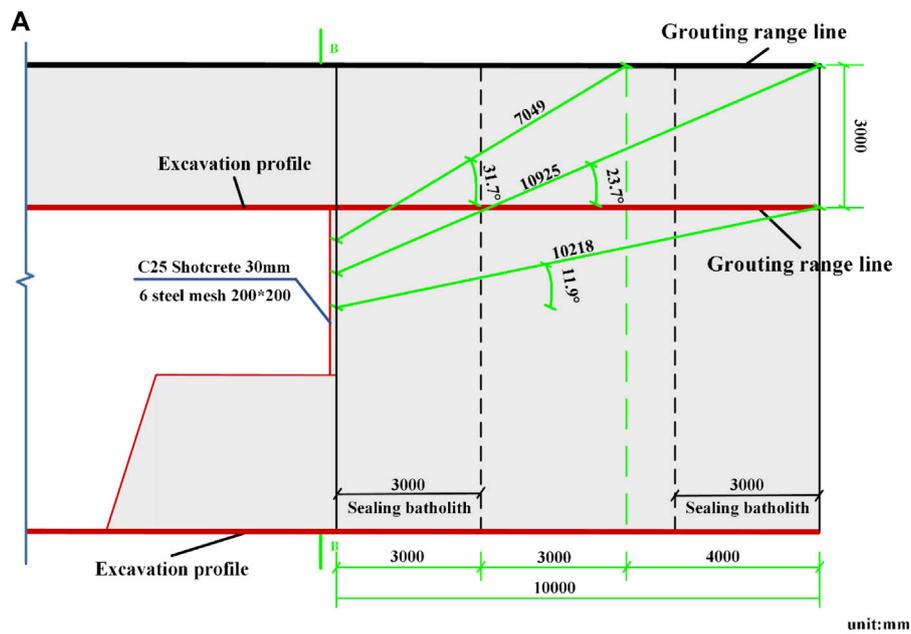
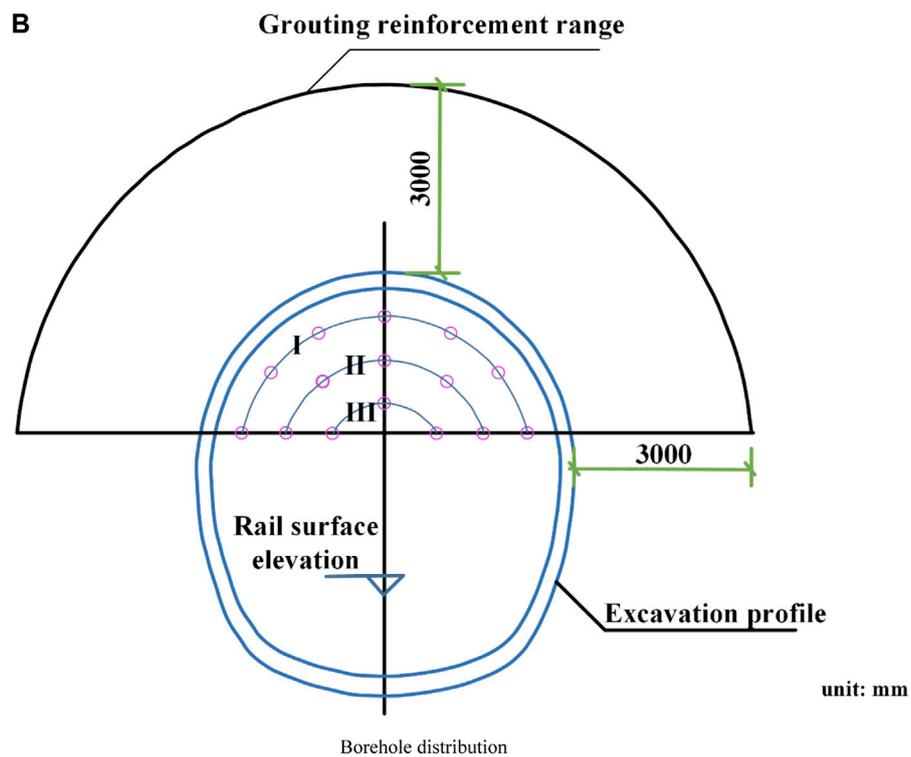
**FIGURE 3** Schematic diagram of semi-section advanced deep hole grouting. (A) The single-hole depth and inclination of three different boreholes. (B) Borehole distribution.

When the tunnel vault encounters the strong-weathered rock layer and sand layer, the semi-section advanced deep hole grouting, as illustrated in Figure 3, was conducted. A total of 15 boreholes are drilled in the tunnel face, including 7 boreholes

I, 5 boreholes II and 3 boreholes III (Figure 3B). Figure 3A shows the single-hole depth and inclination of three different boreholes with a diameter of 89 mm, *i.e.*, the borehole I has a single-hole depth of 7.1 m and inclination of 31.7°, the borehole II has a single-hole depth of 10.9 m and inclination of 23.7°, the borehole III has a single-hole depth of 10.2 m and inclination of 11.9°.

Cement-water glass slurry is used as grouting material. The grouting reinforcement was conducted in an area within 3 m of the initial support of the tunnel contour line (Figure 3B). Before the first cycle of construction, C25 shotcrete with a

thickness of 300 mm was sprayed on the working face to serve as a pulp wall, and then grouting is performed (Figure 3A). In the subsequent construction of 10 m per cycle, 7 m will be excavated and 3 m will be reserved as sealing batholite (Figure 3A).

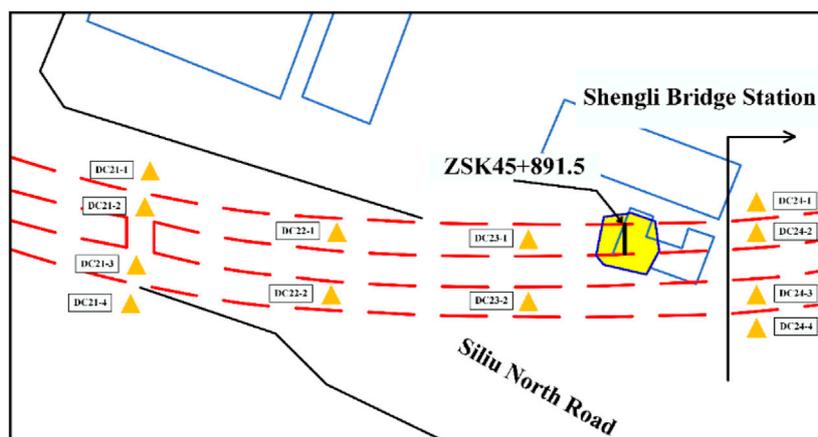
FIGURE 5  
Distribution of monitoring points.

In order to understand the impact of the construction on the surrounding environment and ensure the construction safety, many monitoring points were placed on the surface to record the ground settlement, as shown in Figure 5. The interval between two adjacent monitoring points for ground surface settlement, e.g., DC22 and DC23, is about 20 m. Figure 6 shows the variations of ground settlement from 4 June to 3 July 2019. It can be observed that the settlement increased rapidly at DC21, DC22 and DC24 from 9 June to 13 June. During this

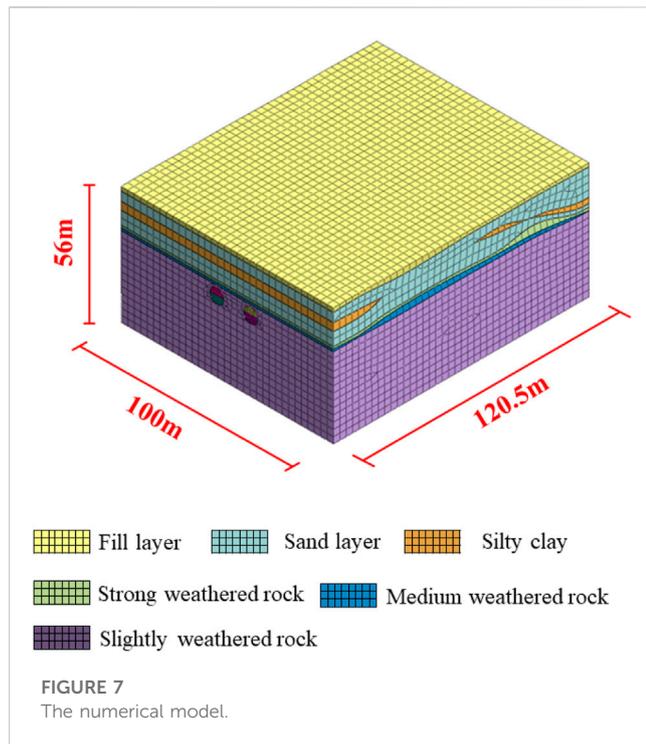
45+937.00, the 3D finite element numerical model was established by Midas GTX NX, as shown in Figure 7. The model size was 100 m×120.5 m×56 m, and the buried depth of tunnel was 18.5 m. In the model, the mechanical properties of strata are shown in Table 2. Meanwhile, considering the deterioration of surrounding rock caused by seepage, blasting and other factors, the values of  $c$  and  $\varphi$  were taken as 60% of the values in Table 2 (Qiu et al., 2021). According to the actual excavation process, the left tunnel face was ahead of the right tunnel face with an interval of 15 m. The tunnel was excavated by the benching method, with a single bench length of 5 m. After the excavation of each bench, C25 concrete was conducted as the initial support. In terms of on-site support, only 3 m was supported after the last bench excavation was completed, and 2 m suspension space was set between the primary support and the tunnel face. The water level of the model was set at the bottom of the plain fill, i.e., at the interface with the sand layer, which was about -2 m.
