Yao J, Yang Y, Yang M, Shen Z, He X and
Chen X (2025) Research on the diagnosis of
leakage hazards in a karst reservoir based on
integrated electrical method and geological
method.
Front. Earth Sci. 13:1578017.
doi: 10.3389/feart.2025.1578017

Research on the diagnosis of leakage hazards in a karst reservoir based on integrated electrical method and geological method

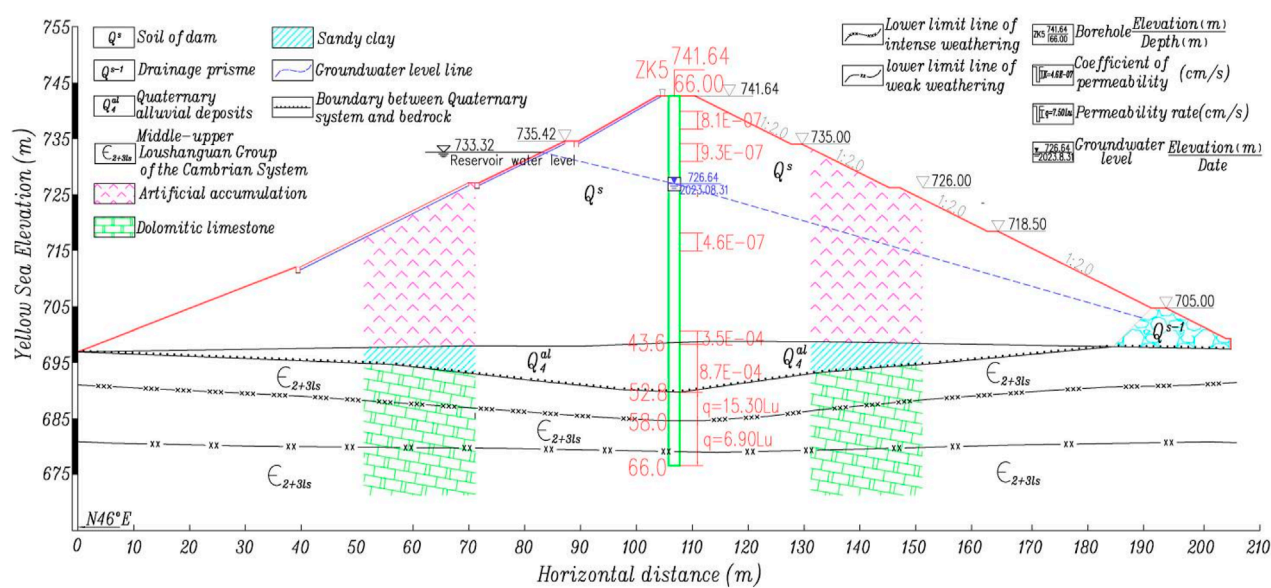
FIGURE 3
Longitudinal section at the centerline of the dam body.

On 18 August 2023, when the reservoir water level was at 733.32 m, we conducted an exhaustive geological survey and inspection of the leakage risk indications in the dam site area. Field geological investigations revealed that there was abutment seepage around both the left and right dam abutments below elevations of approximately 728.0 m and 724.0 m, respectively. The total seepage volumes amounted to approximately 0.5 L/s and 0.3 L/s, respectively. Additionally, near the areas of concentrated abutment seepage, there were large areas of dispersed seepage with multiple concentrated leakage points on the third and fourth-grade downstream slopes at both ends of the dam body. The dispersed seepage areas measured approximately 30 m² and 18 m², with total seepage volumes of 0.25 L/s and 0.1 L/s, designated as Leakage Area 1 and Leakage Area 2, respectively. Meanwhile, there was a sump well at the middle of the dam toe from which water flowed continuously throughout the year, with a seepage rate of approximately 0.8 L/s, labeled as Leakage Area 3. There was also a dispersed wet area measuring approximately 12 m² on the fourth-grade downstream slope at the top of the power conveyance culvert outlet section, though no concentrated leakage points were observed, designated as Leakage Area 4. Notably, the leakage volumes at these leakage risk points exhibited a high correlation with the reservoir water level, disappearing partially during low water levels but significantly increasing in terms of both dispersed seepage area and concentrated leakage volumes during high water levels, posing a serious threat to dam safety.
