Bai P, Li Z, Yu C, Liu E, Gao H, Xie Y and Yan Z (2024), Experimental research on creep characteristics and failure mechanism of mining roadway in nearly vertical coal seams. *Front. Earth Sci.* 12:1425208. doi: 10.3389/feart.2024.1425208

# Experimental research on creep characteristics and failure mechanism of mining roadway in nearly vertical coal seams

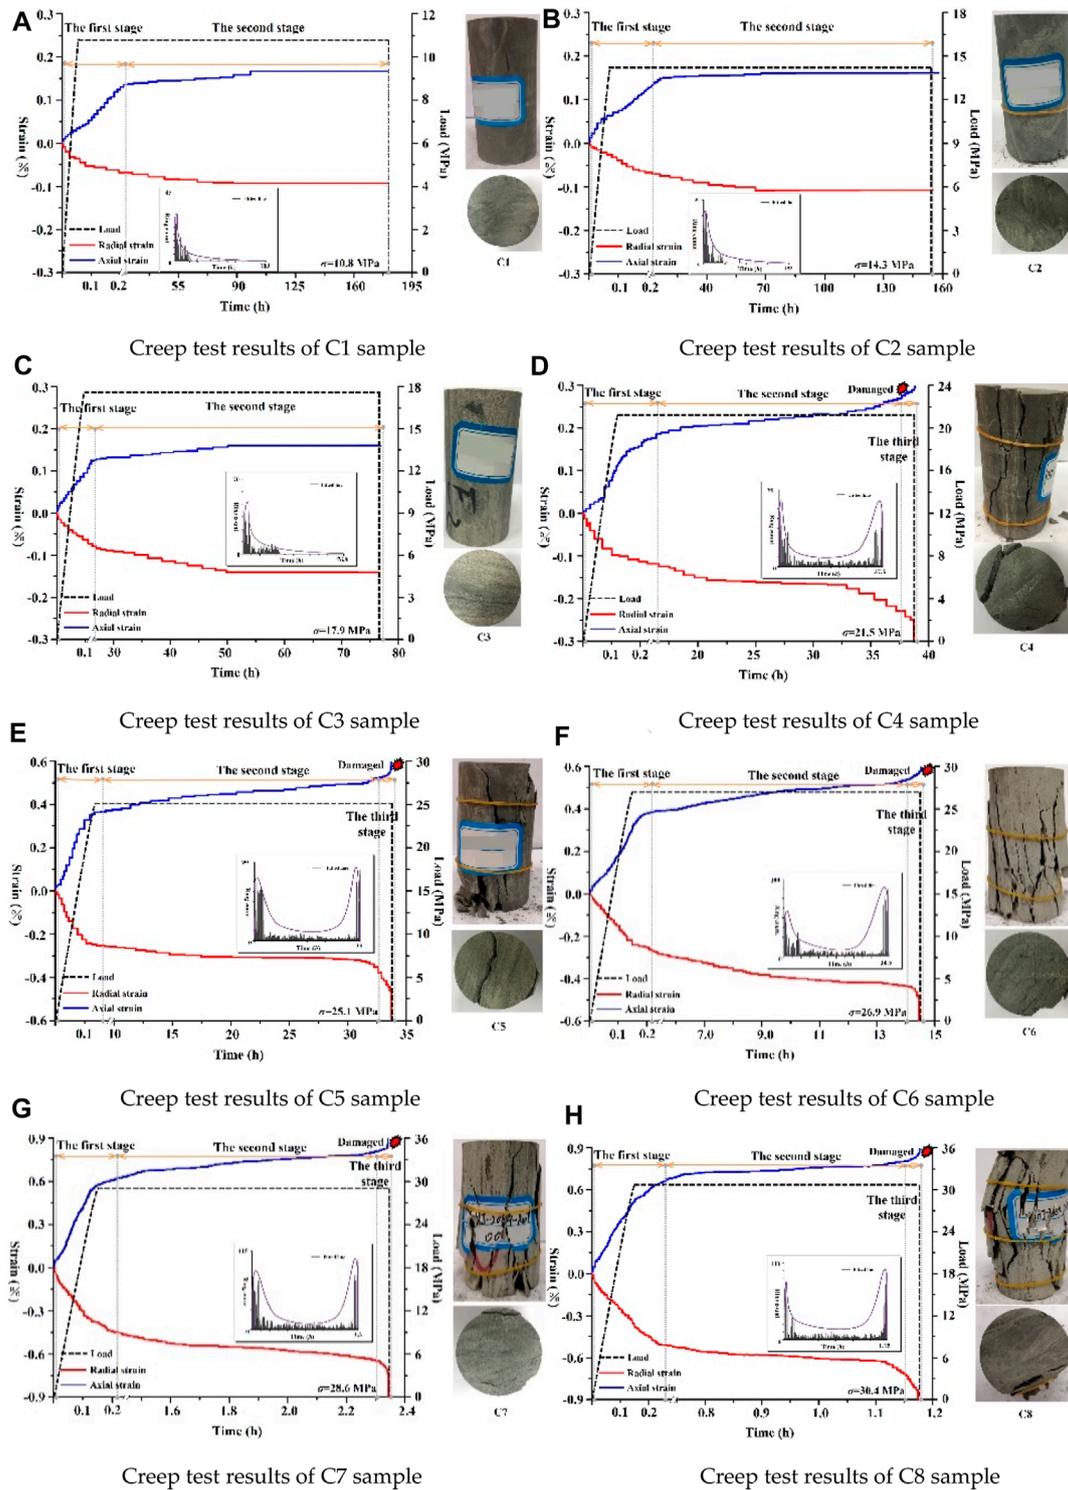
**FIGURE 1** Creep test curve of rock samples. (A) Creep test results of C1 sample (B) Creep test results of C2 sample (C) Creep test results of C3 sample (D) Creep test results of C4 sample (E) Creep test results of C5 sample (F) Creep test results of C6 sample (G) Creep test results of C7 sample (H) Creep test results of C8 sample.

Figures 1A–C show the time evolution of stress and strain for samples C1, C2, and C3. These samples underwent both the first and second stages under static load, and finally reached a stress equilibrium state in the second stage, without any overall or local damage. A small amount of debris was visible on the upper and lower surfaces of samples C2 and C3, caused by the large stiffness of the press bearing plate and press shaft, although this did not impact

Figures 1D through H demonstrate the stress-strain evolution and failure modes for five rock samples (C4 to C8). The creep time decreases as the applied stress increases while the final creep

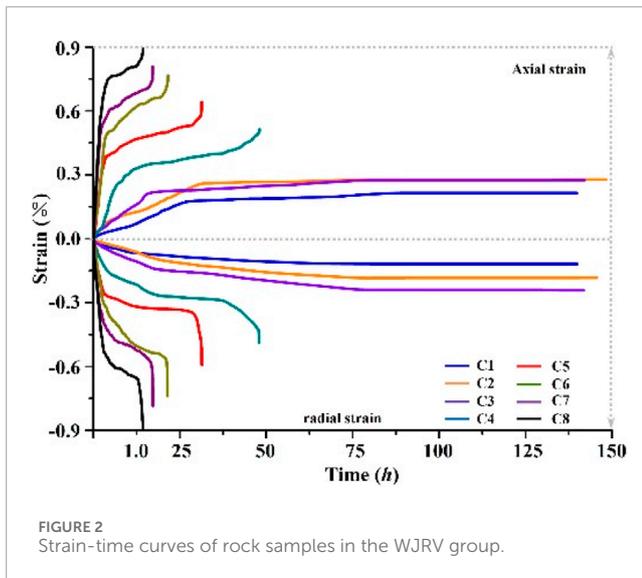
FIGURE 2  
Strain-time curves of rock samples in the WJRV group.

and strain rate during the first stage increase proportionally to the applied stress as shown in Figure 2. The failure mode of the specimens is primarily shear failure occurring along the structural plane as well as in the normal direction to the structure through transverse shear failure. When under static load, the stress state of the vertical structural plane can be simplified as a plate structure with fixed ends. Under the influence of the horizontal component force, transverse tensile and shear failure occurs in the middle part of the plate structure. Usually, the initial failure occurs near the unsupported free surface, followed by layer-by-layer tension-shear failure from the outside to the inside until the entire sample becomes unstable. In one experiment with C4, the rock sample first exhibited two vertically stepped tension-shear failure surfaces, followed by a connection failure surface with a stepped tension-shear failure surface. This occurrence was due to the shear failure of the sample; the rocks on both sides of the failure surface fell off the sample. The rock in the area between the two failure surfaces bore the static loads and had inclined slip shear failure along the direction of the weakest thickness. As a result, the samples exhibited a combined failure form of vertical stepped tension-shear failure and inclined slip shear failure.

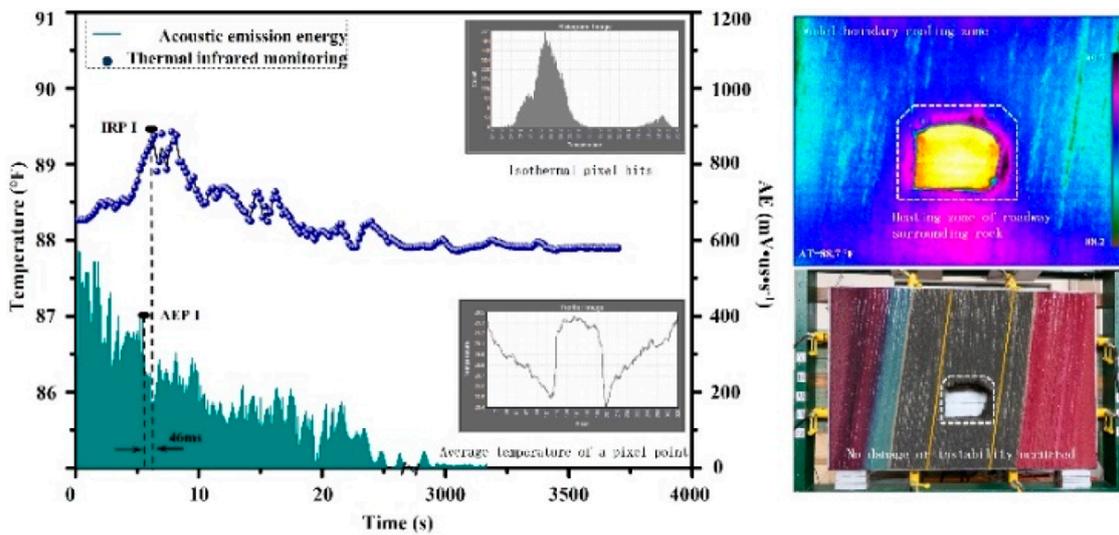
FIGURE 4 Monitoring results of the first stage.

deformation, and the acoustic emission signals gradually weakened. The model contracted inwards with a decreasing shrinkage rate. Eventually, a transverse elastic deformation of about 1.2 cm and a vertical elastic deformation of 1.6 cm were generated. It is noteworthy that during this process, weak heat emission was detected at the edge of the model by thermal infrared imaging (Figure 4).

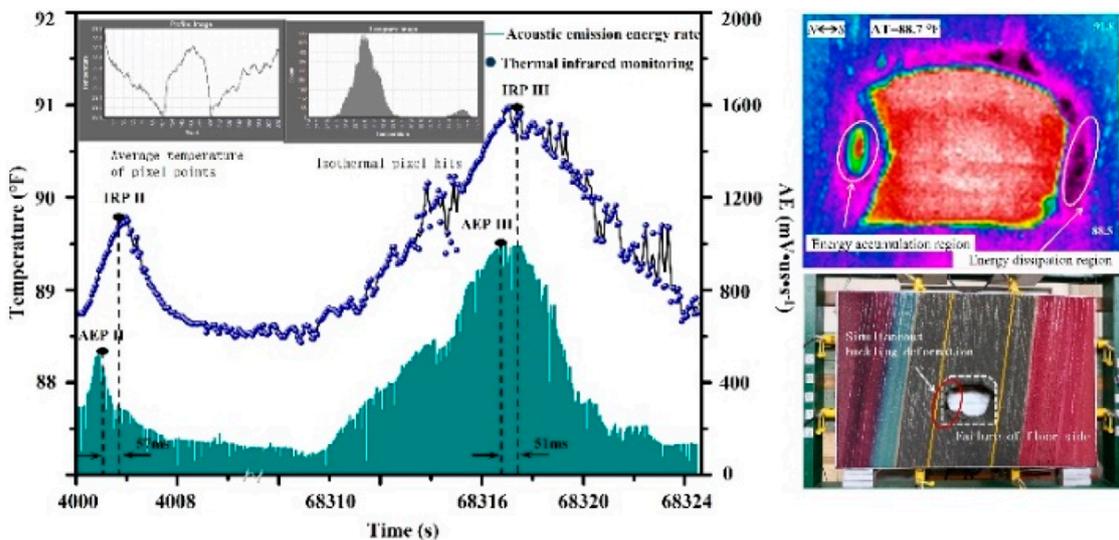
FIGURE 5 Monitoring results of the second stage.

The thermal infrared monitoring results showed that during the secondary stress loading phase, the model exhibited plastic deformation at the edge, leading to a temperature rise at the corresponding position. Due to the model's energy and heat exchange process with the environment being short, there was a transient temperature rise phenomenon observed. During localized creep of the coal and rock surrounding the roadway, there was a significant temperature rise, indicating the existence of accumulated

energy under the influence of high stress levels. This points to a serious tendency towards failure (Figure 5).

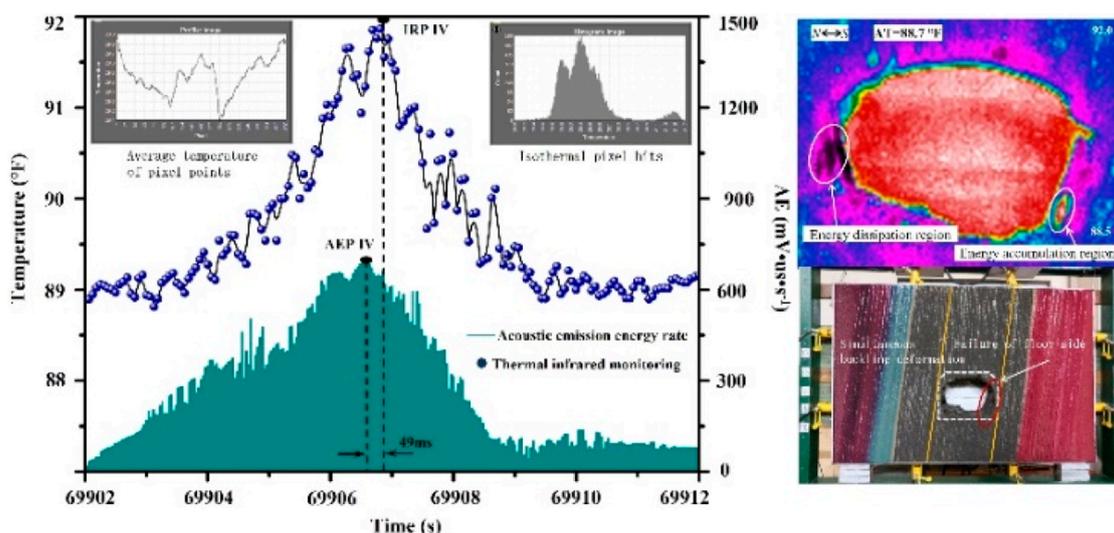
FIGURE 6  
Monitoring results of the third stage.

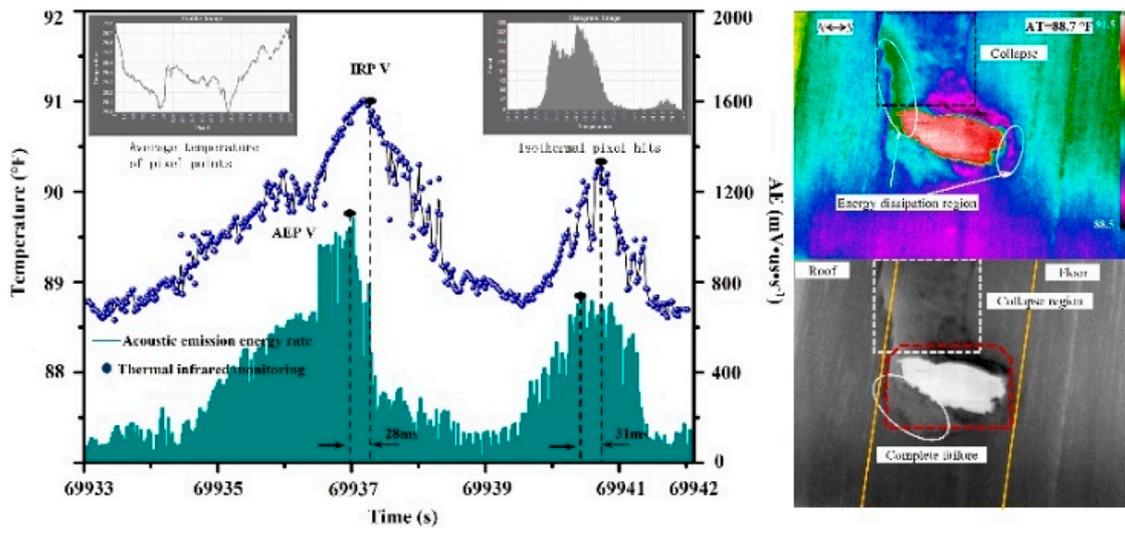
FIGURE 7 Monitoring results of the fourth stage.

the bottom of the coal free surface increased to the fourth infrared monitoring peak point (IRP IV), forming a heat radiation zone. The horizontal distance between the heat radiation zone and the free surface of the coal and rock is 0.8 m. In the process of coal and rock deformation and dynamic instability, local temperature-rise and acoustic emission energy rate jumps occur, with the AE peak time being 16–18 ms earlier than rock fracture. This provides a basis for locating coal and rock stress concentration and disaster warning caused by instability through AE and thermal radiation area (Figure 7).

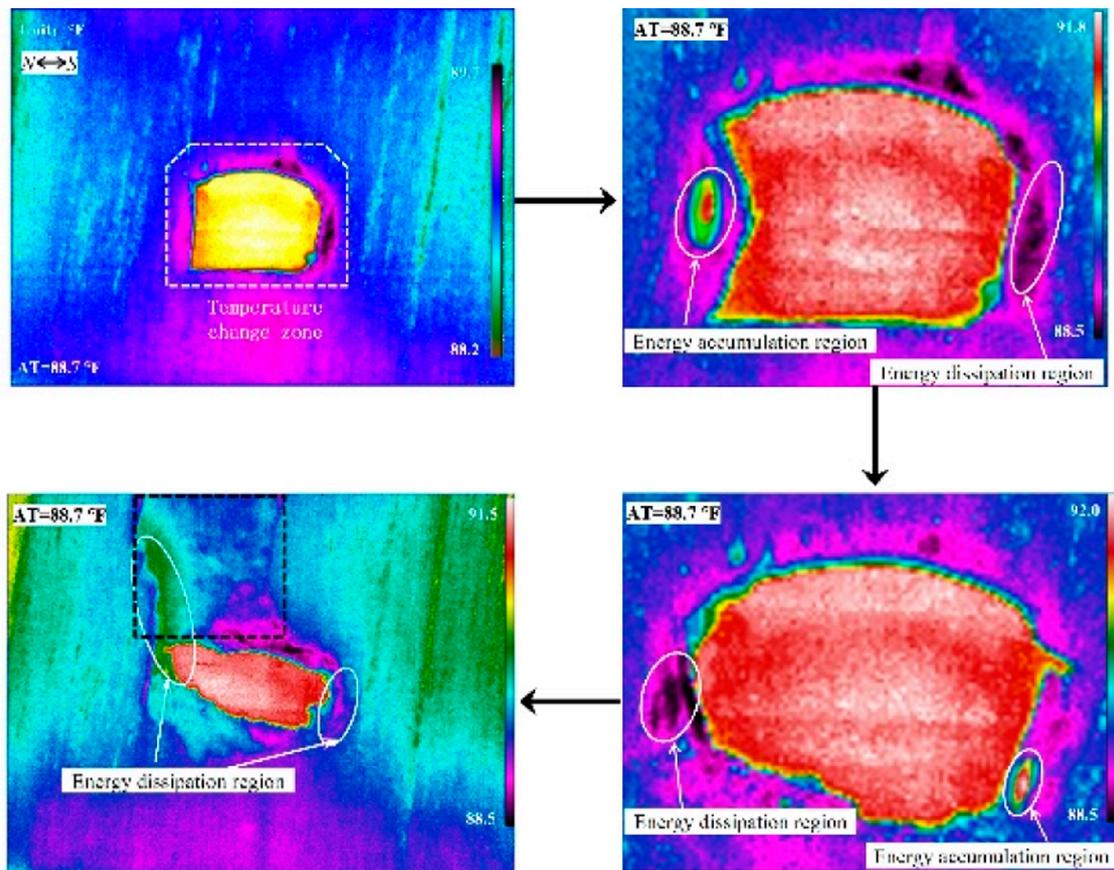
FIGURE 8 Dynamic aging characteristics of roadway rock mass deformation.

The thermal infrared monitoring data shows that the coal and rock at the boundary of the model have undergone a creep process, and energy is consumed or lost before the coal and rock at the top of the tunnel are destroyed and unstable. Most of the coal and rock at the boundary are in a state after energy dissipation, without any temperature jumps, indicating that the energy is accumulating currently. The fifth and sixth peak points of thermal infrared (IRP V and VI) appear after the corresponding peak points of acoustic emission, and the intensity of the sixth peak point is weaker than that of the fifth peak point due to the smaller collapse range of coal and rock at the top of the roadway. Subsequently, the model enters the process of temperature drop again, and the surface temperature of the model returns to normal room temperature (Figure 8).

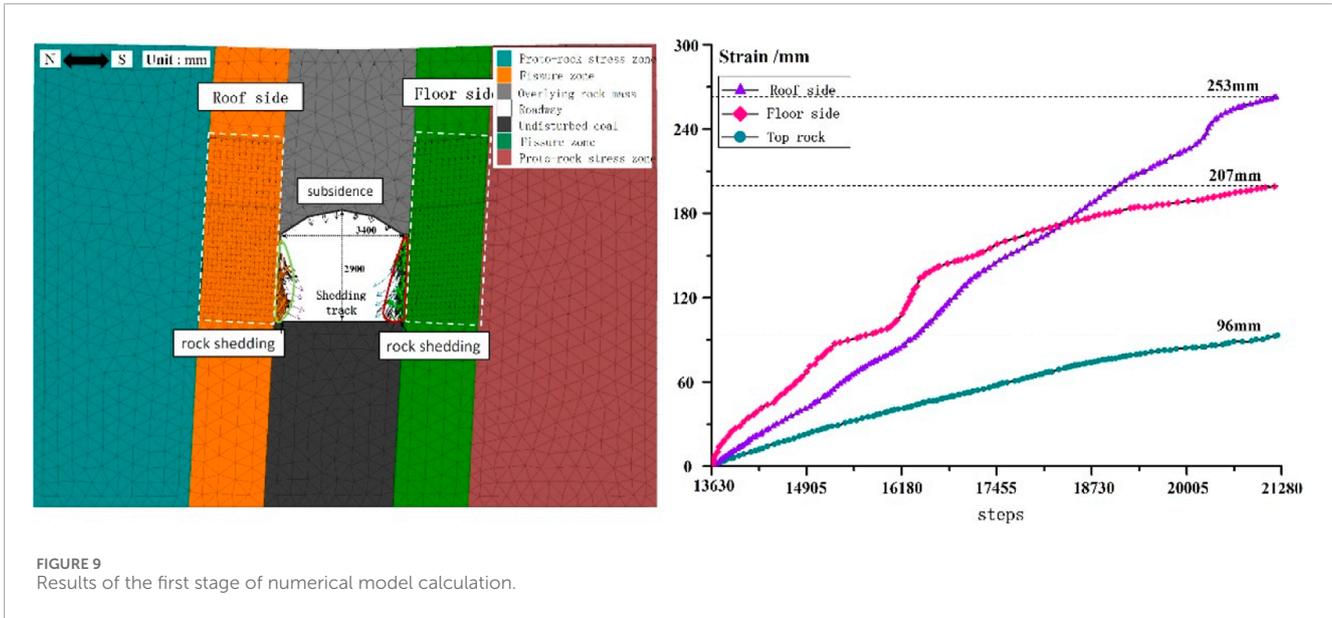
The coal and rock on both sides of the roadway roof and floor begin to deform and collapse under the comprehensive action of vertical and horizontal dynamic loads, with complete collapse observed when the calculation step reaches 21,275. As the coal and rock in the range of mining disturbance form fracture zones with low internal strength, the mechanical structure of the coal and rock becomes a unilateral opening force, leading to a caving behavior towards the free surface direction under the coupling disturbance of its dead weight and static and dynamic load. This behavior causes coal and rock to strip layer by layer from the parent coal and rock and accumulate in the roadway floor. The coal and rock far away from the roadway surface, however, retain good integrity and bear the majority of the vertical dynamic load. The main factors triggering the collapse of coal and rock on the surface are the dead weight of coal and rock, along with the horizontal dynamic load (Figure 9).

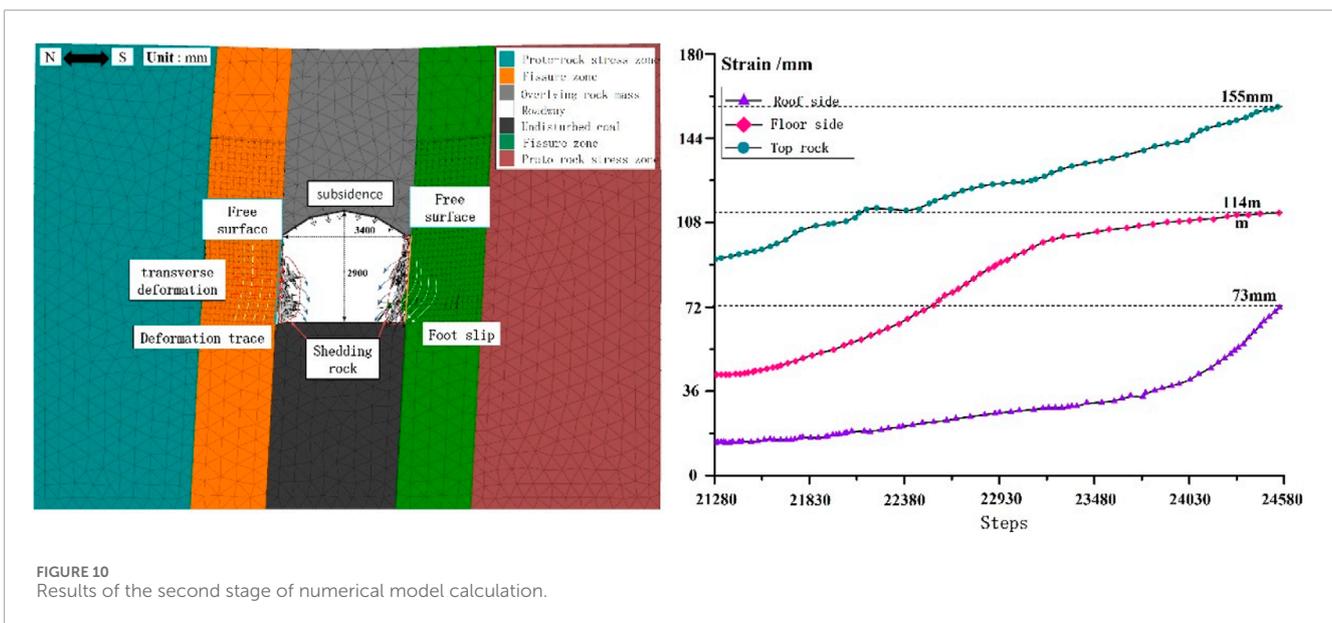
Following the deformation of coal and rock on the floor side, a portion of the stress transfers to the coal and rock on the roof side, resulting in a rise in strain rate on the roof side and an improvement in stress state on the floor side. The strain rate of coal and rock on the floor side gradually decreases, but the strain continues to increase. The calculation step reaches 24,500 when the strain rate of coal and rock on the floor side reaches its minimum value of 1.6 mm/102 steps, marking the end of the second stage of the calculation time limit. The roadway's two sides in coal and rock surface has caved in the bottom due to the action of gravity, with the load being transferred down to the two coal and rock formations. Due to the mechanical structural differences and horizontal force imbalances, the shallow part of the bottom side is prone to slip deformation and instability along the direction of the bedding structure of the coal and rock formation. Additionally, dynamic loads can cause further deterioration of the force environment, leading to separations of rock (Figure 10).

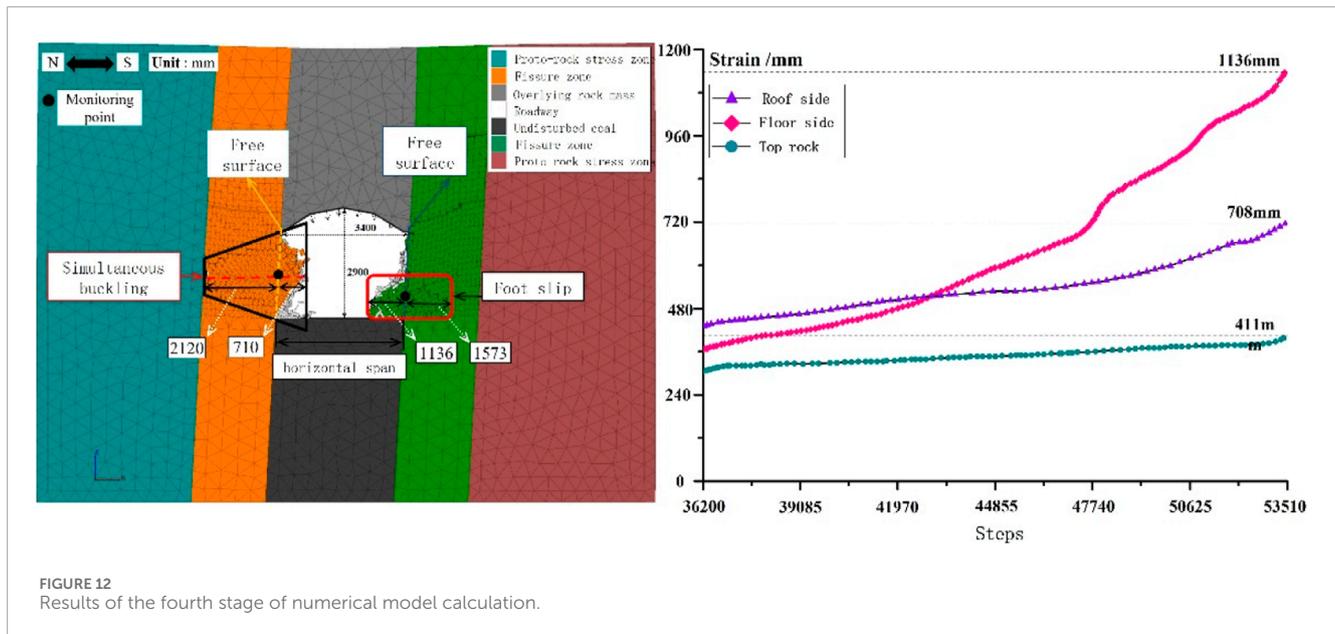
of the lower part of the coal and rock roadway roof side, which was excavated for roadway construction. Additionally, the large dip angle (about  $87^\circ$ ) of the coal and rock roadway sides resulted in the vertical compressive stress less than its internal layered structure surface strength, which was not enough to cause abscission of the hierarchical structure of the coal and rock. The outer layer of the roadway on both sides experienced compressive stress and obvious plastic deformation of coal. Under the influence of time effect, the creep of coal and rock on the roof side started from the central position of the roadway wall and the yield deformation grouped from inside to outside direction of the free surface leading to the phenomenon of co-buckling of roadway rock mass, produced by the combination of vertical compressive stress and lateral horizontal stress (Figure 12).
