Design, Fabrication, Installation, and Population of a Novel Fiberglass Reinforced Plastic Coral Nursery Structure Off the South Shore of O'ahu, Hawaii

Bardia Konh^{1*} and Matthew Parry²

Keywords: fiberglass reinforced plastic, underwater structure, manufacturing, coral nursery, coral rehabilitation, Hawaii, finite element analysis, whole colony

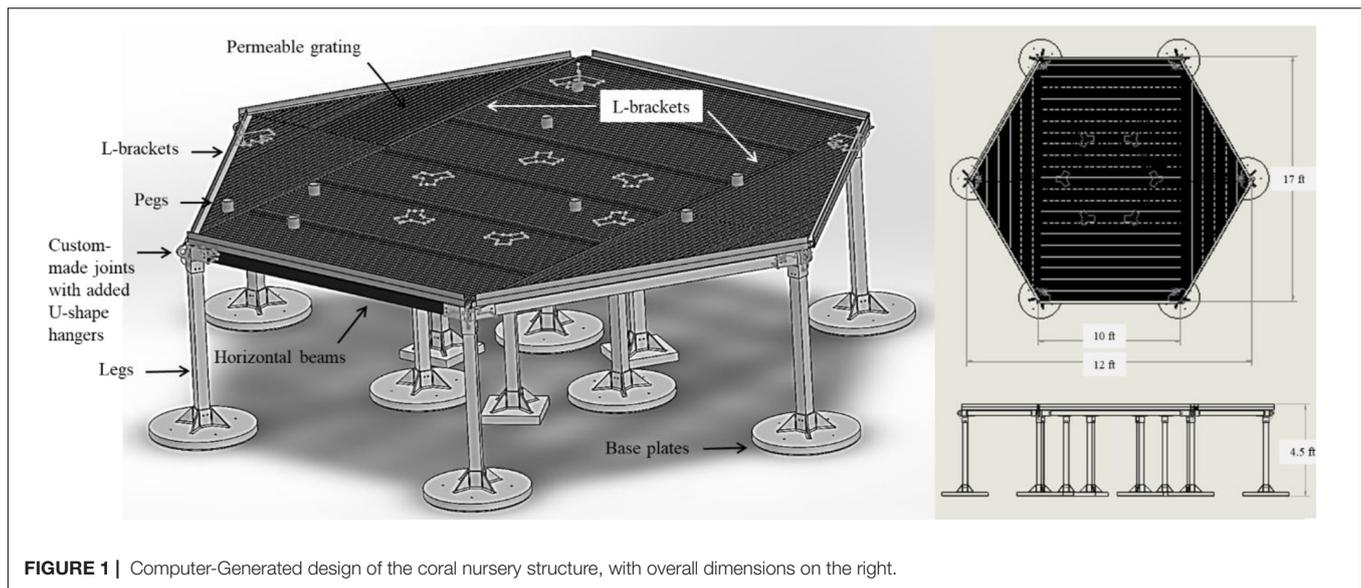
FIGURE 1 | Computer-Generated design of the coral nursery structure, with overall dimensions on the right.

The designed structure for the coral nursery structure is shown in **Figure 1**. This single-tier, hexagonal benthic structure was chosen for its ease of access and stability. The symmetrical shape of the structure was selected to resist the dynamic forces applied in any magnitude and direction. The single-tier platform was supported by 18 horizontal beams. The platform sat on 12 legs (six at the peripheral side and six at the center). These legs were distributed at specific points to prevent the top face from buckling or bending. Custom-designed joints were included to accommodate assembly of the structure. The joints were rigidly formed at predetermined angles for ease of assembly, as well as introducing more strength to the structure. The legs were sitting on a base plate that was either in a circular or a square shape. These plates helped prevent the structure from sinking into the sand. To hold the legs properly, the plates were reinforced by four angular gussets. The square shape base plates were used at the center to leave enough space between all base plates. In case of misalignment between the legs due to irregular bottom topography, this space provided easy access to divers to fit all

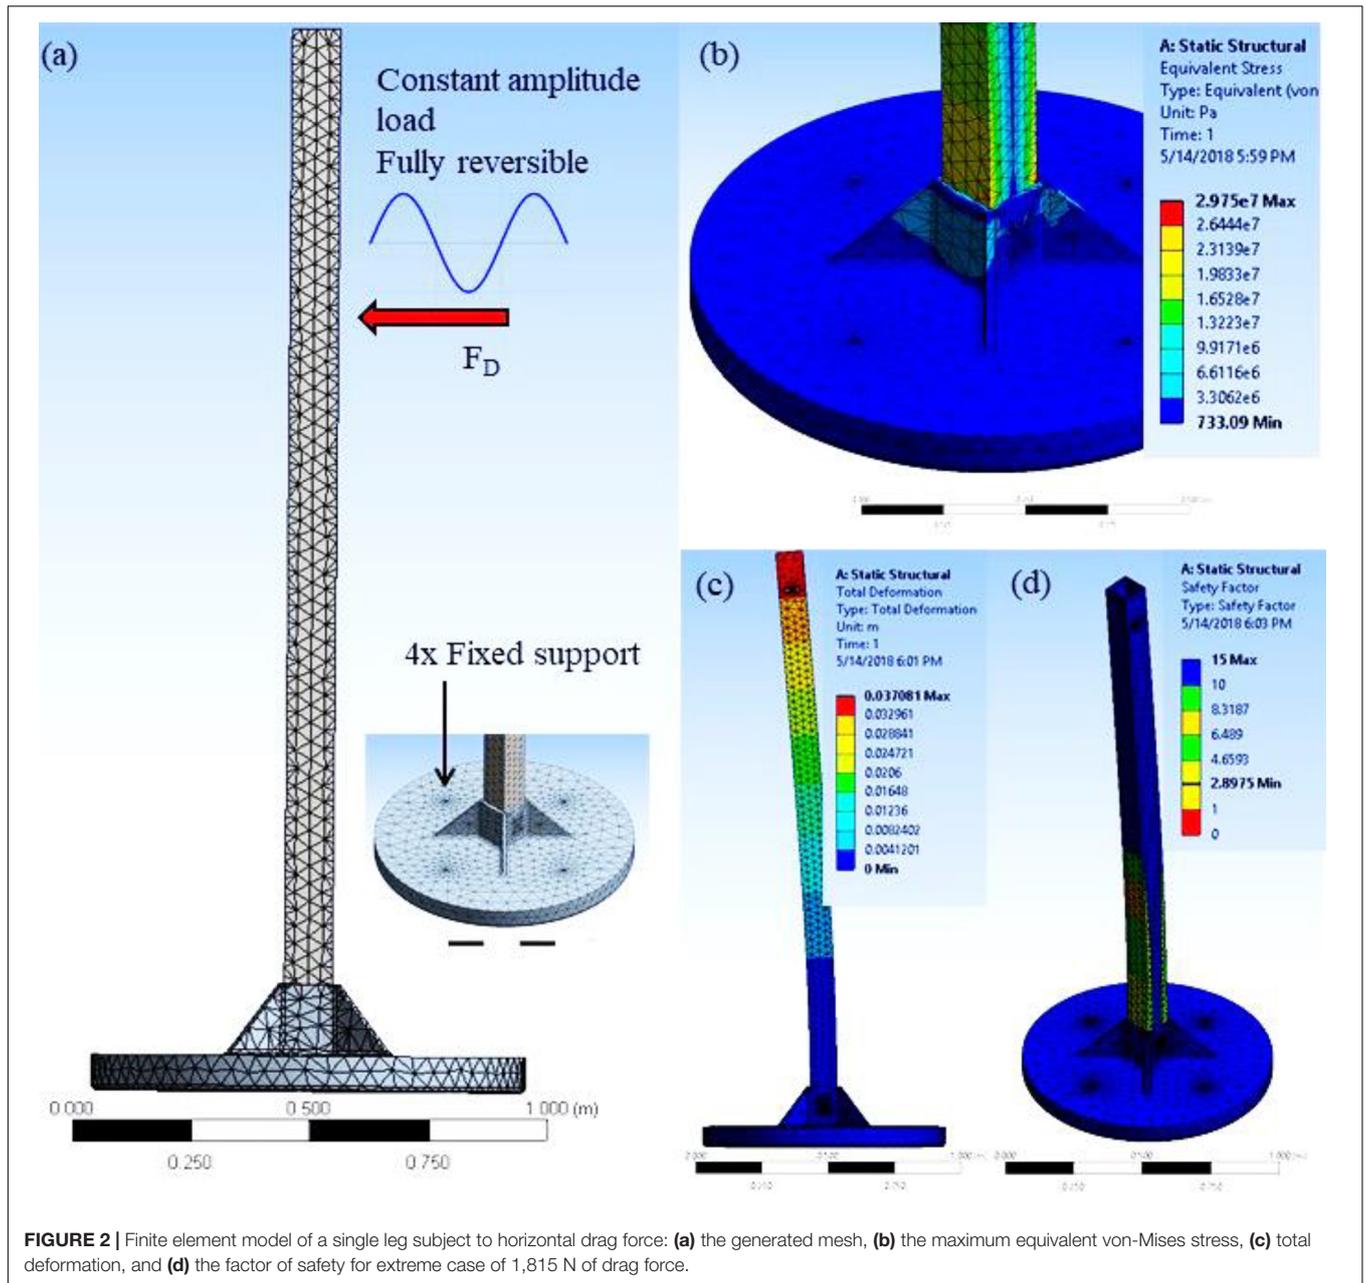
FIGURE 2 | Finite element model of a single leg subject to horizontal drag force: **(a)** the generated mesh, **(b)** the maximum equivalent von-Mises stress, **(c)** total deformation, and **(d)** the factor of safety for extreme case of 1,815 N of drag force.

s^{-1} during a swell event, and up to approximately 2.5 m s^{-1} in the case of a tsunami. Six case studies were developed to study each scenario with different wave strength and coefficient of drag. The study was repeated with the two worst-case scenarios for aluminum and structural steel for comparison. An additional study was performed with a force of 1,815 N applied horizontally to the leg to make sure that each leg could tolerate unexpected shocking forces applied from external objects as well. The mesh, generated in ANSYS on the 3D model of the leg, is shown in Figure 2a. The model consists of 23,283 elements and 43,036 nodes. Mesh refinement was applied to the edges connecting the leg to the base plate. The Goodman mean stress theory with fully reversible cyclic loads was used for fatigue analyses. Figures 2b–d show the equivalent von-Mises stress, total deformation, and safety factor, respectively, for the extreme case of 1,815 N of force.

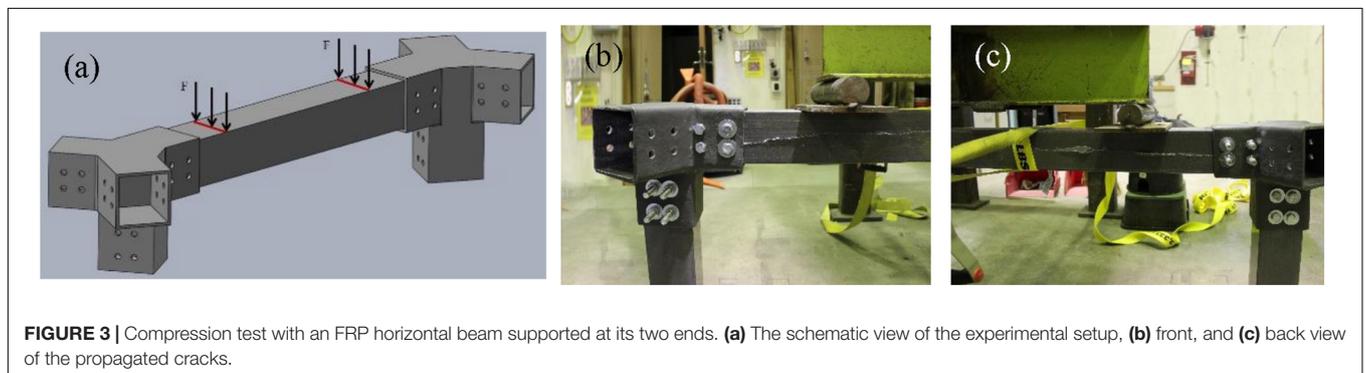
FIGURE 3 | Compression test with an FRP horizontal beam supported at its two ends. **(a)** The schematic view of the experimental setup, **(b)** front, and **(c)** back view of the propagated cracks.

During the bending test on the Instron compression machine, fracture was observed after 8,555 kg of vertical force and

displacement of 53 mm, with cracks propagated at the pins (**Figure 3**). **Figures 3b,c** show the front and back views of the cracks. The bending test proved the strength of the FRP under vertical loading conditions. However, additional epoxy was applied to the holes to reinforce the connection points.

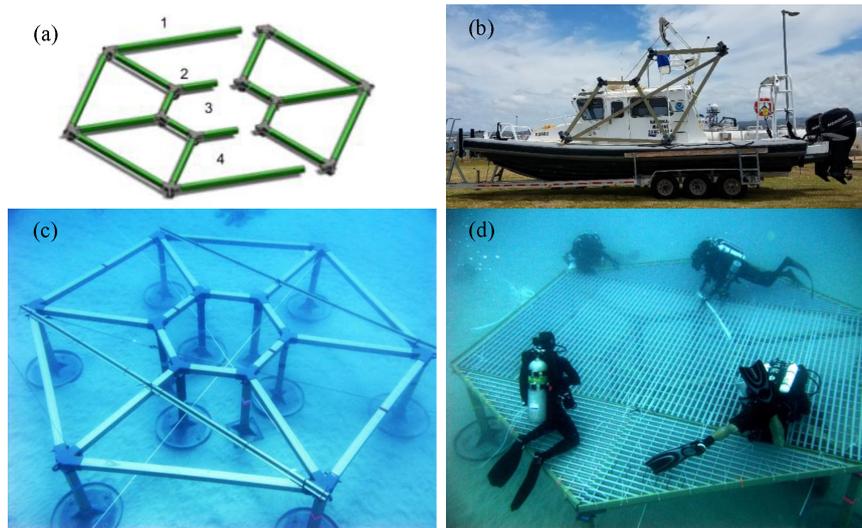
FIGURE 5 | (a) The pre-assembled halves, and installation method under water, (b) NOAA 36 ft vessel R/V Hihimanu of the Papahānaumokuākea National Marine Monument with pre-constructed nursery top surface secured to side, and (c,d) the deployed coral nursery structure underwater.

Primary assembly of portions of the structure was done above water. The top section of the structure was built above water in two halves (**Figure 5b**). Once both sides were constructed, the halves were transported to the location by a boat. Legs, footings, and the grates were transported on the deck of the vessel and down in the forward cabin. Once at the location, the halves were lowered to the ocean floor and bolted together. The bolts were sealed with a marine epoxy curable underwater. Once the two halves of the framework were brought together,

the four connecting beams marked with red tape were finally bolted together. This provided an adequate amount of space to line up the sections accordingly and bolt the entire structure together. Once the two halves were joined, one side of the structure was lifted for the legs to be added. The opposite side was then lifted to add the remaining legs. Once the legs were attached, the last step was to place the grates on the frame. Once the frame was fully assembled, the 10-piece grating was placed on top of the frame. Three Danforth style anchors (each providing roughly 1,810 kg of holding force) were used to secure the structure in the sand using rope and 3 m of anchor chain. Ropes were secured to opposing U-shaped hangers molded into the joints and the ropes run under the nursery with anchors secured in the sand roughly 6 m away from the nursery providing ample scope (Figure 5c). The deployed coral nursery structure underwater is shown in Figure 5d. The deployment took 3 days, during which the structure was transported by a 9-m boat to the location and installed underwater by five divers in about 8 h.

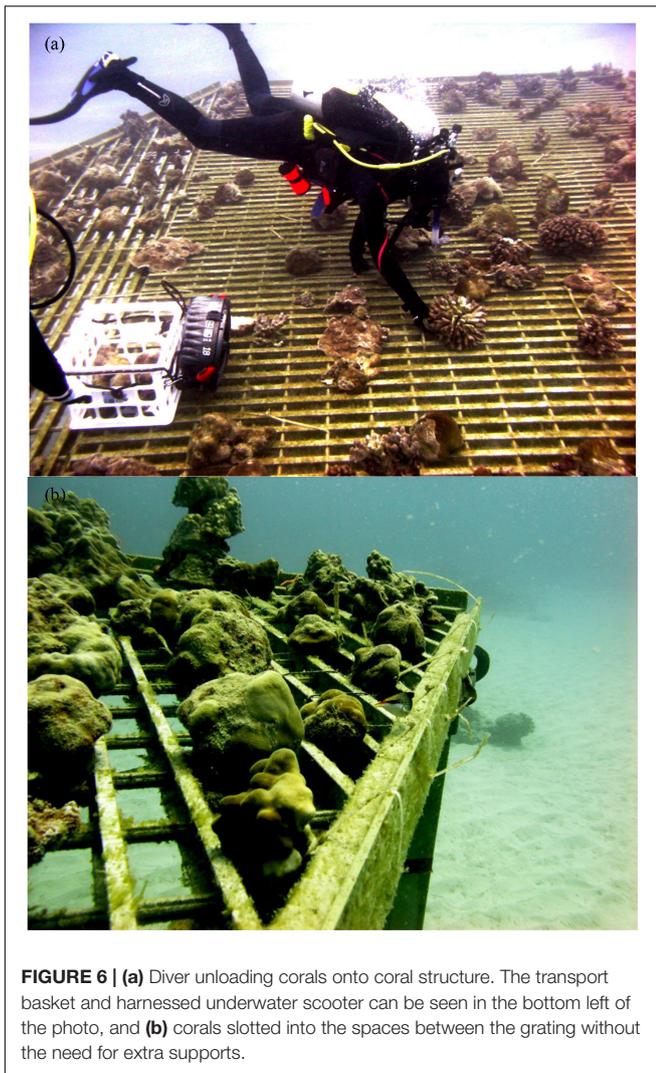
FIGURE 6 | (a) Diver unloading corals onto coral structure. The transport basket and harnessed underwater scooter can be seen in the bottom left of the photo, and **(b)** corals slotted into the spaces between the grating without the need for extra supports.

A total of 415 coral colonies of various species and size classes were collected and placed on the nursery (Figure 6a). As shown in Figure 6b, the pegs were not used to date to hold the corals in place, since the grating appeared to provide ample space to slot protrusions from the coral into the grating by itself. The corals were ensured to get stuck well between the grates for stability in rough weathers. Pegs were only used for the areas that the space was not large enough for the corals. Corals were censused using longest axis measurements for each colony and visually identified (Table 2).
