Artificial slope deformation monitoring and analyzing based on SBAS technology

artificial slopes, the risk of geological disasters, slope stability, SBAS-InSAR, Foshan

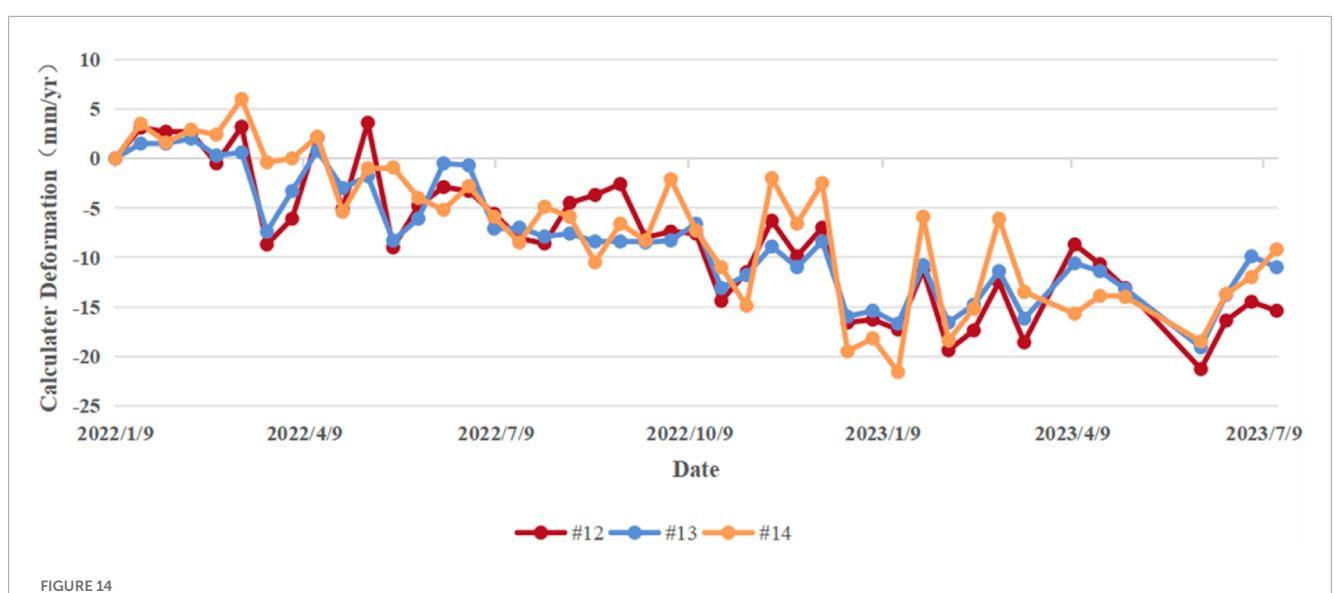
Time series deformation of sampling points #12~#14.

Sampling points #12-#14 were selected in the settlement area B1, with their coordinates listed in Table 5. Through time

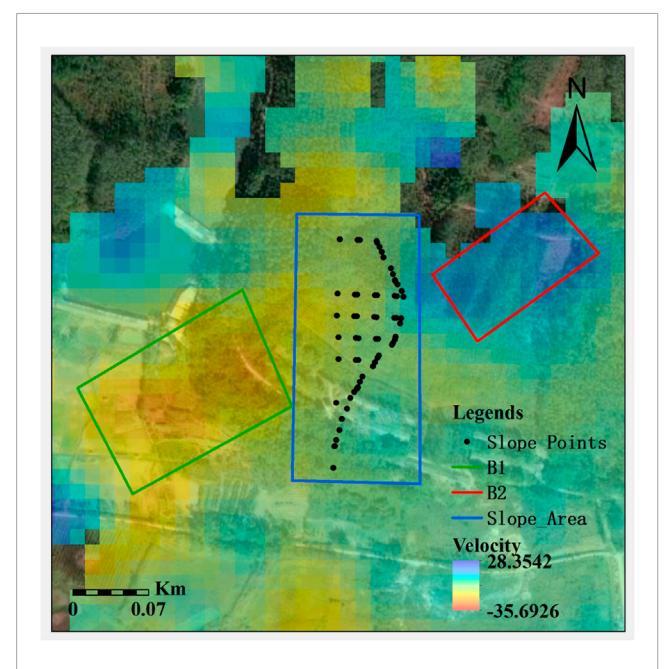
FIGURE 17 Sedimentation rate overlay optical image

The results of slope settlement velocity and settlement vector have been overlaid on the optical imagery, as shown in Figure 17. From Figure 17, a more intuitive visualization of the slope area located at the corner of a hillside is provided. By correlating the slope settlement rates with their actual geographical positions, the overall deformation characteristics of the slope can be discerned. Notably, the deformation is more pronounced at the base, followed by the marginal regions, while the top region exhibits minimal settlement or even slight uplift. Similarly, the eastern-northeastern and western-southwestern directions of the slope, as previously analyzed, are situated in the flat area atop the hill and at the foot of the hill, respectively. Considering the nearby human construction activities, the reasons for these deformations can be roughly deduced.Upon examination of the overlaid optical imagery in Figure 17 it is observed that the settlement regions on the slope are predominantly distributed in the middle to lower sections, with a notable tendency for deformation to occur further downwards. Integrating this observation with the construction drawings of the slope area, it can be inferred that the slope at the corner is being reshaped into the desired configuration, necessitating excavation, filling, and leveling operations at the lower section. Conversely, the top of the slope requires a moderate uplift. This inference aligns with the observed deformation outcomes, validating the consistency between the construction results and the deformation patterns.
