Zhang J, Hu Z, Liu D, Qiu J and An R (2025) Thermal-induced damage mechanisms and permeability evolution in gneiss for deep mining applications. *Front. Earth Sci.* 13:1603348. doi: 10.3389/feart.2025.1603348

Thermal-induced damage mechanisms and permeability evolution in gneiss for deep mining applications

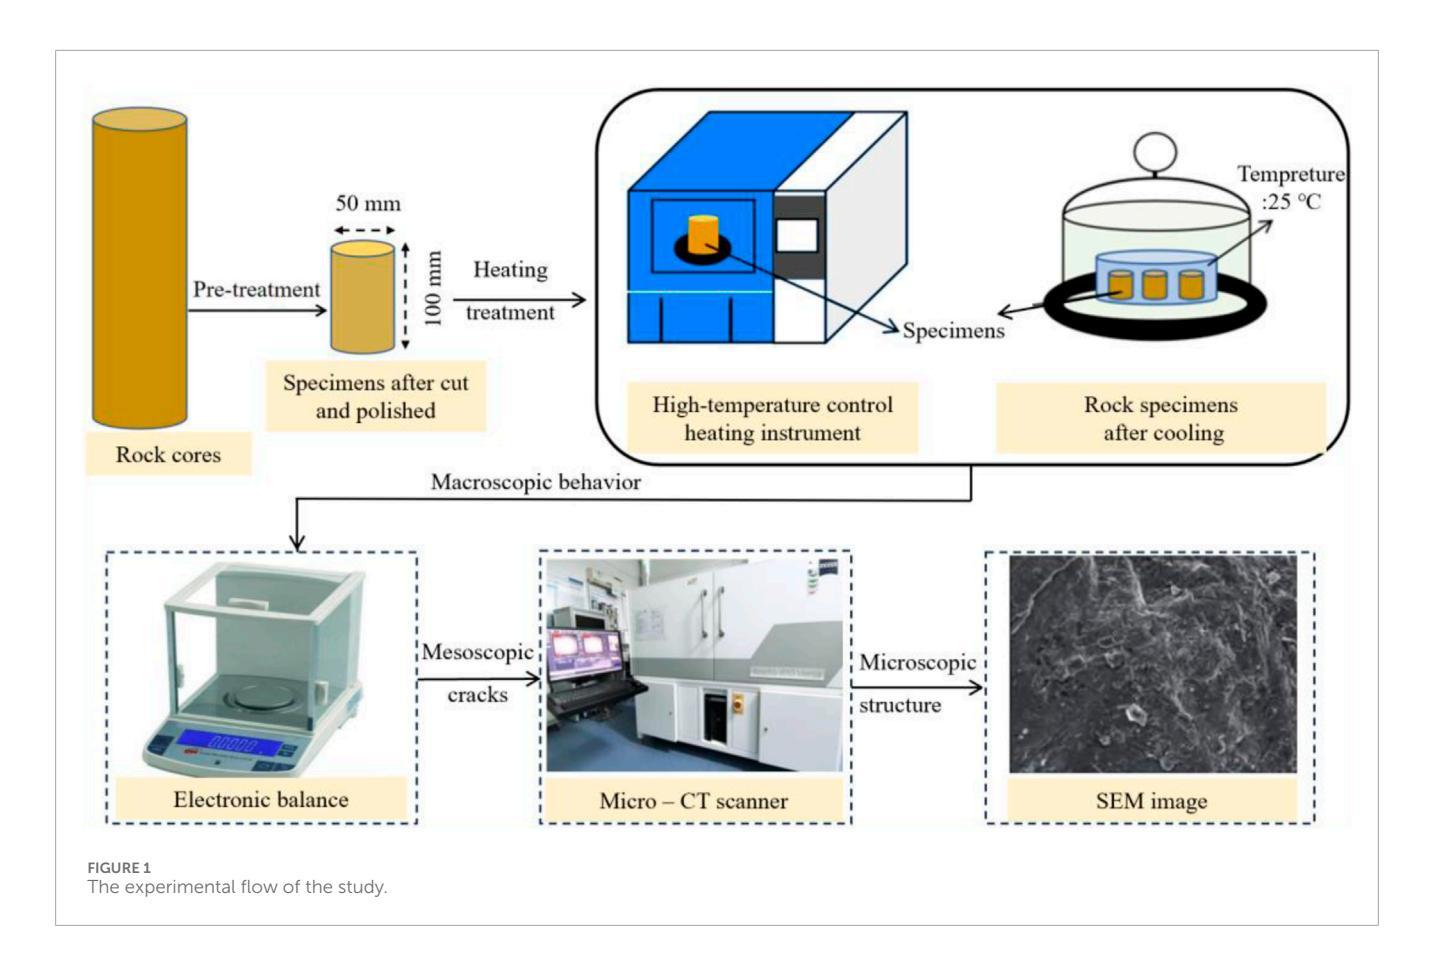
The experimental procedure, as illustrated in Figure 1, follows standardized rock sample preparation methods used in engineering rock body experiments. The process involves coring, cutting, and polishing bulk rock samples to produce cylindrical specimens with a diameter of 50 mm and a length of 100 mm. Specimens with anomalous wave velocities were discarded based on their wave speed measurements. This ensures that the research results are only related to the test conditions and not caused by the sample itself, ensuring the reliability and repeatability of the research structure.

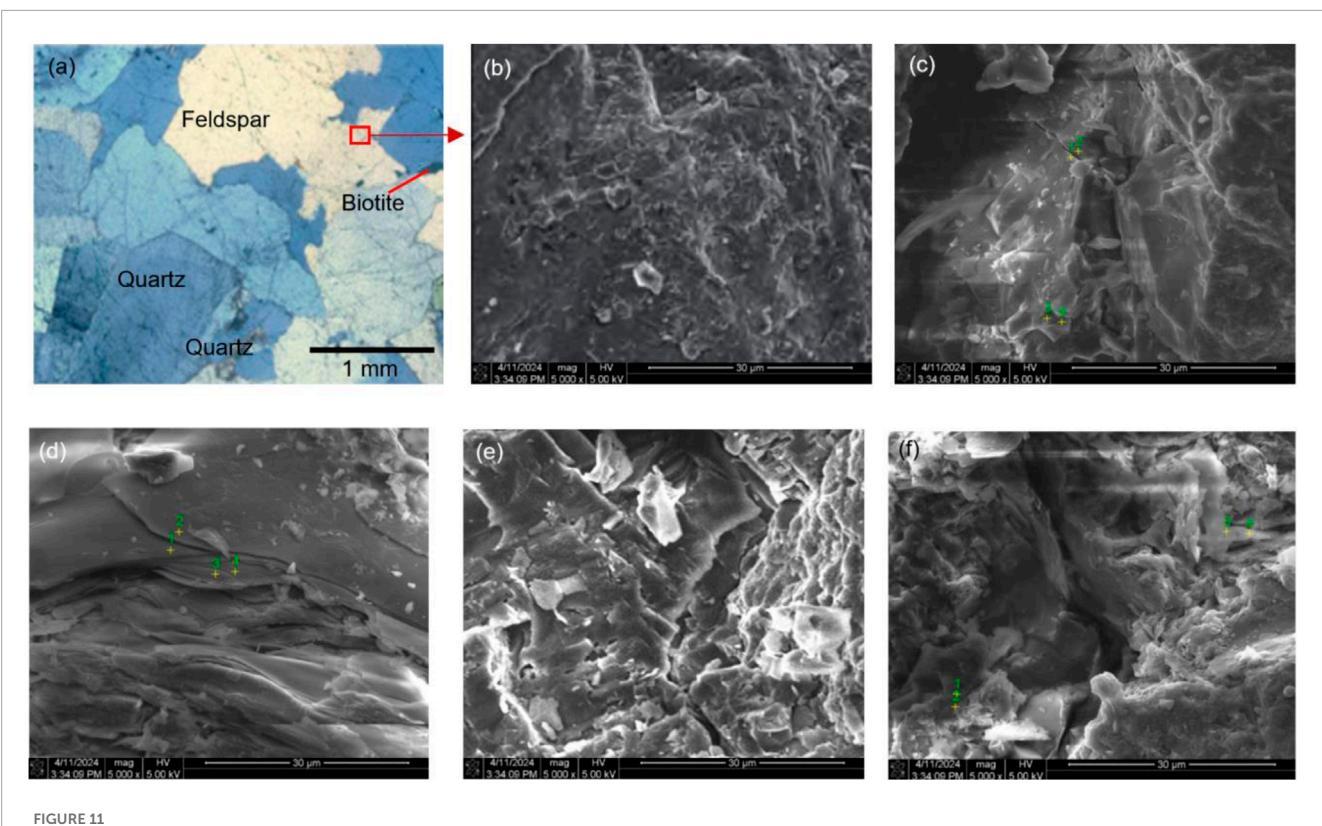
Microscopic morphology of rock at different heating temperatures: (a) cast specimen slice at $T = 25^{\circ}C$, (b) SEM image at $T = 25^{\circ}C$, (c) SEM image at $T = 200^{\circ}C$, (d) SEM image at $T = 400^{\circ}C$, (e) SEM image at $T = 600^{\circ}C$, and (f) SEM image at $T = 800^{\circ}C$.

As illustrated in Figure 11a, the mineral composition of this rock is mainly composed of quartz, feldspar and biotite. To investigate the damage characteristics of the microstructure of gneiss under various heating temperatures, SEM analysis was conducted on the fracture morphology of rock specimens. The results are displayed in Figures 11b-f. At the initial room temperature state (25°C), the distribution of microcracks within the gneiss was uneven, with poor connectivity between them. The heating treatment at 200°C led to the evaporation of free water within the rock, causing thermal expansion in mineral crystals and an increase in the number of microcracks and pores; the thermal cracks were in a closed state. At 400°C, the dehydration of biotite minerals caused thermal expansion, leading to the formation of connected fractures at the weak cementation faces of the rock specimens. Under the influence of 600°C, combined with the volatilization of bound water and expansion of crystals, mica and feldspar underwent thermal decomposition, resulting in connected cracks within the mineral crystals. Experimental results demonstrated that when the temperature exceeded 800°C, thermal cracks were clearly open, and the cracking scale of rocks increased with the heating temperature.
