Experimental analysis of rainfall-induced shallow landslides: a case study of a loess slope in Gaolan County, China

Rainfall is a major trigger for loess landslides, and understanding the associated deformation and failure mechanisms is essential for effective hazard mitigation. This study employed physical model experiments to investigate the hydrological response, deformation behavior, and failure evolution of homogeneous loess slopes subjected to intermittent rainfall. Key parameters, including volumetric water content, pore water pressure, wetting front migration, and displacement, were continuously monitored throughout the tests. The results revealed periodic fluctuations in hydrological parameters and spatially heterogeneous responses across the slope. Repeated transitions between saturated and unsaturated conditions, combined with surface runoff erosion and seepage-induced forces, contributed to a progressive reduction in soil shear strength and increased slope instability. The failure process evolved through three distinct stages: toe erosion, fissure expansion, and gully erosion. These findings improve the understanding of rainfall-induced loess slope failures and support

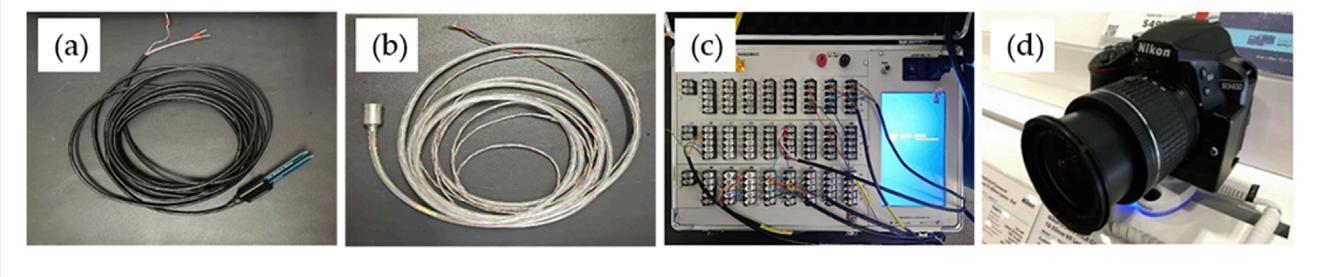
FIGURE 5

Monitoring system: (a) MDK-05 water content sensor; (b) BMWK pore water manometer; (c) DH3818Y static strain tester; (d) Nikon D3400 DSLR camera.

(3) The monitoring system is illustrated in Figure 4. It comprises six volumetric water content sensors, measuring 0%–100% with an accuracy of ±3% for 0%–50% and ±5% for 50%–100% (Figure 5a), as well as six pore water manometers with a range of 20 kPa and an accuracy of 0.3% F·S (Figure 5b). Additionally, it is paired with a 24-channel DH3818Y-type data collector (Figure 5c) and a Nikon D3400 DSLR camera (Figure 5d). During the rainfall process, volumetric water content and pore water pressure readings were automatically recorded at 60-s intervals, which ensured sufficient temporal resolution to capture dynamic infiltration, saturation transitions, and pore pressure buildup.

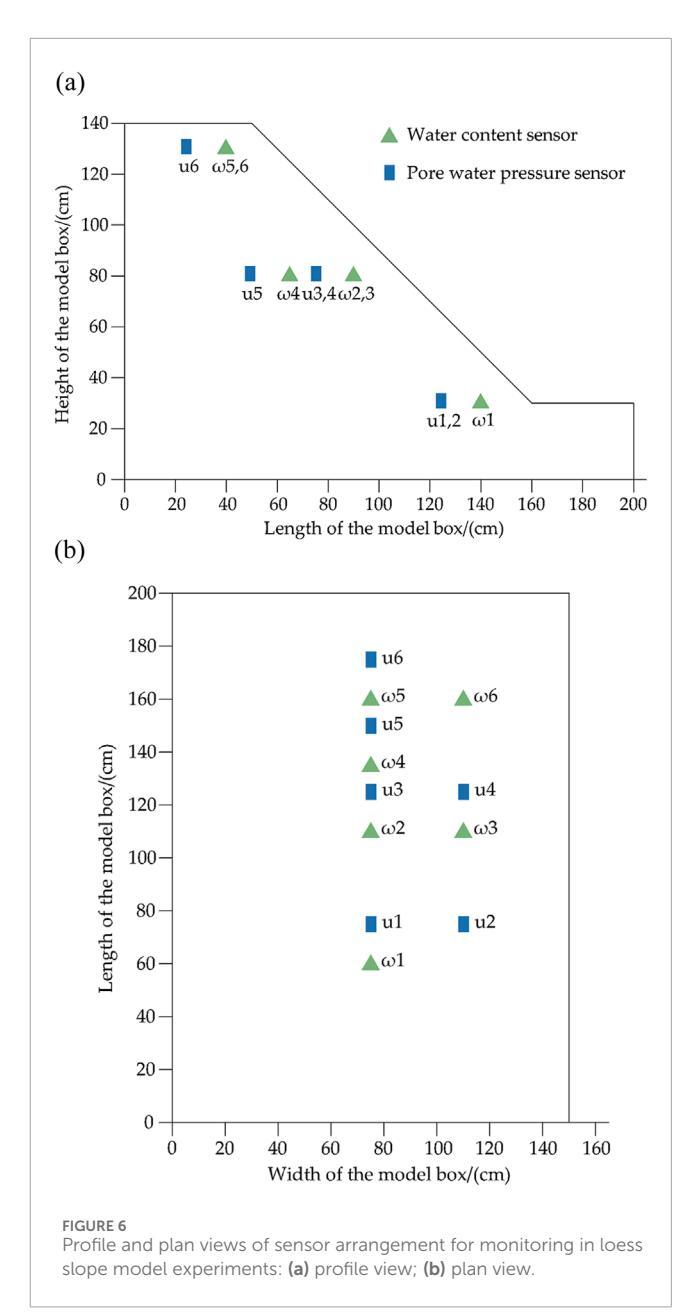
Three sensor layers were deployed inside the slope, parallel to the horizontal plane, positioned 30 cm, 80 cm, and 130 cm from the bottom of the model box. The outermost sensors of each layer were placed at the same distance from the slope. Considering the disturbance caused by deployment density, the horizontal spacing between sensors in the same layer was controlled to range from 10 cm to 20 cm. The volumetric water content sensor and the pore water pressure sensor were placed adjacent to each other in each layer, as they are positively correlated and can be crossverified. The specific placement of each sensor is illustrated in Figure 6.

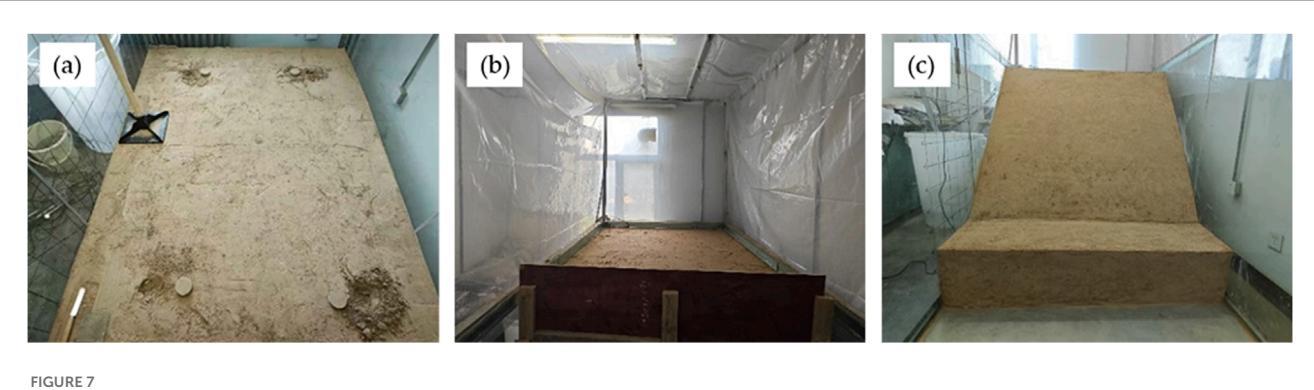
Modeled slope filling process: (a) Sampling with a cutting ring; (b) Completion of filling; (c) Slope model.

sample. After compaction, ring cutter samples were collected from the four corners of each layer (Figure 7a), and their average dry density and water content were measured to assess compliance with the target values. If significant deviations were observed, the layer was reworked to meet the specifications. This compaction protocol ensured consistent homogeneity throughout the slope model and improved the reliability of the test results. The completed slope model after filling is shown in Figure 7b.

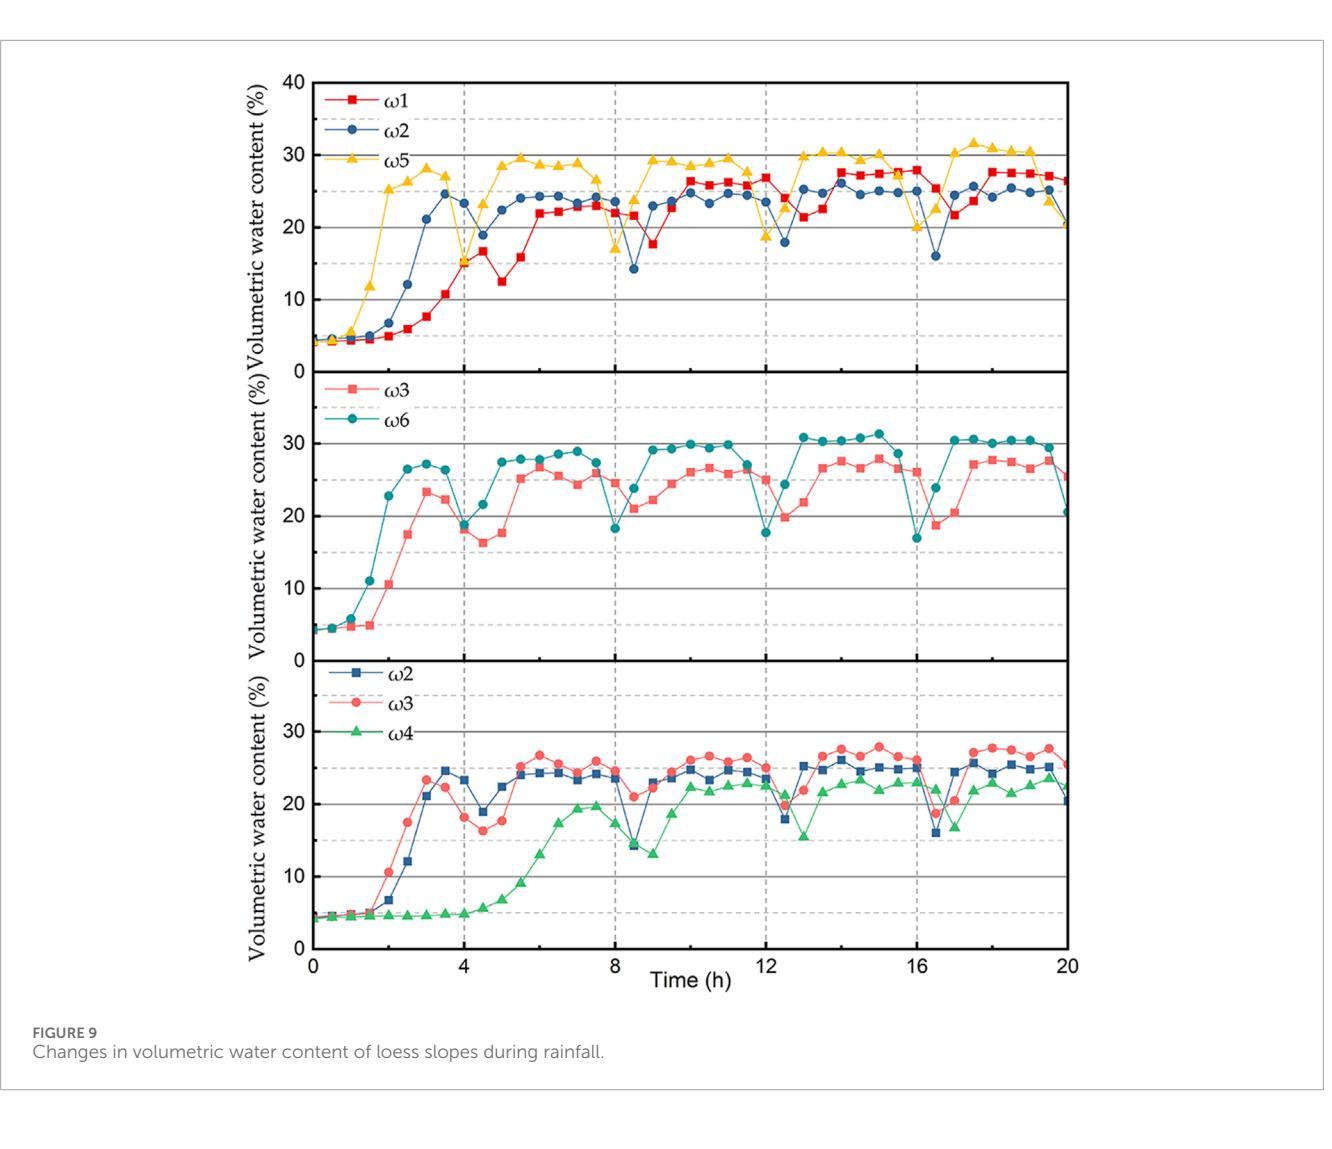
The variation in water content at different locations within the slope during the rainfall infiltration process is shown in Figure 9, with two behaviors observed regarding soil volumetric water content.

At the initial stage of the experiment, the rainfall infiltration depth was shallow, and the soil volumetric water content remained close to the initial value of 5%. As infiltration progressed, the wetting front gradually advanced to the sensor positions, leading to an increase in volumetric water content, which eventually stabilized after reaching its peak. The response time of each sensor to precipitation varied depending on its location. In the longitudinal section (Figure 9, sensors $\omega 1$, $\omega 2$, and $\omega 5$), $\omega 5$, positioned at the shoulder of the slope, exhibited the earliest response, with the wetting front reaching it approximately 1 h after precipitation began.

ω 1, located at the toe of the slope, has the latest response time, with the wetting front arriving after 2 h of precipitation. Compared with $\omega 5$, $\omega 1$ and $\omega 2$ exhibit a clear lag effect in response to rainfall infiltration. w3 and w6 also support this conclusion, with the response of ω 3, located farther from the shoulder of the slope, lagging behind that of ω 6, located nearer to the shoulder. This can be attributed to the fact that ω 5, located at the shoulder of the slope, is closer to the top, allowing precipitation to infiltrate directly at the top of the slope after it accumulates, with the wetting front reaching $\omega 5$ first. In contrast, a portion of the precipitation is lost to runoff before reaching $\omega 1$ and $\omega 2$, reducing the available infiltration. Additionally, coupled with greater energy loss due to the longer infiltration path, this results in a later arrival of the wetting front at $\omega 1$ and $\omega 2$. In the cross-section, as shown by $\omega 2$, $\omega 3$, and $\omega 4$ in Figure 9, the response times of ω^2 and ω^3 , closer to the slope face, are almost the same, with water content changes beginning after 1 h of precipitation. In contrast, ω 4, located in the interior of the slope body, responds significantly later, with data changes appearing after about 4.5 h. This is because $\omega 4$ is buried at a deeper depth, and the path required for precipitation to infiltrate, either from the slope or the top of the slope, is longer, causing the wetting front to take longer to arrive at this location. Additionally, although $\omega 2$ and $\omega 3$ are at the same distance from the slope surface and located at the same height, $\omega 3$ responds slightly earlier than $\omega 2$ and ultimately achieves a maximum water content about 2% higher than $\omega 2$. This is because the soil around the central axis can freely infiltrate water, while the soil near the side is restricted by the side wall, the direction of seepage is relatively single, resulting in a faster accumulation of water in this region, making the moisture content sensor feel the moisture change earlier.

Additionally, regarding the final stabilized maximum water content, $\omega 5$ and $\omega 6$, located at the slope shoulder, exhibited the highest values, stabilizing at approximately 30%, whereas $\omega 4$, positioned within the slope interior, had the lowest value, stabilizing at around 22%. This discrepancy arises from the fact that the soil at the slope crest is more susceptible to saturation during rainfall, as precipitation is directly applied to the surface without being dissipated by runoff. Consequently, the highest stabilized water content is observed at the slope shoulder. In contrast, water infiltrating into the slope interior follows a longer percolation pathway, during which gravitational potential energy dissipates, pore water flow encounters resistance, and a

- (1) As the elevation increases, the soil's response time to rainfall becomes shorter, while the final stabilized water content exhibited an increasing trend. At the top of the slope, direct exposure to rainfall accelerates infiltration, leading to a rapid rise in water content and a higher stabilization value. In contrast, at the midslope and slope foot, a portion of the precipitation is carried away by runoff, and the extended infiltration pathway further delays the response of water content, resulting in a relatively lower stabilization value.
- (2) The moisture levels in deeper soil layers showed a lagged response to precipitation events and fluctuated less significantly compared to upper soil layers, demonstrating greater hydrological reactivity in surface soils to rainfall inputs.

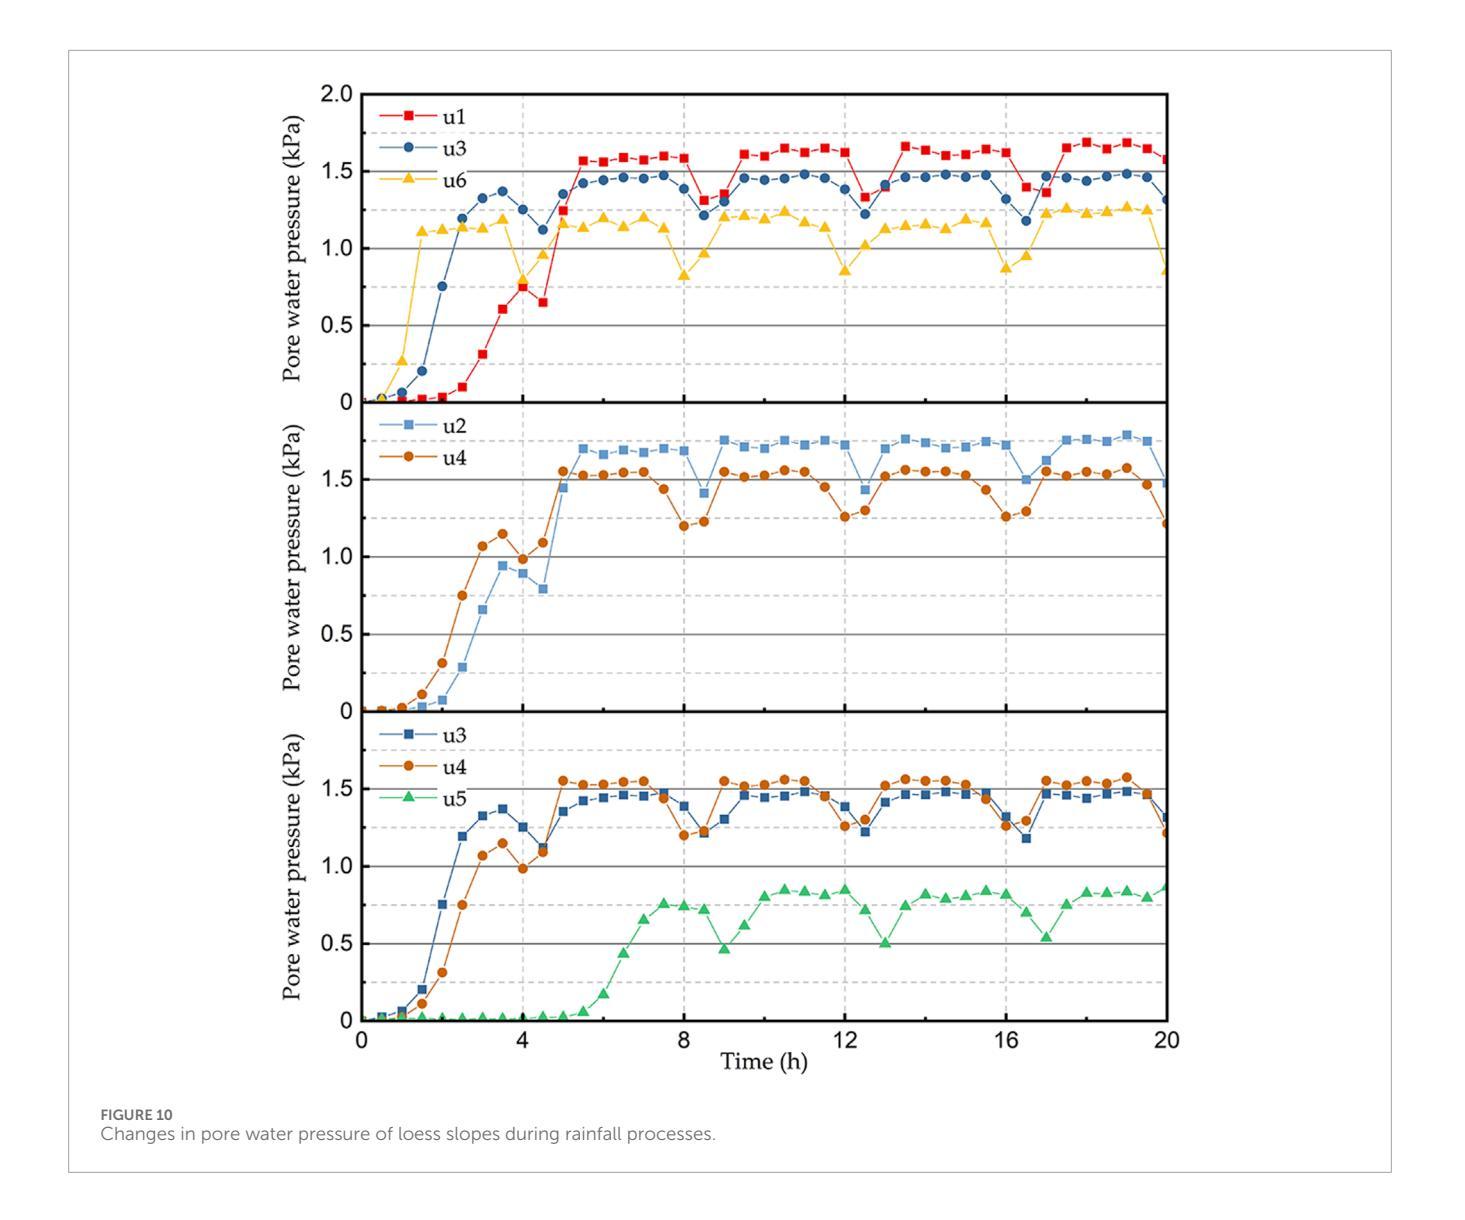
The changes in pore water pressure within loess slopes during rainfall infiltration are illustrated in Figure 10. The overall trend aligns with changes in volumetric water content, exhibiting cyclical fluctuations with rainfall. However, the response of pore water pressure to rainfall infiltration lags behind that of volumetric water content. This delay occurs because volumetric water content increases immediately upon the arrival of the wetting front at the sensor, whereas pore water pressure changes only after water permeates through the sensor's porous stone.

As shown in Figure 10, u6, located near the top of the slope, has the fastest response time. The pore pressure begins to increase after 1 h of rainfall and eventually stabilizes at approximately 1.22 kPa u1, located furthest from the top of the slope, exhibits the latest response time. It does not reach the maximum pore pressure within the first precipitation cycle (the maximum pore pressure being 0.75 kPa during the cycle) and only reaches a maximum pore pressure of approximately 1.65 kPa after 4.5 h of testing. u3, located

in the central part of the slope, the response time and maximum pore pressure value fall between those of u1 and u6. Similarly, the same conclusion can be drawn from the pore pressure-time graphs of u2 and u4 in Figure 10. The more downwardly located u2 exhibits a later response time but a larger maximum pore pressure value, approximately 0.15 kPa greater than u4. Notably, the pore pressure at u5 in Figure 10 takes longer to reach its maximum value and is lower than the maximum pore pressure measured by the other sensors. Under rainfall conditions, the shallow soil layer initially absorbs water, generating higher pore pressure, while gravity and matric forces drive water infiltration downward. However, as the infiltration depth increases, capillary forces between soil particles become more pronounced, impeding water migration and reducing the accumulation rate of moisture in deeper soil layers. Additionally, the deep soil is in a relatively enclosed environment with limited drainage capacity, resulting in a delayed increase in pore pressure. Furthermore, a portion of the precipitation is discharged as surface runoff along the slope, decreasing the effective infiltration into the deeper layers, thereby leading to lower pore pressure levels in the deep soil compared to the shallow layer.

(1) At different heights along the same profile, pore water pressure generally decreases as height increases, while the response speed accelerates with height. During the initial rainfall stage, the surface soil preferentially absorbs rainwater, causing a rapid increase in pore pressure in the shallow layer (particularly along the slope surface), whereas the deeplayer pore pressure responds with a delay. During the intermittent rainfall stage, as infiltration progresses, the deeper part of the slope gradually becomes saturated. The pore pressure increases and reaches its peak near the foot of the slope. Water continues to infiltrate toward the foot of the slope between rainfall intervals. The pore pressure near the top of the slope decreases rapidly as rainfall ceases, whereas the lower part experiences a slower decline due to the hysteresis effect.

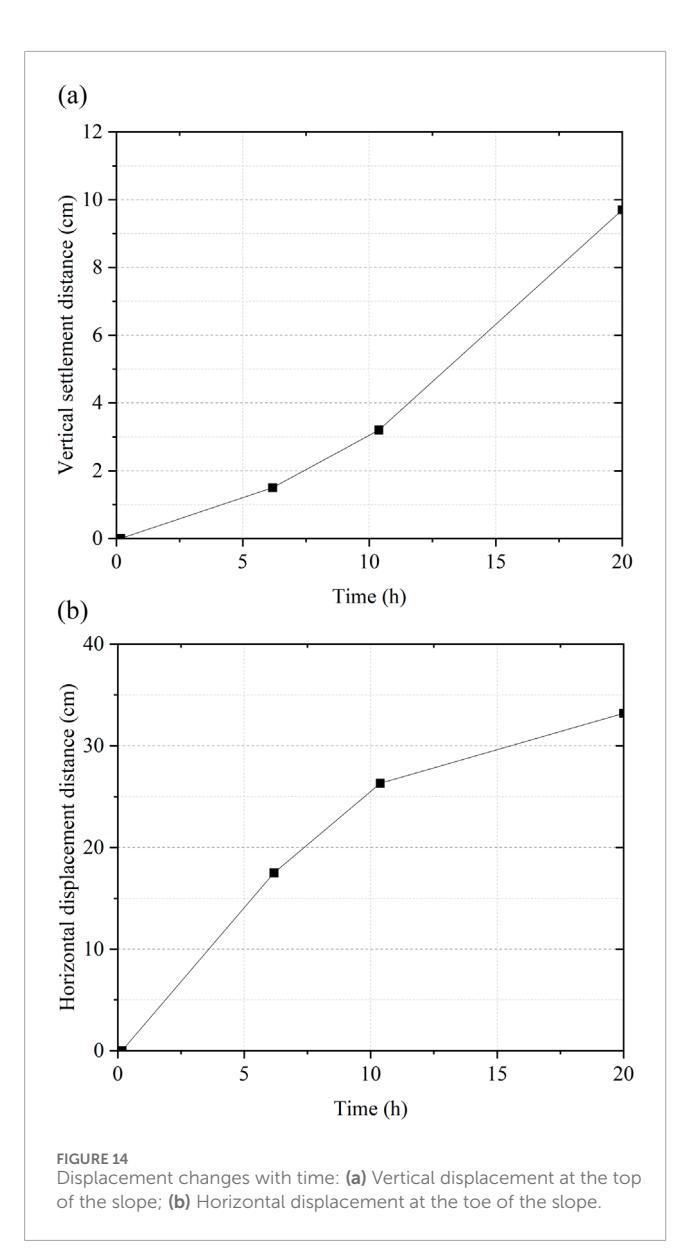
To quantitatively illustrate the temporal evolution of slope deformation and support the classification of failure stages, displacement–time curves were plotted for two key locations: vertical settlement at the slope crest and horizontal displacement at the slope toe (Figure 14).

slope top and horizontal displacement at the slope toe over time, primarily driven by the degradation of soil mechanical properties due to water infiltration. The curve at the crest captures cumulative subsidence associated with the gradual loss of shear strength and structural weakening, as shown in Figure 14a, progresses in three stages: initially (0-6 h), the deformation is slow, reflecting the gradual infiltration of water; in the middle stage (6-10.5 h), the deformation accelerates as increased pore water pressure leads to reduced effective stress and shear strength; in the later stage (10.5-20 h), the deformation increases further, indicating that the slope saturation continues to rise, and the overall subsidence of the slope top occurs, with the loss of matric suction and the formation of a slip surface jointly causing slope instability. For the horizontal displacement at the slope toe, as shown in Figure 14b, the deformation is initially significant but gradually decreases with continuous rainfall. This is because the slope toe is damaged early, leading to a rapid increase in displacement. This process reveals the chain failure mechanism of rainfall-induced landslides, where the increase in pore water pressure weakens shear strength, causing shear failure at the slope toe, which ultimately leads to the settlement of the slope top. These trajectories clearly reflect the phase-wise failure process, providing visual evidence of the transitions between the toe erosion, fissure expansion, and gully erosion stages.

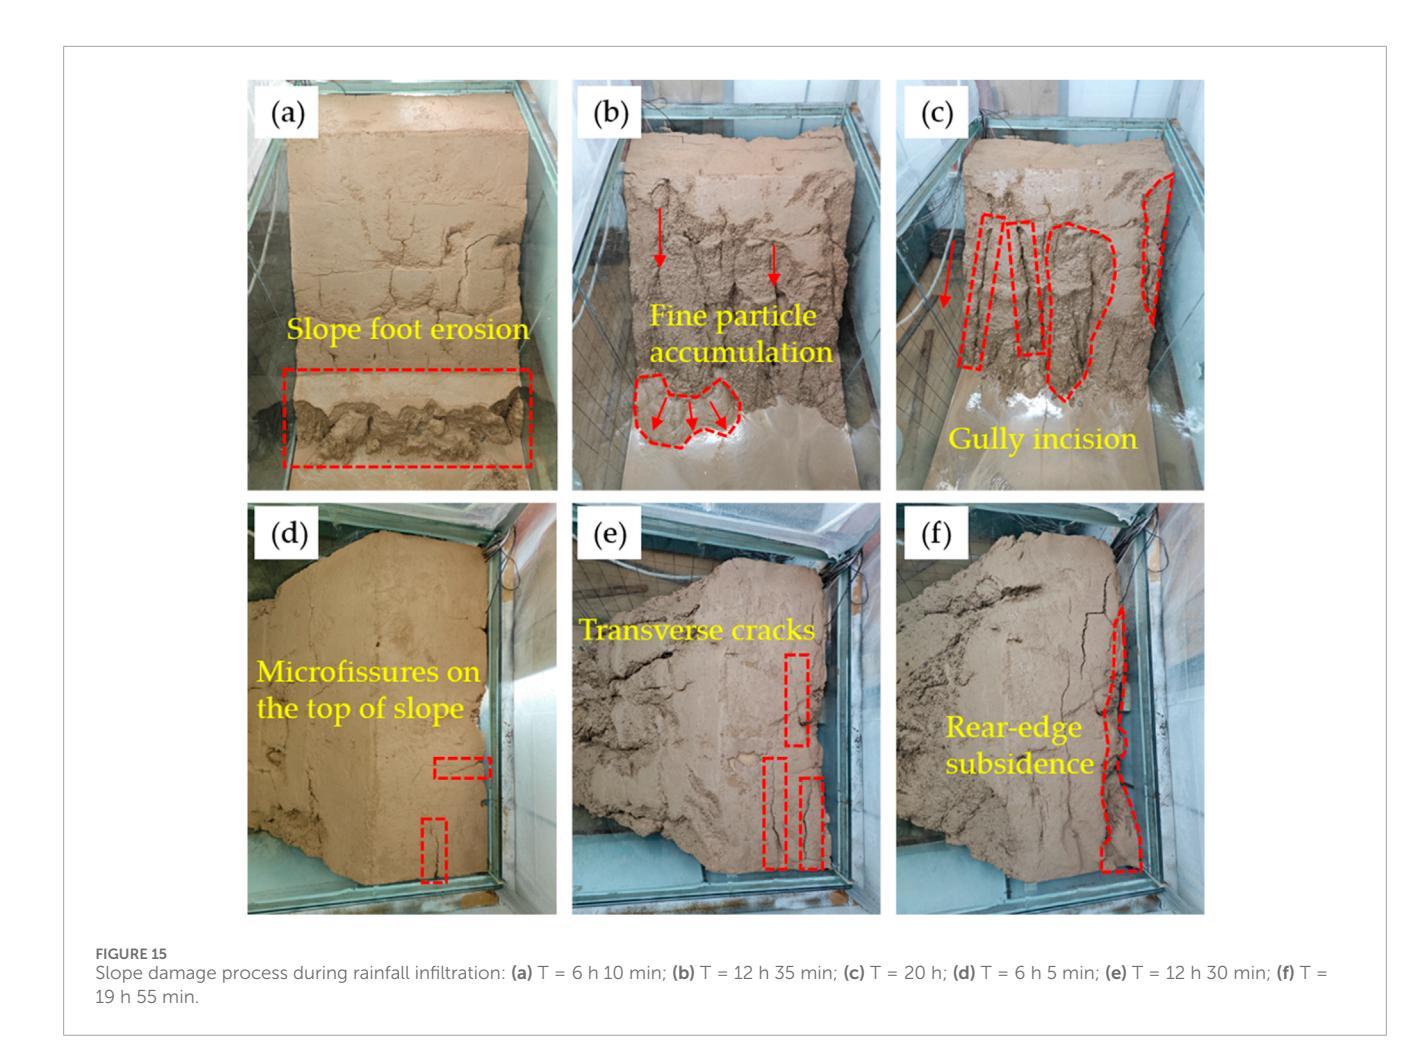
The rainfall-induced loess slope damage process exhibits a clear transformation in damage patterns, as illustrated in Figure 15. The classification of the three-stage failure process-namely toe erosion, fissure expansion, and gully erosion-was based on integrated observations of hydrological responses, deformation patterns, and surface failure characteristics during the physical model tests. In the initial toe erosion stage, a localized increase in pore water pressure near the slope foot and minor displacement (<5 cm) indicated incipient instability. This was followed by the fissure expansion stage, characterized by tensile cracking at the slope crest and shoulder, accompanied by accelerated settlement and horizontal displacement. In the final gully erosion stage, concentrated runoff and deep infiltration through fissures led to the formation of erosion gullies and collapse features, with maximum crest settlement exceeding 10 cm. These features reflect the progressive destabilization of the slope from localized erosion to overall failure. The specific characteristics of each stage are described as follows:

Toe Erosion Stage (0–6 h 10 min): At the onset of rainfall, the infiltration rate exceeds the rainfall intensity, resulting in minimal surface runoff. At this stage, the slope remains nearly intact (Figure 15d). As rainfall continues, the hydraulic gradient decreases, leading to surface runoff and ponding at the slope toe. This process forms a transient saturated zone where strain generates excess pore water pressure, reducing effective stress and shear strength. Once the driving forces surpass the soil's shear resistance, failure initiates at the slope foot (Figure 15a). The erosion at the toe weakens the overall slope stability, while raindrop impact and runoff degrade the loess structure, washing away fine-grained particles and forming initial surface gullies.

Fissure expansion stage (6 h 10 min-12 h 35 min): The instability at the slope foot induces downward movement of the upper slope under gravitational forces. Rainwater infiltration increases pore water pressure, reducing effective stress and further weakening shear strength. This facilitates fissure formation at the slope's trailing edge (Figure 15e), while longitudinal fissures develop along the surface (Figure 15b). Over time, continued infiltration and deformation enlarge these fissures, eventually forming through-cracks that compromise slope integrity.

Gully erosion stage (12 h 35 min–20 h): At this stage, gullies serve as primary runoff channels, concentrating rainfall and intensifying erosive forces (Figure 15c). Runoff undercuts the gully bed, deepening it and forming an unstable free surface. The gully walls collapse under gravitational stress, further exacerbating trailing-edge erosion (Figure 15f). Enlarged fissures promote deeper infiltration, accelerating fine-grained loess loss and forming surface depressions or holes at the slope top.

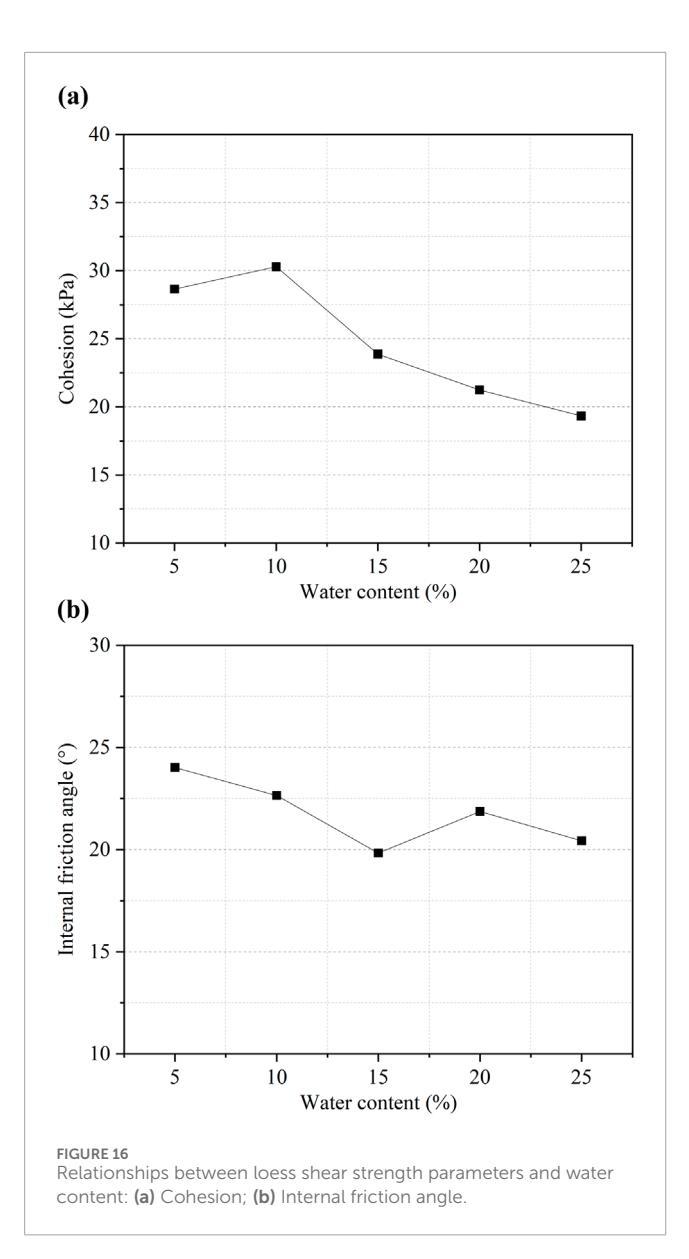
To further investigate the effect of saturation increase due to rainfall infiltration on shear strength, remolded loess samples with water contents of 5%, 15%, 25%, 35%, and 45% were prepared according to the "Standard for Geotechnical Testing Methods" (GB/T 50123-2019) for a series of direct shear tests. During sample preparation, the density was controlled at 1.49 g/cm³. After preparation, shear tests were conducted using a Model ZJ Strain Controlled Direct Shear Apparatus and the shear rate was set to 0.8 mm/min. The variation curves of loess cohesion and internal friction angle with shear strength at different water contents were plotted based on the test results, as presented in Figure 16.

The experimental results show a significant non-linear relationship between cohesion and internal friction angle of loess with respect to water content. As shown in Figure 16a, cohesion slightly increases between 5% and 10% water content, reaching a peak of 30.29 kPa, but then sharply decreases due to water activation of clay minerals in loess, enhancing particle cementation. However, excess water dissolves soluble salts and disrupts structural bonds, leading to a decrease in cohesion. As shown in Figure 16b, The internal friction angle decreases when the water content is below 15%, and increases and then decreases when the water content exceeds 15%. Overall, the internal friction angle changes from 24.02° at 5% water content to 20.43° at 25% water content, showing a slight decreasing trend. The mechanism explanation is as follows: at low water content, the contact friction between particles is high, resulting in a higher friction angle; as water content increases (5%-15%), the water film thickens, reducing direct particle contact and lowering friction, which leads to a reduction in the friction angle. Near the plastic limit, the soil is in a transitional state, with water not enough to liquefy the soil but also not reducing friction, causing the strength to depend more on cementation, which leads to the smallest friction angle. When the water content increases further (15%–20%), water facilitates the reorganization of particles, and the frictional resistance increases in a way that is favorable for shear strength, causing the internal friction angle to increase. Once the water content exceeds 20%, the pores become almost fully saturated, reducing the effective contact area between particles, leading to a decrease in both friction and interlocking forces, and the friction angle decreases again. This phenomenon explains the mechanical nature of loess slope failure induced by rainfall: water infiltration causes cementation softening and friction weakening, which sharply reduces shear strength and leads to sliding. This study provides a significant theoretical basis for landslide early warning and prevention in loess regions.
