# Spatiotemporal evolution of scouring and silting in Made Island port channel (2015–2023)

This paper, based on channel topographic survey data from 2015 to 2023, analyzes the scouring and silting evolution characteristics of the Made Island port channel, port basin, outer anchorage, and empty ship anchorage. By conducting a quantitative analysis of water depth variations and scouring and silting phenomena across different years, this paper investigates the effects of water flow, topographic changes, and human dredging activities on the topographic evolution of the port area. The study utilizes bathymetric survey data collected at two-year intervals using the MV SEA PRINCESS survey vessel, equipped with a Positioning, Motion and Heading Unit, Bathymetric Equipment for Sounding, Sound Velocity Profiler, Single Beam Echosounder, and Transducers. The monitoring methodology involved interpolating and subtracting multi-year bathymetric data to assess sediment transport dynamics. The results indicate that the Made Island port channel exhibits a dynamic alternation of scouring and silting, with significant sediment accumulation in shallow areas, especially after dredging operations. Nota

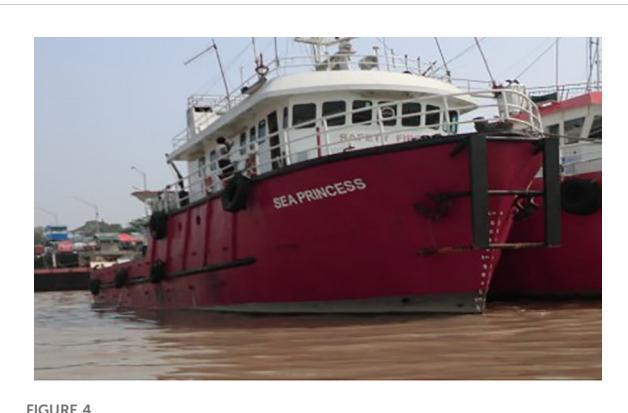
Image of MV SEA PRINCESS.

The survey vessel MV SEA PRINCESS (Figure 4) was chartered from INJYNN Development Company Ltd. It is a twin-propelled Shoal Buster multipurpose vessel registered under the Myanmar flag.

The survey equipment installed on board the MV SEA PRINCESS consisted of a Positioning, Motion and Heading Unit, Bathymetric Equipment for Sounding, Sound Velocity Profiler, Single Beam Echosounder and Transducer, and Two Pacific Crest ADL Vantage Transceivers. These instruments were employed to measure bathymetry with a precision reaching the centimeter level, and a sampling frequency ranging from several Hertz to dozens of Hertz. The bathymetric survey used a Multibeam Echo Sounding technique, which employs multiple beams to map underwater topography, ensuring 100% seabed coverage. The R2Sonic 2024 Multibeam Sonar System used in the survey operates with 256 focused beams, a 0.5° x 1° transducer, and a 160° swath coverage, although only a 120° beam was used to ensure high precision. The frequency was set to 200kHz, and the ping rate was 20 pings per second. Other equipment included the TSS Orion INS Gyro Compass and Integrated Motion Sensors for precise heading and motion compensation, and the Valeport Sound Velocity Profiler for measuring the velocity of sound in the water, correcting for errors due to water column variations. The survey adhered to IHO Special Order standards, ensuring both measurement accuracy and reliability.

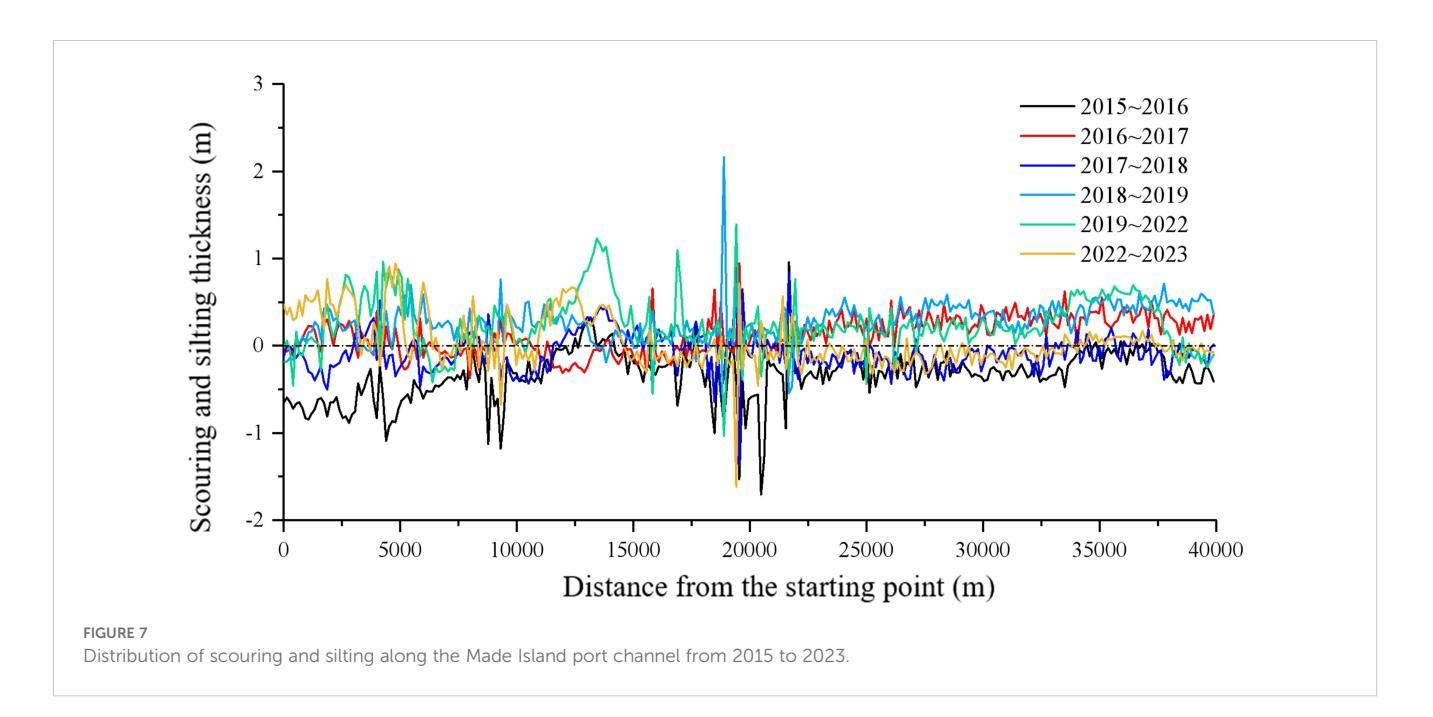
The scouring and silting distribution along the Made Island Port channel exhibited a clear pattern of change over different years, as shown in Figure 7. Following the channel dredging in August 2015, the channel primarily experienced scouring from 2015 to 2016. Between 2016 and 2017, scouring and silting were observed along sections of the channel less than 20.0 km from the starting point, while areas beyond 20.0 km were predominantly affected by silting. From 2017 to 2018, scouring and silting alternated in sections less than 20.0 km from the starting point, while the areas greater than 20.0 km were mostly dominated by scouring. Between 2018 and 2019, as well as 2019 and 2022, the channel generally showed a trend of silting. In 2022 to 2023, the section of the channel less than 20.0 km from the starting point primarily experienced silting, while areas beyond 20.0 km mainly showed minor scouring. From the perspective of scouring and silting thickness, between 2017 and 2023, substantial fluctuations were observed in the channel bed topography in the range of 18.0-20.0 km from the starting point, with elevation changes between -1.7 and 2.2 meters. However, due to the greater water depth in this region (mostly above 45 meters), the silting had minimal impact on channel navigation. In contrast, sections of the channel between 12.3-15.1 km, 23.0-24.8 km, and 32.0-38.5 km from the starting point have predominantly experienced silting since 2018. These areas have shallower water depths, mostly below 24 meters, and may potentially affect the safety of navigation to some extent. Overall, the pattern of scouring and silting in the channel is closely related to factors such as hydrodynamics, topography, and human intervention. Silting fluctuations are smaller in deeper water areas, while shallow areas are more susceptible to scouring or silting. To

ensure the navigability of the channel, regular topographic surveys should be conducted, and timely dredging should be performed in shallow areas.

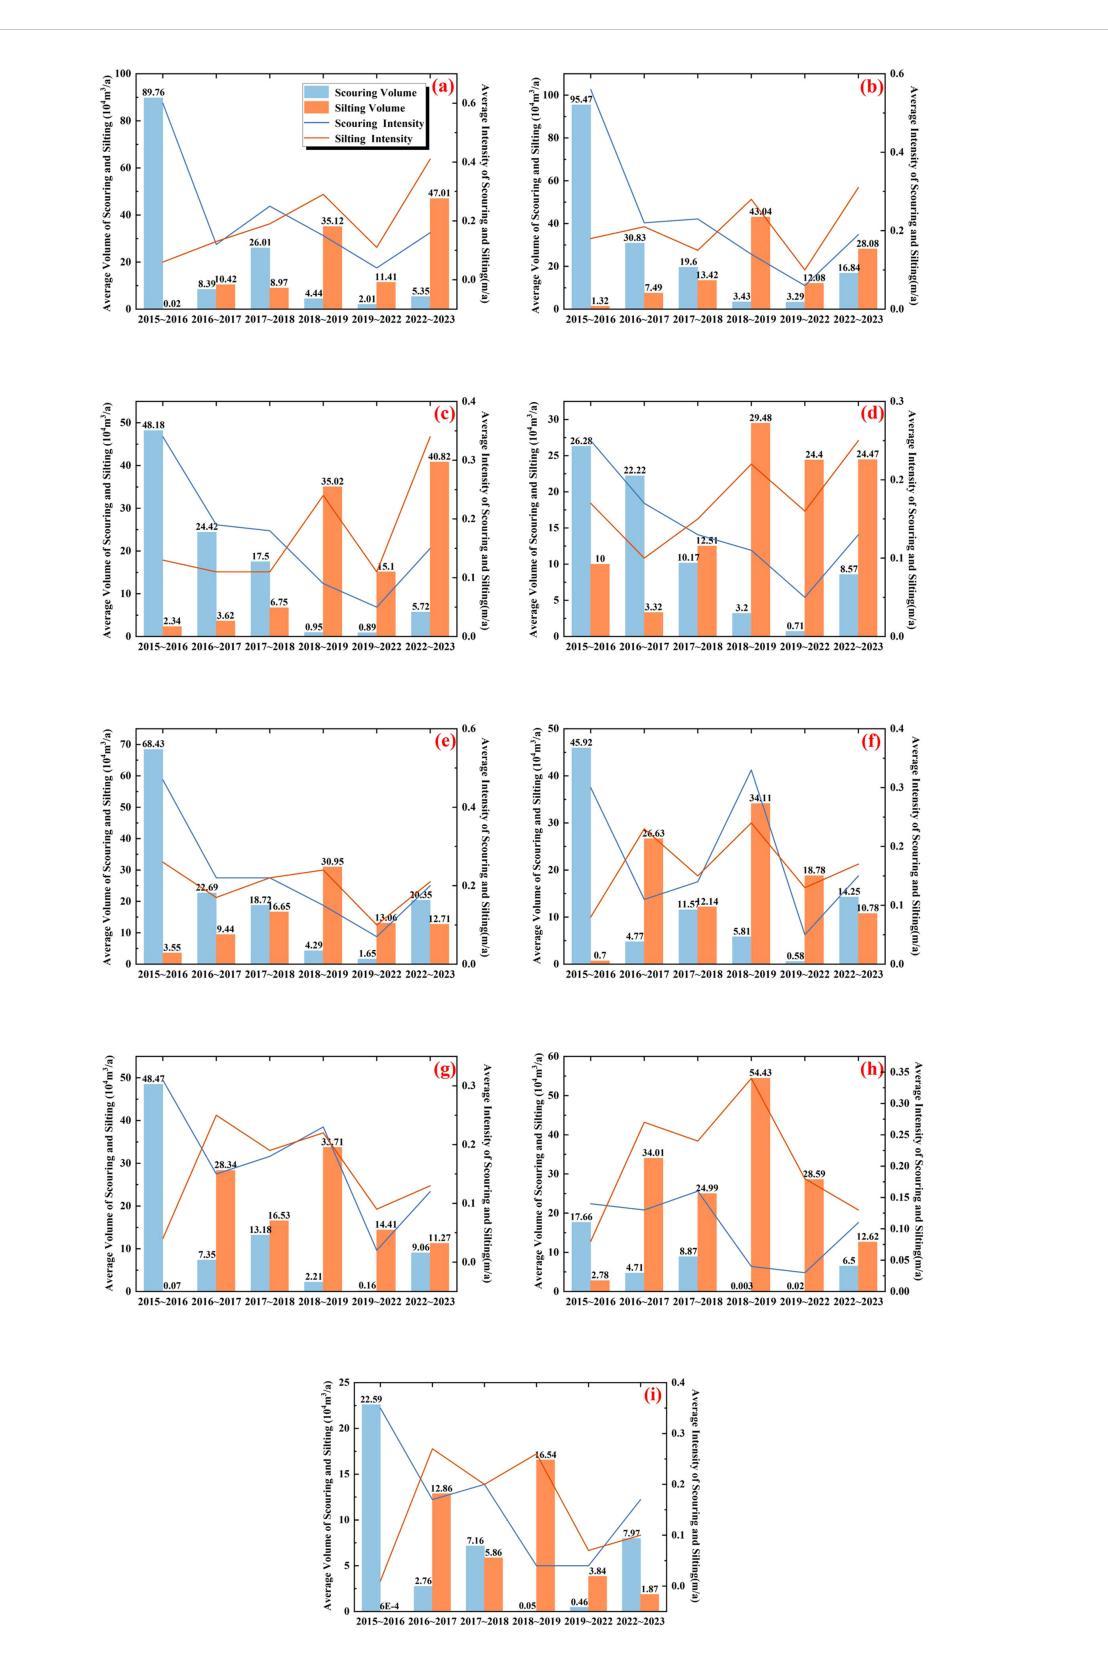
#### FIGURE 9

Average scouring and silting volume and thickness along different channel segments: G41-R42 to G37-R38 (a), G37-R38 to G31-R30 (b), G31-R30 to G23-R24 (c), G23-R24 to G19-R20 (d), G19-R20 to G15-R16 (e), G15-R16 to G11-R12 (f), G11-R12 to G7-R8 (g), G7-R8 to G3-R4 (h), beyond G3-R4 (i).

from G41-R42 to G23-R24, G19-R20 to G15-R16, and G3-R4, while other sections showed a predominant silting trend. The overall scouring volume was 1.3286 million m3/a, with scouring and silting volumes being relatively close. From 2018 to 2019, silting was the most severe, with all sections predominantly experiencing silting. The total silting volume reached 3.1258 million m3/a, with an average silting intensity of 0.26 m/a, while the scouring volume was only 244,200 m<sup>3</sup>/ a, with an average scouring intensity of 0.16 m/a. This period's high intensity silting may have been exacerbated by sediment refilling following the dredging in April 2018. From 2019 to 2022, the channel remained dominated by silting, but the intensity of silting significantly decreased. The total silting volume was 1.4167 million m3/ a, with an average silting intensity of 0.12 m/a. From 2022 to 2023, the scouring and silting trends once again presented a segmented pattern. Sections from G41-R42 to G19-R20 and G11-R12 to G3-R4 were predominantly silting, while other sections showed a scouring trend. Overall, the silting volume was 1.8959 million m3/a, with an average silting intensity of 0.25 m/a, while the scouring volume was 945,600 m<sup>3</sup>/a, with an average scouring intensity of 0.16 m/a.

To quantify the scouring and silting conditions across different years and channel sections, this paper calculates the average scouring and silting volumes and thicknesses for each year and channel section. Figure 8 shows the overall scouring and silting conditions of the entire channel, while Figure 9 reflects the scouring and silting conditions of different channel sections. Figures 9a to i sequentially illustrate the conditions from G41-R42 to G37-R38, G37-R38 to G31-R30, G31-R30 to G23-R24, G23-R24 to G19-R20, G19-R20 to G15-R16, G15-R16 to G11-R12, G11-R12 to G7-R8, G7-R8 to G3-R4, and beyond G3-R4

across nine channel sections. For the specific locations of these sections, refer to Table 1 and Figures 2, 3. From 2015 to 2016, due to the influence of dredging, the channel predominantly exhibited scouring. The total scouring volume for the entire channel was 4.626 million m<sup>3</sup>/ a, with an average scouring intensity of 0.38 m/a, while the silting volume was 208,600 m<sup>3</sup>/a, with an average silting intensity of 0.14 m/a. In this period, the scouring volume significantly exceeded the silting volume in all sections. From 2016 to 2017, the sections from G37-R38 to G15-R16 exhibited a scouring trend, while sections from G41-R42 to G37-R38 and beyond G15-R16 showed higher average silting volumes than scouring volumes, indicating the beginning of a silting trend. In the period from 2017 to 2018, scouring predominated in the sections

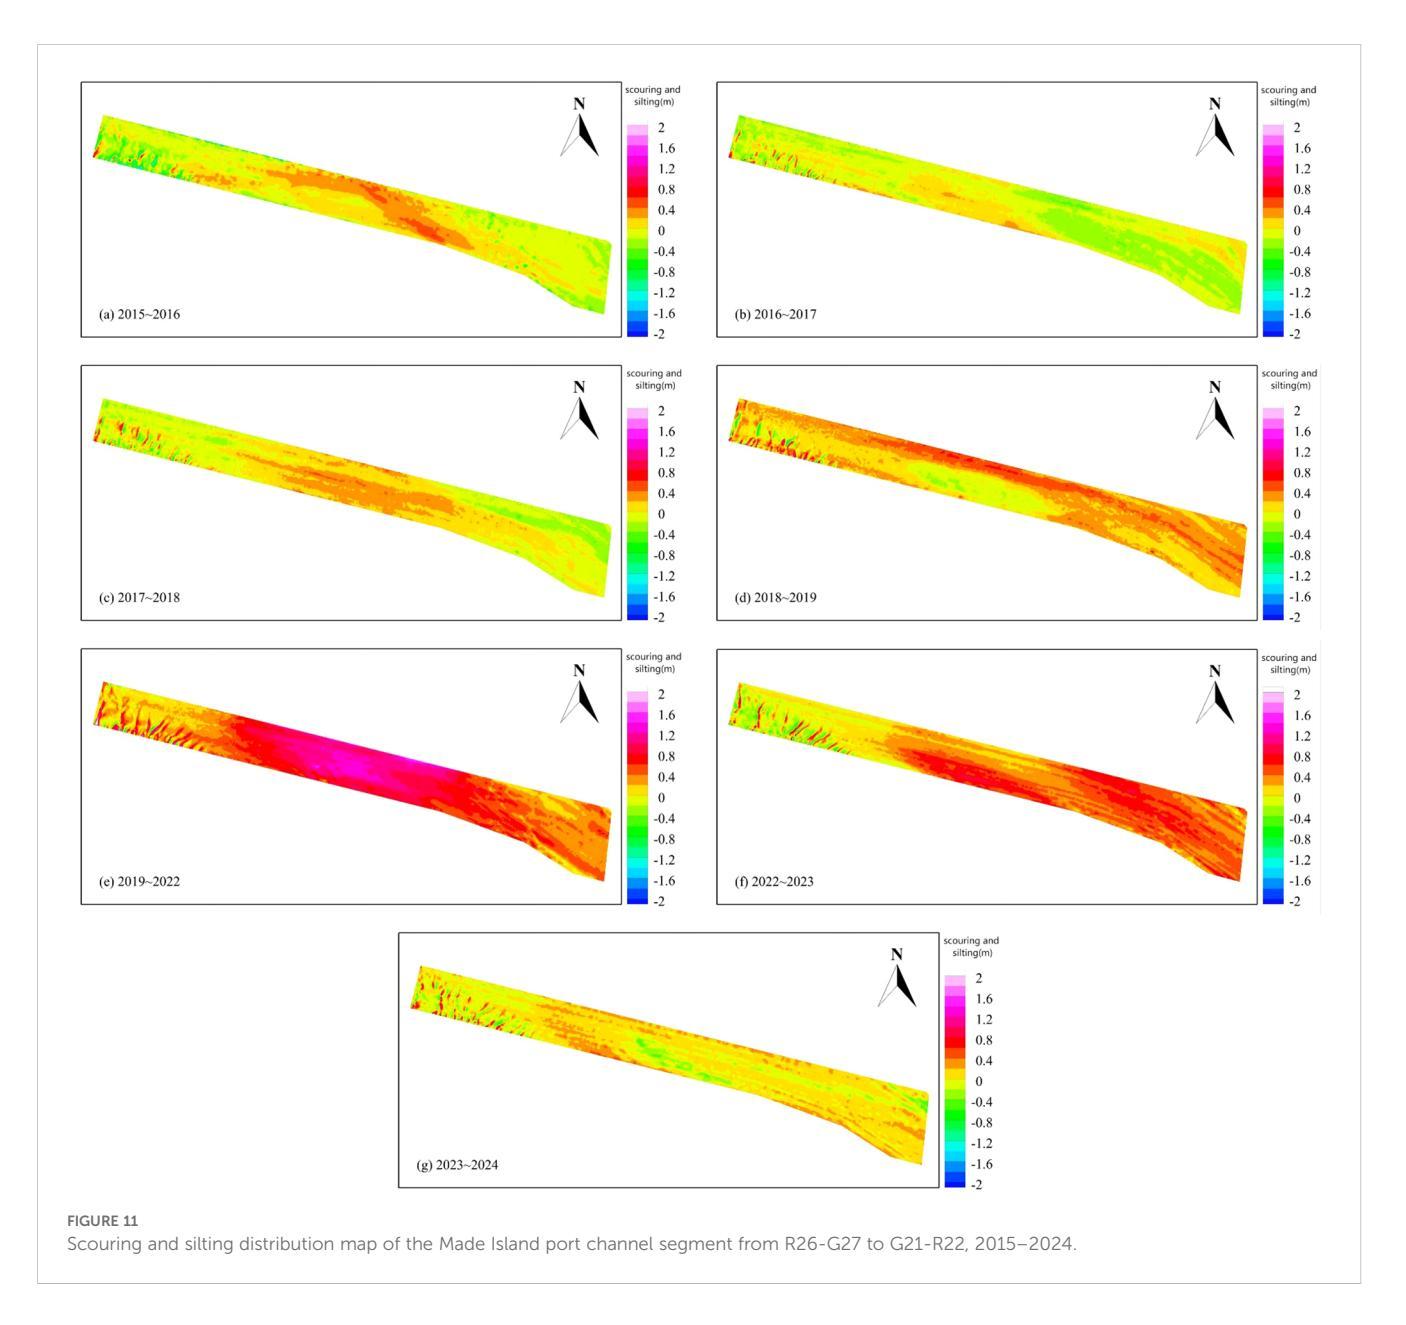
As shown in Figure 11, from 2015 to 2018, the R26-G27 to G21-R22 section of the channel exhibited a pattern of sediment accumulation in the center and scouring at both ends, with the maximum sediment accumulation intensity exceeding 0.5 m/a. This indicates that the central part of the channel was significantly affected by sediment deposition, while the higher flow velocities at the ends resulted in scouring. In 2018–2019, the channel showed a shift to localized scouring in the central area and sediment accumulation on both sides. The dredging activity in April 2018 altered the hydrodynamic conditions, causing scouring in the middle section and sediment accumulation at the sides. This could be attributed to the redistribution of sediment caused by

the increased flow velocity post-dredging. Between 2019 and 2022, the channel overall experienced a trend of sediment accumulation, with both the center and the sides accumulating sediment, and the maximum sediment thickness reaching approximately 1.3 m. This accumulation may have been influenced by increased sediment supply from upstream or sediment resettling after dredging. In 2022–2023, sediment accumulation continued, but at a slower pace, with the maximum accumulation thickness remaining above 0.6 m. In 2023–2024, the channel exhibited an alternating pattern of scouring and sedimentation. Emergency dredging in 2023 cleared some of the shallower areas, leading to noticeable scouring in the central and localized regions, while sediment accumulation persisted at the ends and certain areas. This alternating pattern of scouring and sedimentation is a typical characteristic of postdredging adjustments in the flow field.

As shown in Figure 11, in certain years, the central section of the R26-G27 to G21-R22 channel exhibits a maximum silting depth of over 0.5 m. Combining the analysis of channel topography and scouring/ silting conditions, the sediment supply from upstream is a key factor influencing silting. The tidal effects and seasonal rainfall increase sediment transport, while the low flow velocity in the central region makes it a typical sediment deposition area, resulting in significant silting. Additionally, the intensification of silting may be related to the sediment re-deposition effect following dredging activities in 2018 and 2023. After dredging, the seabed structure becomes loose, making it easier for sediment to accumulate during the return flow. Compared to deeper areas, shallow zones are more sensitive to changes in flow velocity, and often exhibit rapid local silting recovery after dredging.

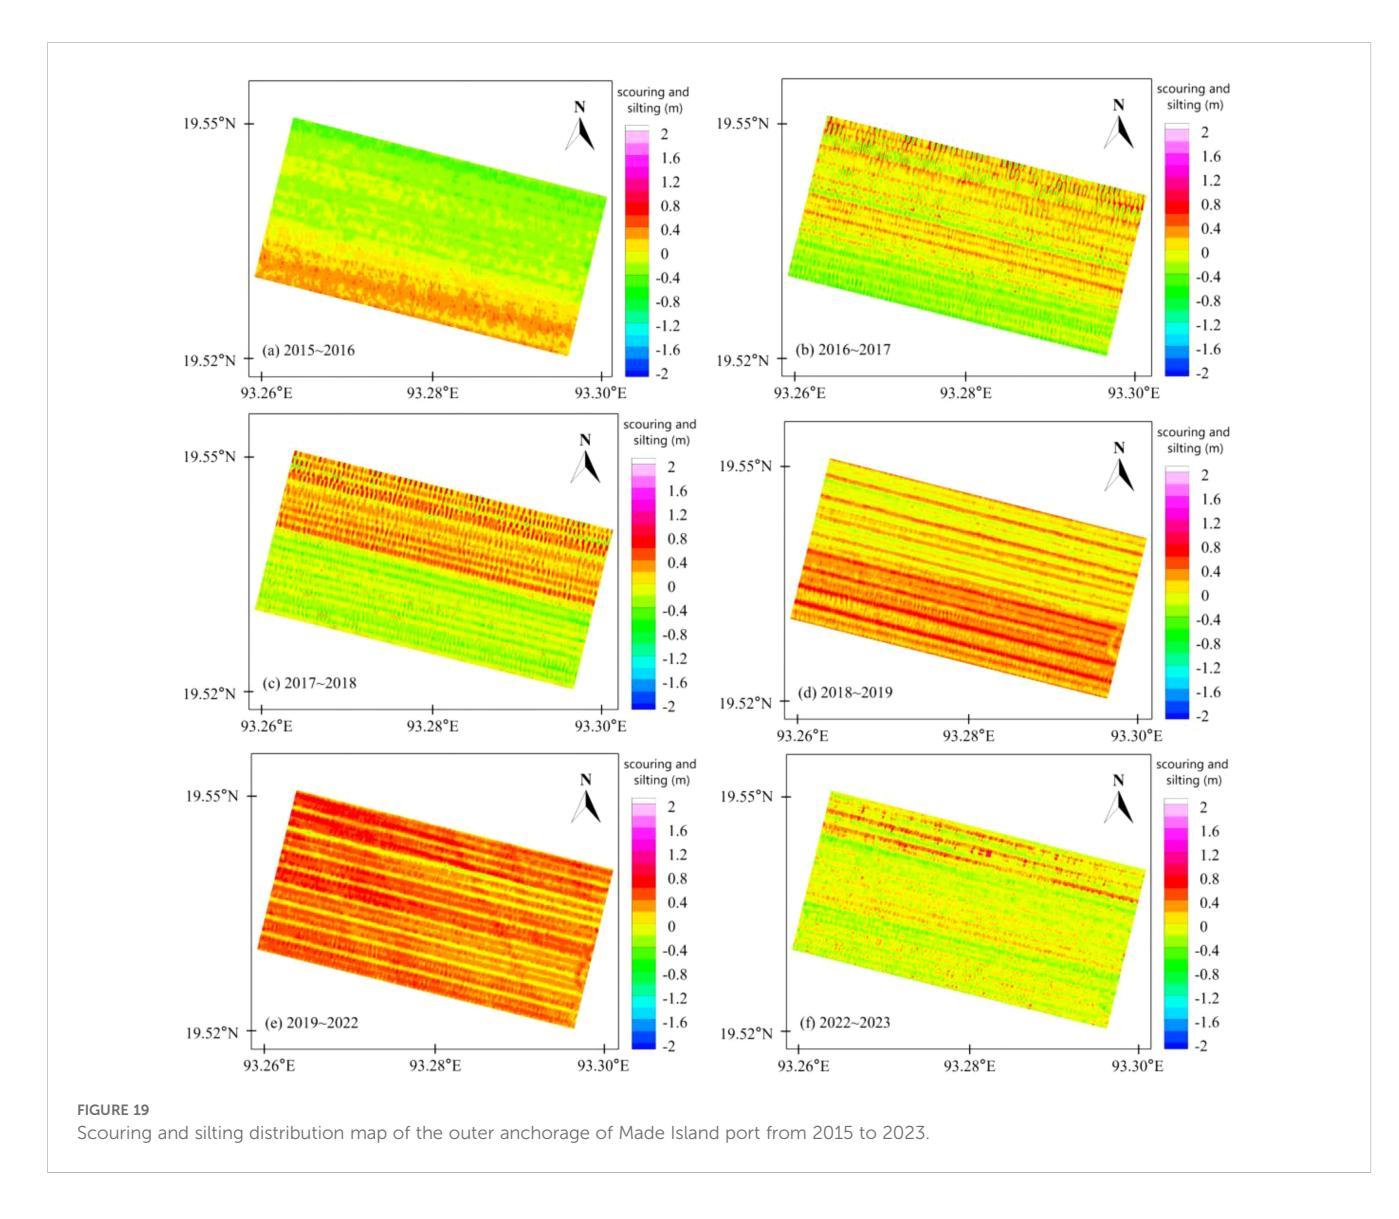
As shown in Figure 19, from 2015 to 2016, the outer anchorage area experienced scouring in the north and silting in the south, with

most scouring and silting amplitudes within 0.5 meters. The scouring was mainly concentrated in the northern region with stronger hydrodynamics, while the southern region, due to relatively weaker hydrodynamics and sediment deposition, formed a silting trend. From 2016 to 2017 and 2017 to 2018, the anchorage area exhibited scouring in the south and silting in the north, which may be related to tidal flow direction and seasonal hydrodynamic changes, with scouring and silting amplitudes mostly within 0.5 meters. From 2018 to 2019, silting predominated in the outer anchorage area, with more significant silting in the south, where some areas had silting depths exceeding 0.7 meters. This could be related to enhanced sediment transport and optimized deposition conditions in the southern region. From 2019 to 2022, there was a clear silting trend in the outer anchorage area. This silting may be associated with increased sediment supply and weakened hydrodynamic conditions, with silting depths exceeding 0.5 meters in most areas. From 2022 to 2023, scouring and silting occurred alternately, with relatively limited scouring and silting volumes, most of which were within 0.2 meters. Only localized areas in the northern part showed silting depths exceeding 0.4 meters, suggesting slight changes in local hydrodynamic conditions, but overall, the situation remained stable.

The causes of silting in the outer anchorage area of Made Island Port are determined by the combined effects of sediment supply, hydrodynamic conditions, external interventions, and seasonal variations. Sediment sources include coastal erosion, port operations, and tidal transport. Significant silting is related to regional subsidence and sediment accumulation. The spatial distribution of hydrodynamics makes the northern region more prone to scouring, while the southern region becomes a sediment deposition area due to reduced water flow. Dredging and engineering activities alter the hydrodynamic environment, leading to changes in the scouring and silting patterns over different years. Seasonal wind, waves, and tidal flow direction changes cause alternating scouring and silting patterns between the north and south. These factors collectively influence the complexity of the anchorage's scouring and silting dynamics.

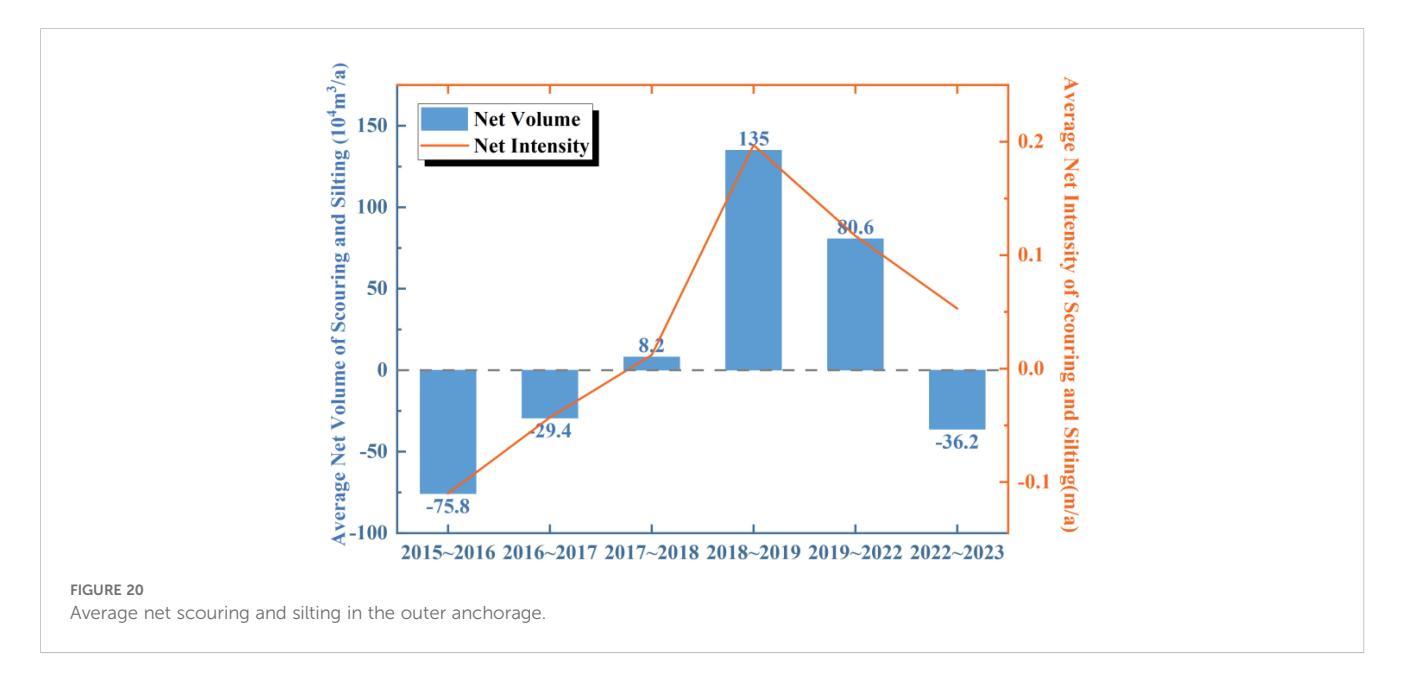
net scouring and silting volume and scouring-silting intensity for each year, as shown in Figure 20. A positive scouring-silting volume indicates silting, while a negative value indicates scouring. The net scouring-silting intensity follows the same principle.

As shown in Figure 20, from 2015 to 2016, the outer anchorage area exhibited a scouring trend caused by dredging, with a net scouring volume of 758,000 cubic meters per year and a scouring intensity of 0.110 meters per year. This indicates that dredging activities significantly reduced sediment accumulation in the anchorage area, improving water depth conditions. From 2016 to 2017, the scouring trend continued, likely related to the weakening of dredging activities or the natural recovery of hydrodynamic conditions, though the scouring volume was relatively limited. In the remaining years, the outer anchorage area exhibited a silting trend. From 2018 to 2019, silting was more pronounced, possibly due to weakened regional hydrodynamics, enhanced sediment transport, or changes in local deposition environments, with a net silting volume of 135.0 cubic meters per year and a silting intensity of 0.197 meters per year. Overall, the water depth conditions in the outer anchorage area of Made Island Port are relatively good, with smaller scouring and silting amplitudes in recent years, suggesting that the anchorage has reached a dynamic equilibrium state and that water depth conditions are stable.

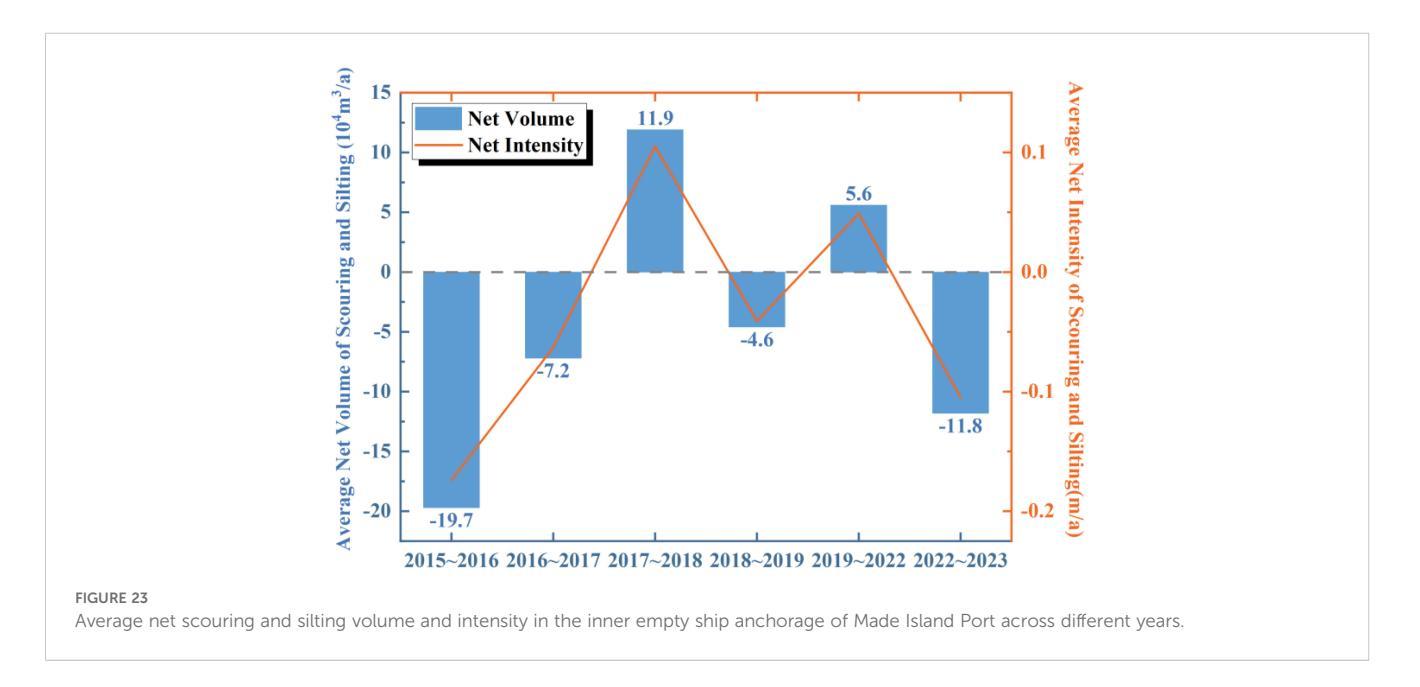
To quantify the scouring and silting conditions of the outer anchorage area across different years, this study calculated the average scouring and silting volumes and intensities for different channel sections, as shown in Figure 23.

As shown in Figure 23, from 2015 to 2016, due to the influence of dredging, the empty vessel anchorage area exhibited a scouring trend, with a net scouring volume of 197,000 cubic meters per year and a scouring intensity of 0.174 meters per year. This phenomenon is likely related to the dredging activities in 2015, which typically lead to changes in the water flow path, altering the velocity and direction of the flow, thereby intensifying scouring in certain areas. Dredging not only increases water flow speed but also may transport sediments away, resulting in a larger scouring volume and stronger scouring intensity. Between 2016-2017, 2018-2019, and 2022-2023, the area also exhibited a scouring trend, though the scouring volumes were relatively limited. Compared to 2015-2016, the scouring effect in these years weakened, likely due to the cessation of dredging activities or changes in water flow conditions. Especially in the absence of further dredging and flow enhancement, the natural flow velocity stabilized, leading to a reduction in scouring volume. In the remaining years, the empty vessel anchorage area exhibited silting conditions, with a more significant silting effect in 2017-2018. The net silting volume during this period was 11.9 cubic meters per year, and the silting intensity was 0.105 meters per year. This period may have seen slower water flow or continuous sediment input into the area, leading to a higher silting volume. In areas with weaker flow, silting is more likely, especially in certain parts of the anchorage area where sediment is constantly brought in and accumulated. In other years (2019-2022), the scouring effect was minimal, and the silting effect gradually became more apparent. The weakening of water flow or the accumulation of sediment in the port area made it difficult for water flow to effectively scour, leading to an increase in silting volume year by year.
