Study on galvanic corrosion caused by coating failure in heat exchangers for chemical cooling water systems

Cooling water heat exchangers are essential components in chemical production processes, requiring long-term stability under corrosive circulating cooling water conditions. Coating protection technology has become increasingly widespread for mitigating corrosion in these systems. However, prolonged immersion in cooling water during operation can result in coating degradation and detachment. This study examines the corrosion behavior associated with coating damage in cooling water heat exchangers under varying immersion times. Coated carbon steel specimens were coupled with artificially stripped specimens to simulate large cathode and small anode systems in a cooling water environment. The results reveal that the corrosion rate of the small exposed anode increases as the exposure area decreases. Simultaneously, the adhesion between the coating and the substrate of the large cathode weakens with immersion time, leading to the formation of voids regardless of the exposure area. The findings indicate that in practical applications, smaller areas of coating delamination drive loc

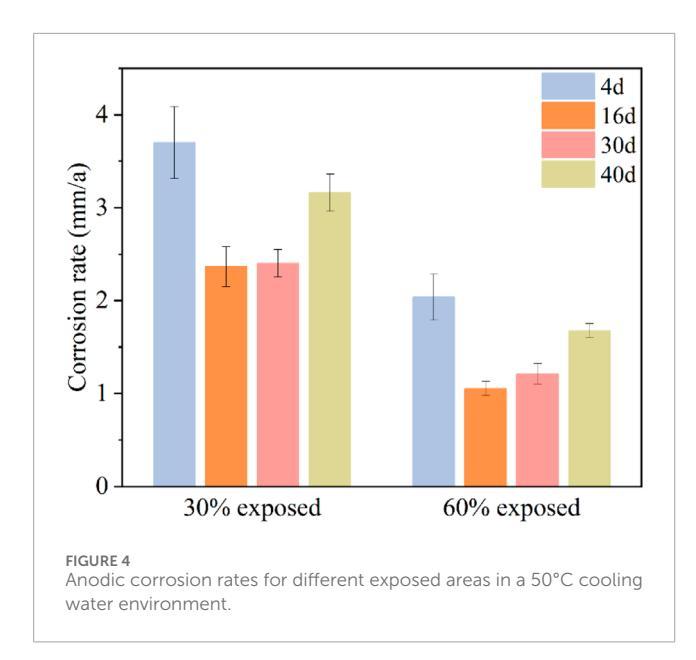
The weight loss test can be used to determine the corrosion development of anode metals with different exposed areas at various stages in a 50°C cooling water environment by calculating the corrosion rate, as shown in Figure 4. The corrosion rates of both anodes with different exposure areas exhibit a trend of initially decreasing and then increasing over time. Additionally, the corrosion rate of the 30% exposed area anode is higher than that of the 60% exposed area anode. Specifically, for the anode with a 30% exposed area, the corrosion rate is relatively high on the 4th day of immersion. At this stage, the oxide film on the anode surface disappears, increasing the electrochemical activity of the anode metal. Meanwhile, the large cathode is not yet under corrosion threat, and corrosion mainly occurs on the anode surface. As the immersion time increases, the corrosion rate of the anode significantly decreases on the 16th day. This is due to the dense accumulation of corrosion products forming a protective film on the anode metal surface, providing a certain degree of corrosion inhibition. By the 30th day, the accumulation of corrosion products reaches its peak. However, as immersion in high-temperature cooling water continues, the corrosion product film is gradually penetrated, weakening its inhibition effect and eventually leading to its failure. This results in a renewed increase in the electrochemical activity of the anode surface, causing the corrosion rate to rise again. For the anode with a 60% exposed area, the initial stage of immersion

also shows a relatively high corrosion rate due to the disappearance of the oxide film. However, because of the larger exposed area, the generated galvanic current density is lower, making the corrosion less severe compared to the 30% exposed area anode. During immersion in cooling water, corrosion products begin to accumulate densely by the 16th day, reducing the electrochemical activity of the metal surface. At the same time, gaps start to appear in the cathodic coating, leading to a reduction in the anode corrosion rate. Due to the larger exposed area, the coverage of the corrosion product film occurs more slowly. From the 16th to the 40th day, the anode surface is gradually covered by the corrosion product film. During this period, corrosion products begin to appear in the gaps of the cathodic coating, driving further anode metal corrosion. However, the presence of the corrosion product film causes the corrosion rate to increase at a slower pace.

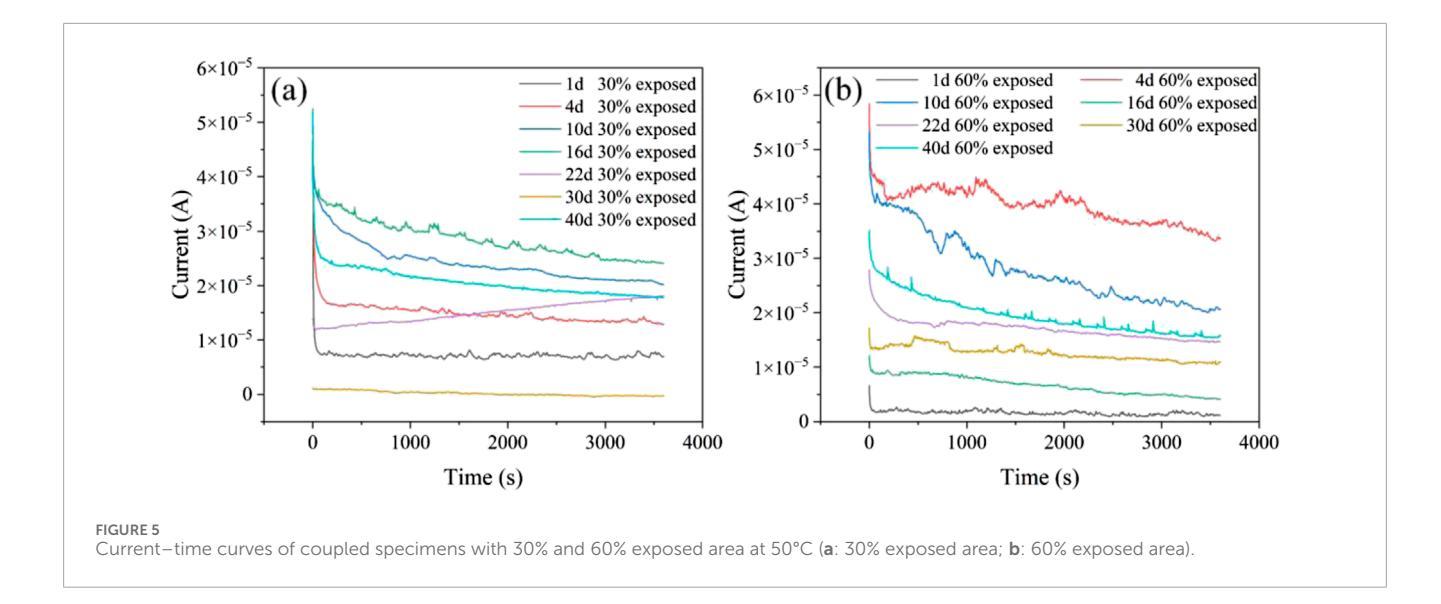
Figure 5 illustrate the current-time curves for the large cathodesmall anode coupling system immersed in a 50°C cooling water environment for 40 days. It can be observed that regardless of the exposure area ratio of the small anode in the coupling system, the galvanic current exhibits a trend of initially increasing and then decreasing over time. This phenomenon occurs because, as the immersion time in the cooling water increases, small defects on the coating surface begin to expose, allowing the solution to penetrate through the coating and come into contact with the metal substrate, leading to an increase in galvanic current. With further immersion, corrosion products gradually accumulate on the metal surface, forming a corrosion product film that provides some protection to the metal substrate, thereby causing the current to decrease. For the coupling system with a 30% exposed area, the galvanic current increases during the first 1–16 days, then begins to decrease between days 16 and 30. Around day 30, a current reversal phenomenon occurs, and the current rises slightly again between days 30 and 40; For the coupling system with a 60% exposed area, the galvanic current increases during the first 1–4 days, decreases between days 4 and 16, and then rises again from days 16–40.

From the macroscopic morphology analysis, it can be observed that for the coupling system with a 30% exposed area, the accumulation of corrosion products during the first 16 days does not completely cover the entire working surface. At the initial stage of immersion, an oxide film forms on the metal surface, reducing surface activity, which explains why the galvanic current is initially low. As immersion time increases, the surface activity of the metal rises, and the oxide film is penetrated and destroyed, causing the galvanic current to increase. Simultaneously, corrosion products begin to accumulate densely on the surface. With the dense accumulation of corrosion products, the electron exchange between the metal and the solution becomes hindered, leading to a subsequent decrease in the galvanic current (Yoo et al., 2014). Although the corrosion product film can slow down the corrosion rate to a certain extent, leading to a decrease in galvanic current, its inhibition ability is limited (Chen et al., 2024). As immersion time increases, small defects in the cathode coating begin to emerge, allowing the solution to penetrate through the pores into the coating and form gaps between the coating and the metal substrate. This leads to an expansion of the exposed area, and the cathode substrate starts to corrode. The rate of decrease in galvanic current slows down. By the 30th day, the corrosion product film on the anode provides a certain shielding effect, while the failure of the cathode coating progresses further, enlarging the gaps under the coating. The contact area between the metal substrate and the solution increases, resulting in the phenomenon of current reversal on the 30th day. At this point, cathode corrosion intensifies, and the dense corrosion product film on the anode isolates electron exchange with the solution, causing the galvanic current to reverse. Subsequently, the inhibition capability of the corrosion product film in the cooling water environment weakens, and the shielding effect of the film begins to fail. This re-exposes the anode to the solution, leading to a rise in galvanic current. For the coupling system with a 60% exposed area, the macroscopic morphology analysis reveals that from the 1st to the 4th day, the corrosion products are not dense, and the cathode coating has not failed extensively. Consequently, as immersion progresses, the electrochemical activity on the anode surface increases, raising the galvanic current. With the dense accumulation of corrosion products, the corrosion product film begins to impede electron exchange between the anode surface and the solution, causing the galvanic current to decrease. Meanwhile, under the influence of high temperatures and cooling water, small defects in the cathode coating become exposed, weakening the adhesion between the cathode coating and the metal substrate, and gaps form. This allows the solution to contact the cathode substrate. Simultaneously, the corrosion product film on the anode is penetrated due to prolonged exposure to high-temperature cooling water, further expanding the anode's working area. This results in an increase in galvanic current from the 30th to the 40th day. Due to the larger exposed area of the 60% coupling system's

anode, the corrosion products cannot completely cover the working surface. Thus, even with extensive cathode coating failure, no current reversal is observed in the system.

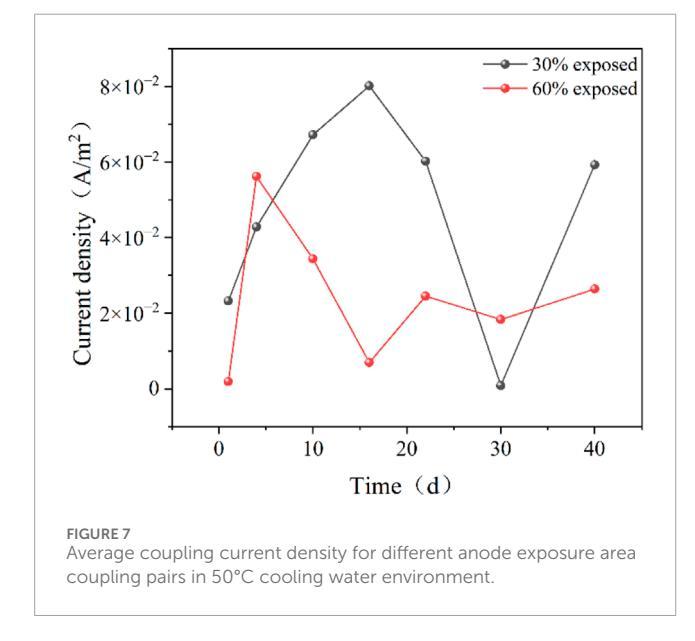
Figure 7 shows the average galvanic current density of galvanic couples with different anode exposed areas in a 50°C cooling water environment. A comparison of the galvanic current density between the two coupling pairs with different anode exposed areas indicates that the coupling pair with 30% exposed area has a higher current density than the one with 60% exposed area. This suggests that the coupling pair with 30% exposed area has a more severe corrosion degree and a faster corrosion rate. This is because a smaller exposed area implies a smaller working surface, which concentrates the current. Additionally, more corrosion products accumulate on the anode of the 30% exposed area coupling pair, further reducing the effective working area. On the 30 days, the corrosion product film on the anode becomes densely accumulated, and with prolonged exposure to high-temperature cooling water, the adhesive force between the cathode coating and the metal substrate decreases.

Cooling water infiltrates through small defects in the coating, forming gaps between the coating and the metal substrate, leading to contact between the cooling water and the metal substrate. As a result, the coating partially fails. With the accumulation of corrosion product film, the anode and cathode reverse, and the galvanic current crosses zero, resulting in a current reversal. Therefore, the galvanic current density at this point is relatively low.

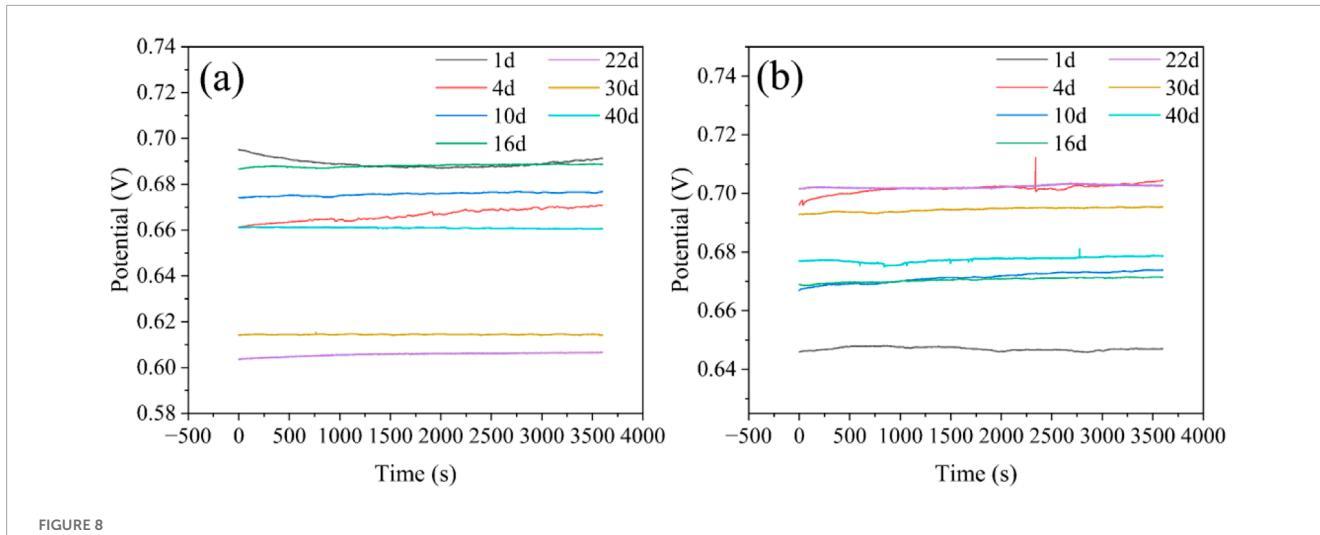
As shown in Figure 8, the galvanic potentials of two galvanic couples with different anode exposure areas in a 50°C cooling water environment are presented. The average galvanic potentials of the two couples are calculated and shown in Figure 9. On the first day of immersion, the galvanic potentials of the couples with different anode exposure areas differ significantly, with the 30% exposure area couple having a higher galvanic potential than the 60% exposure area couple. This is due to more intense corrosion and electrochemical reactions on the metal surface in the early stages of immersion, and the initial electrochemical reactions may lead to interfacial reactions between the coating and the metal substrate, affecting the galvanic potential difference. As the immersion time increases, both couples exhibit a decrease in galvanic potential, which is attributed to the formation of an oxide film on the metal surface. The oxide film is eventually penetrated, and its corrosion inhibition ability weakens, leading to a subsequent increase in galvanic potential. As corrosion products accumulate and compact on the surface, the effective working area of the metal decreases, causing the galvanic potential to decline once more. After the corrosion product film fails and is penetrated, the galvanic potential increases again. From the figures, it can be observed that the galvanic potential of the 30% exposure area couple decreases more significantly. This indicates that compared to couples with larger exposed metal areas, the couple with smaller exposed areas is more easily covered by the corrosion product film, and the corrosion inhibition ability of the corrosion products is more pronounced (Shamsa et al., 2021). Additionally, a comparison of the two couples with different anode exposure areas reveals that although their galvanic potentials are not identical, the fluctuations are relatively small, suggesting that the dominant corrosion process in both cases is uniform corrosion.

Electrochemical potential of coupled metals with varying anode exposure areas during 40 days immersion in 50°C cooling water [(a): 30% anode exposure area; (b) 60% anode exposure area].

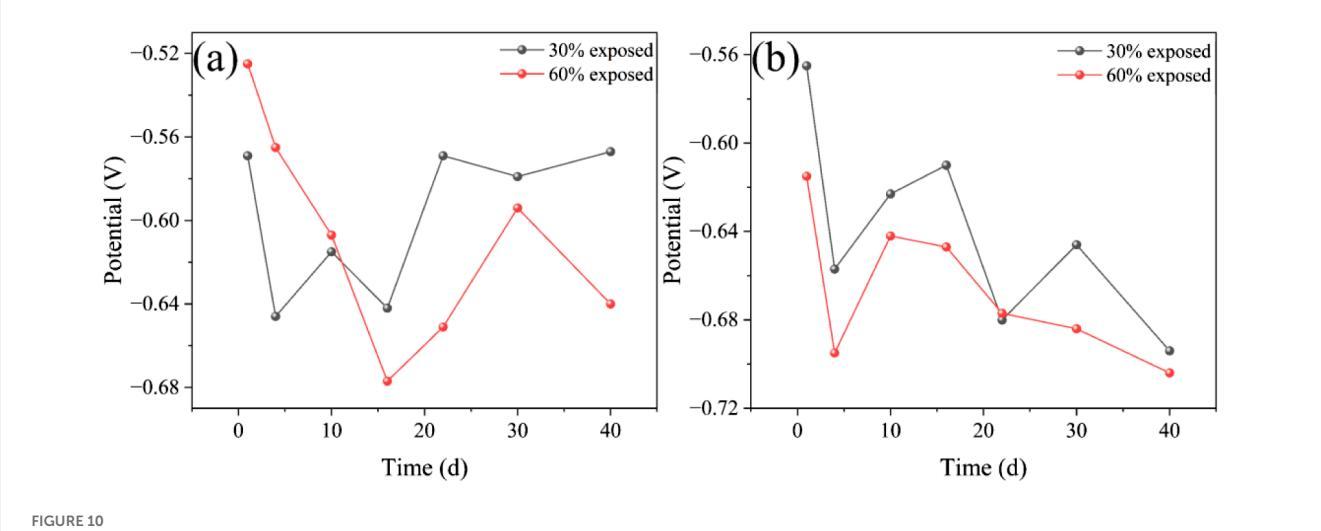
As shown in Figure 10, the OCP of the large cathode and small anode in the 50°C cooling water environment is presented. From the figure, it can be observed that the OCP of the large cathode in both coupled systems with small anodes of different exposure areas first decreases and then increases. At the beginning of immersion, the OCP of the large cathode for both coupled systems is relatively positive, indicating that the coating provides effective protection to the metal substrate during the initial stage of immersion. From days 4-16, a rapid decline in OCP is observed, suggesting that the shielding effect of the coating gradually weakens. Small defects in the coating provide channels for the solution to contact the metal substrate, and with the increasing immersion time, gaps begin to appear between the coating and the metal substrate, thereby reducing the protective efficiency of the coating. On day 16, the OCP of the large cathode in both coupled systems becomes negative, indicating that significant corrosion of the metal substrate has occurred beneath the coating. The coating's protective effect is diminished, and the exposed area of the anode is reduced due to the formation of the corrosion product film. This results in an increase in the anode activity of the cathode, leading to further corrosion. Between days 16 and 40, the corrosion product film formed on the metal substrate provides some passivation effect, causing the OCP to shift positively. However, during this period, the passivation effect of the corrosion product film on the anode surface weakens, and the

The OCP of the small anode in the 50°C cooling water environment, which exhibits a trend of first decreasing, then increasing, and then decreasing again. The OCP trends for both small anodes with different exposure areas are consistent. On day 1, both systems show relatively positive OCP values, which is due to the formation of an oxide film on the metal surface at the beginning of immersion, reducing the surface's electrochemical activity. From days 1–4, the OCP rapidly decreases due to the dissolution or breakdown of the oxide film. As corrosion products accumulate and form a dense corrosion product film, the electronic exchange at the metal surface is hindered, and the exposed anode area gradually decreases, leading to a quasi-passivation state. As a result, the OCP starts to rise, the exposed metal substrate of 30% exposure area is relatively smaller, so the accumulation of corrosion products becomes more compact, which leads to a slightly more positive OCP compared to the 60% exposure area anode. From days 16–40, the corrosion product film is gradually penetrated, causing the OCP to decrease again. Notably, on day 30, for the small anode with 30% exposure area, the compact accumulation of corrosion products again plays a significant role, resulting in a brief increase in OCP. This observation is consistent with the analysis of the galvanic current density.

Open circuit potential variation of large cathode and small anode in coupled pairs with different exposure areas during 40 days of immersion in 50°C cooling water environment [(a): large cathode; (b) small anode].

By analyzing the OCP of both the cathode and anode in the galvanic pairs with different exposure areas, it can be observed that, regardless of the exposure area, the cathodic coatings of both systems have experienced failure. For the galvanic pair with a larger exposure area, the cathodic corrosion is relatively more severe. In contrast, the galvanic pair with a smaller exposure area, due to the smaller exposed metal substrate, has a relatively stronger corrosion inhibition effect from the corrosion products. This results in more localized corrosion on the cathode part (Wang et al., 2021; Zhou et al., 2024).

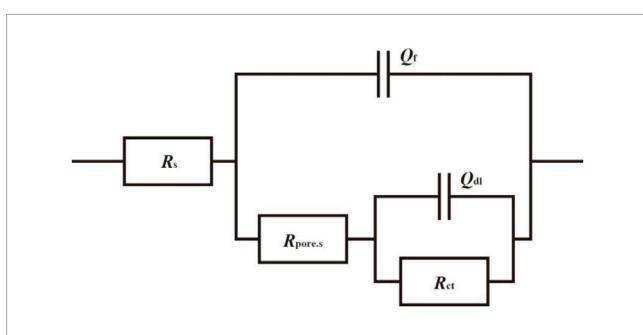
FIGURE 13

Fitted circuits for coupled pairs of small anodes immersed for 1d, 4d, 10d, 16d and 40d in a cooling water environment at 50° C.

products, and the charge transfer process in the double electric layer, and according to the characteristics of the impedance spectra, the fitting circuit shown in Figure 13 is selected to fit the impedance spectra from days 1–16 and day 40. Since the Nyquist plot from days 22–30 exhibits diffusion phenomena, the fitting circuit shown in Figure 14 is chosen to fit the Nyquist plot for the period of days 22–30. In fitting circuits, R_s represents the solution resistance; R_{pore.s} and Q_f correspond to the resistance and capacitance of the corrosion product film, respectively; Q_{dl} represents the double-layer capacitance; R_{ct} is the charge transfer resistance; and W is the Warburg impedance. The fitting results are shown in Tables 5–8.

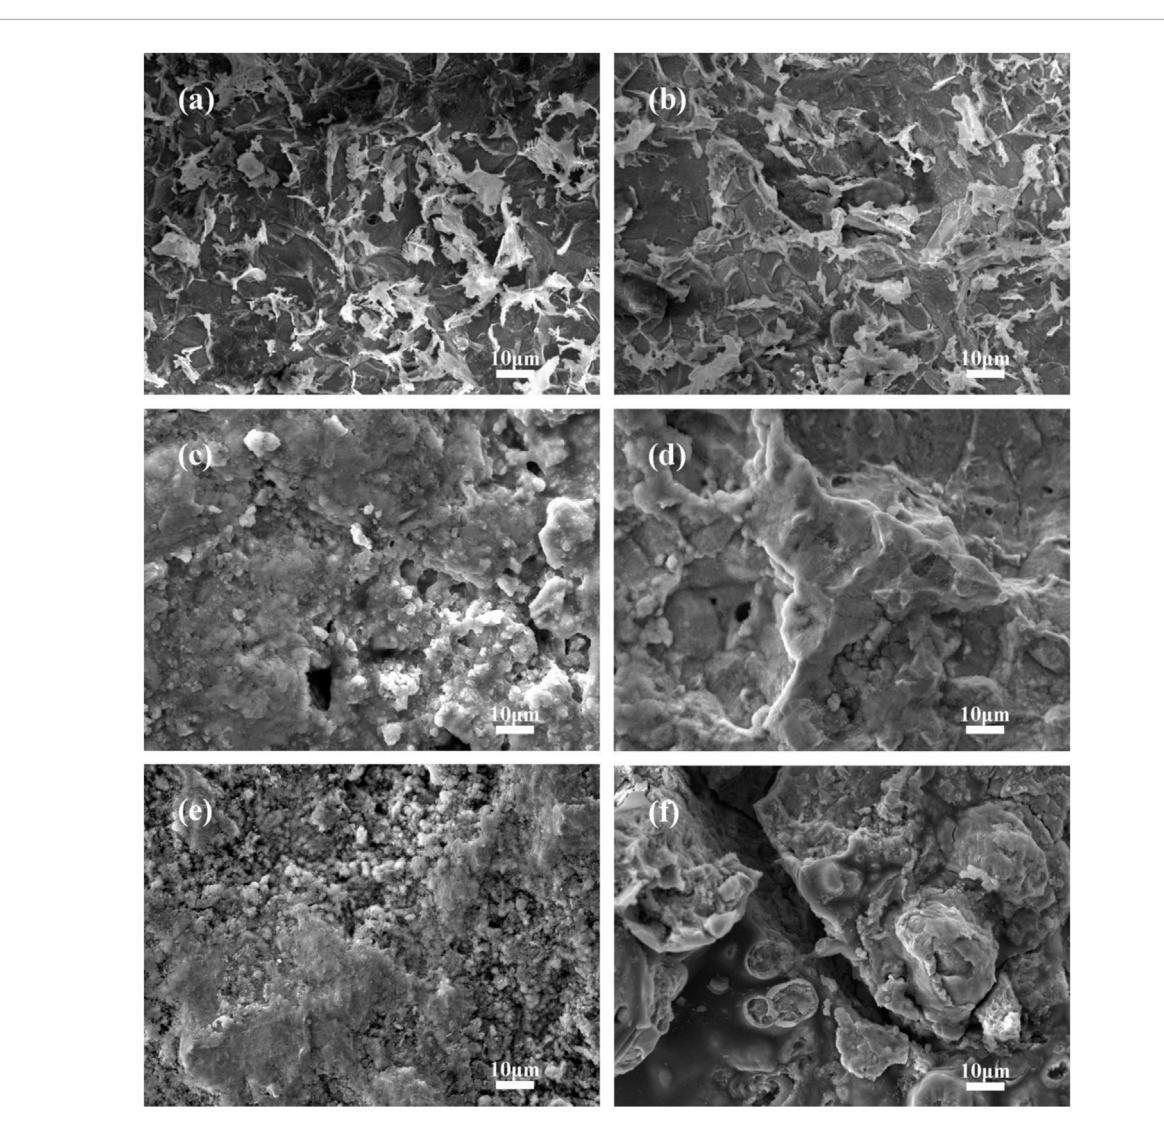
FIGURE 16

cooling water environment. After immersion in high-temperature cooling water, the small anodes exhibited varying degrees of corrosion. From the images, it can be seen that during the early stages of immersion, an oxide film forms on the anode surface, providing some protection to the metal. Therefore, the corrosion on the surface of the small anodes with both exposed areas is not severe (Figures 16a,b). As immersion time increases, the oxide film is damaged, and corrosion begins to appear on the small anodes (Figures 16c,d). It is observed that the corrosion on the small anodes is primarily uniform, accompanied by localized corrosion. This is due to the uneven surface current distribution on the sandblasted anode surfaces, where local current densities are too high, resulting in intensified localized corrosion. Among them, the small anode

with 30% exposed area exhibits more severe uniform corrosion. After 40 days, both small anodes with different exposed areas show significant corrosion, with the metal substrate of the 30% exposed area anode still exhibiting more severe corrosion than the 60% exposed area anode (Figures 16e,f). Although the corrosion of the 60% exposed area anode is mainly localized, deep corrosion pits caused by localized corrosion can still be observed on its surface.

Surface morphology of small anode immersed for 40d in 50°C cooling water environment with different exposure area coupling pairs (a) 4d 30% exposure area small anode; (b) 4d 60% exposure area small anode; (c) 16d 30% exposure area small anode; (d) 16d 60% exposure area small anode; (e) 40d 30% exposure area small anode; (f) 40d 60% exposure area small anodes.

Comparing the small anodes with different exposed areas, both types of anodes exhibited uniform corrosion, along with localized corrosion. Typically, to improve the bonding strength of the coating to the metal, sandblasting is applied to the metal surface before coating (Benea et al., 2020). After the coating accidently detaches, the sandblasted metal substrate is exposed to the cooling

water solution. While sandblasting enhances the adhesion of the coating, it also causes uneven current distribution on the exposed metal surface. This leads to a high local current density, which intensifies localized corrosion, resulting in corrosion pits, cracks, and other forms of damage. The small anode with a smaller exposed area shows more severe uniform corrosion compared to the larger exposed area anode. Additionally, the localized corrosion on the larger exposed area anode is more pronounced than that on the smaller exposed area anode. This is because the smaller exposed area generates a higher galvanic current density, causing both

the corrosion rate and the formation of the corrosion product film to increase more rapidly. In contrast, the larger exposed area anode, although having a lower galvanic current density and experiences a slower corrosion rate. However, the larger exposed area combined with the slower accumulation of corrosion products leads to areas where dense corrosion products coexist with exposed metal regions. As a result, local current density becomes more concentrated, further intensifying localized corrosion. In actual working environments, when the coating first begins to peel off, uniform corrosion predominates. As high-temperature cooling

water continues to immerse and erode the surface, the exposed area of the coating expands, and localized corrosion starts to develop. This is accompanied by the localized accumulation of corrosion products. As a result, local current density increases at the exposed surface, exacerbating localized corrosion and leading to the formation of corrosion pits and cracks.

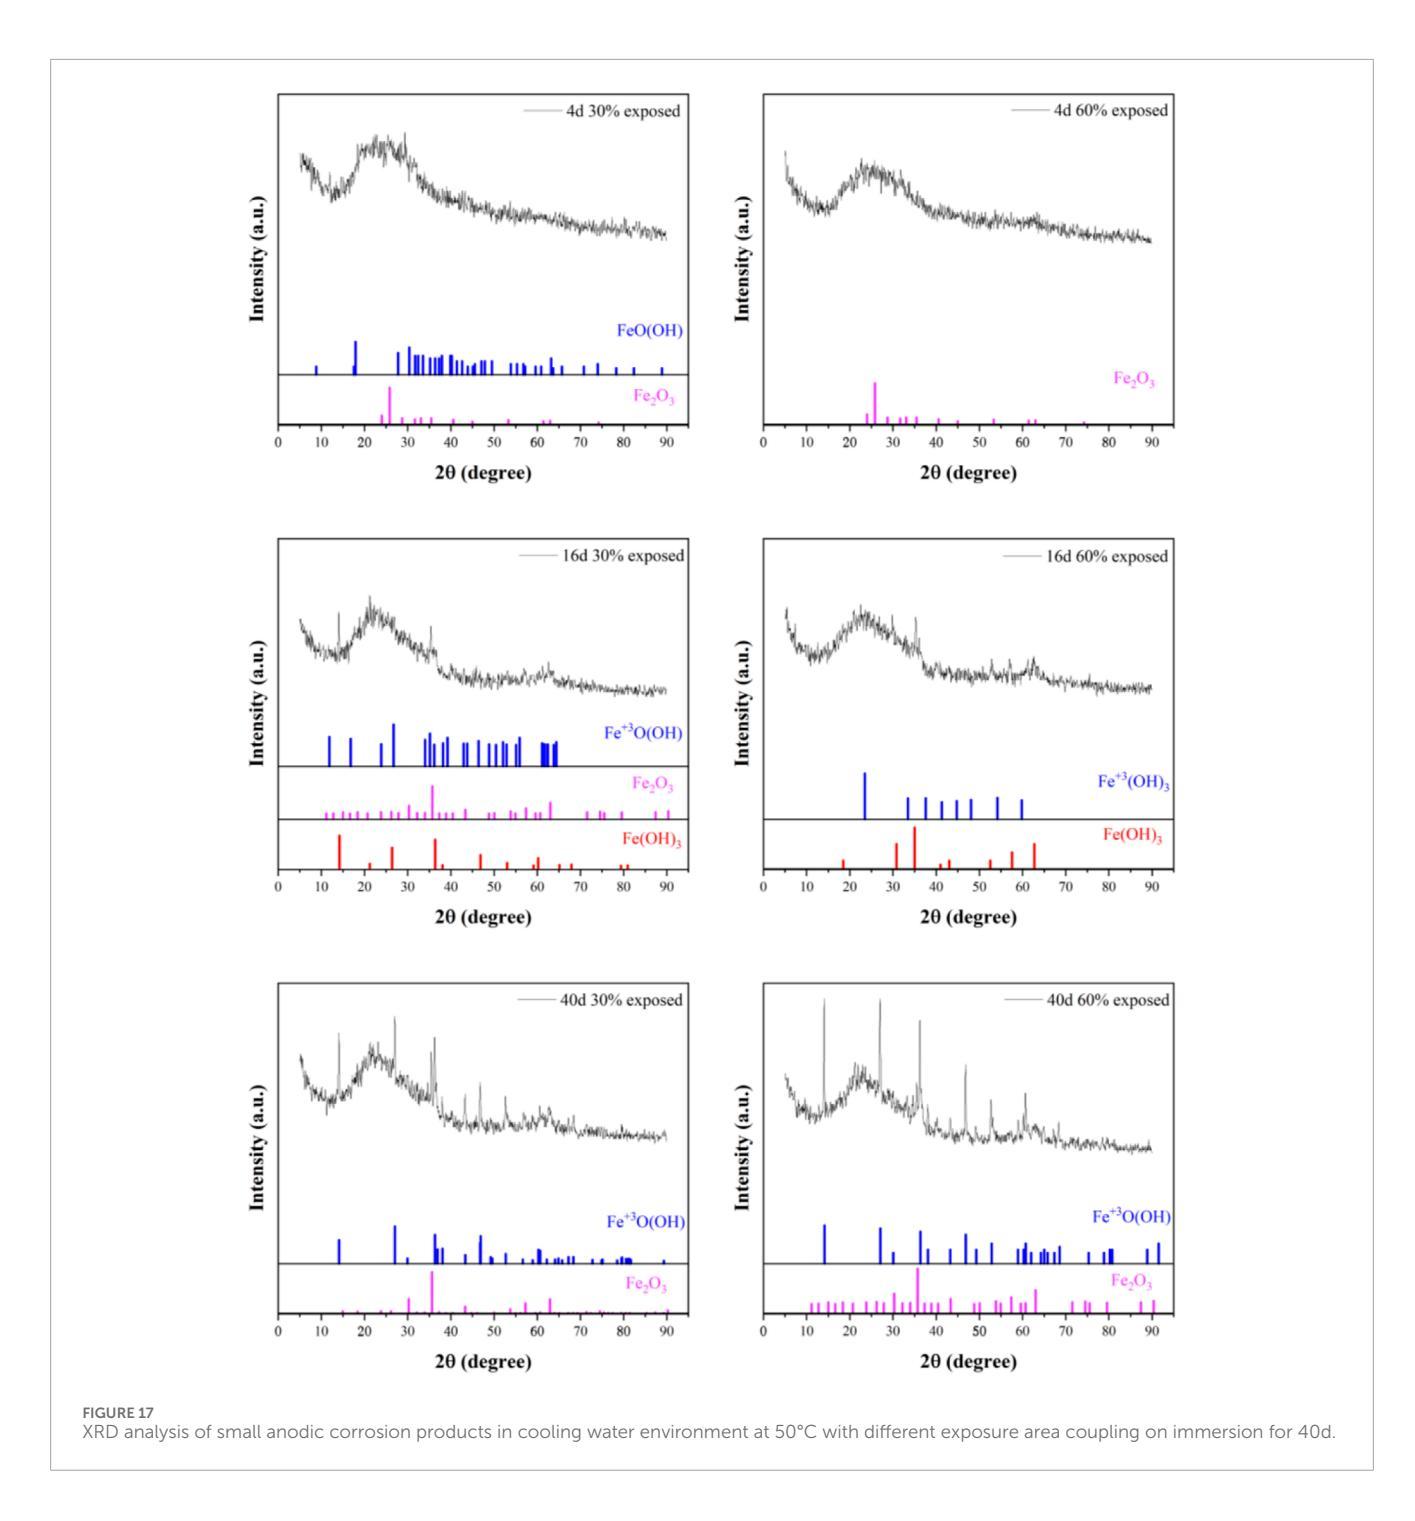
The corrosion products formed on different anode exposure areas coupled in a 50°C cooling water environment for 40 days were analyzed using X-ray diffraction (XRD), as shown in Figure 17. The cooling water contains ions such as NaOH and K₂PO₄, with the primary corrosive ions being (OH)⁻, PO₄²⁻, and others. The XRD analysis of the corrosion products revealed that they primarily consist of FeO(OH), Fe₂O₃, and Fe(OH)₃. These iron oxides formed

and adhered to the metal surface, providing some level of corrosion protection. The formation of iron compounds and their adhesion to the metal surface provided some corrosion protection; however, they also contributed to the intensification of localized corrosion on the anode surface to some extent. By comparing the composition of corrosion products at different immersion times for the two exposure areas, it can be observed that as the immersion time increases, the corrosion products transition from FeO(OH) and Fe_2O_3 to the more stable $Fe(OH)_3$ and $Fe^{+3}O(OH)$. This indicates that the corrosion process gradually stabilizes over time. Specifically, in the early immersion stage, the corrosion products of the 30% exposure area anode mainly consist of FeO(OH) and Fe₂O₃, while those of the 60% exposure area anode are primarily Fe₂O₃. This suggests that the anode with a smaller exposure area undergoes more severe corrosion, resulting in a higher corrosion rate and more complex corrosion products. In contrast, the anode with a larger exposure area experiences stronger polarization effects, leading to

simpler corrosion products. As immersion time increases, by the 16th day, the corrosion products of the 30% exposure area anode mainly consist of $Fe^{+3}O(OH)$, Fe_2O_3 , and $Fe(OH)_3$, while those of the 60% exposure area anode primarily include $Fe^{+3}O(OH)$ and $Fe(OH)_3$. The presence of $Fe(OH)_3$ as an oxidation product of FeO(OH) indicates that the corrosion process is evolving towards a more stable state, with corrosion products becoming more hydrated and less compact. By the 40th day, the corrosion products of both exposure areas converge, consisting mainly of $Fe^{+3}O(OH)$ and Fe_2O_3 . This suggests that despite the difference in exposure areas, the corrosion mechanisms are similar, ultimately leading to the formation of stable iron oxide products. Consequently, as immersion

time increases, the corrosion products tend to transform into more stable forms, signifying that the corrosion process has entered a relatively stable phase.

Overall, in the early immersion stage, the corrosion products of the 30% exposure area anode are more complex, indicating more severe corrosion. As immersion time increases, the corrosion products of both exposure areas transition from FeO(OH) and Fe₂O₃ to the more stable Fe⁺³O(OH) and Fe(OH)₃, eventually becoming consistent. This suggests that the corrosion process stabilizes over time. When the anode exposure area is smaller, corrosion is concentrated in the anode region, leading to more complex corrosion products. In contrast, when the anode exposure area is larger, the corrosion process develops more slowly. The corrosion products of both exposure areas provide a certain degree of corrosion inhibition to the metal substrate.
