Zhao S, Chen Y, Xu W, Xu J and Cheng X (2025) Mechanical behaviour and fracture mechanism of coal mine roadway surrounding rock considering seepage field. *Front. Mater.* 12:1612136. doi: 10.3389/fmats.2025.1612136

Mechanical behaviour and fracture mechanism of coal mine roadway surrounding rock considering seepage field

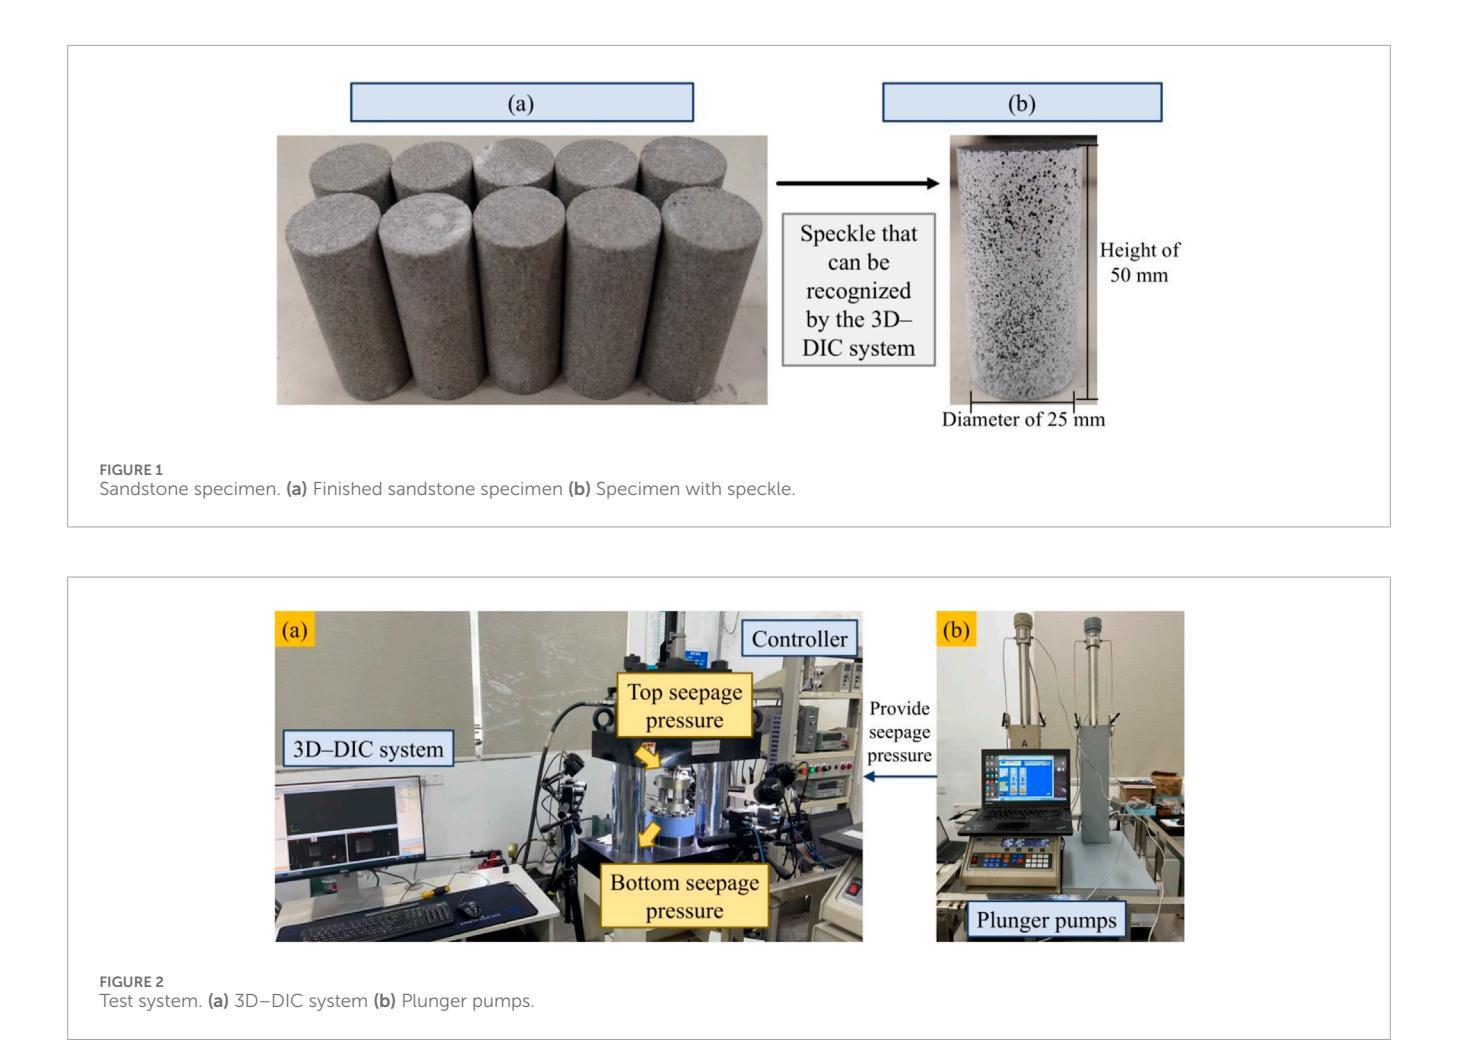
In this study, sandstone, a surrounding rock commonly found in coal mine roadways, is selected for conventional triaxial compression tests under seepage–stress coupling conditions. The sandstone primarily comprises quartz (42.6%), followed by albite (33.6%), potassium feldspar (9.3%), muscovite (7.3%), and chlorite

(7.2%). To ensure the reliability of experimental results, the sandstone rock mass is uniformly cut along the same joint direction before fabricating standard cylindrical specimens. The specimens are coated with a black speckle pattern on a white background to enable recognition by a three-dimensional digital image correlation (3D–DIC) system (Chen Y. et al., 2022; 2023c), as shown in Figure 1. Each cylindrical specimen measured 50 mm in height and 25 mm in diameter. Additionally, to minimize end constraints during testing, the flatness of the end face is maintained within 0.05 mm. The prepared sandstone specimen was saturated using the vacuum water saturation method. Once its mass stabilized, the specimen was considered fully saturated. Subsequently, the water-saturated specimen was placed in a transparent pressure chamber for triaxial compression testing.

To investigate the mechanical behaviours and permeability characteristics of sandstone, a transparent triaxial compression servo-control test system has been independently developed (Chen et al., 2023b), as shown in Figure 2. A 3D–DIC system is incorporated to track the progressive failure behaviour of specimens under triaxial compression, enabling detailed observation of the spatio–temporal development of the strain fields. Additionally, two plunger pumps are integrated into the system to independently apply seepage pressure to the top and bottom of the specimen, enabling the simulation of seepage–stress coupling conditions.

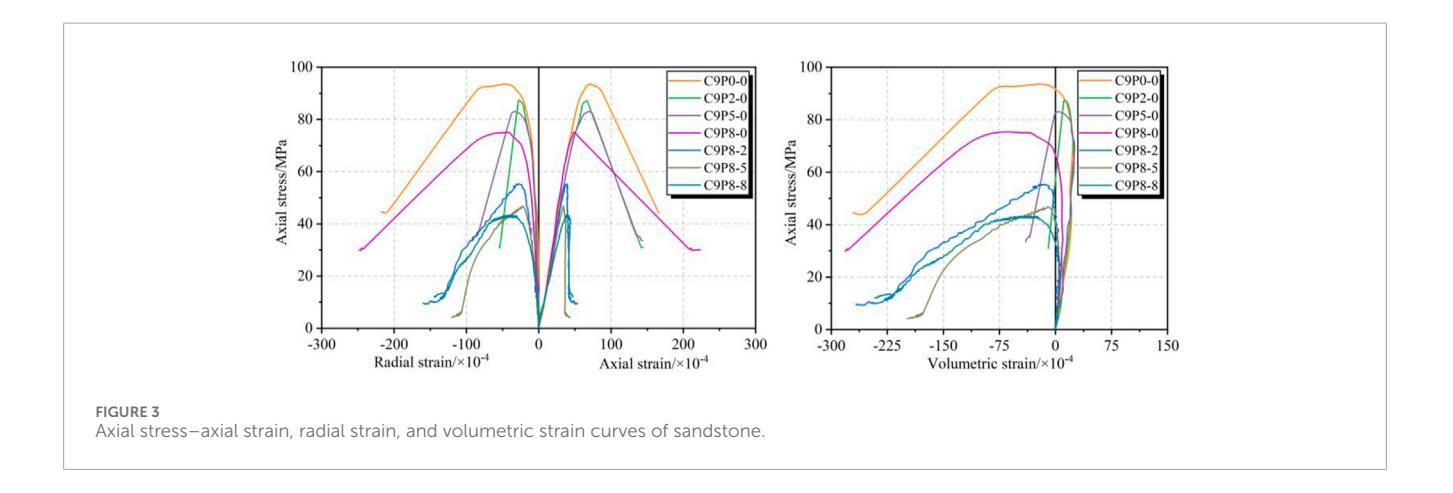
As shown in Figure 3, the axial stress–strain, radial strain, and volumetric strain responses of sandstone are depicted under varying seepage pressure levels. The results indicate that as both top and bottom seepage pressures increase, the peak stress of sandstone decreases. Additionally, changes in the seepage field are positively correlated with strain and failure. With increasing pore pressure, the sandstone exhibits reduced brittleness, demonstrating the softening effect of seepage pressure.

Under seepage-stress coupling, the non-continuous pores within the specimen undergo a sequential process of closure, opening, evolution, and penetration due to external force and seepage pressure. This leads to a gradual loss of bearing capacity of sandstone. The axial stress-axial strain curves reveal that sandstone specimens experience distinct deformation stages: pre-peak pore compaction, elastic deformation, plastic deformation, and residual strength deformation leading to failure. The volumetric strain curves show that specimens transition through volume compaction and volume expansion before complete fracture. Higher seepage pressure results in greater volumetric strain and reduces the stress required for expansion.

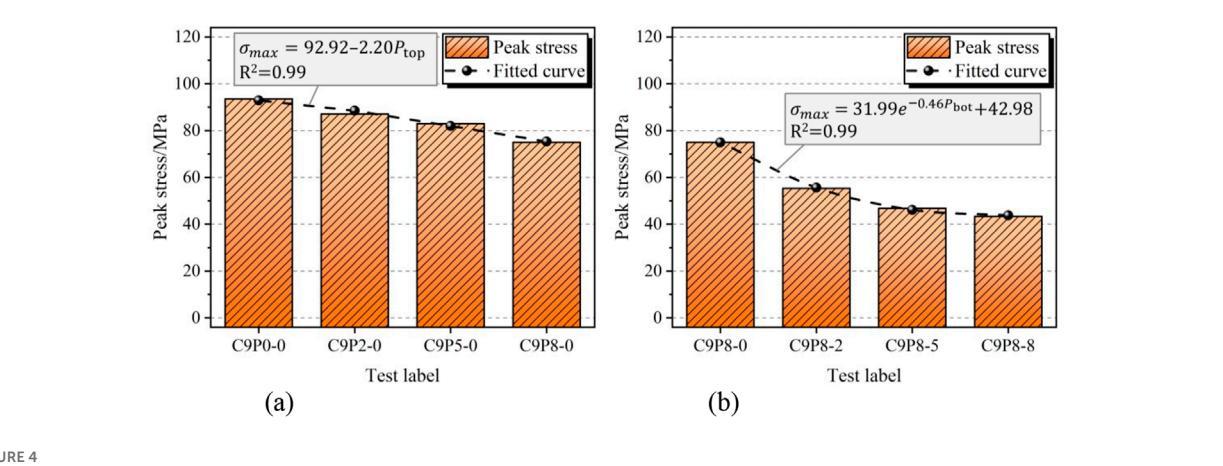
Figures 4a,b present histograms that compare the peak stress of sandstone specimens subjected to different levels of seepage pressure, highlighting the influence of seepage pressure on mechanical behaviours of sandstone. The peak stress of the sandstone specimen decreases with increasing top seepage pressure, following a linear trend. In contrast, as the bottom seepage pressure increases, the peak stress decreases nonlinearly. This behaviour can be attributed to the uniform distribution of top seepage pressure inside the specimen, influenced by gravity, which causes a consistent attenuation of peak stress at approximately 2.20 MPa/MPa. However, the bottom seepage pressure disrupts the internal seepage field flow, leading to a nonlinear increase in pore pressure. This effect partially counteracts the restraining influence of confining pressure, resulting in the observed nonlinear reduction in peak stress.

The histogram of peak stress of sandstone specimen under different seepage pressure conditions (a) Top seepage pressure (b) Bottom seepage pressure
