## Surface quality study of paint stripping on aircraft skins with high energy nanosecond pulsed laser cleaning

aircraft skin, laser cleaning, nanosecond pulses, area cleaning, single spot cleaning

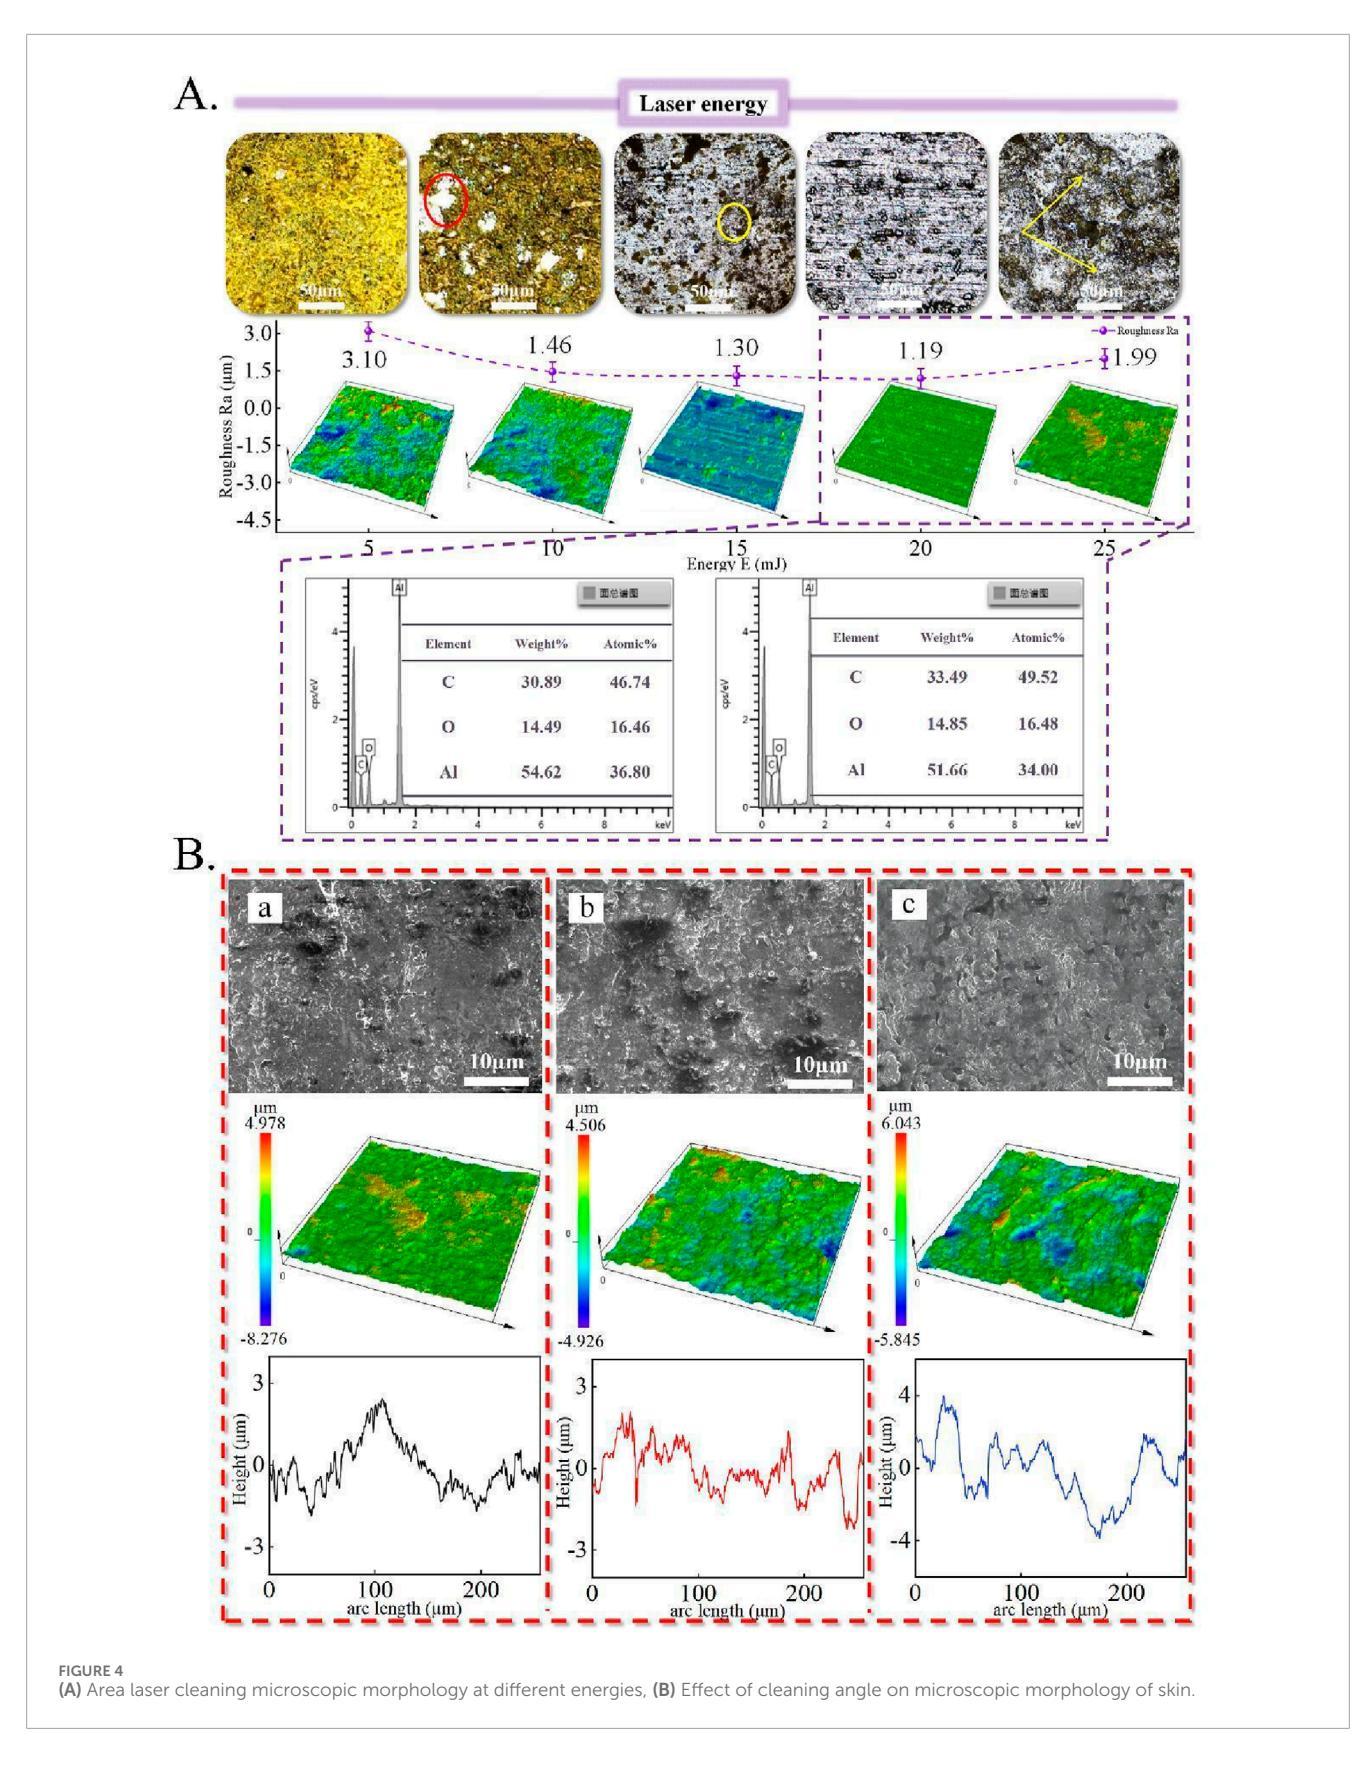
The peak power densities were 4.72, 9.43, 14.15, 18.87, and 23.58  $MW/mm^2$  for the experimental single pulse energy range of 5 mJ–25 mJ, while the cleaning effect became more and more prominent, as shown in Figure 3 below.

When the single pulse energy reaches 10 mJ, it can be seen that part of the yellow primer has been completely removed, and the white substrate begins to appear, indicating that the cleaning threshold of the paint layer has been reached at this time, which is 9.43 MW/mm<sup>2</sup>; Upon scaling the single pulse energy to 20 mJ, an entire surface paint layer of the aircraft skin can be effectively and wholly removed, manifesting an optimal cleaning outcome bereft of observable impairments. However, as the laser energy escalates to 25 mJ, the cleaning domain begins to manifest evident instances of pinpoint and streak-based damage. This outcome stems from the peak power density surpassing the threshold for laser cleaning-induced impairment.

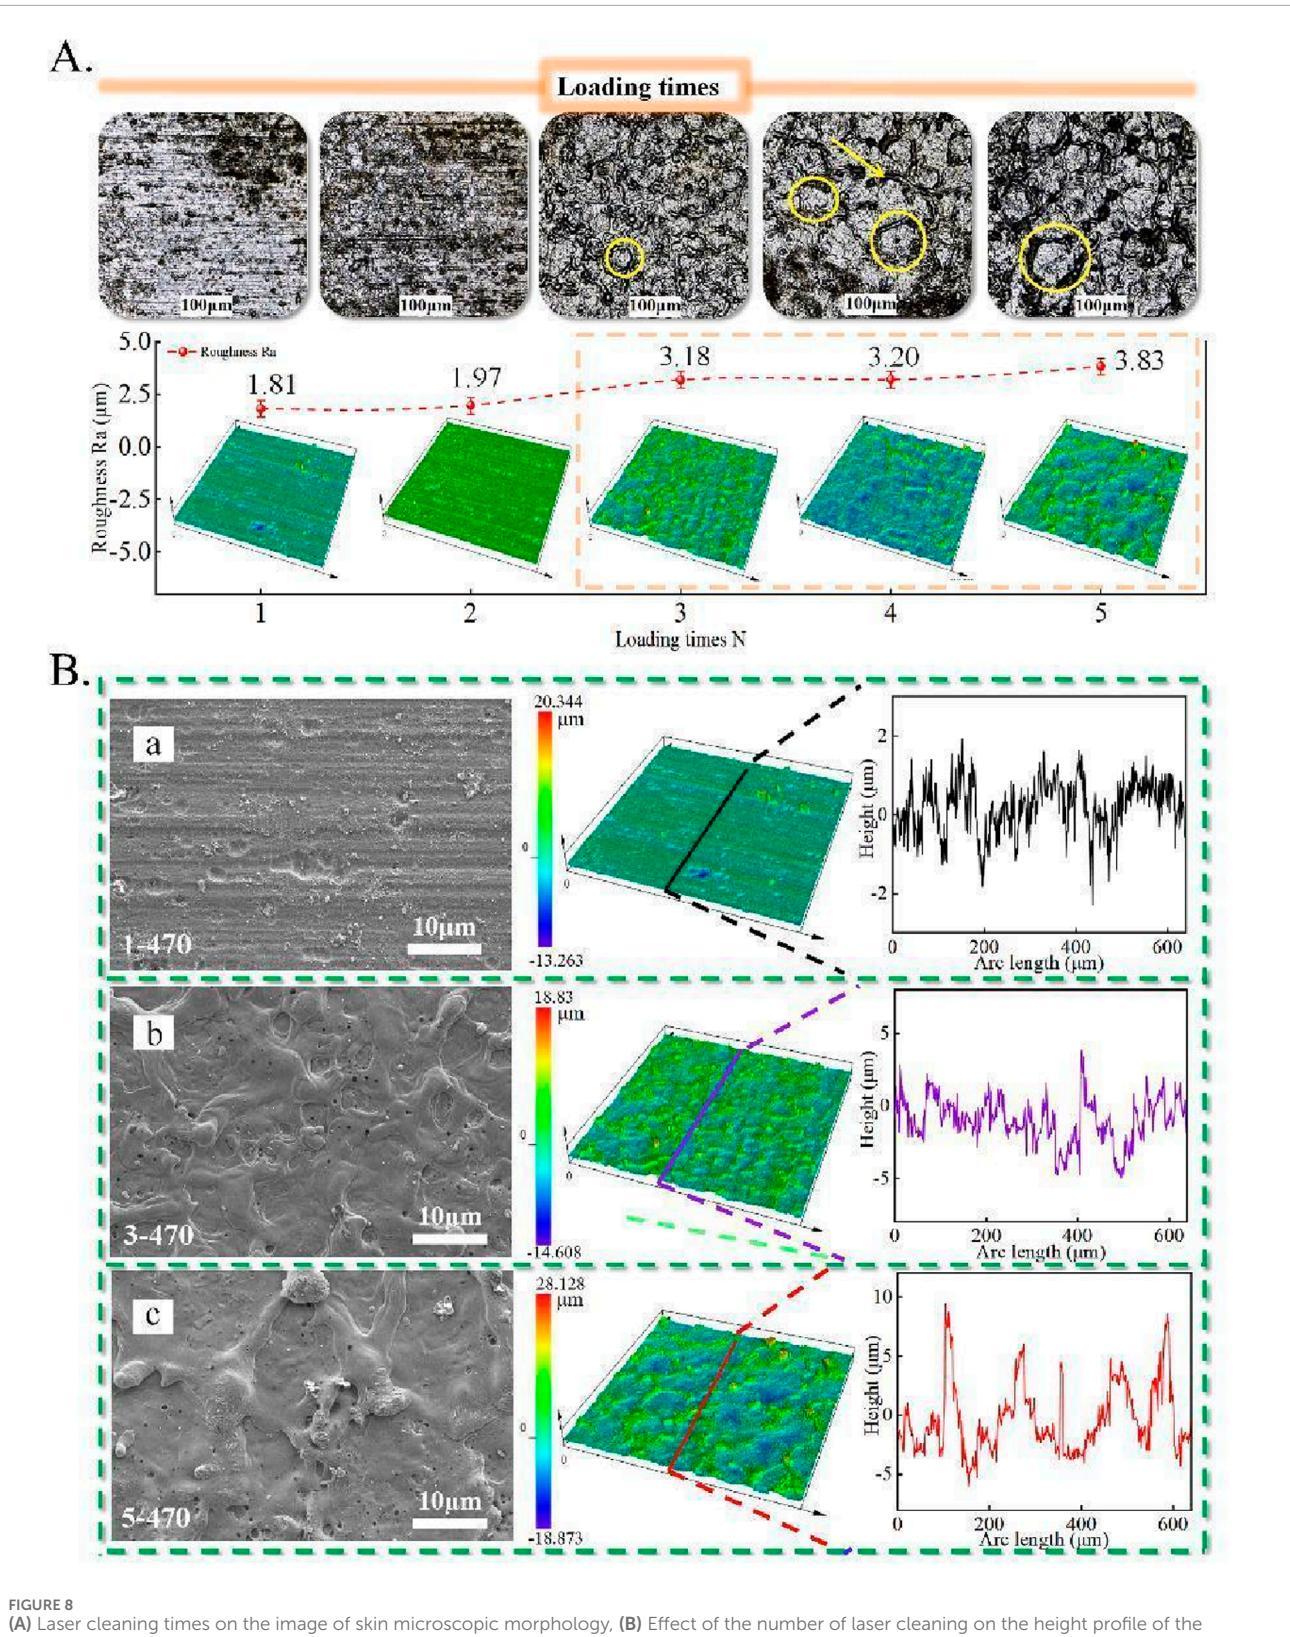
(A) Laser cleaning times on the image of skin microscopic morphology, (B) Effect of the number of laser cleaning on the height profile of the skin surface.

surface micro-morphology and roughness when subjected to laser cleaning cycles ranging from 1 to 5 times. The outcomes are illustrated in Figure 8A below.

The findings reveal that after a single instance of laser cleaning, the skin's surface remains free from apparent structural damage, signifying optimal cleaning efficiency. Furthermore, with escalating

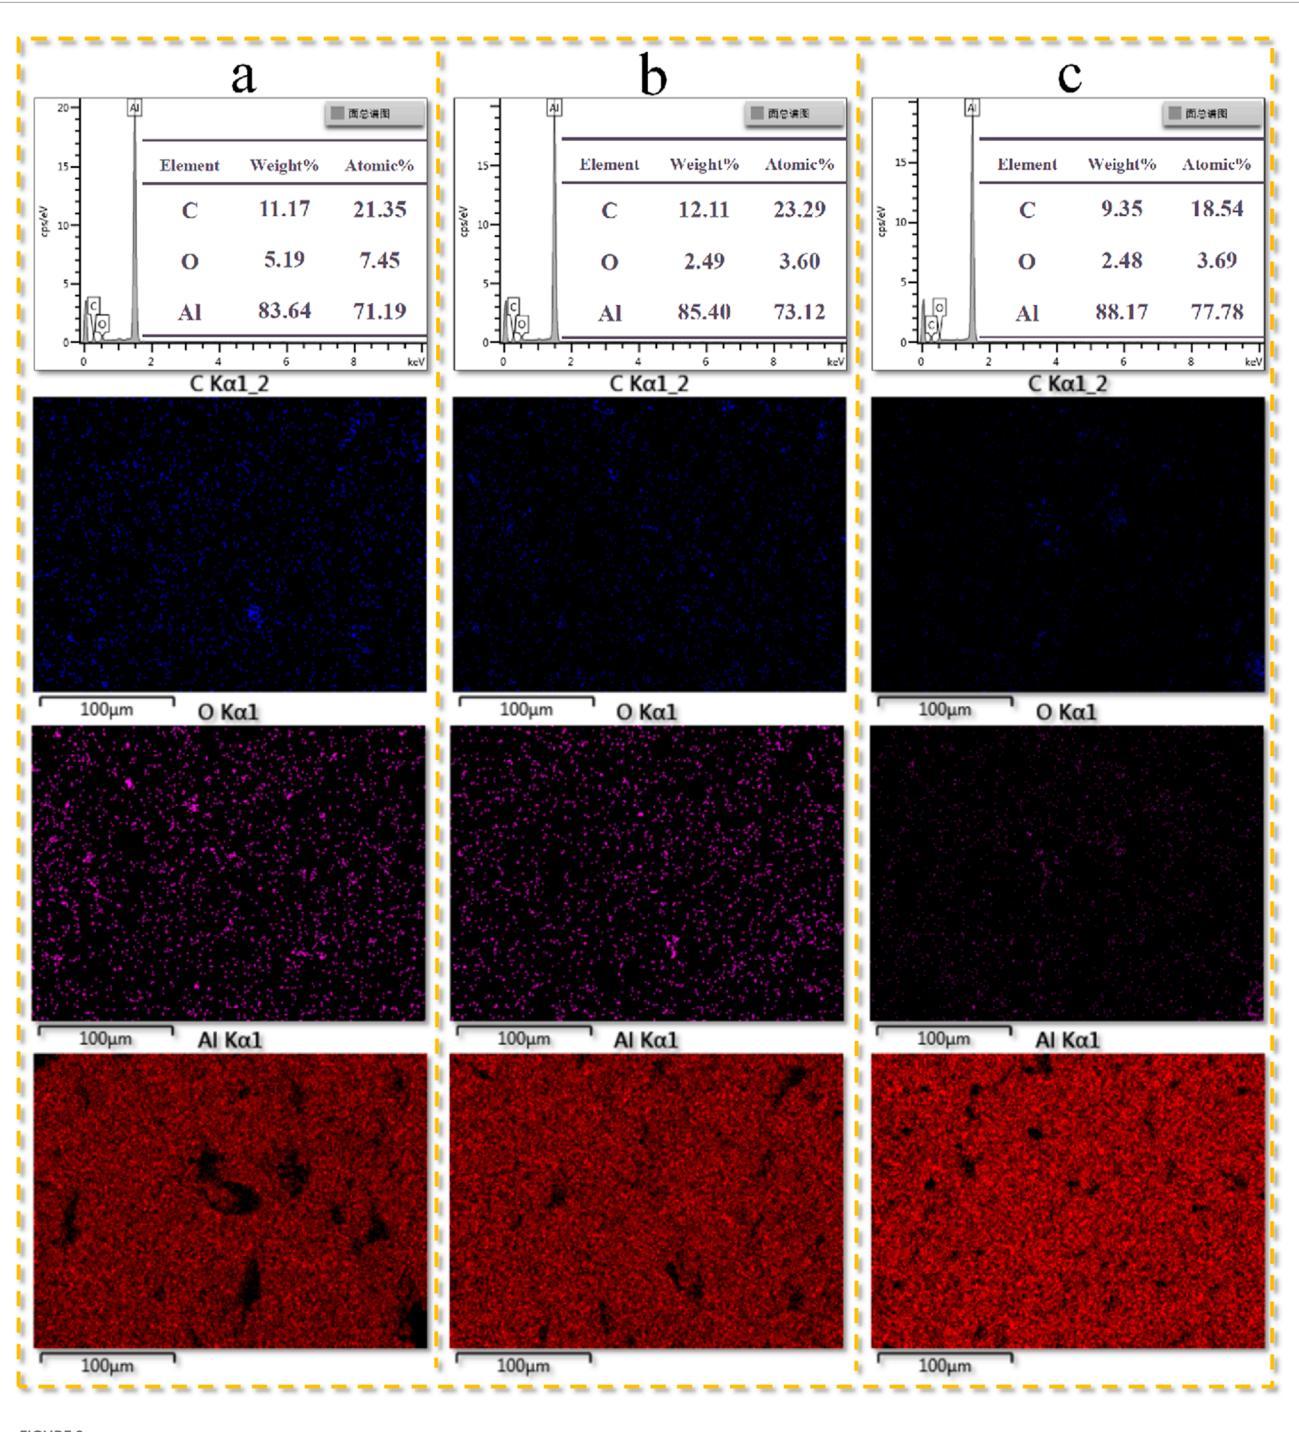
FIGURE 9

The effect of cleaning times on the content and distribution of surface elements. (A) One cleaning cycle; (B) Three cleaning cycles; (C) Five cleaning cycles.

a heightened presence of melt-induced damage becomes apparent on the skin's surface, coupled with an emerging trend of substrate detachment. Laser cleaning was performed for 1, 3, and 5 cycles, with the corresponding surface elemental distribution depicted in Figure 9. It is evident that the carbon element content on the surface exhibits an

initial increase followed by a subsequent decline with varying pulse numbers. Notably, in comparison to a single laser cleaning session, the atomic percentage of carbon element reduces by 2.81%, oxygen element by 3.76%, while the atomic percentage of aluminum element increases by 6.59% following five successive cleaning cycles. These outcomes underscore that augmenting the frequency of cleaning sessions can effectively enhance the overall cleaning efficiency.

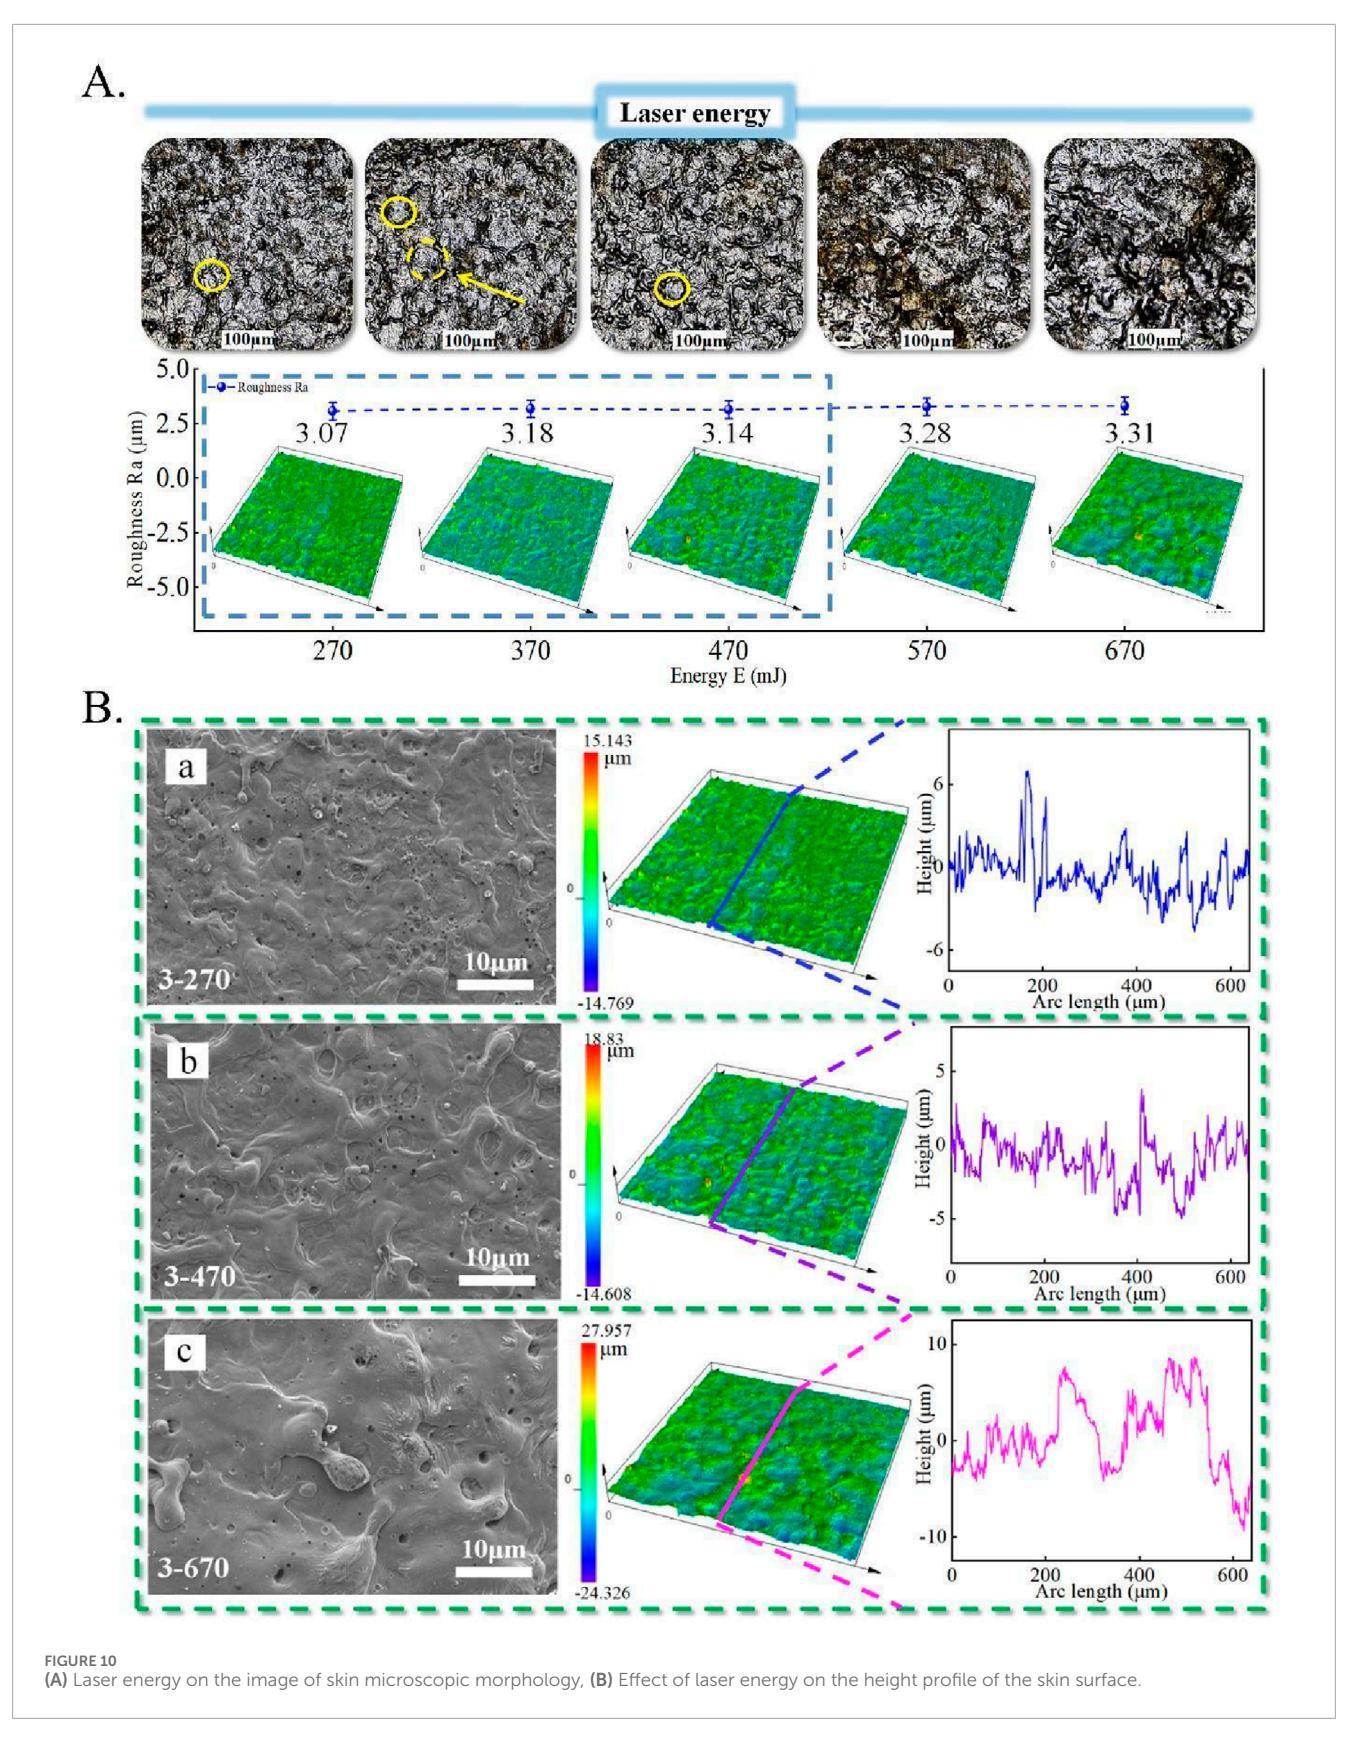
The microscopic morphology of the cleaned surface was examined at single pulse energies of 270, 370, 470, 570, and 670 mJ, as depicted in Figure 10A below.

The investigation revealed that a pulse energy of 270 mJ initiated damage to the skin substrate, manifested as densely distributed,

molten-sputtering, crater-like structures. As energy escalated to 570 mJ and 670 mJ, surface damage experienced substantial augmentation, rendering the system chaotic and challenging to discern, with the surface cloaked in black residue. The 3D morphology diagram unveiled a progressive emergence of skin surface damage structures as energy levels rose, concomitant with a gradual increment in surface roughness. Notably, the minimum surface roughness was attained at 270 mJ, measuring 3.07 µm.

In addition, at laser energy levels of 270, 470, and 670 mJ, the surface height differences are 29.912, 33.438, and 52.283  $\mu$ m, respectively. These results indicate that surface damage experiences a sudden increase once the energy surpasses a specific threshold value, as illustrated in Figure 10B below.

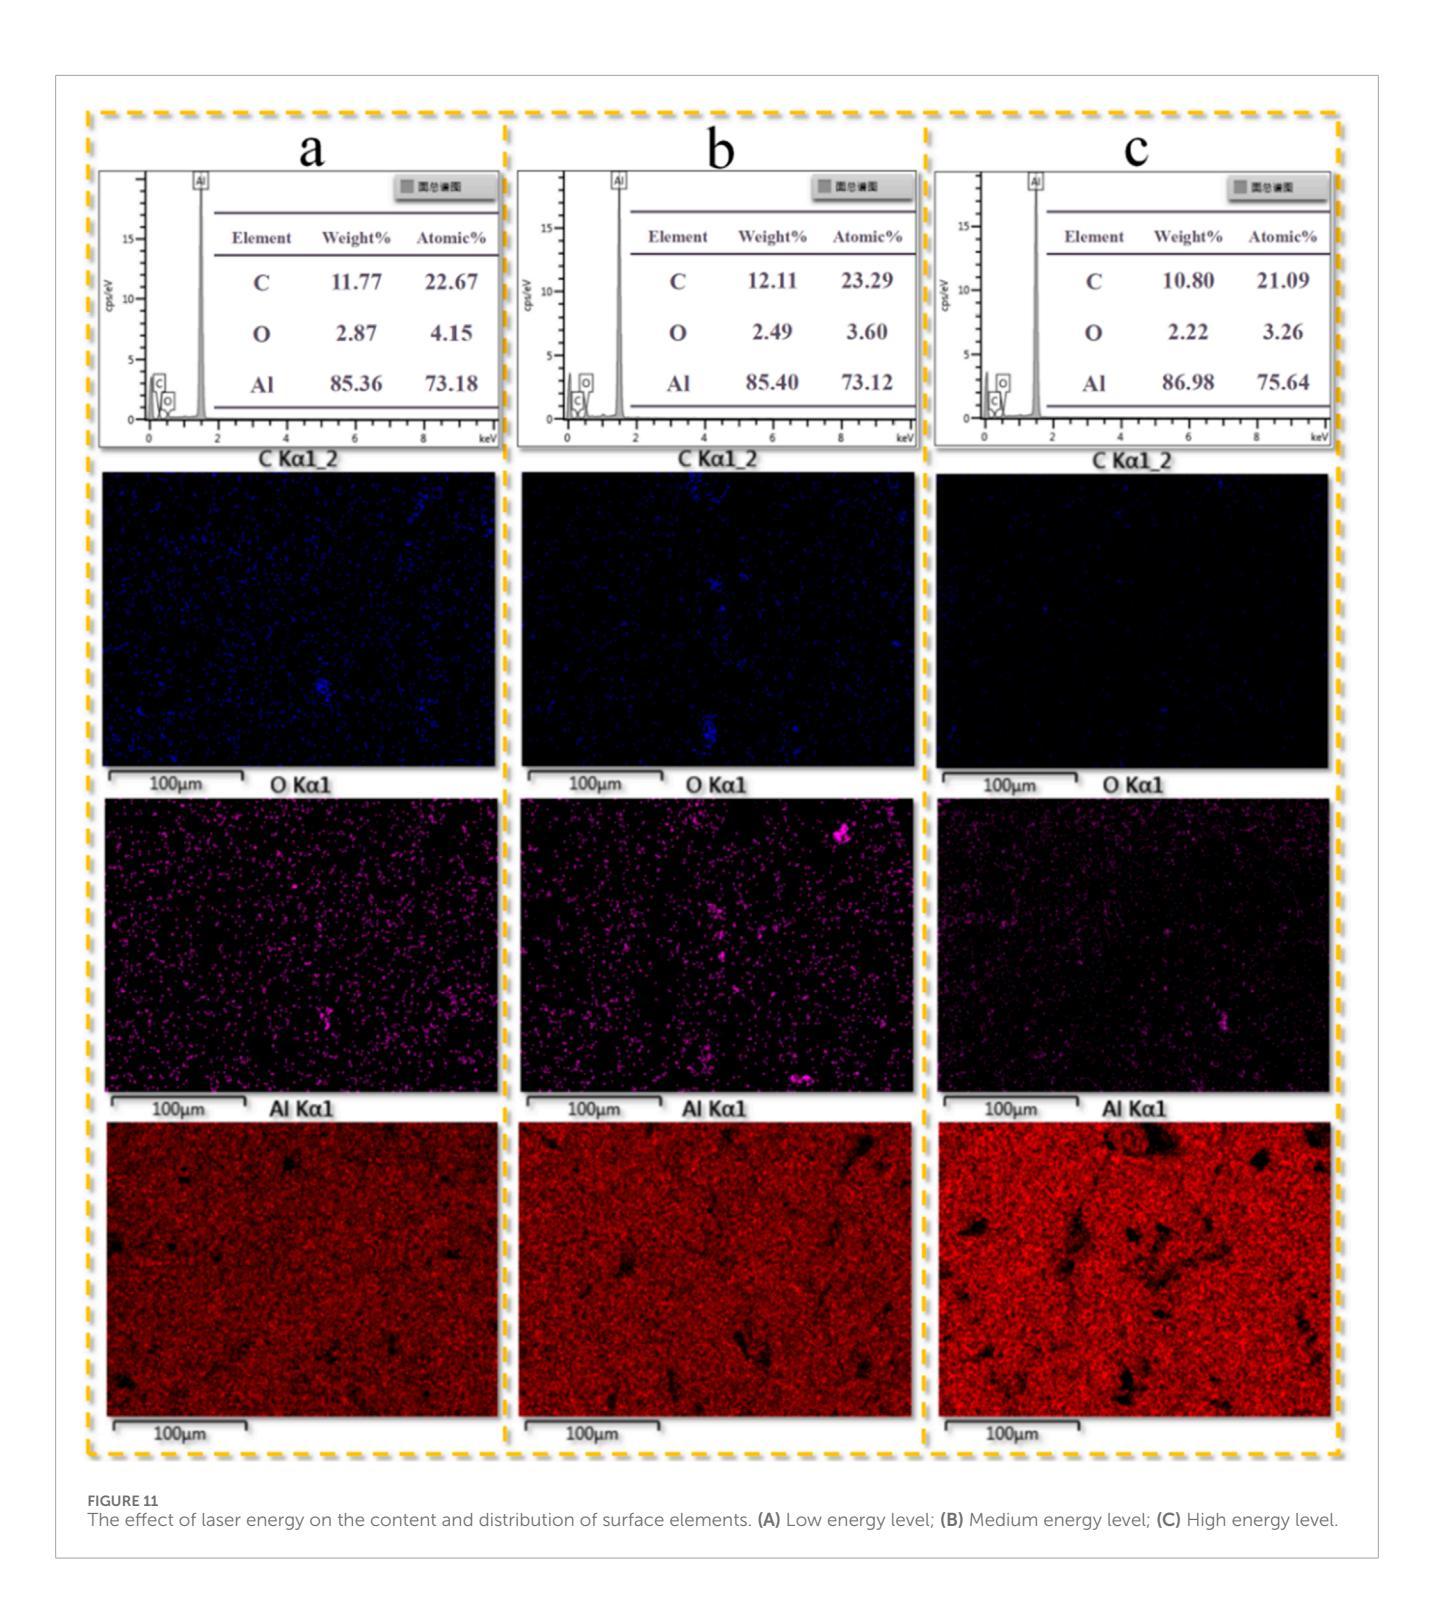
The elemental distribution on the skin's surface is depicted in Figure 11 below. The observations reveal a slight initial rise followed by a significant decline in surface carbon content as energy levels increase. Simultaneously, the content of elemental oxygen exhibits a gradual reduction, while the content of elemental aluminum experiences a noteworthy escalation. In terms of atomic percentages, a collective decrease of 1.58% and 0.89% is observed for carbon and oxygen elements, respectively, alongside a rise of 2.46% for aluminum elements. These outcomes suggest that elevated energy levels might induce the disruption of the alumina film, thereby exposing the substrate and engendering alterations in surface elemental composition.

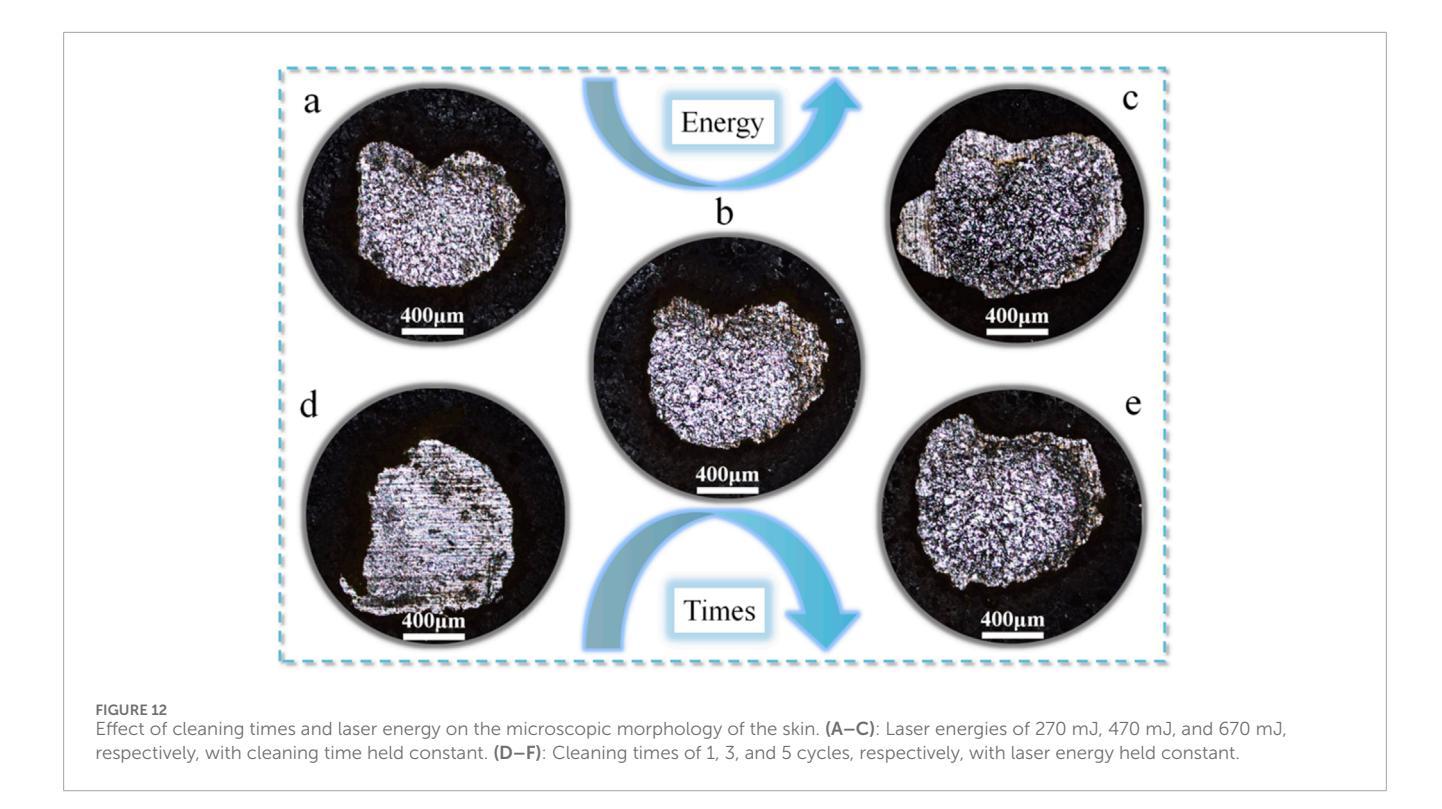
A comparison of the effects of different cleaning times and energies on the microscopic morphology of the skin surface postcleaning is presented in Figure 12 below. Keeping other variables constant, graphs (a), (b), and (c) correspond to laser energies of 270, 470, and 670 mJ, respectively, while graphs (d), (e), and (f) represent cleaning times of 1, 3, and 5 times, respectively. The findings indicate that as energy gradually increases, the substrate surface damage structure remains relatively unchanged, yet the heat-affected area due to laser cleaning significantly expands. Therefore, it can be concluded that an increase in the number of cleaning cycles does not notably influence changes in the laser cleaning area, but it does lead to a significant increase in surface damage.

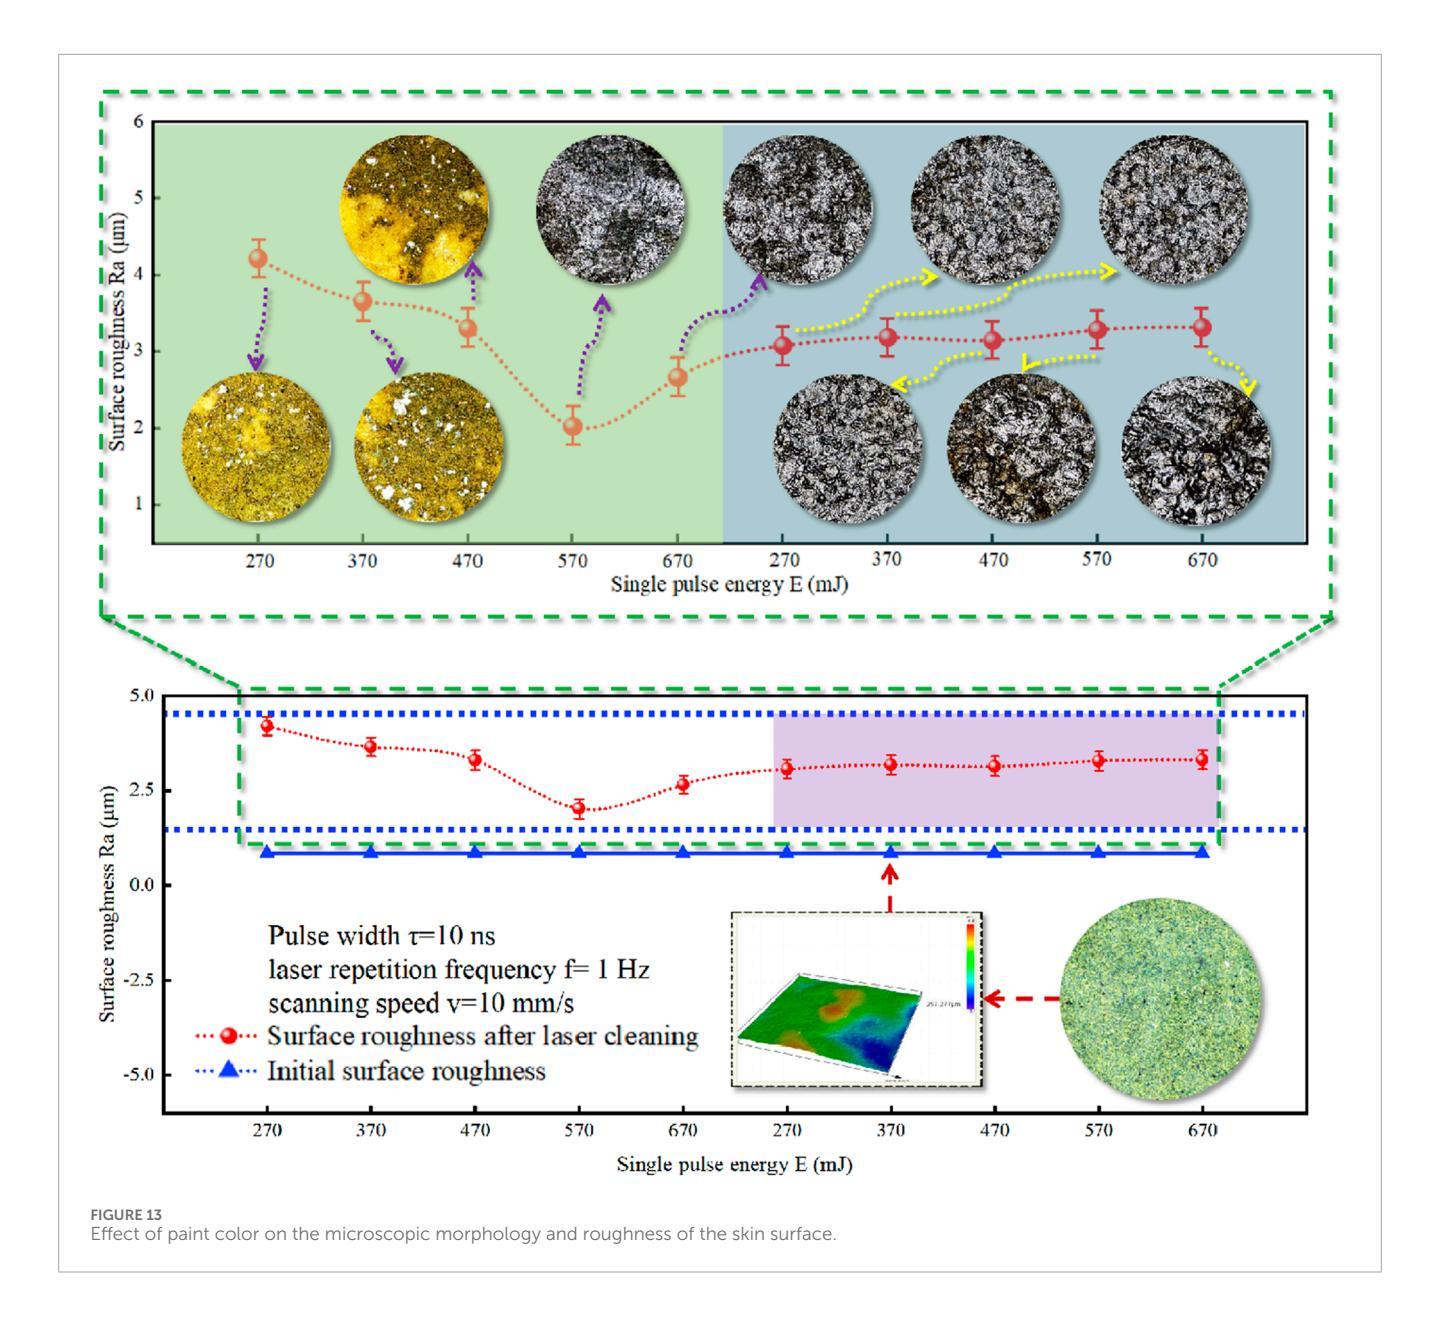
Laser cleaning experiments were conducted on aircraft skins of different colors using energies ranging from 270 mJ to 670 mJ. The results obtained through confocal microscope observation are presented in Figure 13 below.

Within the energy range of 270 mJ–470 mJ, complete removal of the surface paint layer from the green aircraft skin was not achieved. Significant paint residues were visible on the cleaned skin's surface. Thorough cleaning was achieved at an energy level of 570 mJ, while substrate damage occurred at 670 mJ. In contrast, complete surface cleaning was achieved at a laser energy of 270 mJ when cleaning the blue skin. With increasing energy, surface damage gradually escalated. Across laser energies of 270 mJ–670 mJ, the associated surface roughness for green skin cleaning stood at 4.2, 3.65, 3.30, 2.02, and 2.66  $\mu$ m, respectively. For blue skin cleaning, the corresponding surface roughness values were 3.07, 3.18, 3.14, 3.28, and 3.31  $\mu$ m. To further comprehend the influence of paint color on cleaning outcomes, subsequent experiments were undertaken.

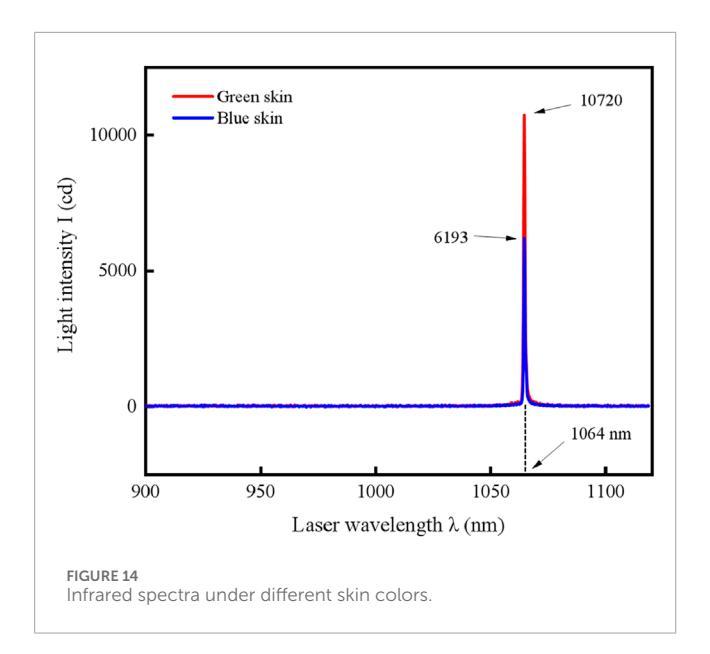
An infrared grating spectrometer was employed to measure the reflected light. Stronger received reflected light indicates lower absorption capacity of the paint layer towards the laser, while weaker received reflected light signifies stronger absorption

capability of the paint layer towards the laser. To ensure the efficiency and precision of the infrared spectrometer acquisition, the laser's repetition frequency for this experiment was set to 200 Hz, ensuring the detection probe remained consistently positioned for accurate readings.

Twenty laser cleaning experiments were conducted on both green and blue skins, respectively, with the spectrometer probe collecting reflected light waves at the same position. Finally, the spectra depicting absorbed light intensity versus laser wavelength were plotted in Figure 14 below. During the laser cleaning experiment on the green aircraft skin, the reflected laser light intensity reached 10,720 cd. Conversely, in the case of the blue aircraft skin, the reflected light power was only 6,193 cd, highlighting a nearly twofold difference between the two scenarios.
